# Strategies and Actions to Recover the Landscape after Flooding: The Case of Vernazza in the Cinque Terre National Park (Italy)

School of Architecture and Design “E. Vittoria,” University of Camerino, 63100 Ascoli Piceno, Italy

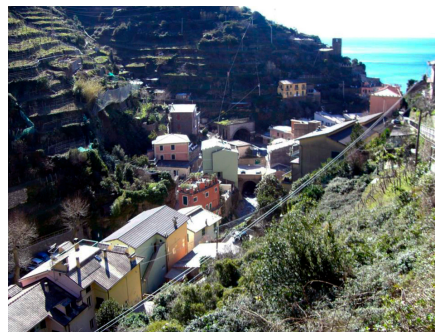
**Figure 3.** The settlement along the Vernazzola stream and the hillside terraces.

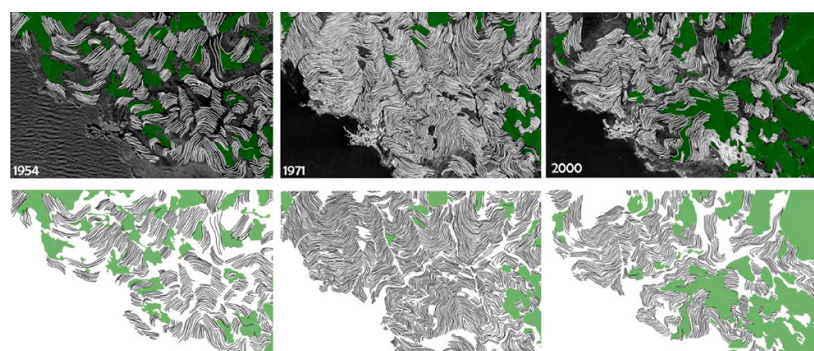
**Figure 4.** Historical evolution of the landscape. Aerial photos from the Italian Military Geographical Institute flights: 1954; 1971; 2000.

The 1954 flight renders a territory widely used for agriculture with the technique of terracing. However, natural areas with forest vegetation can be seen. With the 1971 flight, a strong expansion in terracing can be seen, which extends throughout the territory, eliminating nearly all the natural areas. Starting in 2000, a decided decrease in cultivated areas can be seen, with the consequent abandonment of terraces and their degradation, along with the growth of uncultivated green areas. The orthophoto of 2015 shows the current situation: numerous abandoned terraces, with evident degradation and current or potential instability phenomena (Figures 4 and 5). Vegetation has overtaken these areas in secondary succession, leaving the olive trees abandoned, mixed with the Mediterranean macchia. A subsequent part of the study on the territorial signs was dedicated to identifying some types of terracing among the most evident or repeated.

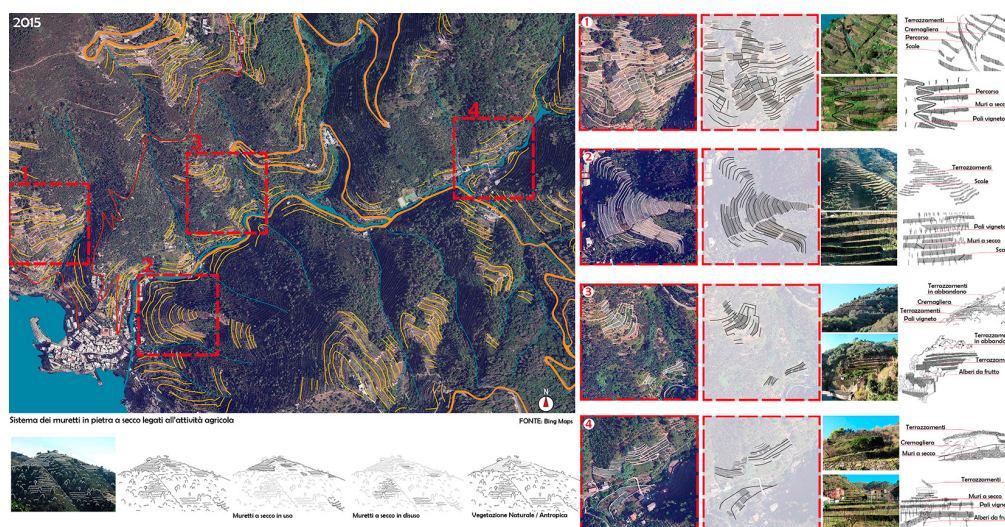
**Figure 5.** The landscape: current state. Orthophoto from 2015. In blue the Vernazzola stream and in red the different types of terracing.

The discriminating factors mainly consisted in the type of cultivation, in relation to the depth of the terraces and the means with which these were connected together. The steep stone steps tangent to the containment wall, traditionally always in dry stone, were substituted in newer terraces with a path of small ramps. These are certainly more functional in that they can also be traversed by small farming implements but they are potentially dangerous due to streams of rainwater and therefore possible flooding or landslide phenomena. Different types of terracing can be seen depending on the cultivation

practised. Grapevines are mainly cultivated on narrow terraces on very steep slopes, held back by containment walls in dry stone, flush with the plane of use. Olive trees and citrus trees are instead cultivated mainly on deeper terraces. The objective of the critical/exploratory investigation was to understand the evolution of the territory regarding land use and the related agricultural techniques. This revealed a tendency toward the progressive abandonment of the typical agricultural terraces, with possible resultant episodes of hydrogeological instability. The importance of maintaining the terrace structures not only relates to the history/landscape; it is also practical for protecting the stability of the land.

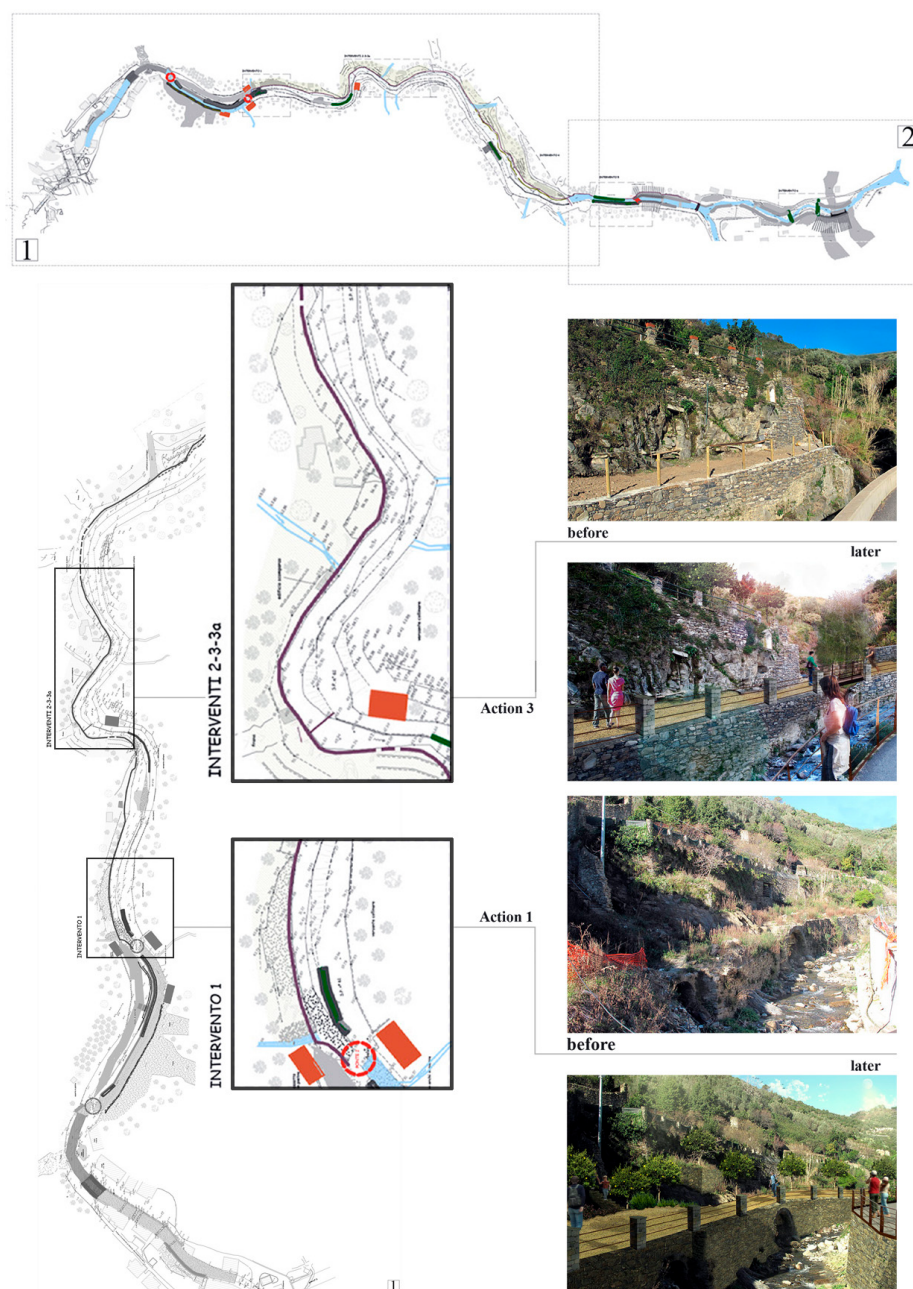
Figure 7. Masterplan.

The masterplan spatially specifies the guidelines and also systematizes and makes coherent specific actions and categories of intervention. It represents a single technical/operational design that conceptually and graphically renders the works to be realized. Coherent with the type of area identified in the critical/evaluation phase, the masterplan identifies the technical interventions to be made, in harmony with the appearance and historical/cultural values of the entire territory. Each individual intervention resolves a problem technically and contributes to recovering and enhancing the wider landscape. This links to the system of terracing, pedestrian crossings, the mitigation and environmental/landscape character of the natural engineering works realized. It leads to a role of design synthesis between the large and small scales of cultural values of the UNESCO heritage under consideration and of the entire methodological and cultural approach of the research (Figure 7).

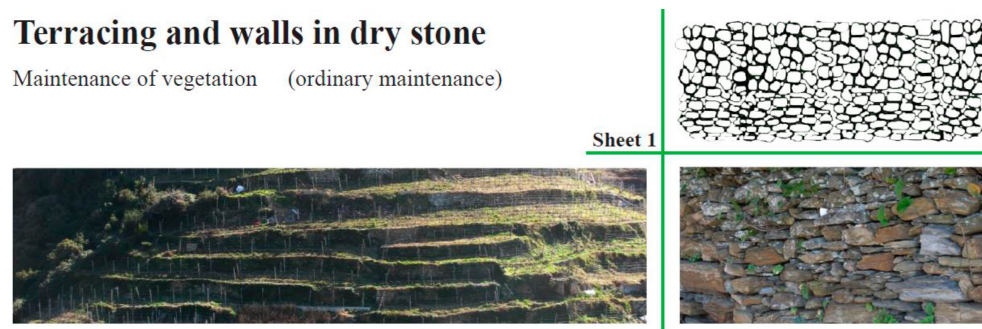
(a)

All the interventions listed below are aimed at the correct structural and architectural maintenance of dry containment walls for agricultural terraces. Their maintenance is of primary importance in securing the hillsides from landslides. It is also important to maintain the original structures and propose traditional techniques for building new walls in order to maintain the identifying characteristics of the territory.

**Figure 8.** (a). Sheets of the intervention types. List of actions; (b) Sheets of the intervention types. Ordinary maintenance actions of the walls.

These sheets identify the different types of intervention possible as a function of the instability to be counteracted. They also describe the main details of the project, indicating the materials used and the finishing works, always following the general strategy of protection, conservation and enhancement of the cultural and landscape heritage of the territory. In this sense, the types of intervention possible as a function of the instability to be counteracted do not foresee excavations or other modifications of the local morphology. In harmony with what emerged in the analytical/exploratory and critical/assessment phase, the specification sheets were drafted for the following types and elements of the anthropic/landscape system: terraces and walls in dry stone, traditional agriculture, historical constructions/buildings, railings, levees and riverbanks, weirs and crests. By way of example and methodology, the following lists the planning actions suggested for the type of terrace and dry stone wall (Figure 8a,b).

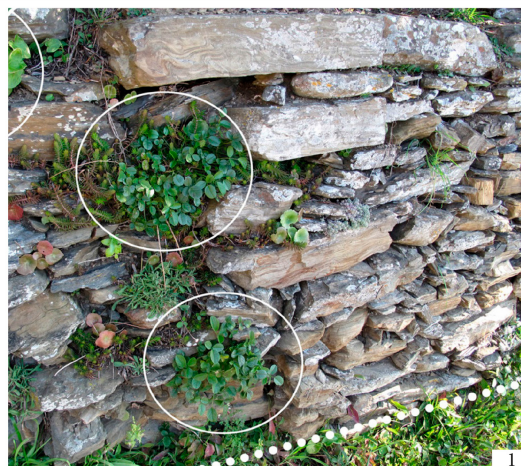
**1. Weeds growing in the cracks.**  
To be removed.

In order to ensure the stability of the wall, the possibility of removing brush growing in the cracks of the wall should be carefully evaluated. Uprooting it could, in fact, cause structural failure or collapse. In this case, protruding branches can simply be pruned.

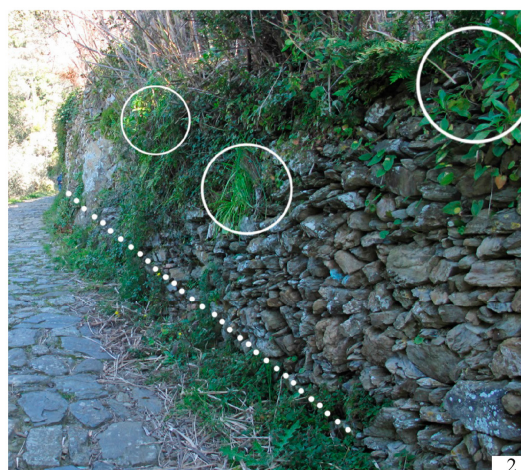
**2. Weeds/brush**  
The vegetation growing at the foot of the wall and on the coping should be pulled out to enable the drainage of rainwater and maintain the strength of the wall itself.

It is necessary to remove weeds and brush at the foot of the wall, where the small canal is located to collect and remove superficial stream water flowing on the terrace planes. To correctly maintain water runoff, this should be free of obstacles (stones, vegetation, various other material).
