# Seismic and Energy Retrofit of the Historic Urban Fabric of Enna (Italy)

**Keywords:** seismic retrofit; energy retrofit; historic urban fabric

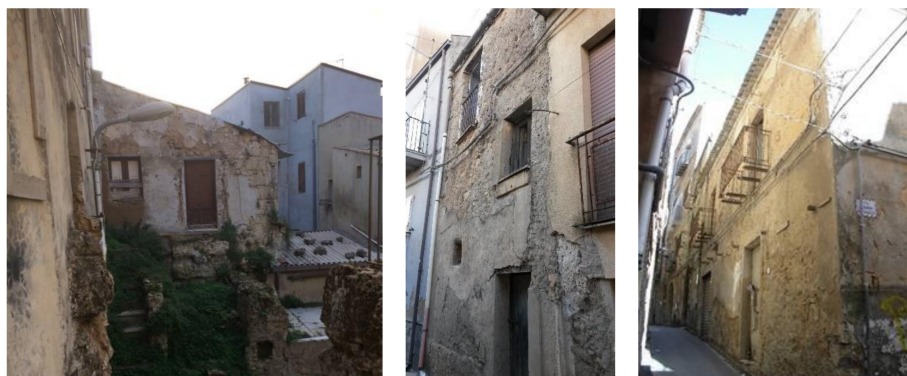
Figure 2. Examples of abandoned and partially collapsed buildings in the historical centre of Enna.

The lack of use of most building in the historic centre eventually caused partial collapses (Figure 2).

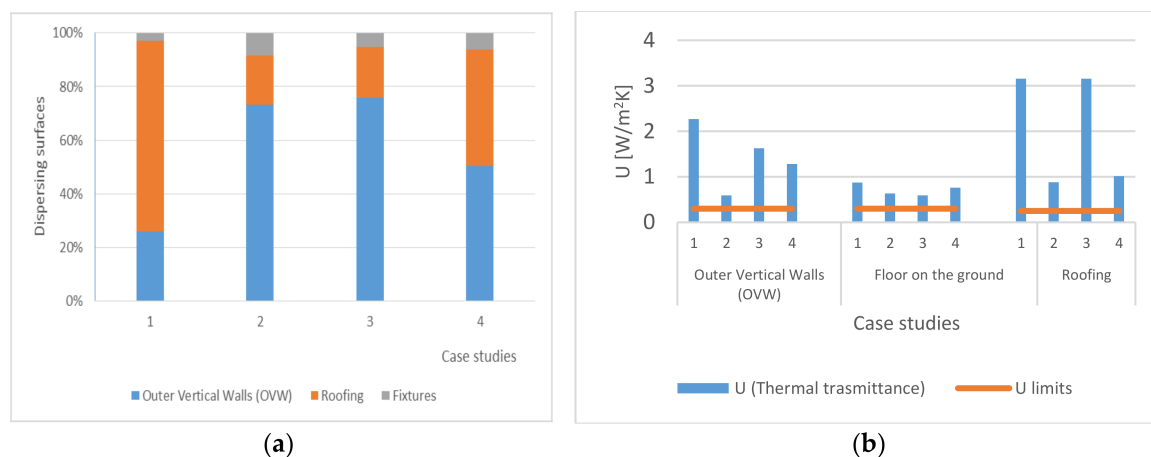
From the comparison of the thermal transmittances obtained for the various technical elements of the envelope with the performance requirements, according to the current regulations, the thermal transmittance values were found to be considerably higher than the threshold values, as shown in Figure 8b.

**Figure 8.** (a) Surface percentages of the various technical elements of the envelope on the total surface; (b) Thermal transmittance of the technical elements of the envelope of the considered case studies.

The elements with higher heat losses were the roofing (maximum value  $3.22 \text{ W/m}^2\text{K}$  for cases No. 1 and 3) exceeding from 4 to 15 times the threshold thermal transmittance, equal to  $0.25 \text{ W/m}^2\text{K}$ , and the walls (maximum value  $2.25 \text{ W/m}^2\text{K}$  for case No. 1), exceeding from four to seven times the threshold value of  $0.3 \text{ W/m}^2\text{K}$ . Only in case No. 2, for the walls ( $0.61 \text{ W/m}^2\text{K}$ ), which exceeded by only two times the threshold value, as this building had experienced energy improvement interventions with internal insulation.

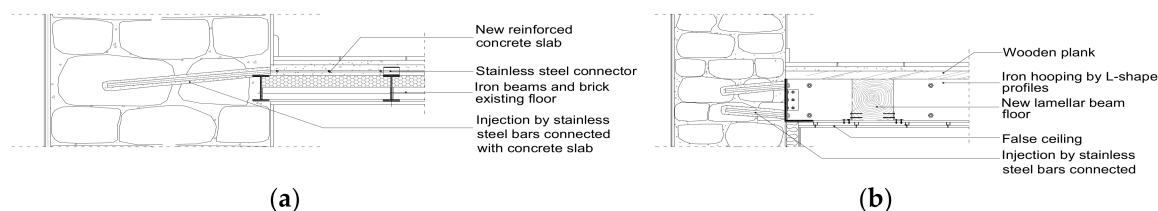
In the case of the maintenance of existing steel floors, stiffening interventions have been provided from the extrados by means of reinforced concrete slabs, connected to the masonry through injections with stainless steel bars (Figure 10a).

**Figure 10.** Connection interventions between walls and slabs.

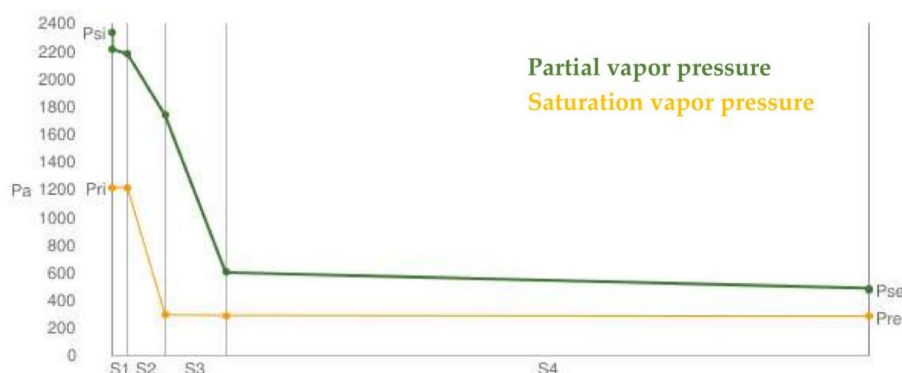
To verify this, a calculation by means of a Glaser diagram was performed and Figure 11 shows the results.

Figure 11. Glaser diagram of the proposed retrofit solution for Case No. 4.

This solution was able to reach the performance standards required by law ( $U = 0.279 \text{ W/m}^2\text{K}$ ) and did not cause condensation problems in winter and mould growth.

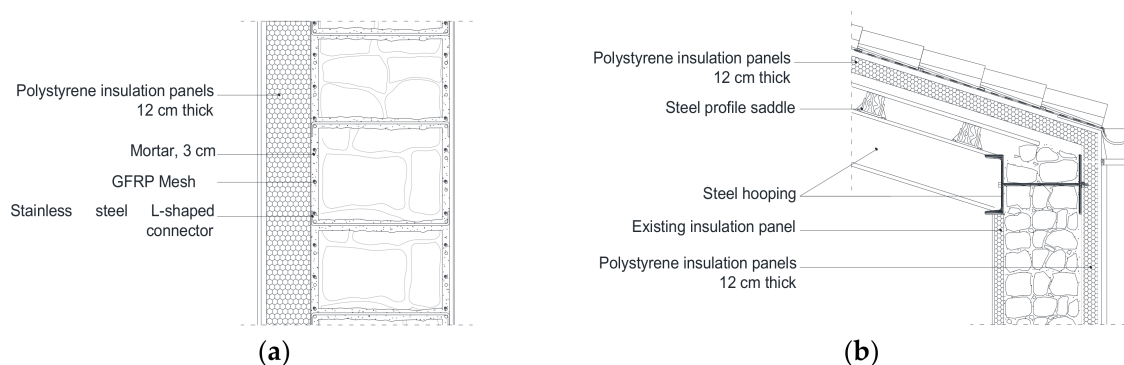
**Figure 12.** Detail of seismic and energy interventions on roofing and outer vertical walls (a) Case No. 1; (b) Case No. 2.
