Article

Sustainable Green Roof Ecosystems: 100 Years of Functioning on Fortifications—A Case Study

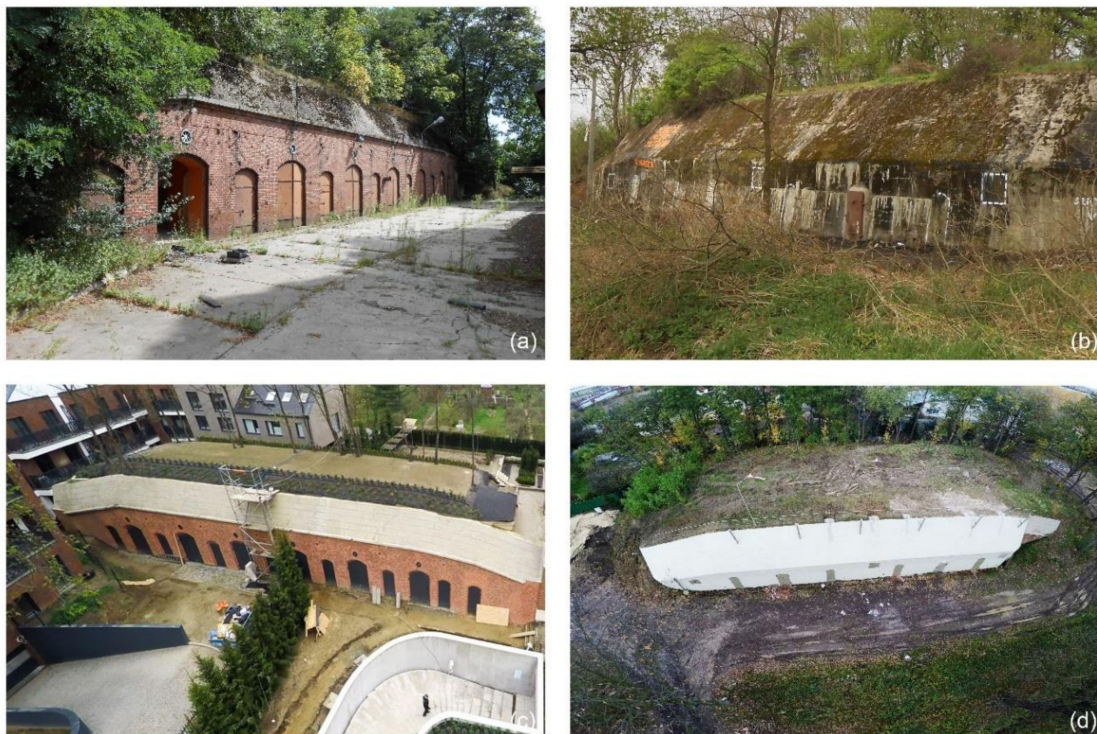
Figure 1. Examples of work that cause soil and plant ecosystem degradation of historical green roofs: (a,c) Infantry shelter before and after restoration; (b,d) infantry shelter before and during restoration works with a new green roof, Wrocław, Poland. 2012 and 2016, sourced from the author Łukasz Pardela’s archive.

Environmental aspects related to climate change often fade to the background, opening the way to dangers in the form of “idealized scenery,” resulting from the premise of restoring historic monuments to their former military glory of yesteryear. After some time, counterproductive practices come to light involving the degradation of historical sites, often resulting from a desire to tidy them up. Degradation may affect the whole area or part of it (e.g., earthworks and green roofs on buildings) regardless of the form of their conservational protection. This can last for years or can take the form of one-off incidents. As a result, there are changes in the form of soil erosion, water retention, and disturbance in plant coverage (Figure 1).

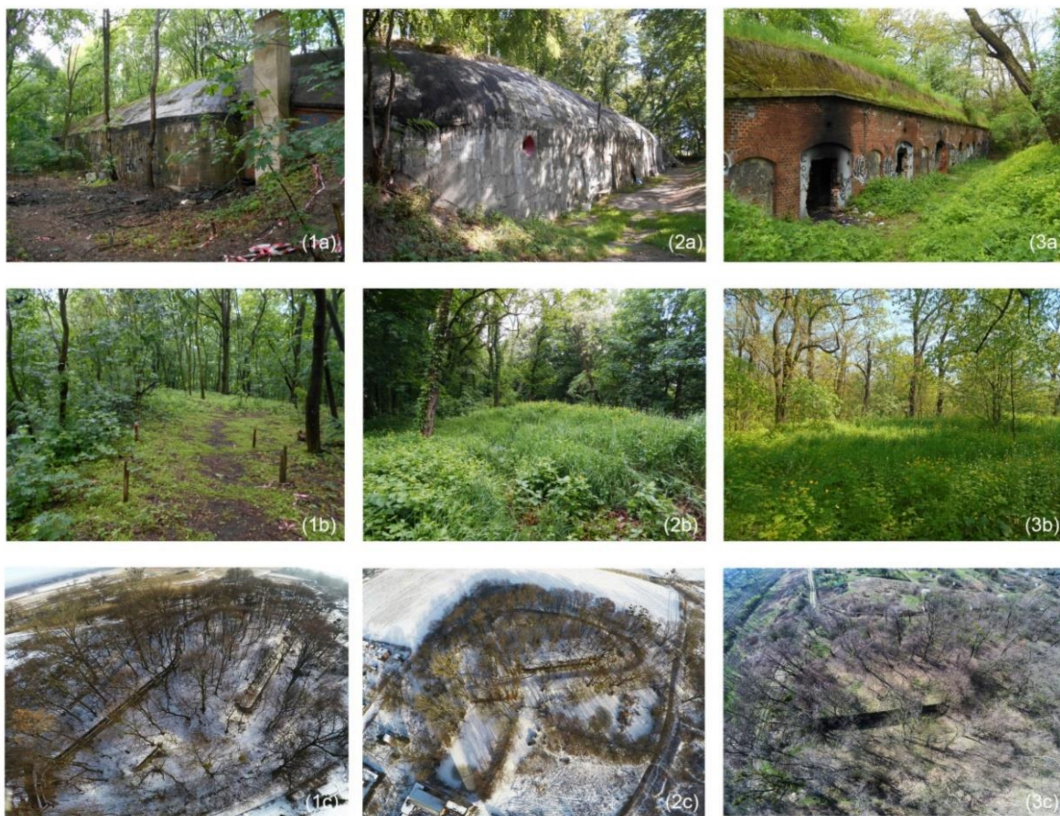
Figure 3. The green roof shelters in winter, 2016, and spring, 2019. From left: Shelter S-1 (1a–c), S-2 (2a–c), and S-3 (3a–c). Sourced from the author Łukasz Pardela's archive.

Three historical infantry shelters (more accurately referred to as ‘Infanterie Raum’) (Table 1, Figures 3 and 4), whose construction is described in literature regarding fortifications, were selected for the research [43,44].
