Reconstructing the History of Glacial Lake Outburst Floods (GLOF) in the Kanchenjunga Conservation Area, East Nepal: An Interdisciplinary Approach

Abstract: An interdisciplinary field investigation of historic glacial lake outburst floods (GLOFs) in the Kanchenjunga region of Nepal was conducted between April and May, 2019. Oral history and field measurements suggested that at least six major GLOFs have occurred in the region since 1921. A remote sensing analysis confirmed the occurrence of the six GLOFs mentioned by informants, including two smaller flood events not mentioned that had occurred at some point before 1962. A numerical simulation of the Nangama GLOF suggested that it was triggered by an ice/debris avalanche of some 800,000 m³ of material, causing a surge wave that breached the terminal moraine and released an estimated $11.2 \times 10^6 \text{ m}^3 \pm 1.4 \times 10^6 \text{ m}^3$ of water. Debris from the flood dammed the Pabuk Khola river 2 km below the lake to form what is today known as Chheche Pokhari lake. Some concern has been expressed for the possibility of a second GLOF from Nangama as the result of continued and growing landslide activity from its right la

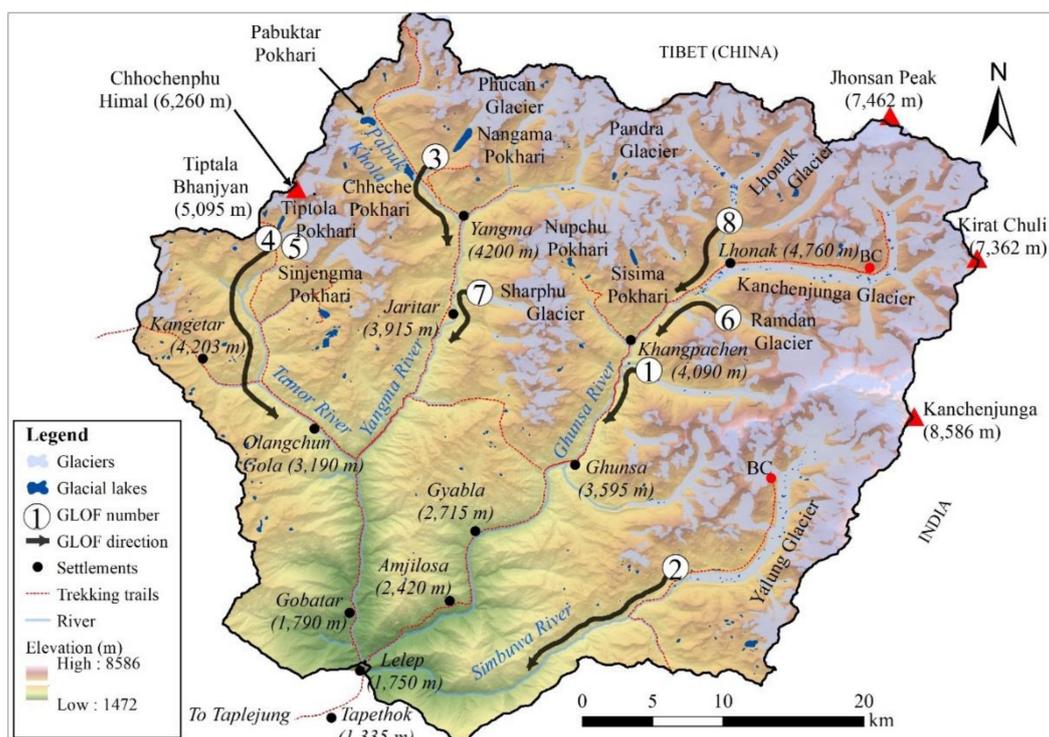
Figure 1. Map of the Kanchenjunga region, upper Tamor river basin, East Nepal, including its glaciers, glacial lakes, and contemporary glacial lake outburst floods (GLOFs).

Figure 1 and Table 3 present a list of GLOFs, date of occurrence, source, and location as recorded by the oral testimony component. In addition to the 1980 Nangama GLOF (map symbol 3), participants identified an additional five GLOFs that had occurred in the region since 1921 (map symbols 1, 2, 4, 5, and 8). Map symbols 6 and 7 refer to two additional flood events that were identified by the remote sensing component, but not mentioned by informants.

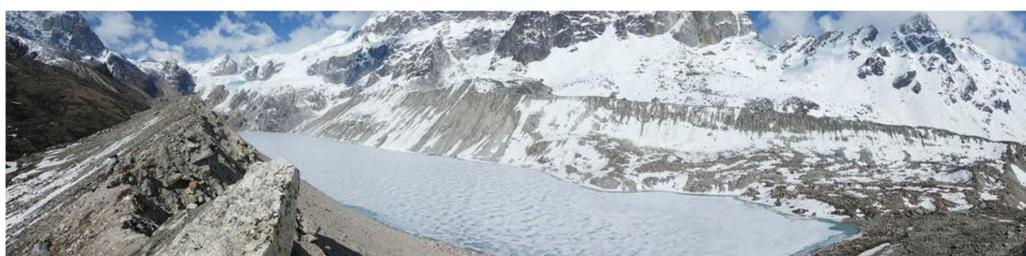
Figure 2. Nangama glacial lake from the west, May 2019 (photograph by A. Byers).

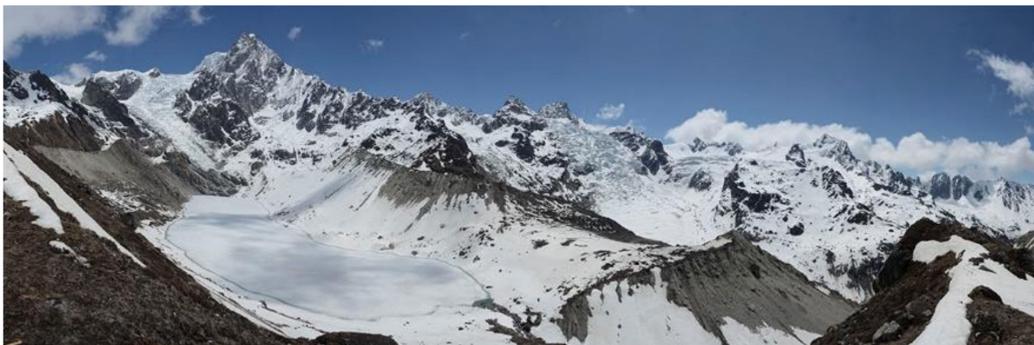
**Figure 3.** Tiptola glacial lake, May 2019 (photograph by A. Byers).

Respondents linked the cause of the 1963 and 1968 Olangchun Gola floods (map symbols 5 and 4) to icefall from Chhochenphu Himal (6260 m) (Figure 1), which fell into Tiptola glacial lake and caused a surge wave that then breached the terminal moraine. Most respondents agreed that other floods could be expected to come in the future, although it was frequently added that it is “better not to talk about such things”. People’s reluctance to discuss negative phenomena (e.g., floods, death, misfortune) is common among Buddhist-Bón communities throughout the Himalayas, as this is viewed as representing an invitation to their actual occurrence [51]. Other informants, however, expressed little concern about the possibility of future floods.

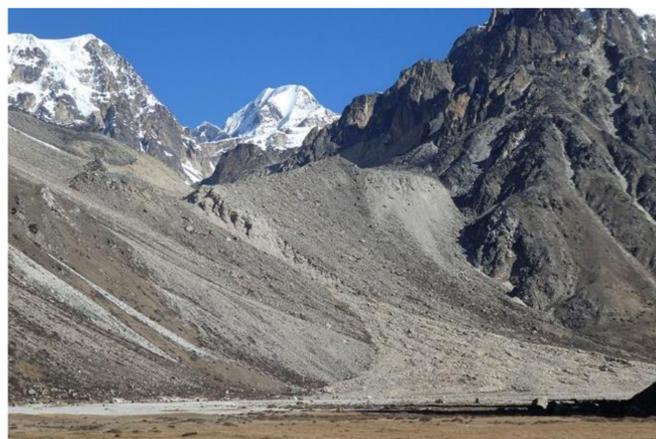
**Figure 4.** Breached terminal moraine below Lhonak glacier, source of the 1921 “Ghunsa GLOF”, May 2019 (photograph by A. Byers).

Finally, evidence of the 1921 Lhonak GLOF is abundant in Figure 12m, primarily in the form of the breached terminal moraine, massive channel scour, and deposition of debris to the north-east of the seasonal settlement of Lhonak. This particular flood is of note because of the fact that it is still remembered by people throughout the Kanchenjunga region, perhaps a testimony to both its size and amount of damage inflicted. Interestingly, reference to this event has yet to appear in any study to date that includes a table of historic GLOF events in Nepal (e.g., [5]).

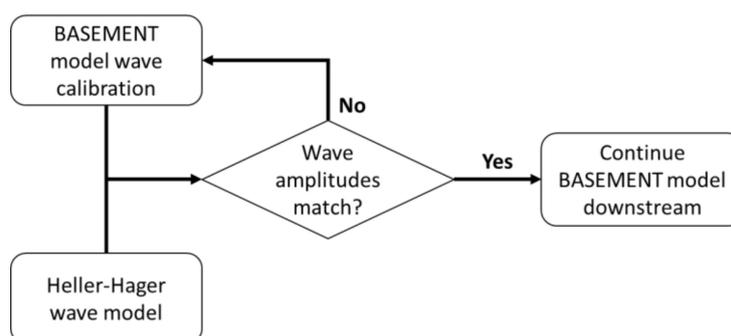
Figure 5. Flow chart of the calibration and modeling process.

Numeric Modeling: Because the Nangama GLOF—triggered by an avalanche that entered the lake and generated a large impulse wave—was among the largest of the GLOF events to have occurred in the region, a numerical simulation of the flood was performed in order to develop estimates related to triggering mechanisms, wave amplitude, and total flood volume. The Basic Simulation Environment for Computation of Environmental Flow and Natural Hazard Simulation (BASEMENT) model [30] was used for this purpose, incorporating a range of direct measurements of the Nangama terminal moraine and breach characteristics that included feature height, width, altitude, high water marks, glacier terminus condition, and new potential flood triggers. BASEMENT is a hydrodynamic model based on the 2D shallow water equations with additional capabilities for sediment transport and erosion modeling [30]. Validation of BASEMENT’s wave generation and propagation procedure was achieved by additionally employing an empirical model (the “Heller-Hager model” [31]), which uses basic morphological attributes of the lake and surrounding slopes to characterize avalanche-induced impulse waves in lakes. BASEMENT’s capabilities make it ideal for GLOF modeling [32], and a combination of BASEMENT simulations with calibration via the Heller-Hager model has been carried out on a variety of GLOFs, both for historic reconstruction and to evaluate future hazard [33–35]. The model process chain followed the following steps: (1) using the Heller-Hager model, estimating the mass of the avalanche given the wave height and morphology of the lake; (2) iteratively setting inflow conditions for the BASEMENT model to characterize the transfer of energy from the avalanche to the wave, until the wave amplitude matched that of the Heller-Hager model; (3) continuing BASEMENT model downstream under various sediment transport models to characterize moraine erosion and downstream discharge. Figure 5 depicts this process chain in a brief flow chart.

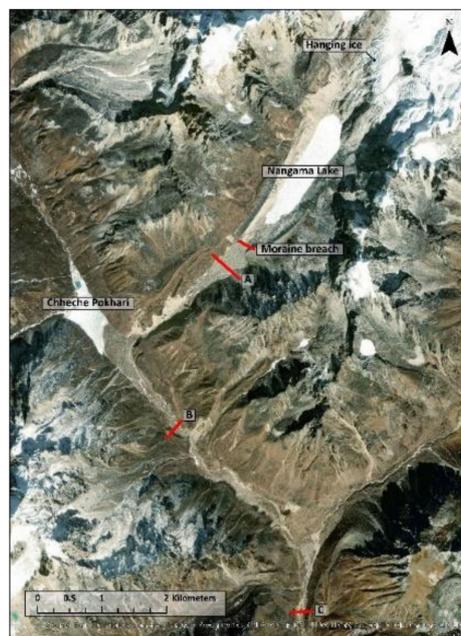
Figure 6. Overview of the Nangama Lake area, showing hanging ice (upper left), moraine breach, and cross sections (A, B, and C) used for measuring modeled discharge.

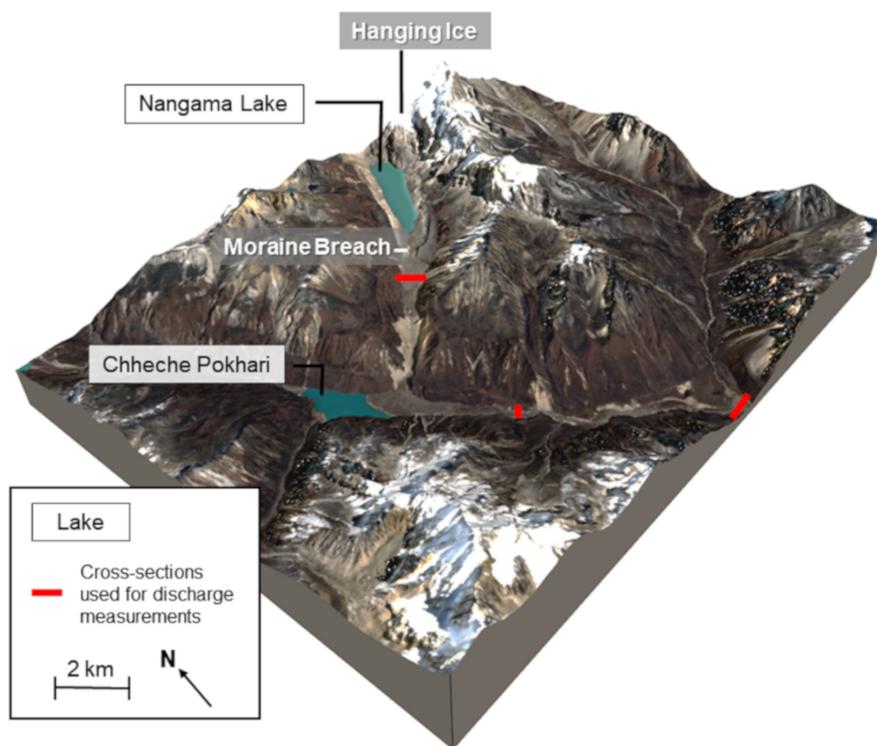
Figure 7. Block diagram of Nangama glacial lake and Chheche Pokhari after the 1980 GLOF.

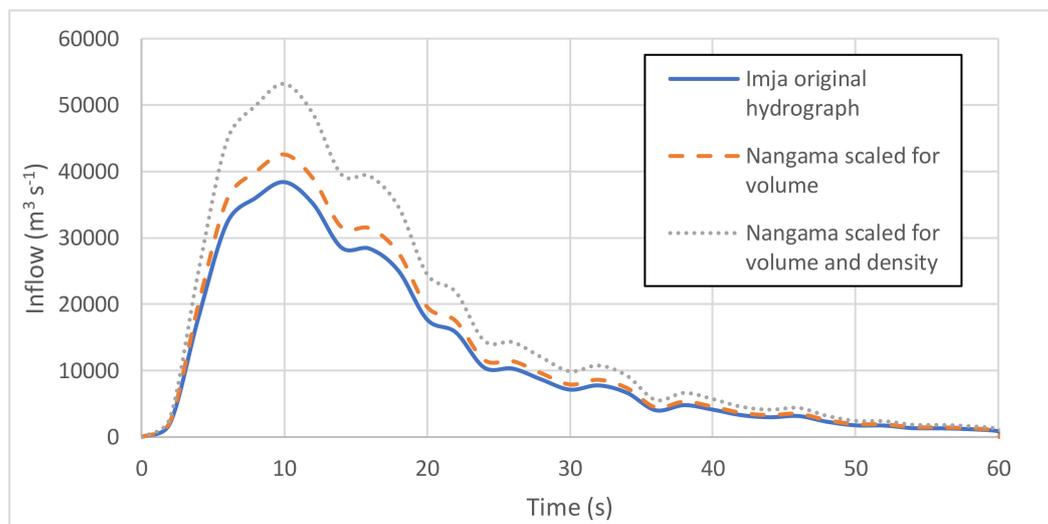
Figure 8. Mass entry rate used in Basic Simulation Environment for Computation of Environmental Flow and Natural Hazard Simulation (BASEMENT) simulations, showing the original rate from Imja Tsho [35] and scaled entry rates for Nangama.

Very little is known about the avalanche that triggered the GLOF. The volume of debris carried downstream suggests it was very large, as do reports of “fountains” (most likely wave crests) visible over the moraines by yak herders in the area following the avalanche. Judging from imagery and field visits, there was no evidence of a wave overtopping the lateral moraines, suggesting a wave height under 10 m but greater than 7 m to overtop the terminal moraine. Assuming the avalanche started from hanging ice approximately 1 km northeast of the lake (Figures 6 and 7), the Heller-Hager model estimates an avalanche volume of 800,000 m³, based on the height of the ice and slope angle between the ice and lake, to generate a wave height of 8 m (see Supplementary Materials for calculations). Lacking firsthand evidence, the rate of entry of the avalanche into the lake was adapted from a similar modeling study of Imja Tsho, a glacial lake 90 km west of Nangama [35]. The entry time series from Imja Tsho was based on a snow and ice avalanche of approximately 720,000 m³ with a density of 1000 kg m⁻³. The avalanche material at Nangama was estimated to have a slightly higher rock and debris content (~75% snow and ice and ~25% rock and debris); assuming a density of 1000 kg m⁻³ for ice and snow-dominated avalanches [33,40] and a density of 2000 kg m⁻³ for rockslides [41,42] yields an estimated density of 1250 kg m⁻³ for the Nangama avalanche. Because BASEMENT only accepts water as inflow, this difference in density was considered by simply increasing the Imja Tsho entry rate by a factor of 1.25, in addition to another scaling factor of 1.1 to account for the ratio of the Nangama avalanche’s volume to that of Imja Tsho’s (Figure 8).

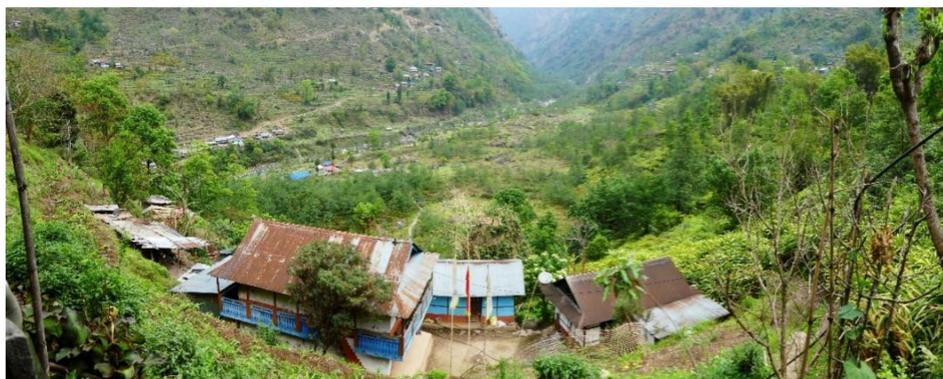
Figure 9. Village of Tapetok (1380 m) on the Tamor River. Eye witness informants claimed that the floodwaters of the 1963 Olangchun Gola 1 GLOF nearly reached the level of the houses in the foreground, or about 100 m above the river channel (photograph by A. Byers).

Other informants in the downstream village of Tapetok also confirmed that the 1963 Olangchun Gola 1 flood was by far the largest in their memory, nearly reaching their houses some 100 m above the river (Figure 9). Of additional interest is that while the 1963 flood destroyed cropland situated upon river terraces, leaving behind a layer of rubble, the 1980 Nangama flood (map symbol 3) left behind thick layers of black soil, which informants philosophically attributed to the fact that “some floods bring rocks, and some floods bring fertile soil”.

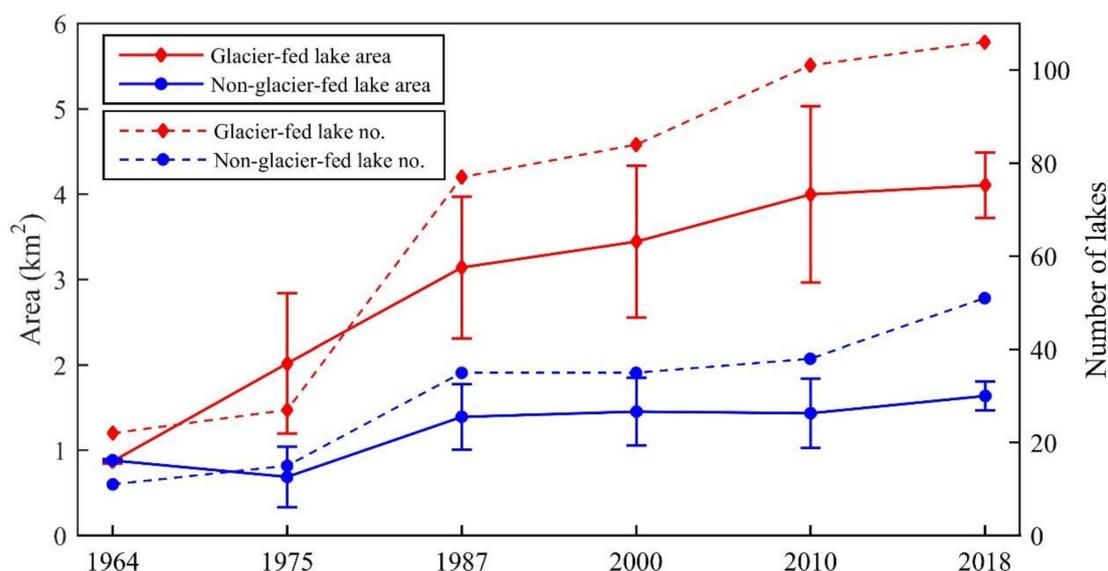
Figure 10. Changes in the total number and surface area of glacier-fed and non-glacier-fed lakes (>5000 m²) from 1964 to 2018 in the Kanchenjunga region.

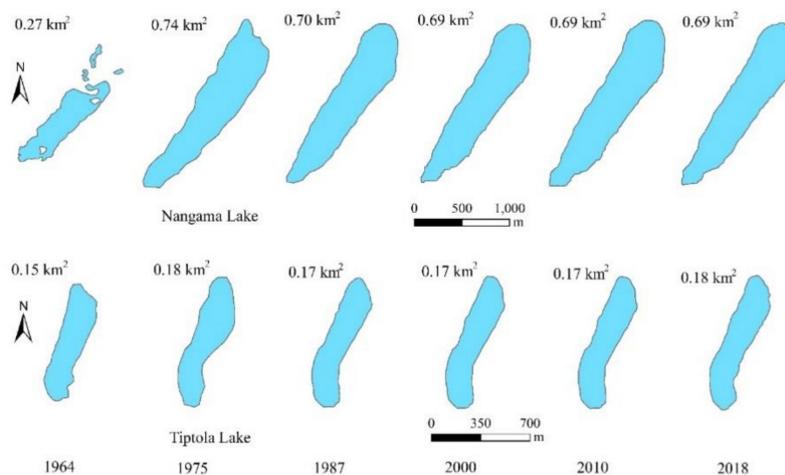
Figure 11. Growth of Nangama and Tiptola glacial lakes since 1964.

Tiptola glacial lake, source of the 1963 and 1968 Olangchun Gola floods, has likewise remained remarkably stable in size since 1975, with only a 0.03 km² increase between the 1968 event and 1975 satellite image. Because the Olangchun Gola 1 flood occurred in 1963, it is not possible to discern the growth patterns from before that time.

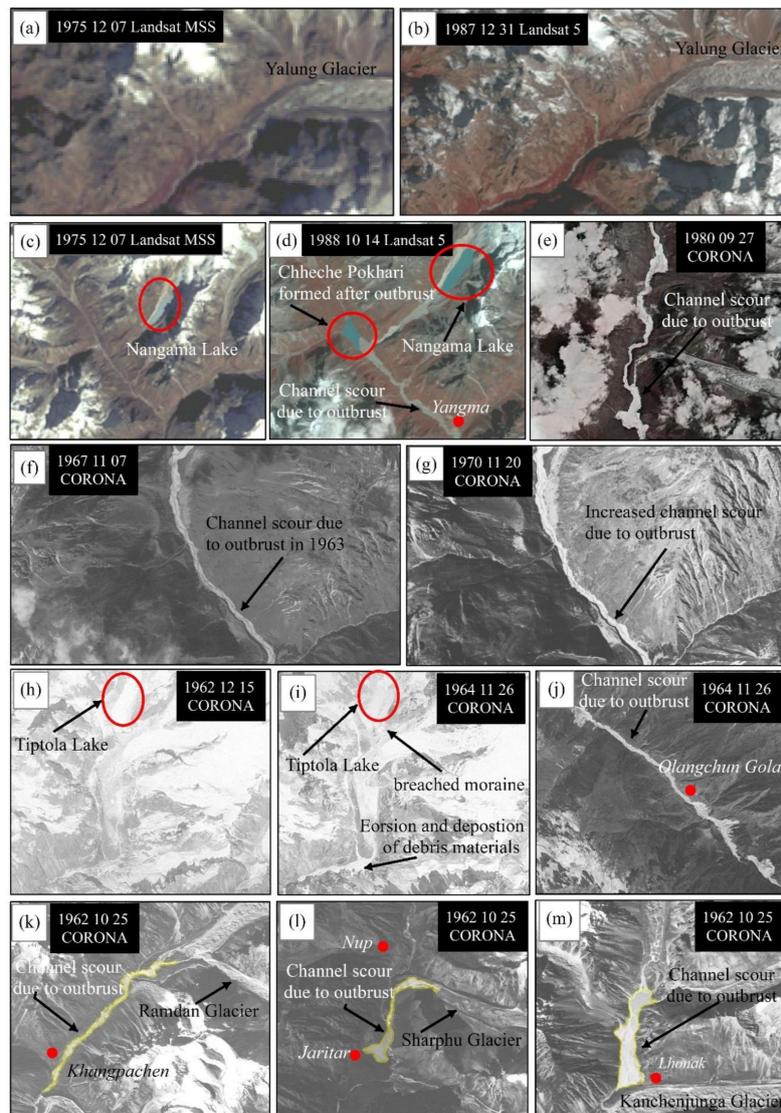
Figure 12. Satellite imagery of the study region showing presence or absence of geomorphological changes most likely caused by past GLOFs, including: (a,b) 1986 Simbhuwa (no clear changes detected), (c–e) 1980 Nangama (clear change was detected), (f,g) 1968 Olangchun Gola 1 (clear changes detected), (h–j) 1968 Olangchun Gola 2 (clear changes detected), (k) ‘before 1962’ Khangpachen (clear evidence detected), (l) ‘before 1962’ Jaritar (clear changes detected), and (m) 1921 Ghunsa (clear changes detected).

Figure 12k,l show evidence of the pre-1962 Khangpachen and Jaritar GLOFs, primarily in the form of river scouring, debris splays, and likely source of origin. Since little evidence of pre-GLOF glacial lakes exists in either image, the floods were most likely caused by some form of glacier outburst flood activity, although further field-based research would be required for verification.

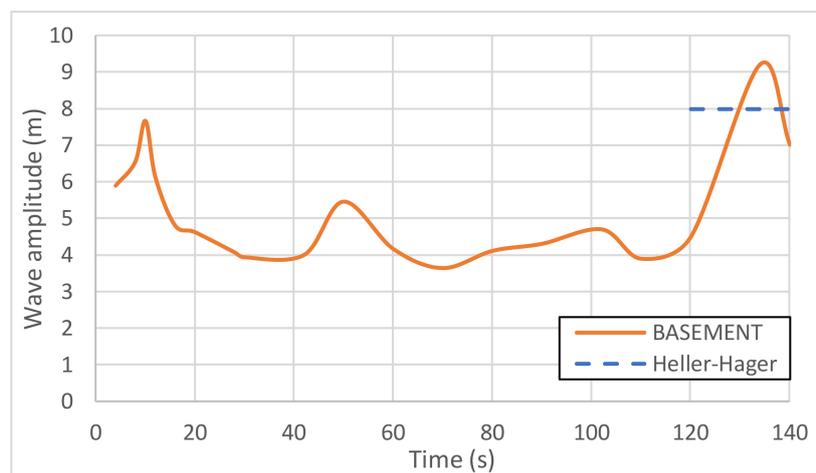
Figure 13. Wave amplitude as it traverses Nangama Lake, showing corresponding estimate from Heller-Hager at the point of overtopping.

Numeric Modeling: Wave amplitudes within the lake agreed well between BASEMENT and the Heller-Hager model, with a peak wave amplitude of 9.2 m in BASEMENT and 8.0 m in Heller-Hager—both within the range of 7 to 10 m estimated from field observations of the lateral moraines (Figure 13). This was true for both lake bathymetries considered; the slightly sloping lakebed increased wave height by less than 0.04 m relative to the flat lake bed.

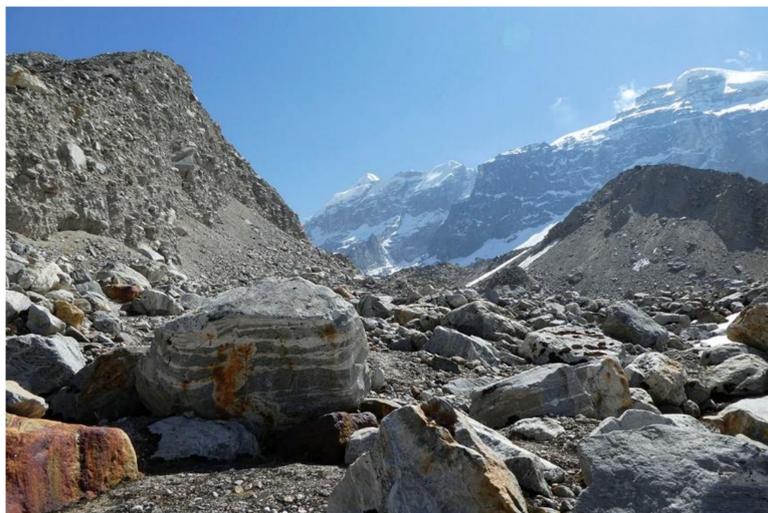
Figure 14. Breach of the terminal moraine below Nangama glacial lake in 2019 (photograph by A. Byers).

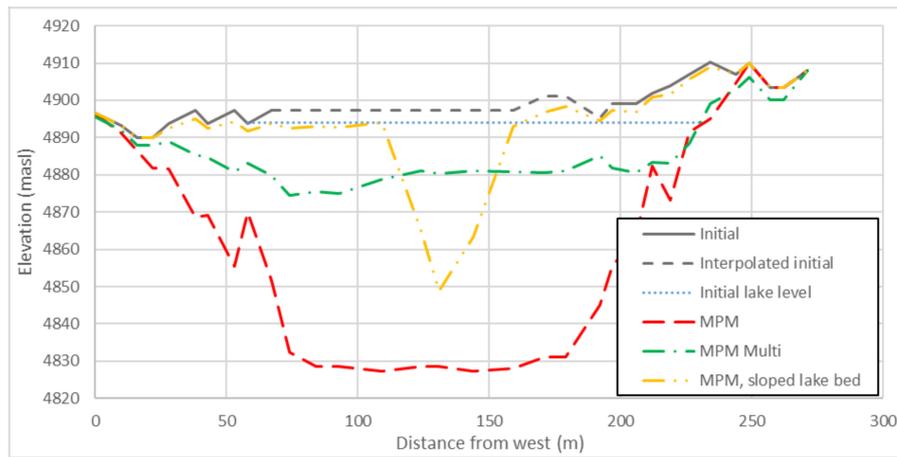
Figure 15. Cross-section, looking upstream, of terminal moraine breach before and after outburst for various scenarios.

Although varying lake bathymetry did not notably affect wave height, it did affect overtopping volume as well as overall erosion of the terminal moraine. Depending on the sediment transport model and bathymetry used, erosion of the terminal moraine at its deepest point (Figures 4 and 14) ranged from 23 m to nearly 70 m (Figure 15). The MPM-Multi scenario with a sloping lakebed did not result in sufficient erosion for a GLOF; hence, it was omitted from this study.

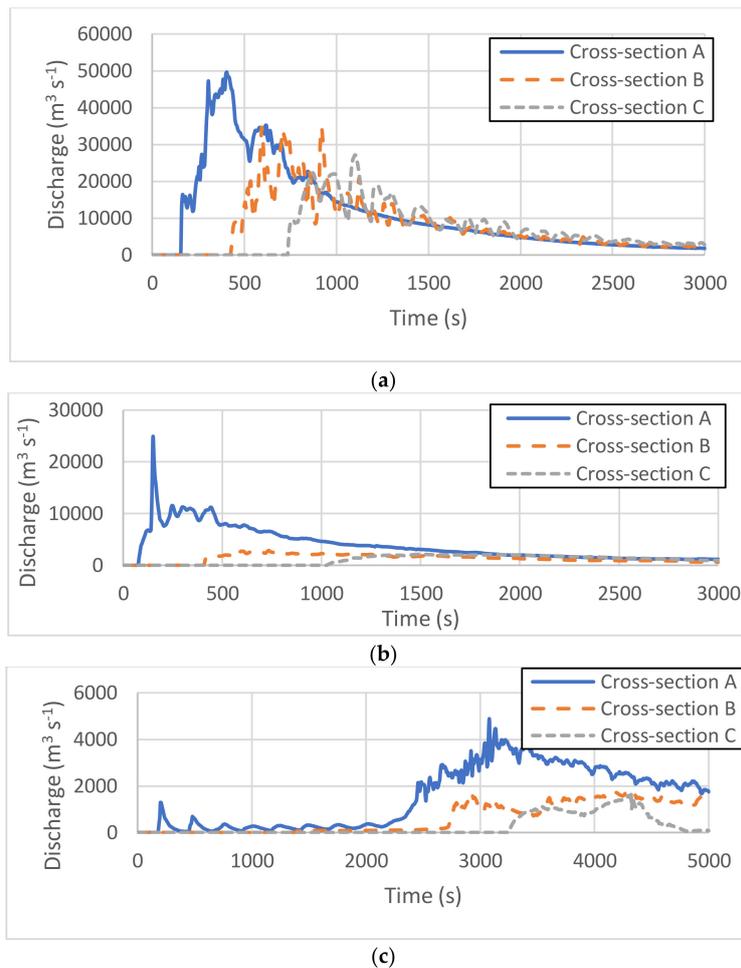
Figure 16. Discharge time series for flat lakebed, Meyer-Peter and Müller (MPM) scenario (a), flat lakebed, MPM-Multi scenario (b), and sloping lake bed, MPM scenario (c). Note the difference in scales on both axes.

Inundation downstream also varied depending on the scenario simulated (Figure 16). Peak discharge was highest for the flat bathymetry, MPM scenario, which had the greatest erosion; the sloping bathymetry, MPM scenario had a much lower peak discharge that occurred much later in the simulation, suggesting a gradual erosion of the terminal moraine over time rather than a large initial blow.

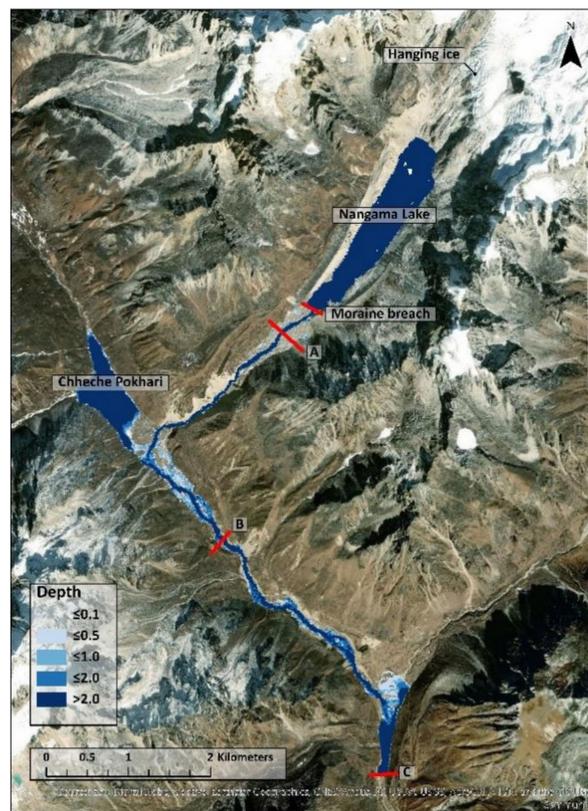
Figure 17. Inundation at end of simulation (5000 s after avalanche entry into lake) for varying bathymetry MPM scenario. Chheche Pokhari, formed by GLOF debris that blocked the Pabuk Khola, can be seen to the left.

All three scenarios resulted in the creation of Chheche Pokhari (lake) (see Figure 17) through flooding of its basin and subsequent damming via sediment deposition, granting some level of confidence to the results. The DEM, however, was not altered downstream of the terminal moraine (i.e., channel scouring was not filled in, and the bathymetry of Chheche Lake was left undetermined), which may have influenced inundation results as well as the shape of the discharge curves.

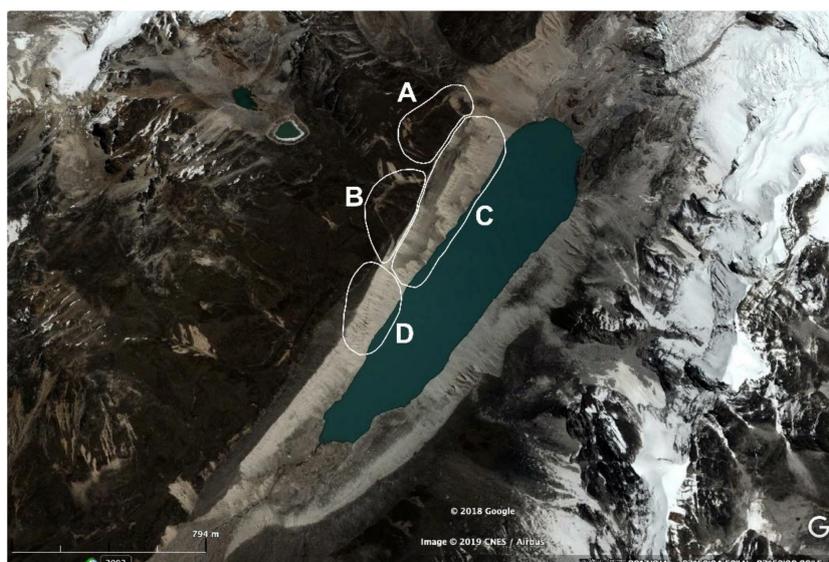
Figure 18. Areas of potential sliding activity on the right lateral moraine of Nangama glacial lake. Regions “A” and “B” show the sliding blocks that cut part of the moraine crest, suggesting that these occurred after the formation of the lateral moraine. Region “C” also occurred after the formation of the lateral moraine, and likely continues sliding and mass wasting processes. In Region “D,” sliding blocks may have already disappeared into the lake (base image: Google Earth).

Likewise, although Nangama glacial lake today falls within the “Minimal Hazard” category as defined by Reynolds (2014) [68], some concern has been expressed about prospective landslide activity on the right lateral moraine of the lake and its prospective role in catalyzing a future GLOF (Figure 18; [20,69]). One report states that “... avalanche push seiche waves originating from debris slides and/or ice avalanched from cornices at the north-eastern edge of the glacier system interfluve” could overtop the existing terminal moraine breach, resulting in a destructive downstream flood. Such phenomena have been documented for various glaciers in the Peruvian Andes [70,71], and suggest that regular monitoring of Nangama, Tiptola, and other glacial lakes in the region be conducted. Monitoring activities should also include smaller lakes less than 0.1 km², as in spite of their small size they have been shown to be capable of flooding and causing enormous downstream damage [34,68].
