Article

Consequences of Abandoning Renovation: Case Study—Neglected Industrial Heritage Building

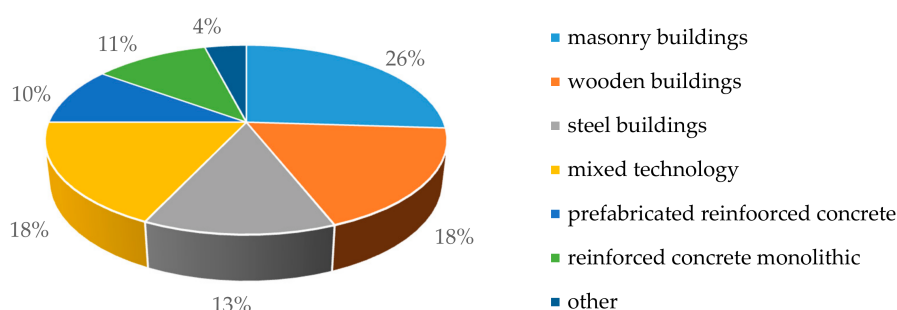
Figure 1. Percentage share of threats, failures, and disasters according to the division into technologies of the constructed object according to [44].

The presented analyses of hazards, breakdowns, and construction disasters in Poland [44] show that over the last 50 years, the largest number of them concerned brick, mixed, and steel structures, followed by wooden and reinforced concrete (prefabricated or monolithic). The results are shown in Figure 1, and the number of construction disasters in Poland is shown in Figure 2.

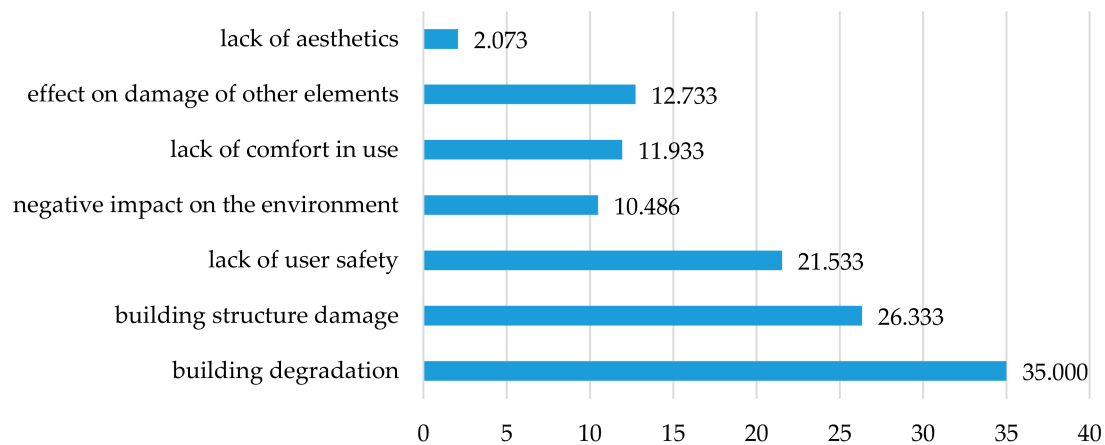
Figure 4. Obtained results of the analytic hierarchy process AHP method— C_j .

The obtained results of consultations are presented in Table 1. The obtained results of the AHP method are presented in the diagram in Figure 4.

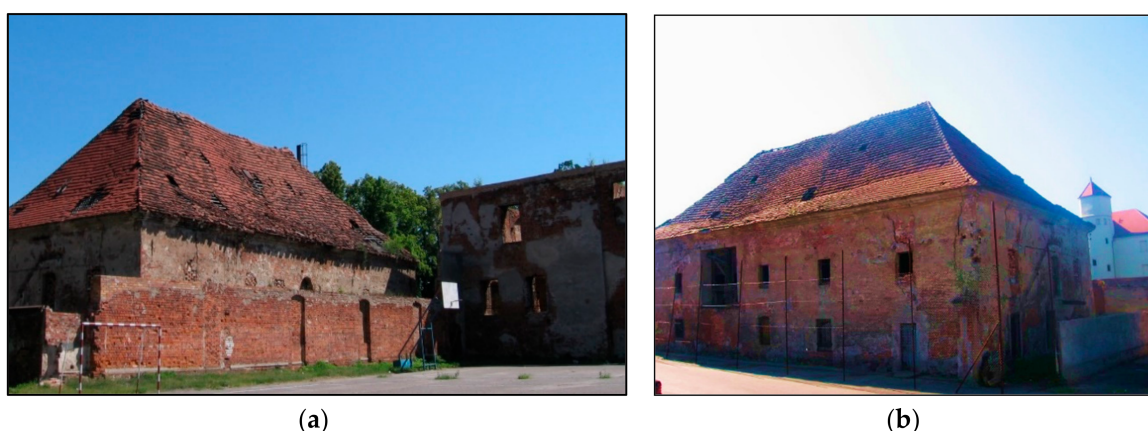
Facades are without divisions (Figure 5). The decoration of elevations are the remains of rustication and traces of window bands. The majority of window openings are rectangular with different dimensions. Rectangular door openings are located in the eastern, western, and northern elevation. The opening in the eastern elevation is closed with a sectional arch.

Figure 5. Granary building—outbuilding of the Piast Castle. (a) outbuilding of the Piast Castle and the south-west part of the castle walls, (b) the view from the north-western side, in the background there is a reconstructed part of the Piast Castle.

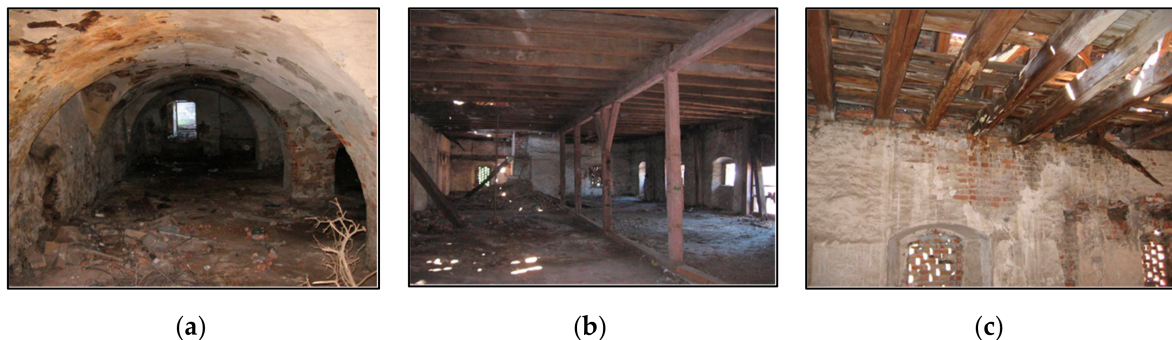
Figure 6. Granary building—cellar (a), first floor (b), second floor (c). (a) Moisture of vaults and basement pillars due to the lack of horizontal and vertical insulation. (b) First floor aboveground. (c) Damaged ends of floor beams in places where they rest on perimeter walls on the south side.

There were numerous cracks and scratches in the walls. Due to the damage to the roofing, the upper parts of the walls were covered with moisture, numerous cracks in bricks, and washed out mortar. The central part of the northern wall was deflected from the vertical about 70 cm at the whole height.

Due to the leaks in the roofing, the precipitation has, for many years, caused the destruction of wooden elements of the building. Elements of the rafter framing structure were damp and molded, and the strength of wood was reduced. There was fungus and moisture in the ceiling joists, pillars, and pillars of the stool wall.

- The significant deviation from the vertical of the central part of the northern wall is caused by the abandonment of the renovation of previously damaged wooden elements of the ceiling and rafter framing structure. Due to the considerable amount of displacement and numerous cracks and scratches, it is recommended to brick up the entire north wall, if possible, using demolition material. Until the renovation is carried out, it is necessary to provide temporary protection to strengthen the wall structure.

- Due to the dampness of basement walls and vaults, vertical and horizontal insulation of foundations and foundation walls should be made.
- Due to the poor technical condition of the ceiling above the ground floor threatening catastrophe, renovation should be carried out immediately, taking into account the preservation of as much of the historical substance as possible in an unchanged form.

- The ends of ceiling joists in places where they are supported on perimeter walls are the most vulnerable to damage, as they are subject to the most intense effects of moisture due to precipitation, wind, or lack of sunlight (especially north and west walls) and lack of natural ventilation. Less damaged parts of ceiling joists on supports directly in contact with the wall should be reinforced with wooden or steel overlays or the damaged end of the joist should be replaced with a supplementary element made of wood or steel, restoring the original length and bearing capacity of the ceiling joist. Heavily corroded beams should be replaced completely.

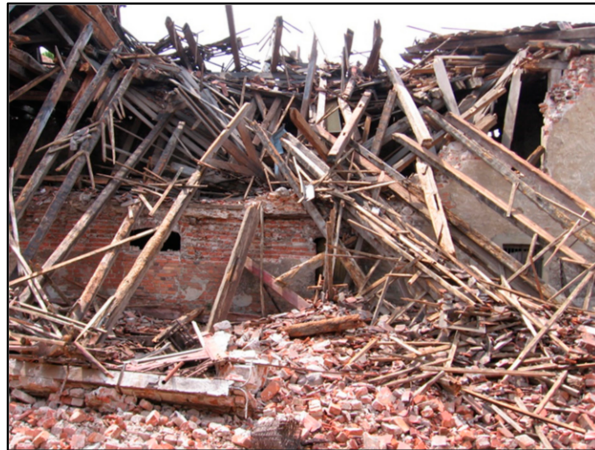
Figure 7. Building after the disaster.

Less than a month after the technical and conservation recommendations were made, a construction disaster occurred. The northern wall and the construction of the rafter framing with a wooden ceiling above the ground floor were destroyed (Figure 7). The immediate cause of the catastrophe was a failure to carry out repair work.

After the catastrophe, it also turned out that there was a wreath in the form of two parallel wooden beams running along the northern wall. The biological corrosion of these elements caused a leaning from the vertical of the wall.

The effects of failure to repair individual elements of the building, presented in point 2 in Table 2, were divided into catastrophic, serious, significant, and insignificant. In the case of the granary in Krosno Odrzańskie, the effects are catastrophic, as can be seen in Figure 7.
