Effect of Corrosion in the Transverse Reinforcements in Concrete Beams: Sustainable Method to Generate and Measure Deterioration

Abstract: A consistent method to generate and measure deterioration by corrosion in transverse reinforcements for concrete beams is presented and discussed in this work. This approach could be applied in other circumstances, such as bending, compression or combinations of stresses, with comparable results and therefore can be used to ensure sustainability. In marine environments, macro-cells are produced primarily from a transverse reinforcement, which works as an anode and therefore becomes a critical part of the structural analysis. To evaluate the adaptation efficiency of our proposed method, the corrosion potential, mass losses and cross-section reductions of the steel were measured. The shear stress behavior of the beams was investigated, including beam responses to load deformations, failure modes and cracking. The method ensured that all the beams exhibited a shear failure from diagonal stress with almost 50% less deflection when mechanically tested. The critical cross-sectional area, calculated according to the experimental diameter with the grea

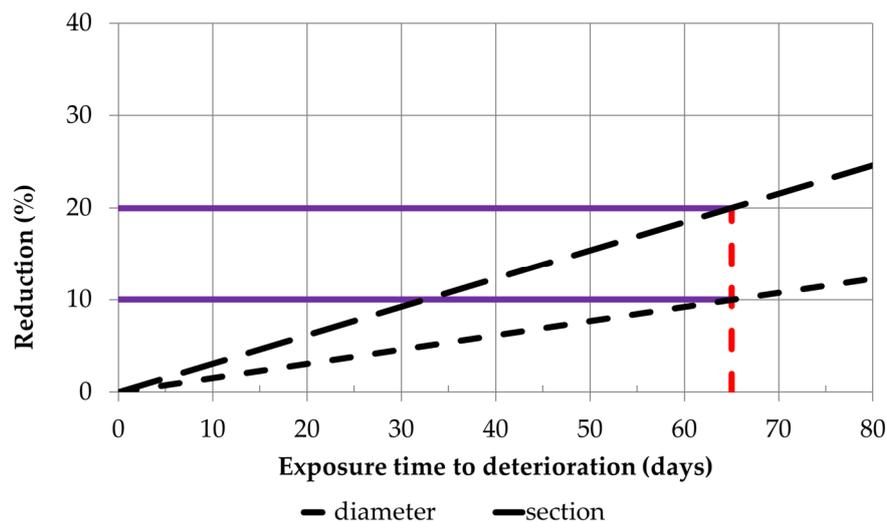
The data shown in Figure 1 illustrate the values from Equation (1), using a proposed value of up to $200 \mu\text{A}/\text{cm}^2$, to realistically reproduce severe corrosion damage and strain [19]. Corrosion products gradually dissipate with this current density level [20]. Higher values could produce oxide products that differ from real corroded structures, causing confusion in the interpretation of the results. In this way, the corrosion damage is theoretically estimated to predict the reduction in the section. For verification, a reduction of 10% of the diameter was established after 65 days of exposure.

Figure 1. Loss of diameter and cross-section per time. $\varnothing_i = 8 \text{ mm}$, $i_{\text{corr}} = 200 \mu\text{A}/\text{cm}^2$.

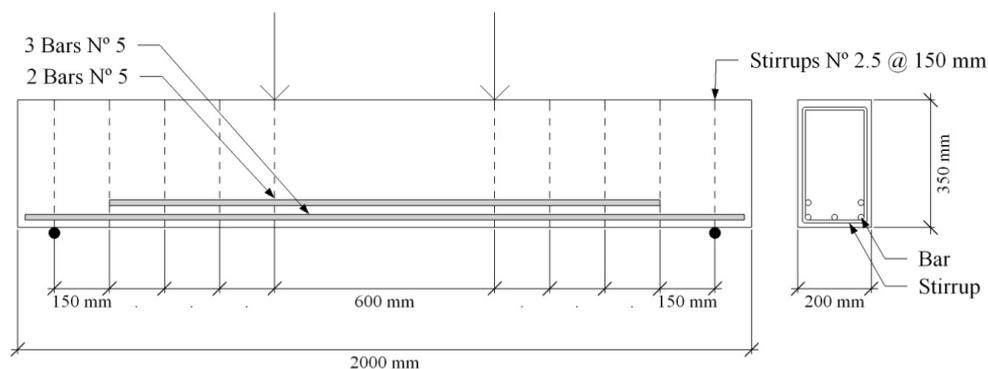
To evaluate the effect of the deterioration procedure of shear stress behavior, six reinforced concrete beams—i.e., two control beams with no deterioration (VSD 1 and 2) and four test beams with induced deterioration (VCD 1–4)—were manufactured; the dimensions of the reinforced concrete beams were set at 2000 mm × 200 mm × 350 mm. By design, a shear span (a) of 600 mm and an effective depth (d) of 296 mm were determined, thus obtaining a shear span to effective depth ratio a/d of 2.02—a value that represents a potential shear failure from diagonal stress. The structural arrangement is presented in Figure 2; the bending reinforcement was placed in two beds with a separation of 20 mm. The first layer comprised three bars, and the second comprised two bars, with diameters of 16 mm ($F_y = 412$ MPa) and number 2.5 bars with diameters of 8 mm ($F_y = 460$ MPa) for the stirrups. The longitudinal bars were coated with epoxy paint to avoid any damage by corrosion. The formation of galvanic stacks in the contact zones between the bending steel and the stirrups was prevented by the addition of electrical insulation tape. The traditional tie-up was replaced by nylon strips. The arrangement of the assembly is shown in Figure 3. The verification of this behavior is presented in Sections 4 and 5.

Figure 2. Structural arrangement to promote shear failure.

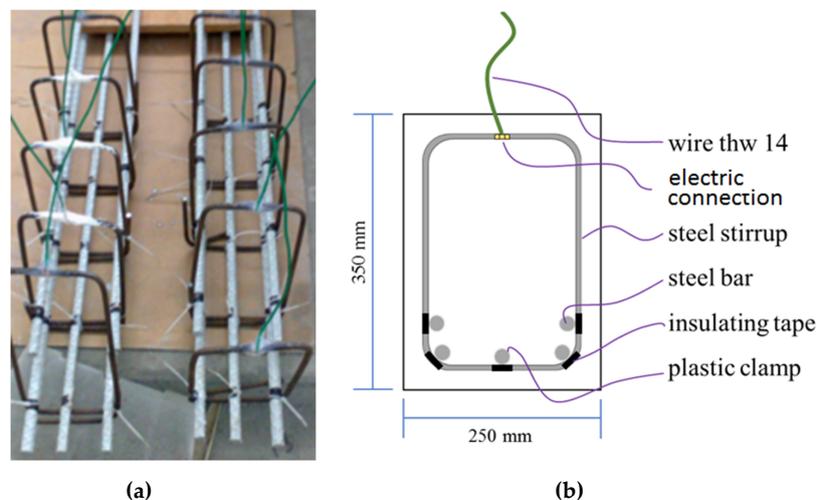
Figure 3. Assembly preparation for deterioration induction. (a) The reinforcement of the beam and its connections before being cast; (b) a diagram of the beam with details of connections for corrosion induction.

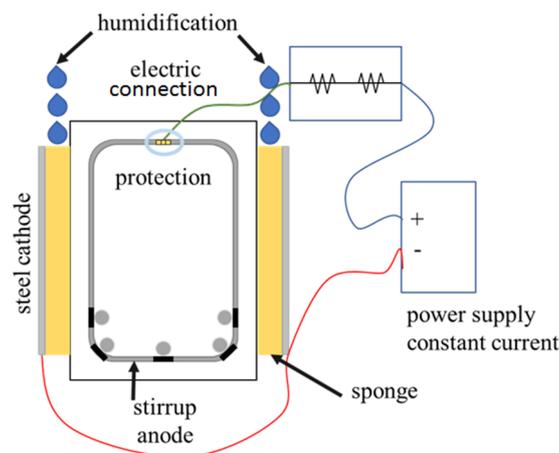
Most significant results about structural behavior can be obtained by artificially corroded specimens [21]. Therefore, because of a wide and scattered spectrum of results for comparison purposes, a sustainable and reliable method to generate damage by severe corrosion in the reinforcement is needed. This is consistent and corresponds with the considerations proposed in the structural behavior described above for transversal rebars. This method must also comply with the conditions outlined in Figure 2. The method comprises the application of current, a humidification cycle and a drying cycle, as shown in Figure 4. The humidification of the beams is accomplished through polyurethane sponges, with dimensions of 600 mm × 300 mm × 20 mm, placed in the shear area. These sponges were moistened daily using a 3.5% NaCl solution to ensure that the applied current remained constant. After a week of humidification, a galvanic current was applied for 65 days to reach a severe deterioration level. The connection of each stirrup was made with a circuit formed by a rheostat of 0–50 kohm and a resistance of 1 ohm, with which it was possible to regulate the current applied to each stirrup. The circuit was connected to a power source of 0–30 volts and 0–5 amperes. A level of 200 $\mu\text{A}/\text{cm}^2$ was applied over the total area of each stirrup. The corrosion potential (E_{corr}) was monitored with an Ag/AgCl reference electrode, presented for analysis as E_{corr} vs. Cu/CuSO₄ (CSE) in the corresponding charts. Measurements were taken weekly. In the following figures, the corrosion potentials are presented with respect to the days of effective exposure to deterioration (application of current, humidification cycle and drying cycle). The measurements of the potentials followed the standard procedures (ASTM C876 [22]).

Figure 4. System for application of current, humidification and drying.

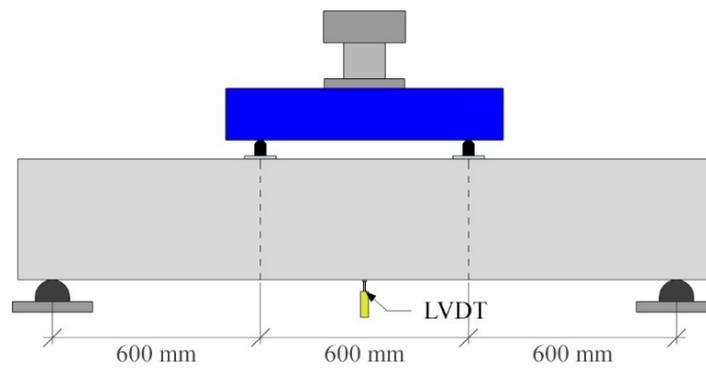
The simply supported beams were tested by applying concentrated loads to 600 mm sections of the supports, as shown in Figure 5. The test was carried out in a Tinius Olsen universal machine with a capacity of 200 tons. The total load was measured by a load cell with a capacity of 50 tons. The deflection at the midspan was measured with a linear variable displacement transducer (LVDT) with a calibration coefficient of 0.0005 cm. The shear strengths of the control beams without deterioration were determined at 28 days.

Figure 5. Testing scheme. LVDT: linear variable displacement transducer.

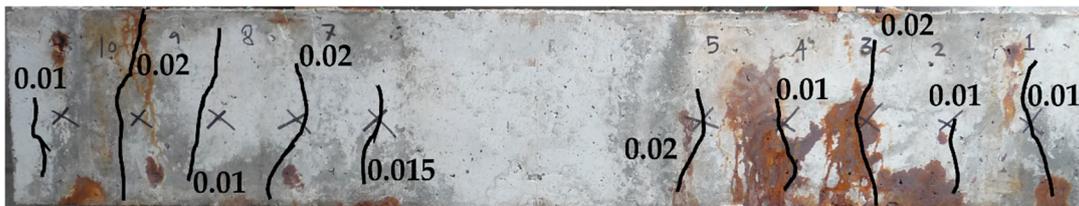
In Figure 6, the visual appearance of the beam VCD-1 side A, after the induction of deterioration, is shown. The data are representative of all the beams. In Figure 7, the schematic appearance of the cracks generated in the stirrups during the process for the same beam are shown. The signs of corrosion—e.g., oxide stains and cracks (location, direction, and dimensions)—were recorded.

Figure 6. Visual appearance of beam VCD-1 side A after 65 days of applied deterioration; the crack widths are noted in cm.

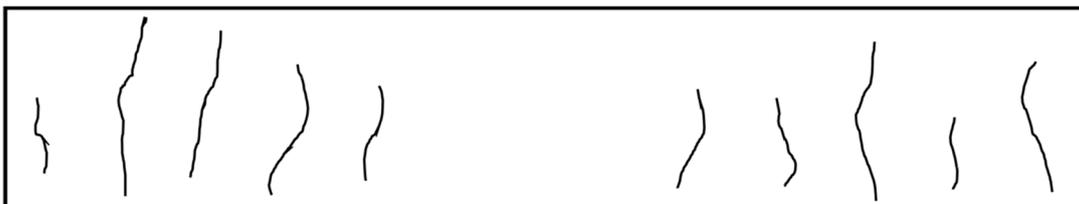
Figure 7. Cracking diagram for beam VCD-1 side A.

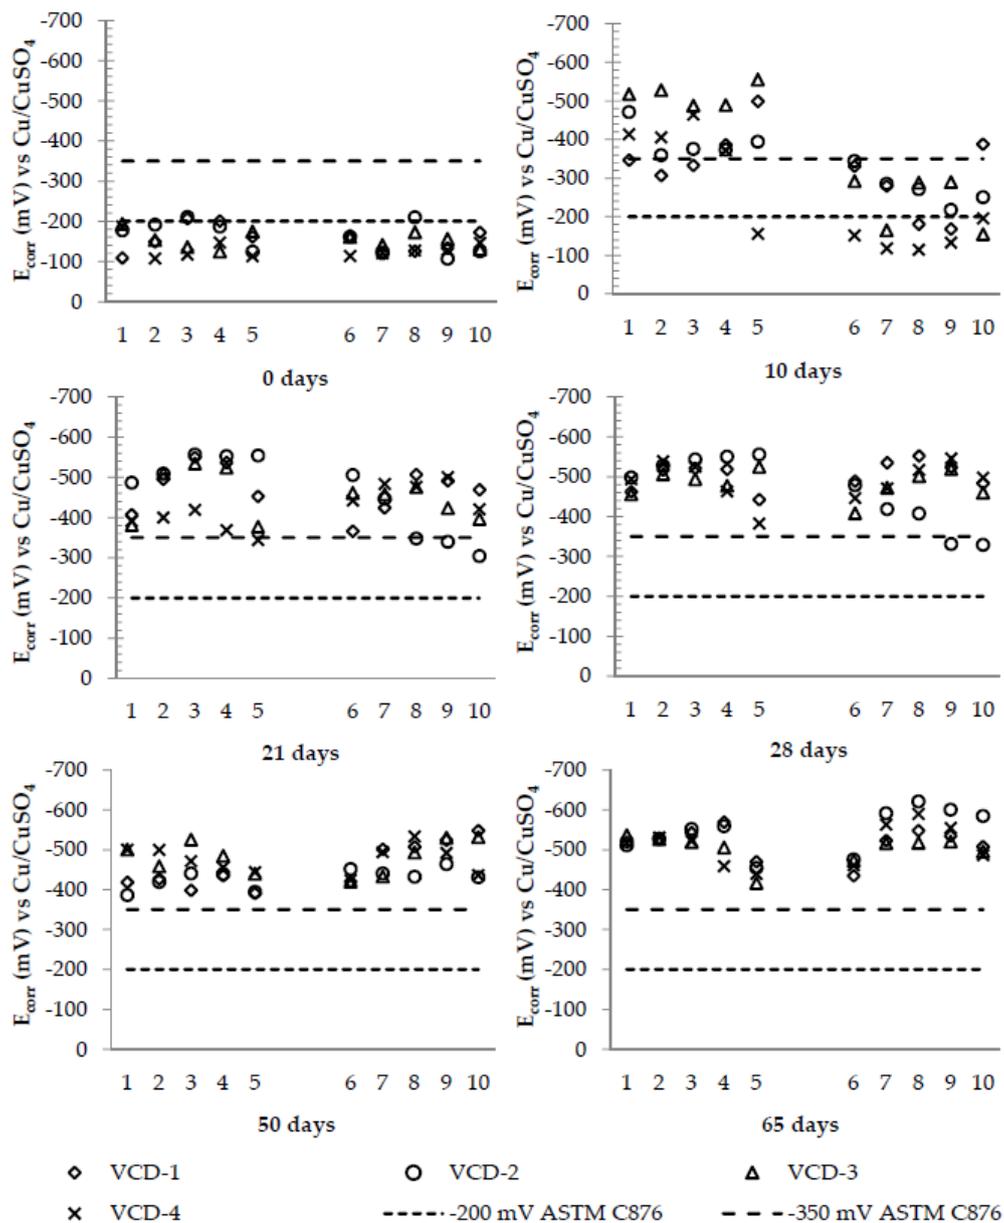
As shown in Figure 8, and for all the beams, the potential intervals indicated a negligible corrosion probability before the initiation of deterioration. Between 21 and 28 days after induction, potential levels vs. CSE were more negative than -350 mV; therefore, the beams were in a highly corrosive state. At the beginning of the process, the corrosion potentials of the stirrups showed some variability. This phenomenon is representative of the actual behavior of structures exposed to a marine environment, where there are variables that cannot be controlled, such as temperature and relative humidity. The potential levels measured at 50 and 65 days of exposure to induced deterioration reached values between -400 mV and -600 mV, respectively, indicating a high probability of advanced corrosion or severe deterioration, according to ASTM C876.

Figure 8. Electrochemical monitoring by measuring the corrosion potentials in the stirrups.

The reproducibility was also verified through electrochemical monitoring. The evolution of the potentials with respect to time, shown in Figure 8, illustrates specific behavior. A homogenization of values at 65 days of exposure illustrates constant aggressiveness. Figure 13 is a representative

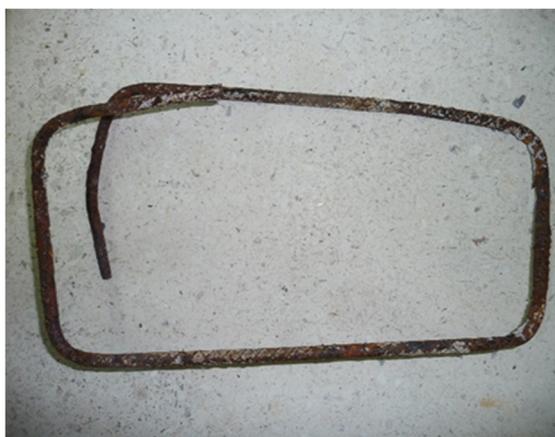
The previously tested beams were demolished to extract the corroded stirrups, as shown in Figure 9. Subsequently, the actual loss of the mass and cross-section of the transverse reinforcement was obtained [23]. Under the induced deterioration, the mass loss was as high as 11% on average. Some authors have reported that when there is a mass loss of 5–10% [24–26], the remaining capacities of the reinforced concrete beams and the steel/concrete adhesion decrease considerably. In Table 2, the relation between the theoretical values obtained by Equation (2) and the experimental values are shown.

Figure 9. Removed corroded stirrup (position 8) with 65 days of exposure to induced deterioration.

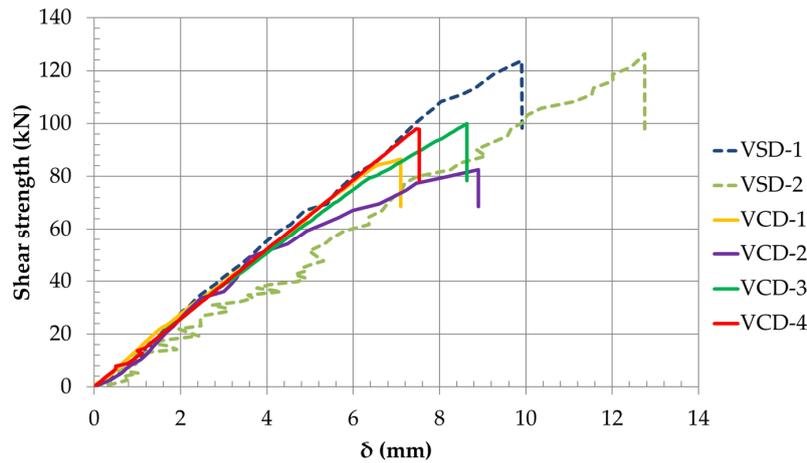
The experimental results of shear structural behavior are presented in Figure 10 and Table 4, where the average deflection for the VSD beams is 11.4 mm. A variation in stiffness can be observed in VSD beams, although the beams are twins; there are factors that can cause such behavior, such as variations in the mixing, vibrating and curing of concrete, as well as different cracking kinetics

between the beams. However, the shear strength was very similar. In the VCD beams, the deflection at the midspan decreased, on average, by 8.0 mm; i.e., a 29.8% decrease in deflection. In general terms, the deterioration by corrosion in the shear reinforcements affected the beams' ductility, as expected, presenting a fragile and sudden failure; this was more evident in the VCD-1 and VCD-2 beams, which had a greater deterioration due to corrosion than the VCD-3 and VCD-4 beams, which caused a reduction in their cracking load. Similarly, the VCD beams decreased their average shear strength by 26% compared to the VSD beams. In Figure 11, the data show a cracking pattern at the end of the shear test. To avoid confusion, the corrosion cracks in Figure 11 were omitted.

Figure 10. Shear strength–displacement curves.

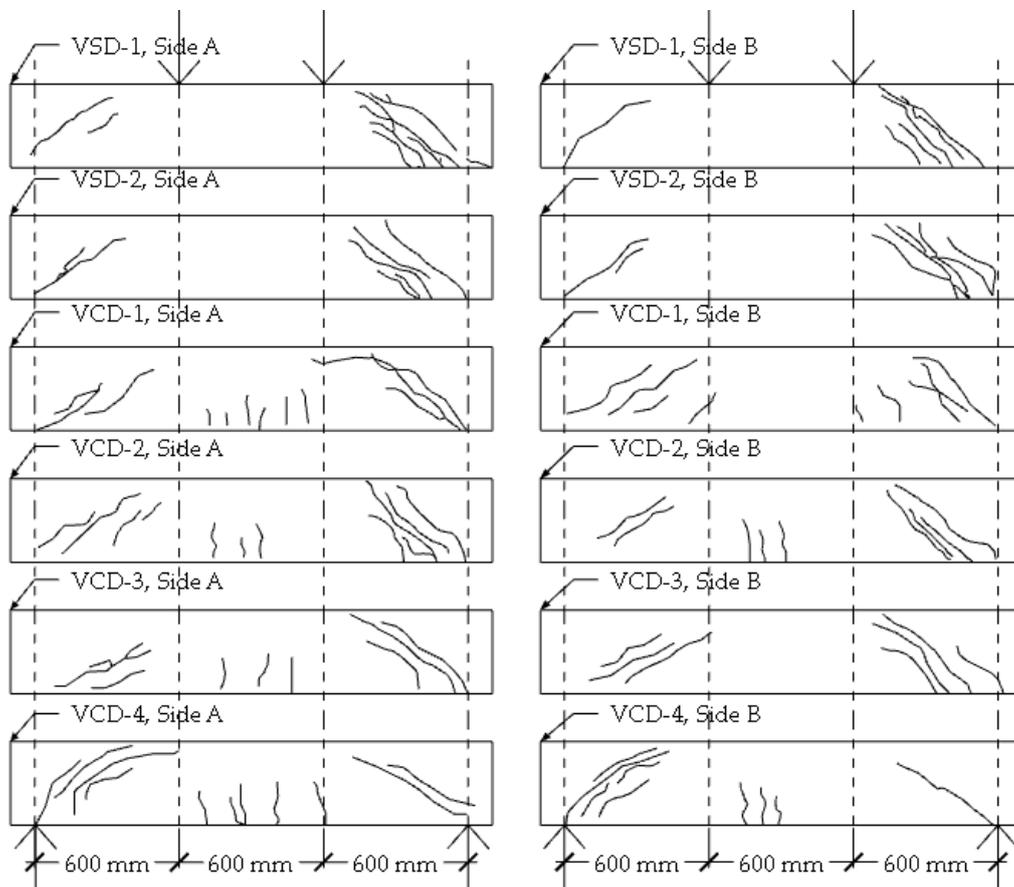
Figure 11. Cracking patterns obtained during the shear tests.

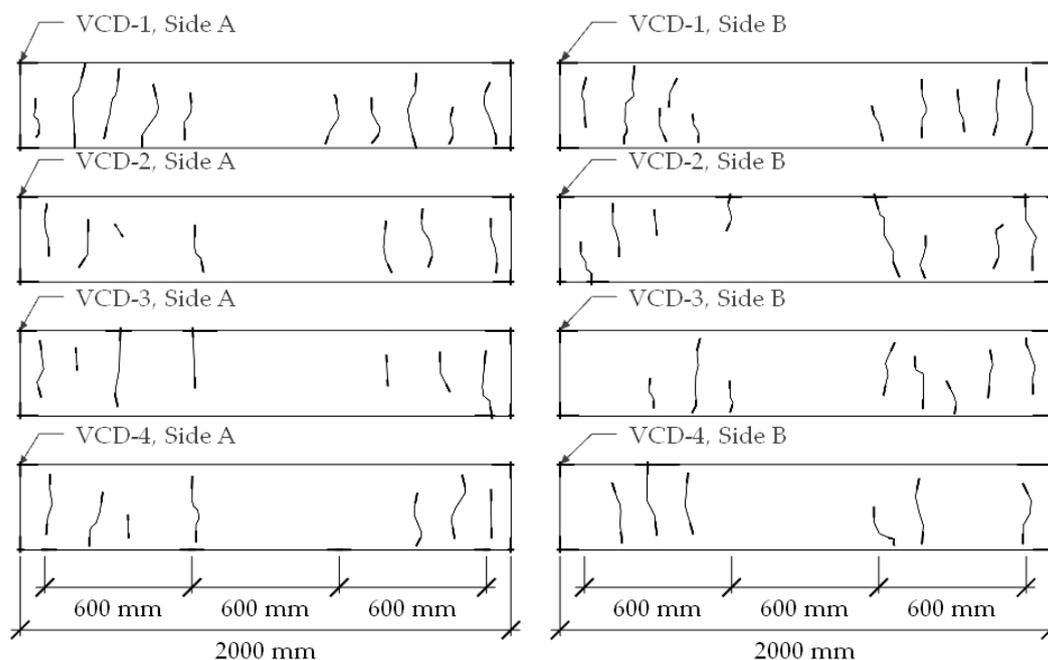
A reliable method yields the expected results reproducibly. As the reproducibility increases, the reliability increases. The design of experiments for the types and sizes of specimens tested in this study is susceptible to variations in the manufacturing process, the instrumentation, exposure, the method of obtaining results, etc. More importantly, the nature of the induction of deterioration affects the design. In this study, the proposed adjustments to an induction of deterioration procedure, such as isolating the corrosion to a shear zone and making it consistent with what is expected from the structural calculation, show excellent reproducibility and can thus be used in future studies in different circumstances. Figure 12 is a schematic of the reproducibility of specific corrosion cracking patterns of the stirrup on all the beams, where cracks emerge on the concrete surface linearly to the reinforcement [19,31]. These results also show that there are neither micro-stresses in the concrete matrix that could have affected the contribution of the concrete central section nor concrete detachments in any area. This reproducibility was also manifested in the crack widths on the shear reinforcements whose values were in the range 0.1–0.2 mm, which is extremely narrow for experiments of this size. None of the cases showed coincident cracking to the bending of the reinforcing bars, as has been reported previously. A measure of the method's reliability to induce cracking is the number of stirrups that failed; in these tests, 36 of 40 stirrups—equivalent to 90% of the total stirrups—failed.

**Figure 12.** Cracking patterns of severe corrosion at the locations of the shear reinforcements.

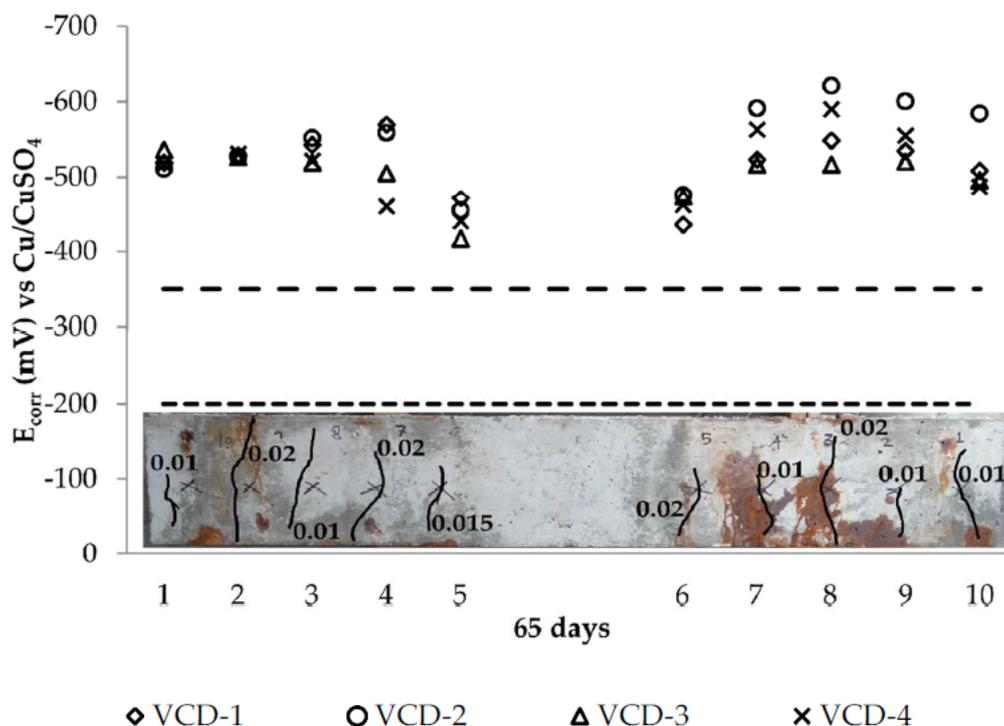
configuration of Figure 8. Figure 13 displays the electrochemical value at the location of the transverse reinforcement that identifies its tendency. Note also that the values of the corrosion potential, despite being a thermodynamic parameter, move in a narrow band below -350 mV vs. CSE. The exceptions were stirrups 5 and 6, which coincided with the ends of the sponges, demonstrating that the attack method must have extreme continuity.

Figure 13. Electrochemical values at the locations of the shear reinforcements.
