Article

Application of Bioengineering Techniques as Geo-Hydrological Risk Mitigation Measures in a Highly Valuable Cultural Landscape: Experiences from the Cinque Terre National Park (Italy)

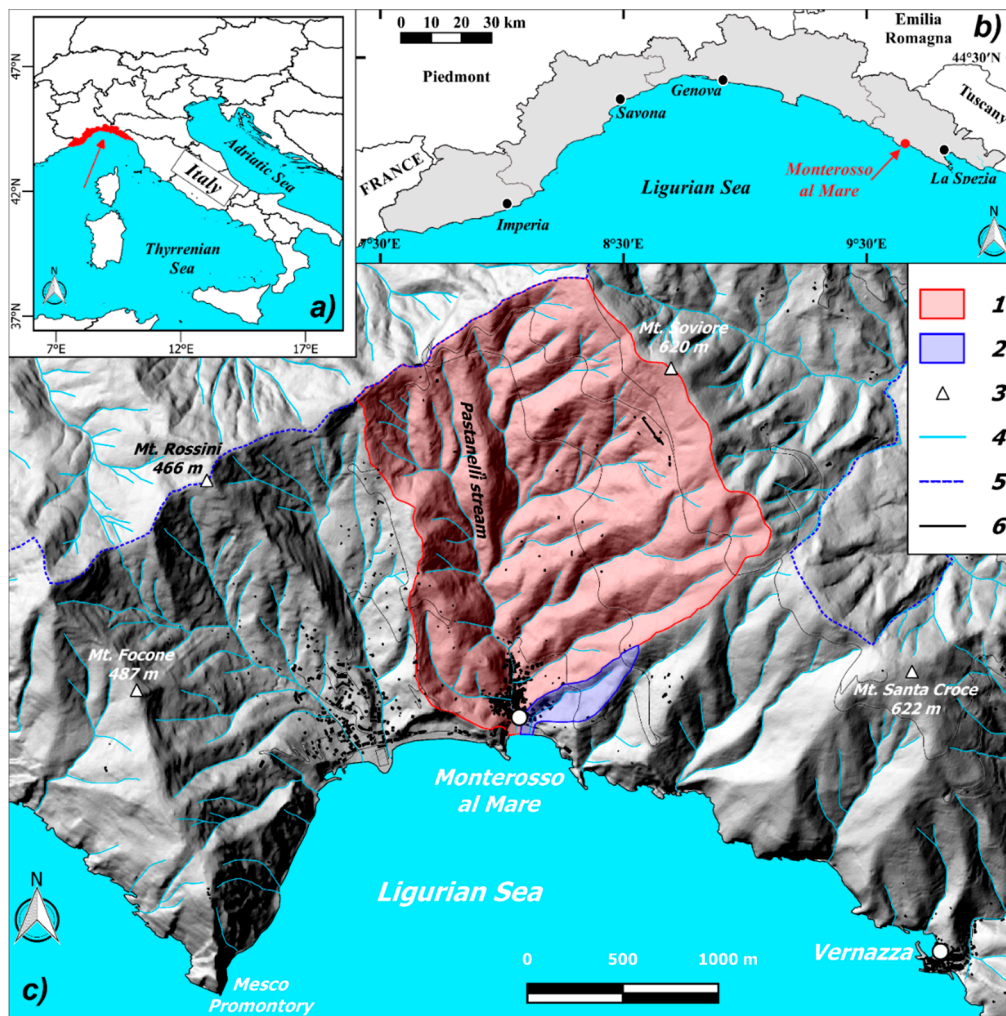
Figure 1. (a,b) Location of the study area; (c) Detailed view of the study area and of the surrounding territory: 1, Pastanelli stream catchment; 2, Fosso Serra stream catchment; 3, main elevations; 4, hydrographic network; 5, Cinque Terre National Park boundary; 6, main road (base map derived from a 5 m cell-size Digital Elevation Model (DEM), source: Geoportale Regione Liguria [78]).

The study area is located in the easternmost section of the Liguria region (La Spezia Province) (Figure 1b), along the Cinque Terre coastal stretch, and it includes two small coastal basins belonging to the territory of the Monterosso al Mare municipality: the Pastanelli stream (3.2 km²) and the Fosso Serra stream (0.1 km²) catchments (Figure 1c). The Cinque Terre area is known worldwide for its terraced coastal landscape, which emphasizes the century-old equilibrium between human activity and the natural environment [74,75]. This coastal portion of Liguria, with its steep agricultural terraces rising from the shoreline, is an outstanding example of the intrinsic link between humankind and nature, and represents an environmental, historical and cultural heritage site for present and future generations [75]. For these reasons, in 1997, the Cinque Terre area was included on the list of World Heritage Sites by UNESCO, and in 1999 it was proclaimed to be a national park with the aim of protecting its peculiar man-made landscape. More than three million tourists annually visit this protected area to hike along several paths spreading out on the steep coastal terraced slopes [76,77].

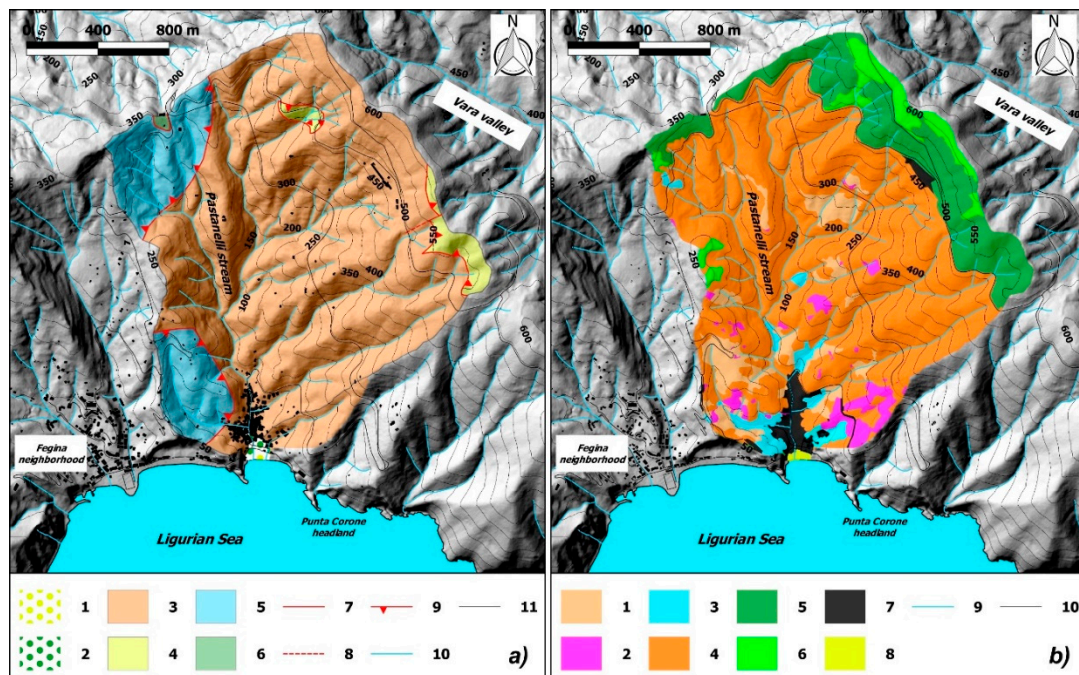
Figure 2. (a) Geologic map of the study area (data source Regione Liguria [78]): 1, beach deposits; 2, alluvial deposits; 3, Macigno Fm.; 4, Canetolo Shales and Limestones Fm.; 5, Monte Veri Shales Fm.; 6, serpentinites; 7, tectonic contact; 8, fault; 9, thrust; 10, hydrographic network; 11, main road. (b) Land use map of the study area (data from Schilirò et al. [80]): 1, cultivated terrace (olive groves); 2, cultivated terrace (vineyards); 3, cultivated terrace (orchards); 4, abandoned terrace; 5, wood; 6, scrubland; 7, urban area; 8, beach; 9, hydrographic network; 10, main road (base maps derived from a 5 m cell-size DEM, source: Geoportale Regione Liguria [78]).

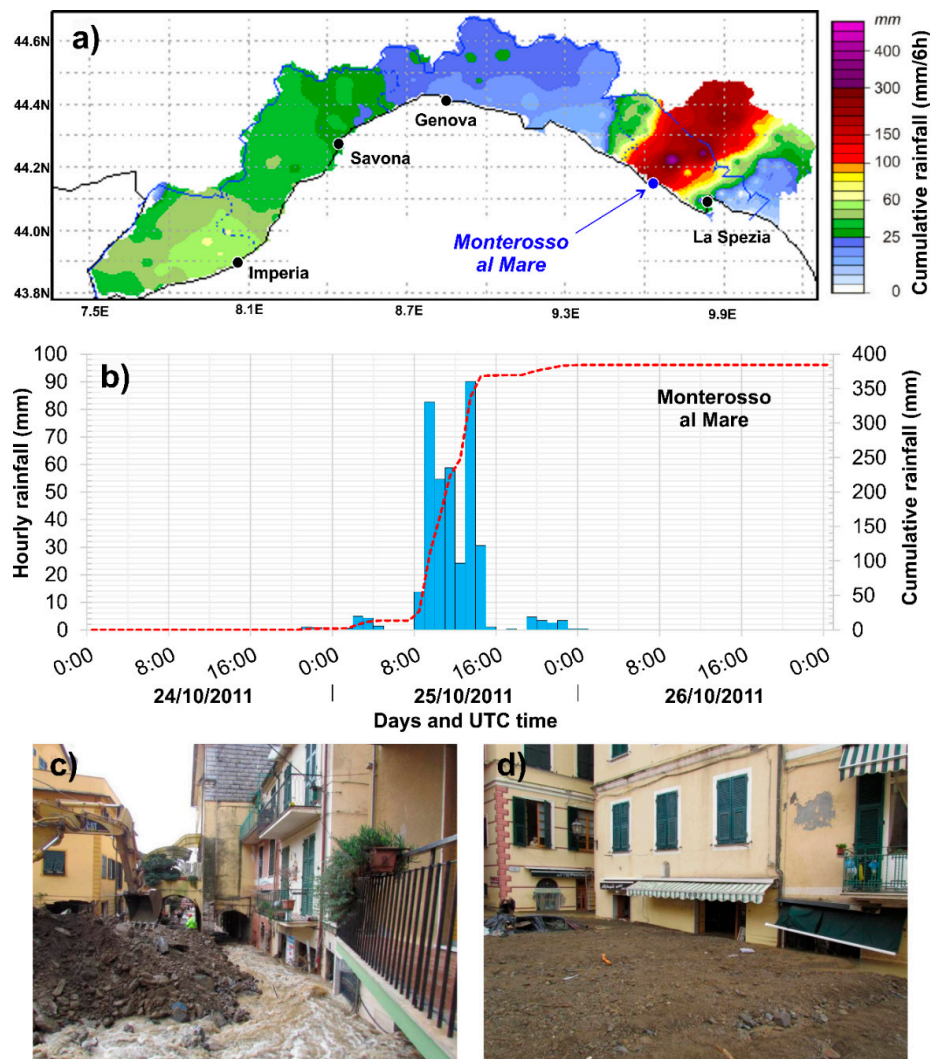
Figure 3. (a) Spatial distribution of the interpolated cumulative rainfall on 25 October 2011, between 10:00 UTC and 16:00 UTC (modified from ARPAL-CFMI-PC [90]). (b) Hourly (light blue bars) and cumulative (red dashed line) rainfall recorded by the Monterosso al Mare rain gauge (data source: Regione Liguria [91]), (c,d) View of some of the road sections of the historic centre of Monterosso al Mare buried by debris after the rainstorm (photos courtesy of Monterosso al Mare Municipality Administration).

On 25 October 2011, the portion of the territory encompassing eastern Liguria and north-western Tuscany was affected by a one-day extreme rainfall event [63,90]. This severe rainstorm was characterized by highly localized and persistent precipitation generated by a back-building mesoscale convective system [64,89]. The rainstorm unleashed the largest part of its enormous energy over approximately 6 h (between 9 and 15 UTC—Universal Time Coordinate) [63,90]. The highest rainfall magnitude was recorded in the inland territories of Liguria, where the maximum cumulative rainfall levels exceeded 530 mm (Figure 3a). The force of the rainfall sequence was also severe along the coastal side of the region, especially in the Cinque Terre area, where the most affected zones were the municipalities of Monterosso al Mare [80] and Vernazza [71]. The rain gauge located at Monterosso al Mare recorded a cumulative rainfall height of 382 mm and an hourly intensity of 90 mm (Figure 3b). Because a significant amount of rainfall occurred in a few hours, the urban areas were impacted by a destructive debris flood (Figure 3c,d). The large quantity of transported sediments filled the covered tract of the Pastanelli stream, subsequently overwhelming roads and buildings and causing severe damage along with the interruption of essential services (i.e., electricity, gas, water, telephone and sewage). One casualty occurred, and many economic activities were devastated by the impact of the debris flood.

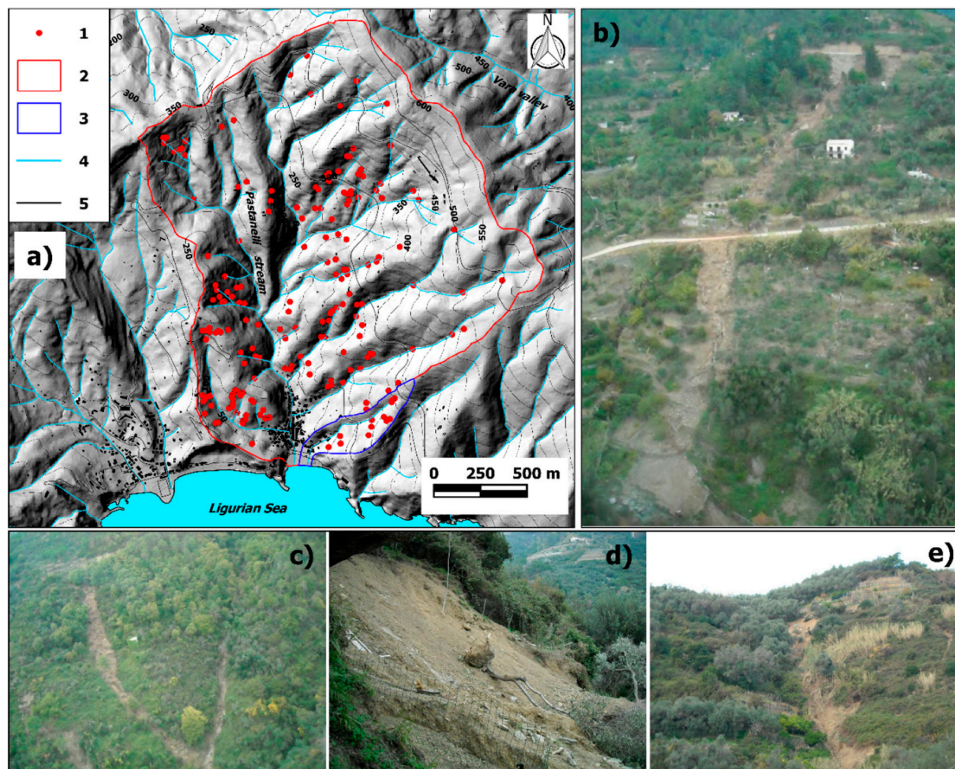
Figure 4. (a) Inventory map of the shallow landslides triggered within the study area during the 25 October 2011 rainstorm (data from Schilirò et al. [80]): 1, landslide source area; 2, Pastanelli stream basin; 3, Fosso Serra stream catchment; 4, hydrographic network; 5, main road. (b–d) Examples of rainfall-induced shallow landslides (photos courtesy of Monterosso al Mare Municipality Administration). (e) Example of the erosion processes and intense sediment mobilization that occurred along a steep stream channel (photos courtesy of Monterosso al Mare Municipality Administration).

On the slopes upstream of Monterosso al Mare village, several hundred rainfall-induced shallow landslides were triggered [80]. Moreover, widespread erosion processes occurred (e.g., gully and rill wash erosion), especially along fluvial channels that were deeply incised. According to the landslide inventory produced by Schilirò et al. [80], a total of 191 landslides were triggered within the study area (Figure 4a), the majority of which (179) affected the Pastanelli stream catchment, where a landslide density of 57.7 landslides/km² was calculated; the percentage of the basin area affected by landslides was 1.45%, corresponding to a total area of 4.51 hectares. The smallest slope failures involved surfaces of more than 10 m², while the largest mass movement covered an area of approximately 2500 m². Generally, shallow mass movements were triggered as debris slides affecting the thin veneers of eluvial-colluvial soils, also sometimes involving the most weathered/fractured horizons of the underlying bedrock (Figure 4b–d). In many cases, debris slides evolved into flow-like landslides, such as debris avalanches or, in a few cases, debris flows. Along channels, the significant rainfall triggered intense headward erosion and riverbank scouring, severely increasing the in-channel

sediment supply (Figure 4e). Many antique artificial hydraulic works constructed by local farmers were swept away by the high stream power developed during the rainstorm.

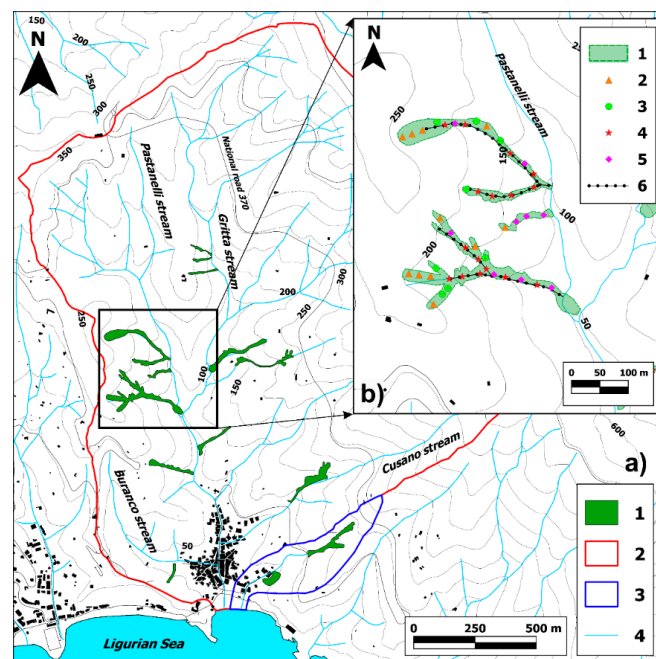
Figure 6. (a) Bioengineering works inventory map: 1, area affected by bioengineering works; 2, Pastanelli stream catchment; 3, Fosso Serra catchment; 4, hydrographic network. (b) Detailed view of the inventory map showing the location of some main structures: 1, area affected by bioengineering works; 2, double crib wall; 3, palisade; 4, log check dam; 5, single crib wall; 6, bed revetment.

A total of 14 bioengineering works were inventoried and mapped by means of archive research and field activities: 12 interventions were implemented within the Pastanelli stream basin whereas two were implemented in the Fosso Serra catchment (Figure 6). The total area affected by the geo-hydrological risk mitigation measures through bioengineering techniques was approximately 4.4 hectares, corresponding to approximately 1.3% of the study area. The largest intervention covers an area of approximately 0.9 hectares while the smallest intervention has an extent of approximately 0.06 hectares.

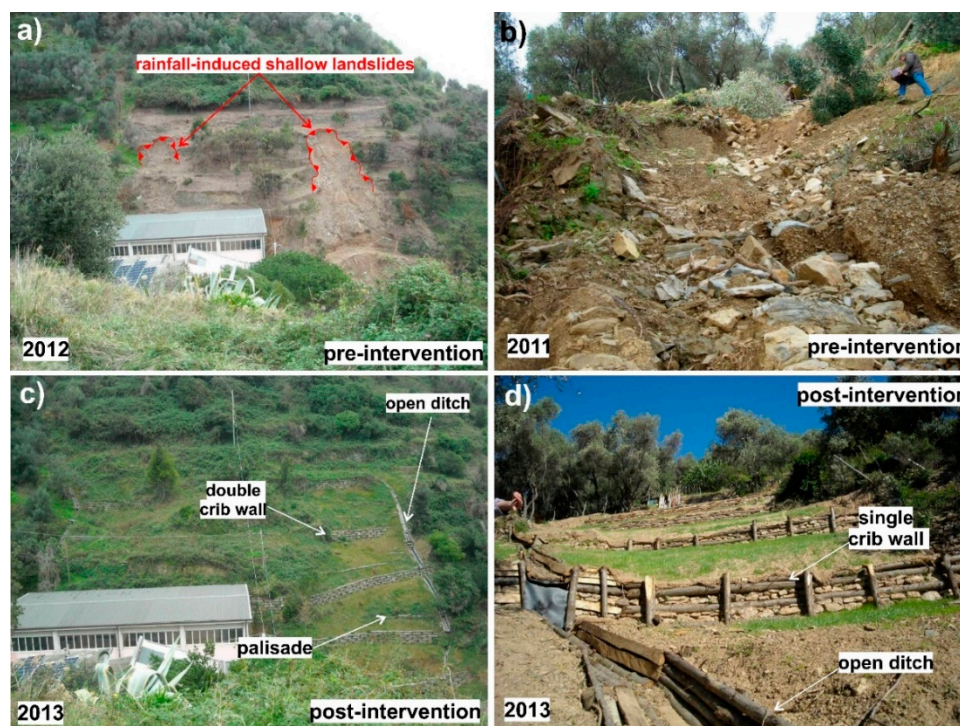
Figure 7. Representative examples of slope stabilization and landslide mitigation bioengineering works: slope conditions pre-intervention (a,b) and post-intervention (c,d) (photos courtesy of Monterosso al Mare Municipality Administration).

Generally, the design approaches adopted for the restoration of the most problematic slopes involved the integration of a wide range of technical solutions aimed at preventing the retreat of landslide scarps, stabilizing displaced material and controlling rain-wash processes. In detail, slopes impacted by shallow mass movements were stabilized by means of grading works and through

construction of a series of vegetated, single or double, crib walls (Figure 7); these structures were arranged as perpendicular as possible to the slope gradient whereas the foundation was placed over the bedrock surface and in a slight counter-slope. Crib walls were built using wooden logs held together with steel staples at the joints; the whole framework was anchored with steel bars (approximately 1.5–2 m long) into the bedrock and backfilled with eluvial-colluvial soils. The slope surface in the inter-zone between vegetated crib walls was further protected with alignments of vegetated palisades in combination with laying of coir nettings, which were carefully overlapped and arranged according to the direction of runoff (Figure 7c,d). The coir nettings were fixed into the ground with steel staples and were laid to provide both adequate resistance of the slope surface against rain-wash erosion and to promote the growth of natural vegetation.

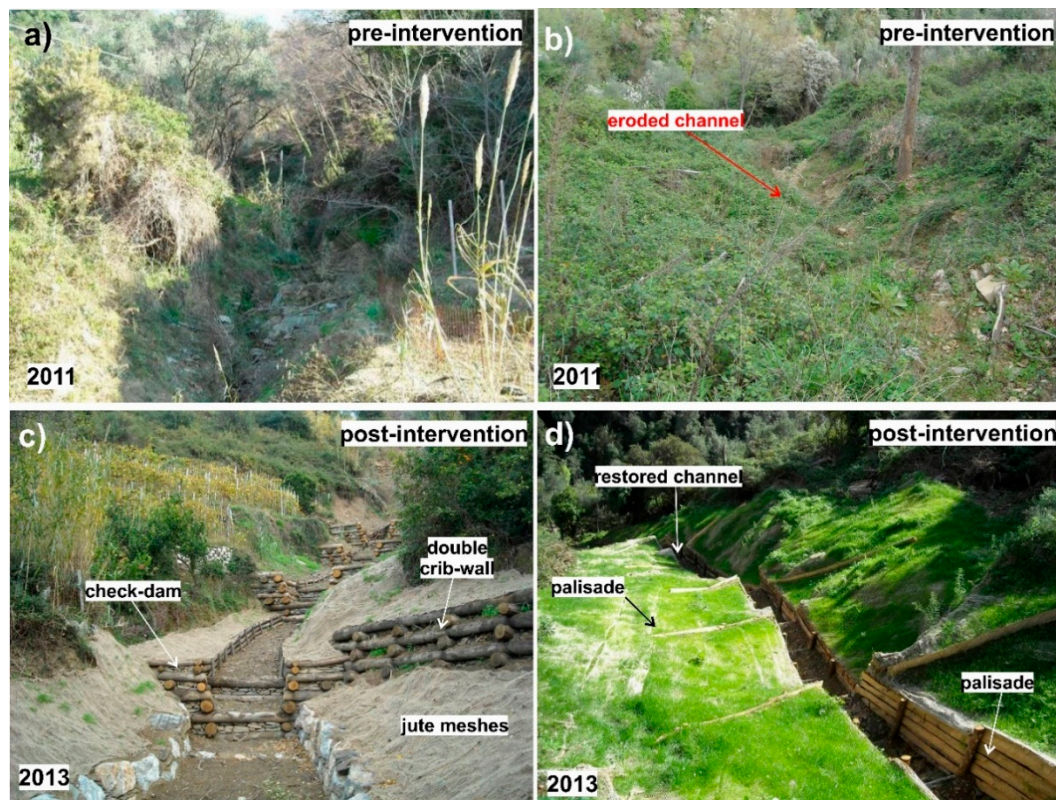
Figure 8. Representative examples of stream channel stabilization and hydraulic bioengineering works: channel conditions pre-intervention (a,b) and post-intervention; (c,d) (photos courtesy of Monterosso al Mare Municipality Administration).

Concerning hydraulic works, both transversal and longitudinal measures were used (Figure 8). The different methods and techniques were aimed at improving water flow, reducing in-channel erosion, protecting riverbanks from erosion and improving their stability against failures. The first phases of the works focused on the restoration of the flow sections by removing sediments and wood elements mobilized by fluvial- and runoff-related processes that were triggered by the rainstorm; the hydraulic sections, where possible, were enlarged through excavations of both streambeds and banks. Subsequently, along the widest channels, the majority of design schemes involved the construction of sequences of log check dams to dissipate the energy of water discharge and to control

in-channel erosion (Figure 8c). In terms of the construction details, log check dams consisting of alternate layers of wood and stones were built. During log check dam assembly, wooden beams were joined using steel bolts, and the voids within the wooden framework were carefully filled with stones packed as closely as possible (Figure 8c). The erosion control structures were set up over the bedrock and anchored with steel bars (approximately 1.5 m long) while shoulders were carefully tied into the flanks of the channels. In minor and steeper channels or short tributaries, the thalweg was shaped in gentle steps through the installation of small log check dams (Figure 8d).

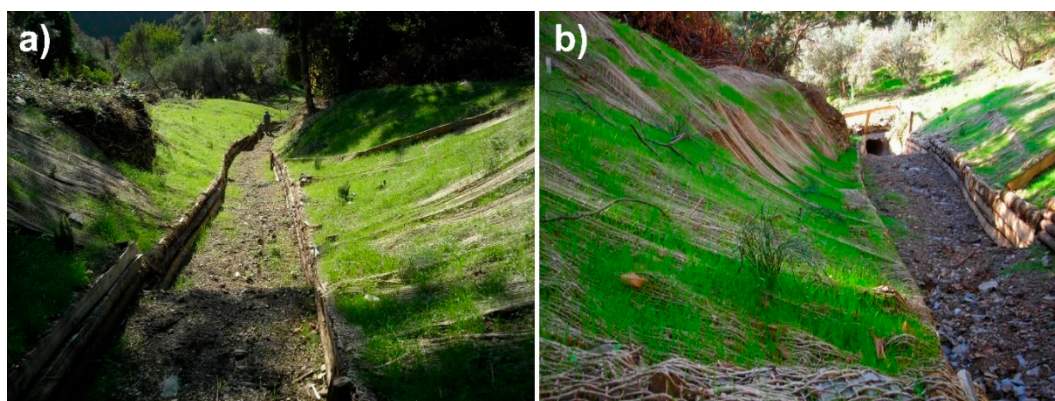
Figure 9. (a) Example of channel flanks stabilized with the combination of jute netting, grass sowing and shrub planting. (b) Detailed view of planted broom species on a stream bank (photos courtesy of Monterosso al Mare Municipality Administration).

In some projects, this technical solution was coupled with bed revetment by placing wooden trunks parallel to the flow direction. Along the most critical or most damaged stream reaches, bank protection was achieved by means of vegetated palisades (Figure 8d); less frequently, stream banks were also protected using vegetated crib walls. However, in some cases, vegetated dry-stone walls and small longitudinal masonry walls were constructed. The set of geo-hydrological mitigation measures implemented along streams and channels were completed through interventions on the flanks to limit rain-wash erosion and improve their overall stability. Therefore, some series of vegetated palisades were positioned over the channel flanks in conjunction with jute meshes fixed using steel staples. Eventually, to improve the establishment of natural vegetation, grass seed mixtures were sown and shrubs belonging to the Mediterranean scrub were planted (i.e., *Spartium junceum* and *Cytisus scoparius* species) (Figure 9).

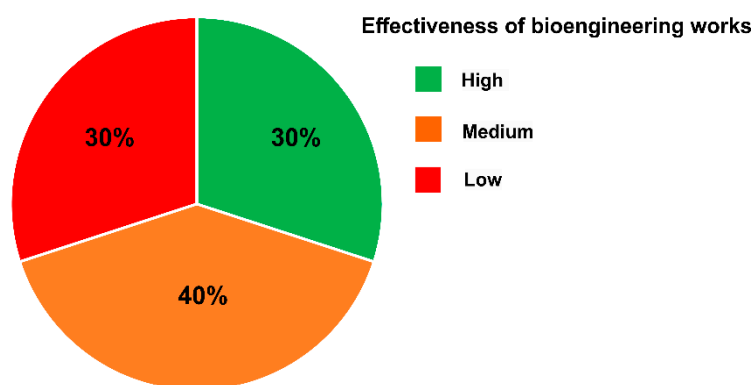
Figure 10. Graph summarizing the degree of effectiveness of the investigated bioengineering works.

Figure 10 summarizes the results of the data analysis of the multidisciplinary field surveys. On the basis of expert judgement, these surveys allowed qualitative assessment of the effectiveness along with the state of conservation of the bioengineering works approximately three years after their completion. The results reveal that approximately 30% of the mitigation measures are poorly effective, approximately 40% are characterized by medium effectiveness, and only 30% show high effectiveness (Figure 10). The bioengineering works classified at high and medium degrees of effectiveness exhibit a positive function both in biotechnical and environmental terms and have also achieved adequate aesthetic conditions (Figure 11a,b). On average, vegetated structures show a good state of conservation, structural elements are generally well anchored, single wooden logs are firmly connected to each other and inert materials within wooden frameworks are closely packed. Nevertheless, the results of this study indicate that the investigated works lack post-intervention maintenance, especially regarding live materials. It is worth highlighting that the main criticalities are related to the role played by the vegetation, namely, the biotechnical functions performed by the species sown or planted on slopes or stream flanks and by live materials positioned within crib walls, palisades and log check dams. In particular, it was observed that in the project sites characterized by the lowest efficiency, sowing and planting procedures were somewhat ineffective (Figure 11c) since several treated slopes and river flanks did not show continuous and dense shrub cover. This was often observed in project sites characterized by the most severe morphological conditions, such as very steep slopes or short tributaries. Moreover, in some interventions an extensive growth of unwanted vegetation was also noted. These field observations suggest that grass species germination has not adequately developed and that the vast majority of planted shrubs have not grown (Figure 12).

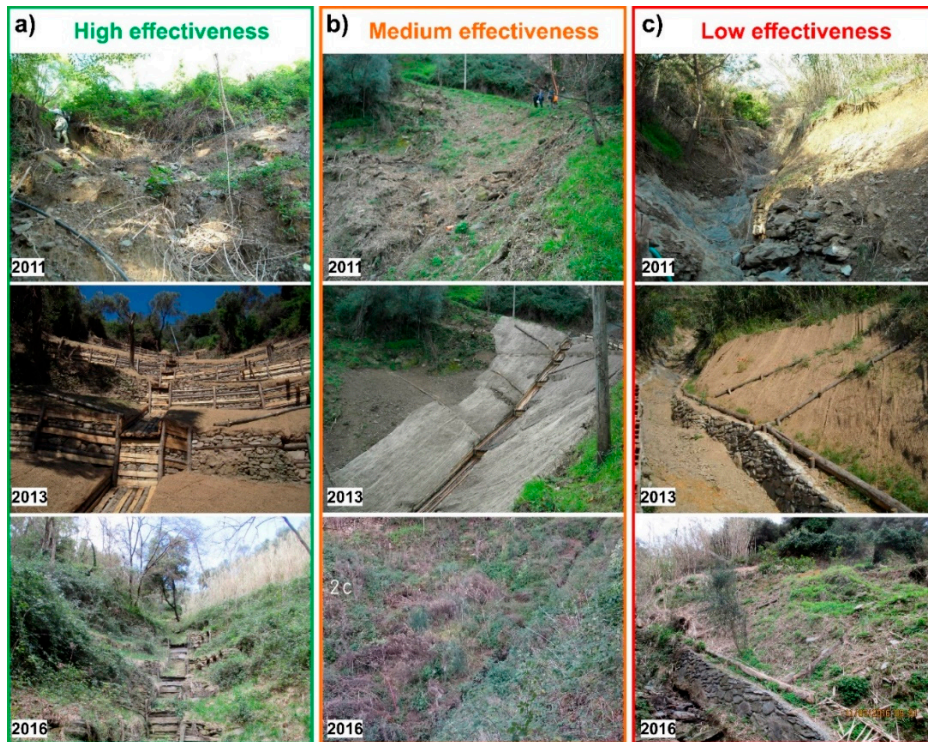
Figure 11. Representative examples of interventions classified at high (a), medium (b) and low (c) effectiveness. For each example, the site conditions immediately after the rainfall event, after stabilization work completion and three years after work execution are showed.

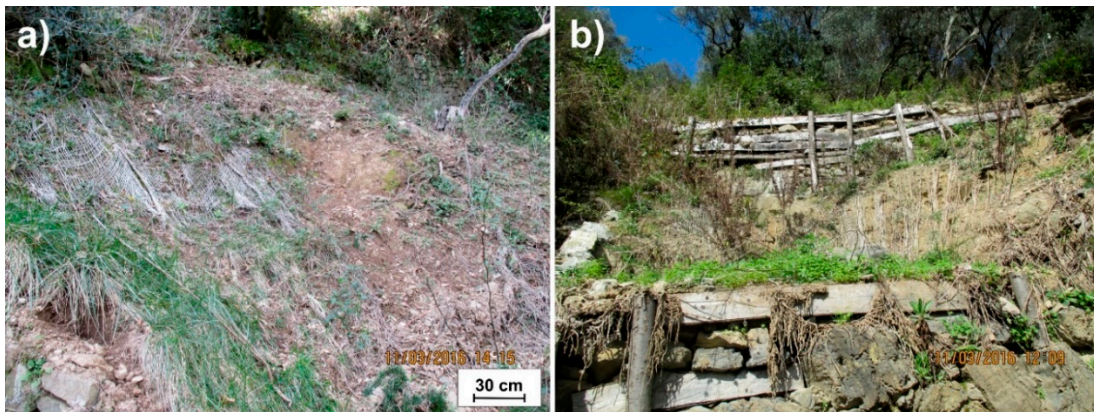
Figure 12. Examples of scarce vegetation cover development along a slope surface (a) and within single palisades (b).
