# Substitution of Building Components in Historic Buildings

**Citation:** Sobotka, A.; Linczowski, K.; Radziejowska, A. Substitution of Building Components in Historic Buildings. *Sustainability* **2021**, *13*, 9211. <https://doi.org/10.3390/su13169211>

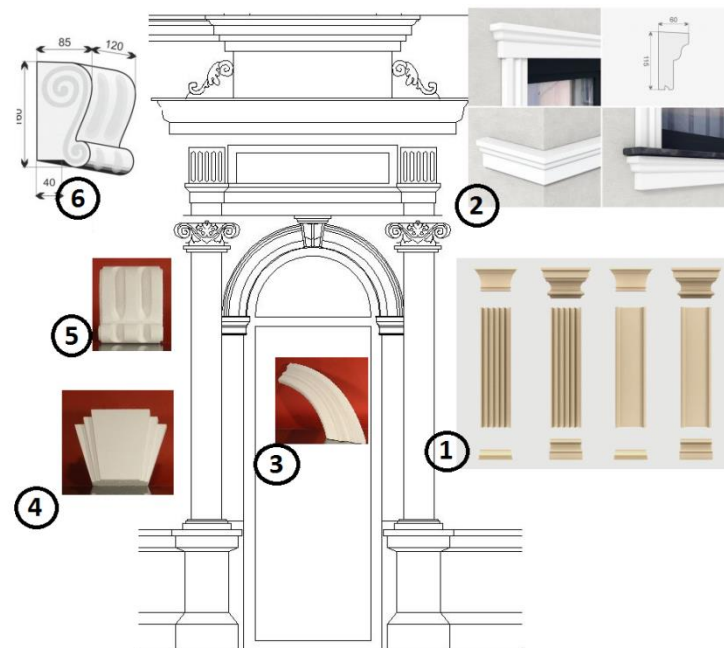
**Figure 2.** Examples of substitutes of building products used in refurbishment of elevations of historic buildings (1. pilasters, 2. cornices, 3. arch, 4. keystone, 5. and 6. brackets), drawings own elaboration, photos from internet resources [30,34,35].

This offers the possibility of using, for example, clinker tiles on facades that were originally built with solid bricks, prefabricated cornices made of polystyrene or inserts of stone elements crafted to create a specific visual effect. Examples of façade element solutions are shown in Figure 2.

Three variants of the front elevation refurbishment were considered (Figures 2 and 4):

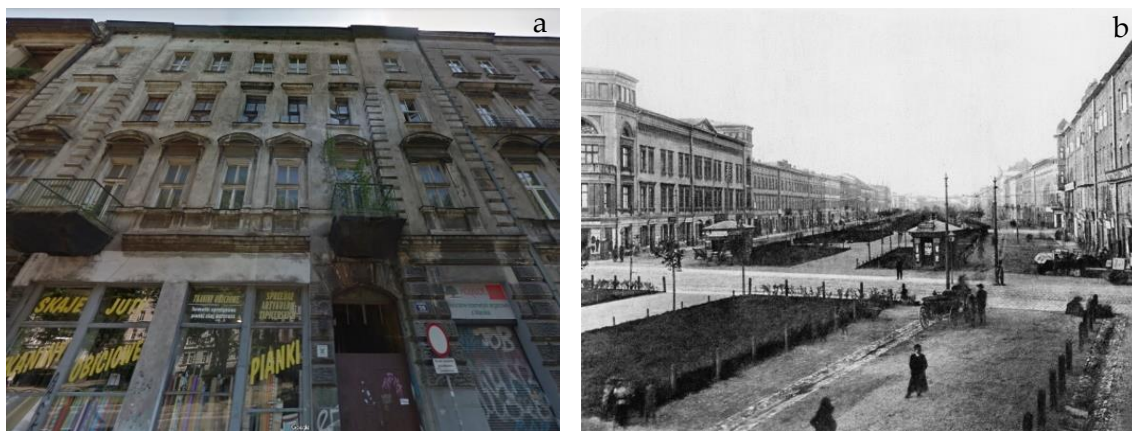
**Figure 3.** (a) Photo of the front elevation of the building August 2017, googlemaps (b). Photo taken by Ignacy Krieger in 1895.

The building is located in the city center in the Kazimierz district Figure 3a; it was built in 1878. There is not much information available in the national archives about the first years of its use; we only know that it was a tenement house serving as a dwelling house. Few photographs were found showing the whole street where the building is located (Figure 3b).

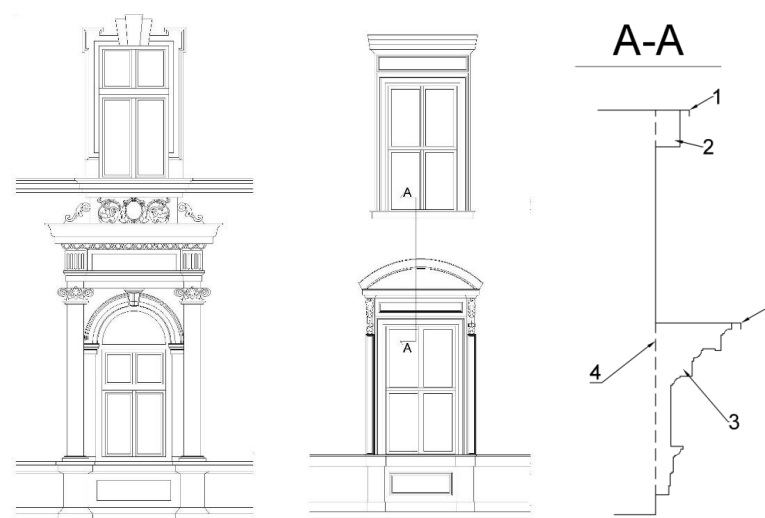
**Figure 4.** Architectural details of the renovated façade: 1. windowsill; 2. above-window stucco; 3. below-window stucco; and 4. building wall.

1. Façade stuccowork made with the use of pulled (wet) method;
2. Façade stuccowork made of prefabricated EPS polystyrene elements covered with a finishing layer;
3. Façade in lightweight concrete.

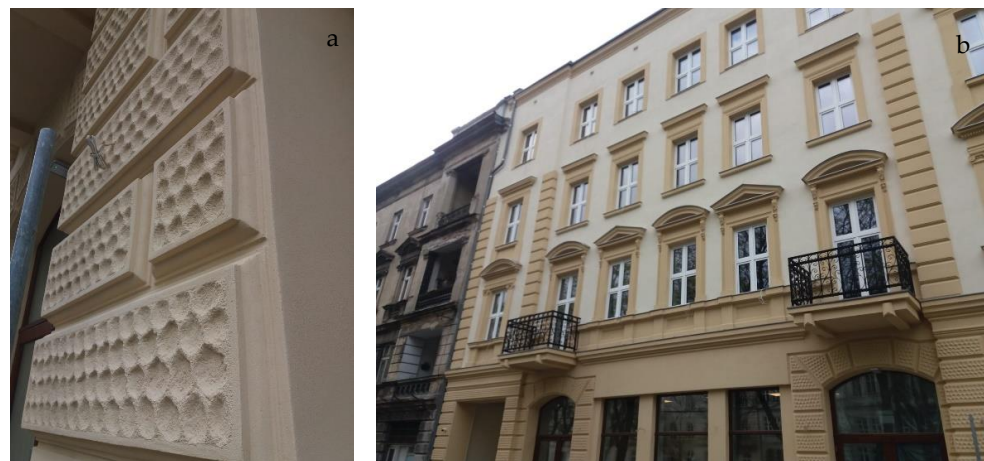
**Figure 5.** (a) Fragment of reconstructed rustication on the facade 29 April 2021; (b) tenement house after refurbishment 29 April 2021, authors' archive.

The solution that was identified as the best in each method was implemented in reality; the final effect of which can be admired recently (Figure 5a,b). As can be seen, the applied solution reflects the authenticity of the historic façade in a very realistic manner. In addition, the use of substitute products made it possible to carry out a larger scope of refurbishment due to the lower costs of the solutions used, which is an additional advantage.
