# Integrated Strategies for Preserving and Enhancing the Historical Heritage of the University of Pavia

**Citation:** Greco, A.; Giacometti, V.; Rota, M.; Senaldi, I.E.; Penna, A. Integrated Strategies for Preserving and Enhancing the Historical Heritage of the University of Pavia. *Sustainability* **2021**, *13*, 783. <https://doi.org/10.3390/su13020783>

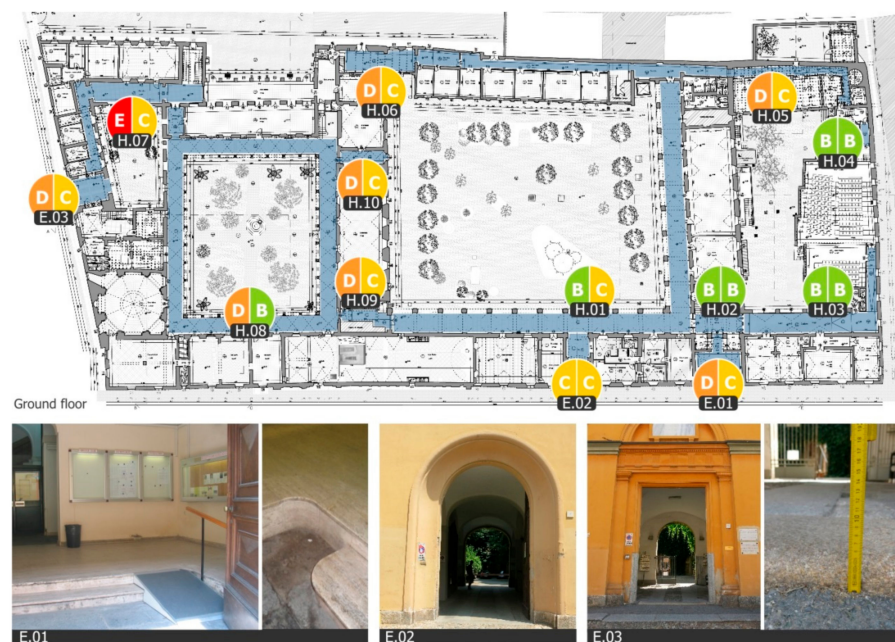
**Figure 3.** Ground floor of San Felice Palace with the results of the accessibility assessment of entrances (E) and the horizontal connections (H) through the prototype assessment tool A.tool, which provides results into five different levels of accessibility (from A to E) for mobility impairments (left paddles) and visual impairments (right paddles).

San Felice Palace was the first case-study to which “A.tool” was applied (2013). Thanks to this research it was possible to understand the building’s state of the art, its strengths and weaknesses. The objective and punctual assessment resulting from “A.tool” is the base of the integrated strategies and the architectural solutions proposed in this paper to improve the accessibility and the quality of the building. (Figure 3).

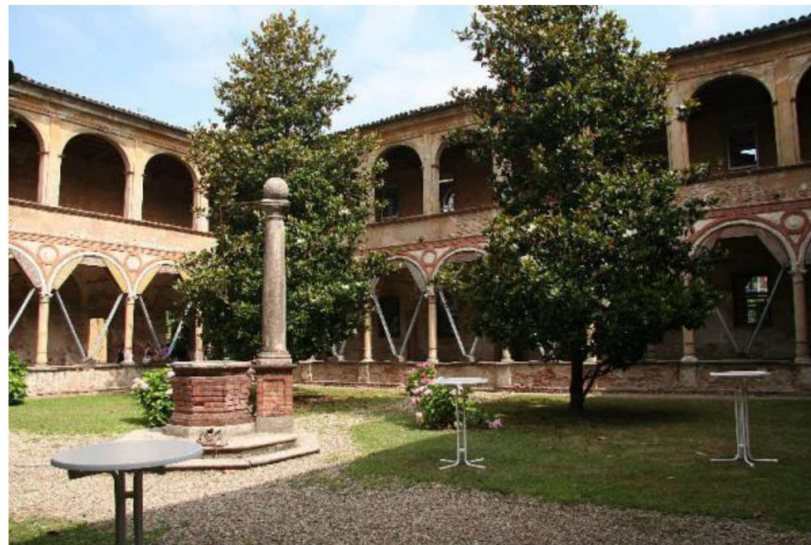
**Figure 5.** A view of the fifteenth-century cloister of San Felice Palace.

Despite the generally good conservation conditions of the San Felice Palace, in some parts a more or less severe level of degradation can be observed, due essentially to the building's age and the action of atmospheric agents. Particularly critical are the conditions of the columns of the fifteenth-century cloister (Figure 5), as they present both significant degradation due to the gypsum neogenesis inside the Angera stone, and significant cracks in the bulbs (Figure 6). This problem was faced in the past by applying steel hoops, most of which are currently ineffective, because of the deterioration of the joint nail, which lost its capacity of stress transfer, and hence its confining action.

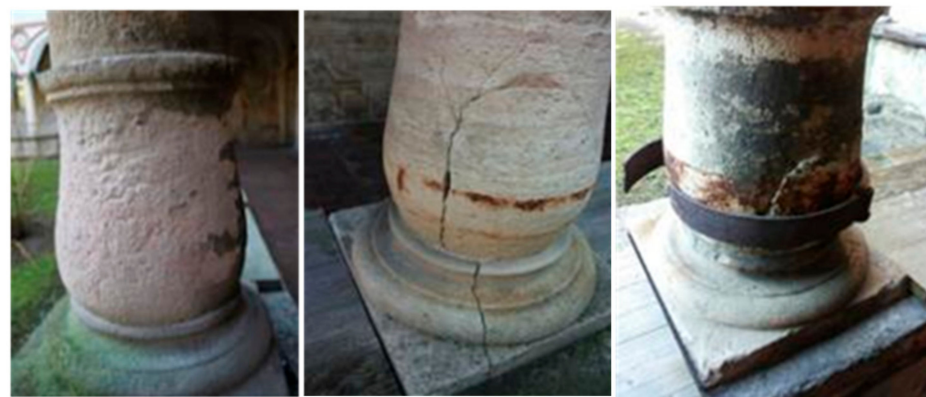
**Figure 6.** Degradation in the cloister's columns due to gypsum neogenesis with the presence of cracks in the columns' bulbs.

Angera stone, used diffusely in historical buildings in Lombardy, is indeed particularly susceptible to degradation phenomena and, in particular, to gypsum neogenesis, not only of the block surface, but also deeply inside the columns. This can create safety issues of this structural portion of the complex, due to the reduced columns' section which can affect their vertical load-bearing capacity. For this reason, within the SICURA project, a detailed survey of all columns of the cloister was carried out, observing the types of damage or deterioration summarised in Figure 7.

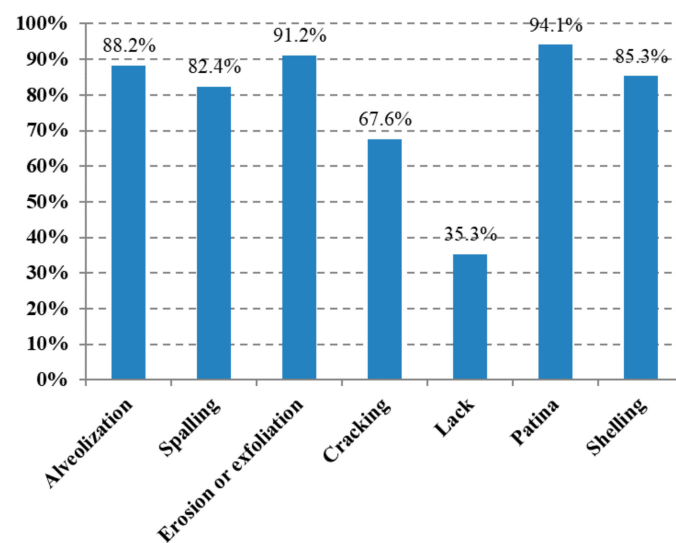
**Figure 7.** Types of damage or deterioration observed in the columns of the fifteenth-century cloister of San Felice Palace, with indication of their frequency of occurrence (in percent over the total number of columns).

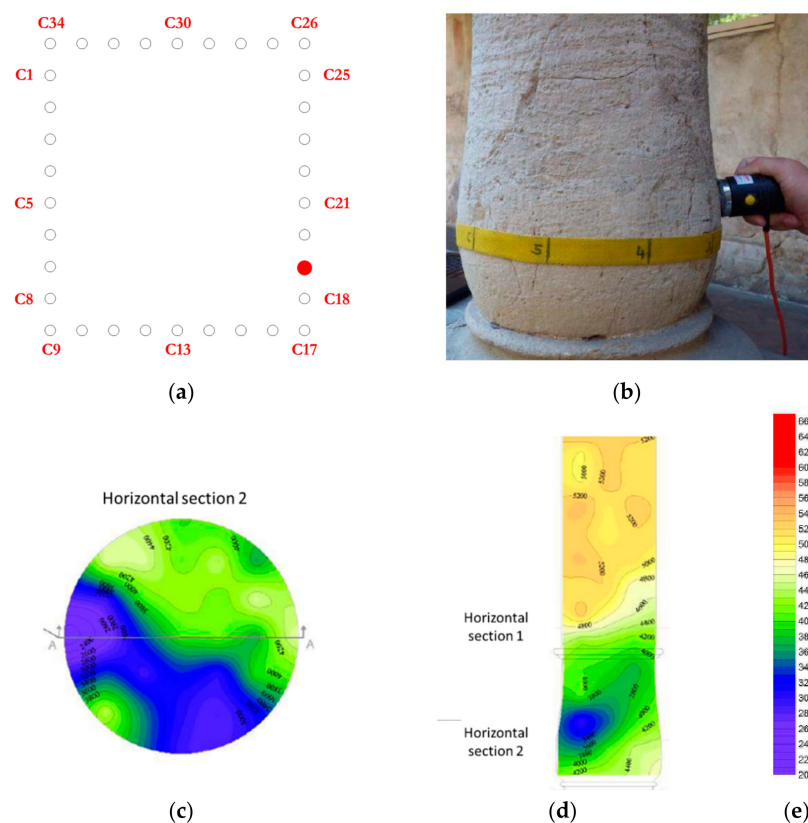
**Figure 8.** Results of the ultrasonic tomography tests on one of the columns of the cloister: location of the column within the colonnade plan (a), view of the column with evidence of cracking (b), results of the tests in terms of P-wave velocity for a horizontal (c) and a vertical (d) section and corresponding colour scale (e) in m/s. (Photo b taken by the authors).

To have a better insight on the actual conditions of the colonnade, some non-destructive in situ tests were carried out, consisting in dynamic vibration tests on tie rods, to evaluate the force acting in the steel ties, and ultrasonic tomography tests on horizontal and vertical sections of the columns. The aim of this type of tests is to evaluate the elastic characteristic of the columns and, more specifically, to identify possible existing cracks and, when possible, to spot the presence of weak areas inside the columns. This allows evaluating the level of degradation and the effective resisting section of each column. Figure 8 reports the results obtained for one of the columns, selected as an example. The colour scale indicates the velocity of P-waves detected through the test. The presence of a significant crack is evident both from the picture (Figure 8b) and from the results of the tomography test on the horizontal and vertical section (Figure 8c,d, respectively), where a slowing effect of the P-waves is clearly visible (blue areas in the plot).

Similar results were obtained for several other columns in the colonnade and this suggested the need of an intervention on this specific area of the complex.

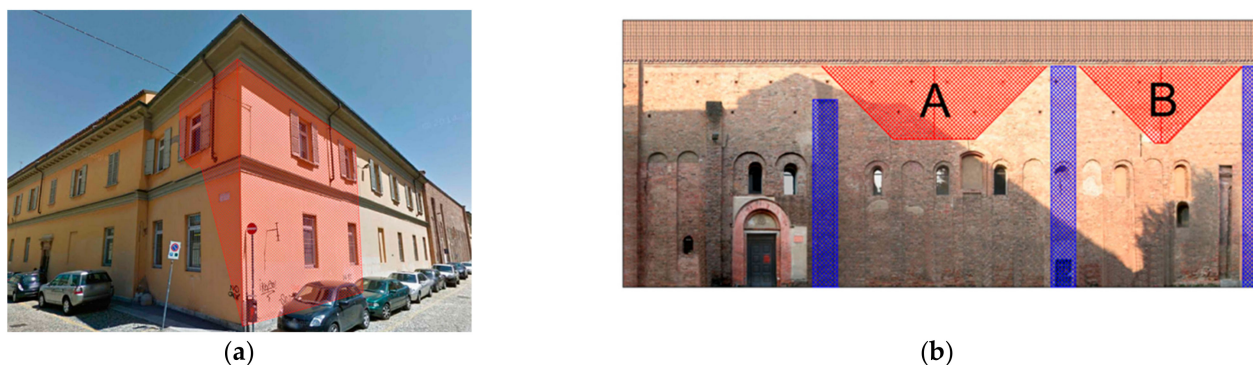
**Figure 9.** Identification of the possible overturning mechanism of the façade involving portions of the orthogonal walls at more than one storey (a). Definition of the constraints and possible activation areas of the out-of-plane two-way bending mechanisms (b). (Photos taken by the authors).

- simple overturning of walls with one or more storeys;
- overturning of the facade involving portions of the orthogonal walls at more than one storey (Figure 9a);
- vertical strip mechanism of a two-storey wall;
- out-of-plane two-way bending mechanism (Figure 9b);
- overturning of wall corners.

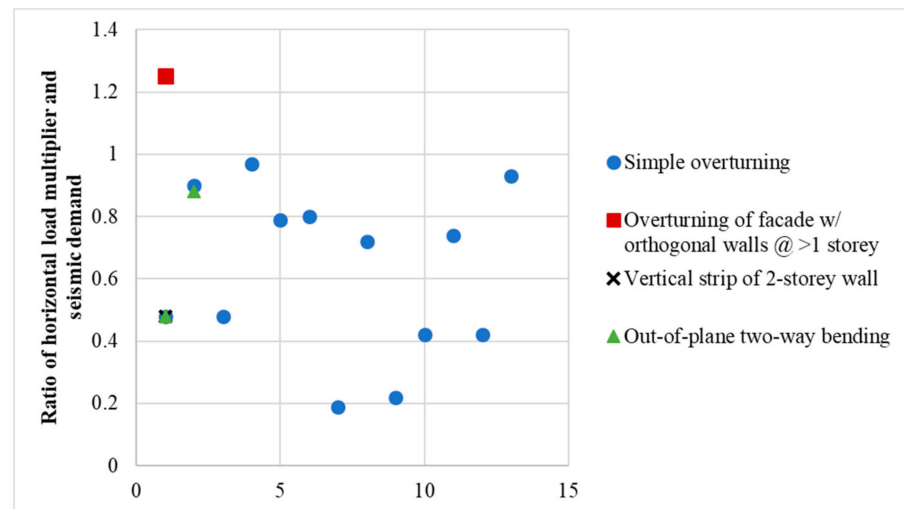
**Figure 10.** Results of the considered out-of-plane mechanisms for the San Felice Palace, in terms of the ratio between the horizontal load multiplier and the seismic demand at the base of each mechanism.

For each possible out-of-plane mechanism, the horizontal load multiplier  $\alpha_0$  was determined by linear kinematic analysis, applying the principle of virtual works and comparing it with the expected horizontal acceleration for a return period of 712 years, corresponding to the life safety limit state. A summary of the results obtained, in terms of the ratio between the horizontal load multiplier and the seismic demand at the base of the mechanism, is reported in Figure 10, for the considered mechanisms. It can be noted that the San Felice complex resulted to be vulnerable to the activation of simple overturning mechanisms (involving one and more than one storey), overturning of wall corners and out-

of-plane two-way bending mechanism, with average values of the ratio around 0.66 and, in few cases, values around 0.2. The results corresponding to the overturning mechanism of wall corners were not calculated, as the complex was deemed to be highly susceptible to this mechanism and, hence, a strengthening intervention was programmed, independently from the values of  $\alpha_0$ .

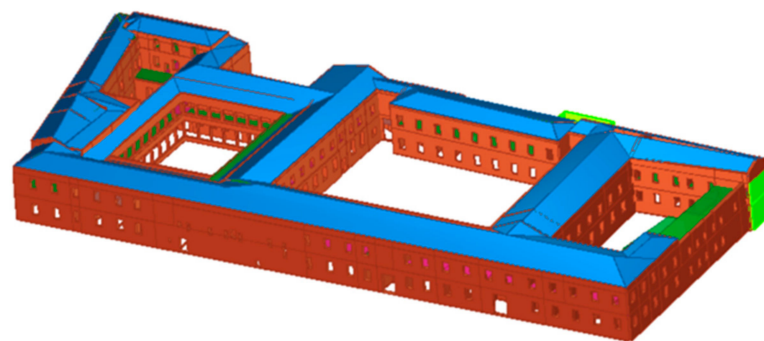
**Figure 12.** View of the 3D numerical model of San Felice Palace.

All diaphragms were modelled as four-node orthotropic membranes, with two displacement degrees of freedom at each node. In case of vaults, a diaphragm with equivalent stiffness was defined, according to [50].

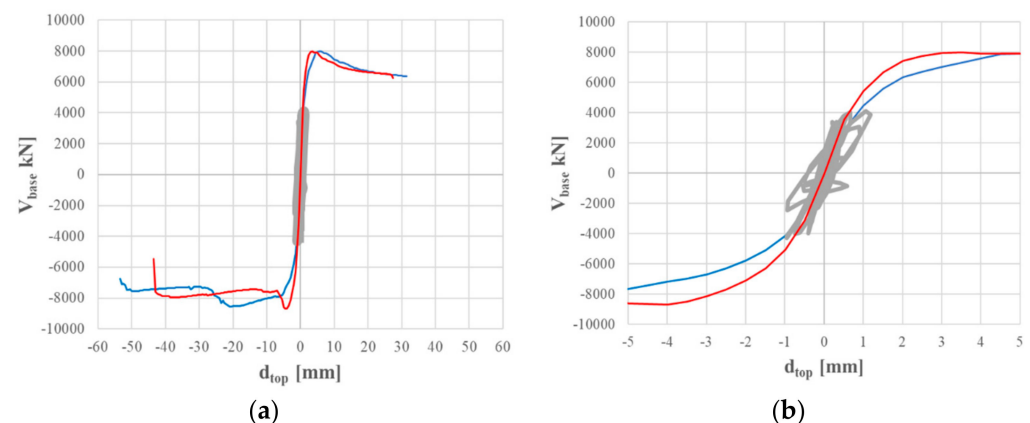
**Figure 14.** Comparison of capacity curves obtained from pushover analyses with the two considered force distributions (mass proportional (red) and inverse triangular (blue) force distribution) and hysteretic curve provided by time-history analyses, for the southern façade (a) and a zoom in the low displacement range (b).

The numerical analysis results on the model’s global response show a very limited seismic vulnerability, as reported in Figure 14, where the in-plane displacement demand computed for the southern façade of the building via time-history analysis for one of the selected records is compared to the capacity curves obtained from pushover analysis (in positive and negative directions). This implies that for the seismic hazard of Pavia the urgent interventions on the damaged cloister accompanied by a set of diffused low-impact interventions (e.g., steel ties to improve wall-to-diaphragm connections and contrast vault thrusts) would guarantee a sufficient seismic performance of the building.

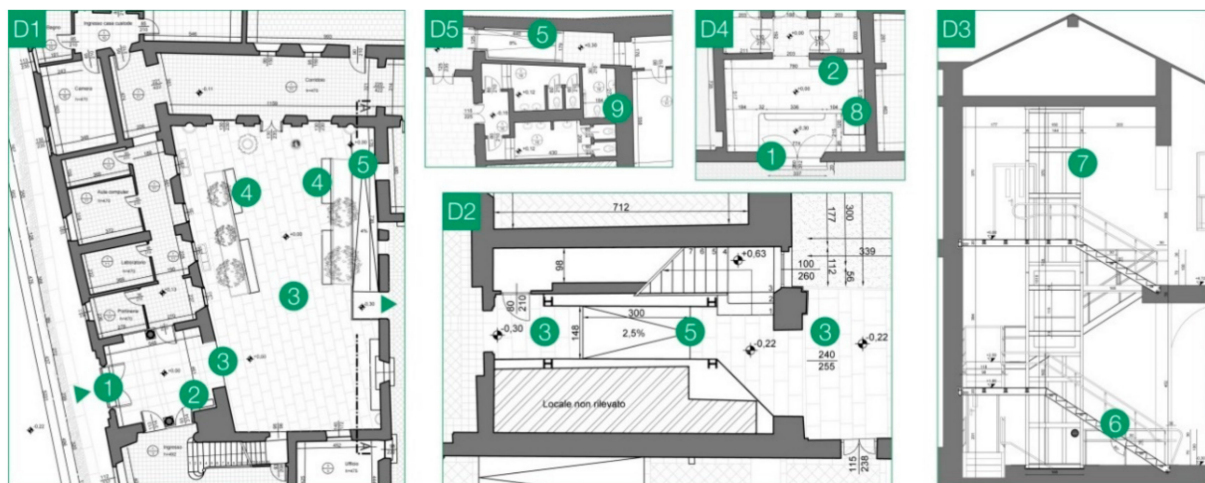
**Figure 15.** Details (D1, D2, D3, D4, D5) of the design solutions for the ground floor of San Felice Palace: 1. Inclined steel surface with anti-slip treatment; 2. informative-tactile map; 3. paving in stone slabs; 4. stone seats with armrests and space for wheelchairs; 5. new ramp; 6. new metal staircase with double height continuous handrail; 7. new elevator; 8. pantograph platform embedded in the pavement; 9. new accessible toilets.

For these critical issues, design interventions are required to improve the situation and guarantee inclusivity, always respecting the principles of conservation and enhancement of the architectural heritage. Details of the designed interventions (indicated with progressive numbering from D1 to D9) are discussed in the following, with reference to Figures 15 and 16.
