Article Identification of the Key Determinants of Bats' Altitude Increase over the S3 Expressway in Poland with Mesh Screens Applied

Alicja Sołowczuk * D and Dominik Kacprzak

Department of Roads and Bridges, West Pomeranian University of Technology in Szczecin, 71-311 Szczecin, Poland * Correspondence: kdim@zut.edu.pl; Tel.: +48-91-449-40-36

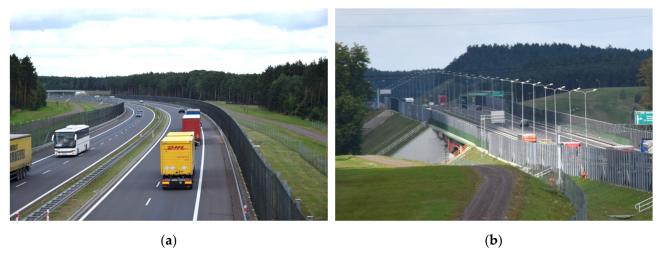
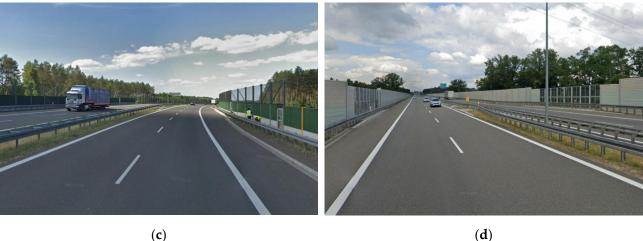
Figure 2. Screens installed on the S3 expressway: (a) an example of 4 m-high mesh screens; (b) an example of various types of screens: 4 m-high mesh screens and mixed screens used on bridges or overpasses (2 m-high EA-17 and EA-18 noise barriers and 2 m-high mesh screens); (c) examples of a 2 m-high EA-15 timber noise barrier combined with a 2 m-high mesh screen (Source: Google Earth [53]); (d) an example of a 4 m-high noise barrier (Source: Google Earth [53]).

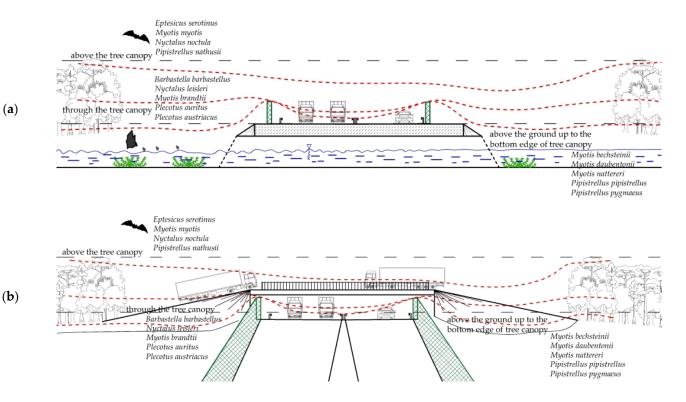
Figure 4. Probable changes in the altitude of flight of bat species confirmed by monitoring due to severed linear landscape features, over a ca. 120 m-wide right-of-way: (**a**) When the expressway is crossed by a culvert or an underpass; (**b**) When the expressway is crossed over by a transverse road running on an overpass.

Additionally, this condition of extending the supplementary vegetation guiding bats up to the screen was given special attention by the authors of the article when identifying the determinants of the effectiveness of the mesh screens under analysis. In line with the conclusions of the publications [10,19,36–38], the height of the new trees or hedges and the continuity of the type of guiding features are also important, as different bat species have their commuting routes at specific altitudes. Based on the bat species determined in the pre-construction monitoring mainly in sustainable road construction, the aim is to retain the vertical structures, landscape and topography along the existing bat commuting routes. Figure 3 shows some examples of failure to retain the continuity of linear features in the case of wildlife underpasses or culverts (Figure 4a), and of a forest clearance along a side road carried by an overpass, and thus of a severed continuity of the bat flight lines (Figure 4b).

The other location where the finding of bat carcasses in the years 2014–2016 was confirmed was the S3 expressway's intersection with a suburban street located on the overpass spanning the S3 expressway (Appendix A—Figure A2). An analysis of the landscape and land development features around the new road indicates that the construction stage was not completed by the extension and restoration of linear landscape features used by bats for navigation. It needs to be noted that after the completion of the S3 expressway, the slopes of the embankment on which the transverse street runs do not serve as linear features for bat flight navigation. Still, the nearby storm pond is a good foraging ground. The mesh screen installed along the S3 expressway (positioned on the lower level) and along the length of several linear forest gaps is not accompanied by any supporting plantings along the treeline on both sides of the road or by any natural funnel for bats to fly through. Thus, the screen is just an abrupt obstruction on the lowered ca. 120 m-wide commuting route. The identified gaps in the linear features of the surrounding landscape and a lack of the guiding funnel most probably made the bats lower their fly height resulting in the identified vehicle–bat collisions shown in Figure 4a,b.

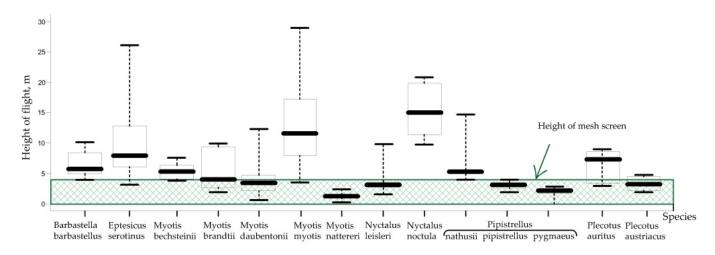
Figure 5. The height of flight of bat species identified during bat mortality surveys conducted on the S3 road. The whiskers represent the minimum and maximum values; lower and upper edges of the boxes determine the first and third quartiles; the bold line designates the median value.

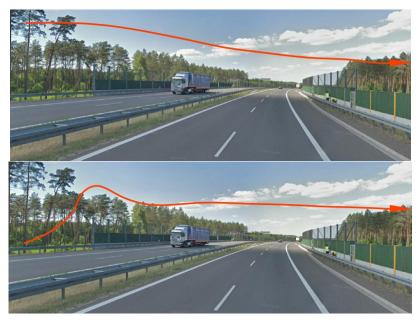
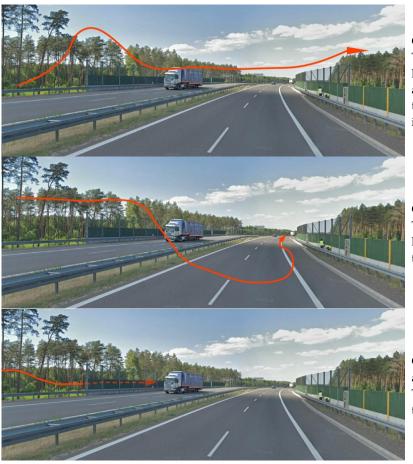
The *Nyctalus* and *Myotis* bat species flying at the tree canopy height, flying over the dual carriageway without lowering their flight and crossing over the screens and carriageway at a safe height.

The *Pipistrellus* bats, having flown over the screen, lower their flight over the roadway (they are then at collision height) and only raise their flight before the screen on the other side of the road to fly over it

Figure 7. The types of bat behaviour observed on the S3 expressway with a 4 m-high combination mesh screen and timber noise barrier. (Visualisation by the authors based on the survey reported in the report [60]). The arrow marked the direction of flight.

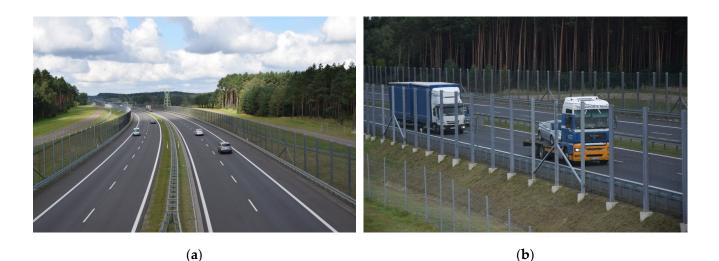
The mesh screen structure consists of polystyrene netting of min. 40 kN/m tensile strength [65,66], spanning between upright S355J0 steel posts (Figure 8). The netting is hung from steel cables anchored to steel posts. The steel posts are I-beams and square hollow sections, anchored to the pile-type foundations. In addition, based on structural calculations [65,66], square hollow section braces were used only at the posts that anchor the steel suspension cables (one bracing at the end posts and two bracings at the intermediate posts). The steel suspension cables are anchored at a height of 0.3, 2.1 and 4.1 m above the ground level spaced at max. 40 m intervals [65,66]. The intermediate posts supporting the mesh are spaced at 4 m intervals. All the steel components of the posts and the cables are protected from corrosion by metal spraying and suitable coatings. The screens are protected from being hit by vehicles with safety barriers. The impact was assumed to be an extraordinary situation and thus the mesh screen support structure was not designed to withstand the resulting load.

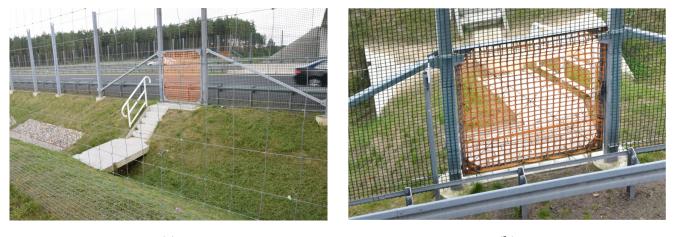
To ensure safety of the motorists travelling along the S3 expressway and the maintenance and other services, easily dismantled screen panels of a contrasting colour were installed at 200 m intervals (Figure 9).

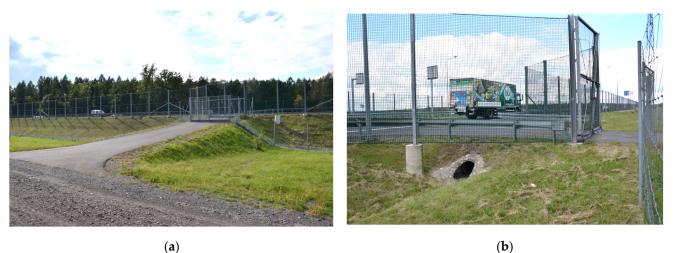
Figure 10. Exit gate on the expressway section with mesh screens: (a) Ramp off to the service road; (b) Safety mesh netting on the exit gate.

Considering the road maintenance requirements and the safety considerations of travellers, several emergency exit points for road maintenance vehicles were provided on these several kilometre long sections of the expressway that had been lined with mesh screens (Figure 10). The whole of the exit gate was also protected with polystyrene mesh, identical to that used in the mesh screen construction.

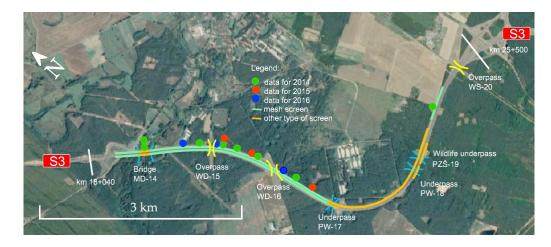
Figure 11. Locations of bat carcasses, screens and road overpasses, underpasses and culverts along the study section No. 1 of the S3 expressway. (Visualisation by the authors based on bat mortality data given in the Reports [60]).

The data show that single dead bats were found at various locations along the S3 expressway with and without screens in place. There were only two locations where two carcasses were found. The first location was on the existing migration route near the bridge over the Obra (Appendix A—Figure A1). There are 4 m-high screens on both sides of this bridge. Both noctule bat (*Nyctalus noctula*) carcasses were found in 2014, shortly after the road was opened for traffic. Given the height of *Nyctalus noctula's* flight, it was probably a result of a hunting bat's collision with a vehicle, as there is a foraging area under the bridge in question. Noteworthily, in that specific case, due to the natural response of a hunting bat to an environmental stimulus, there are no effective and economical ways to eliminate the risk. However, as regards low-flying species, the screens used on the bridge over the Obra River are deemed a satisfactory measure.

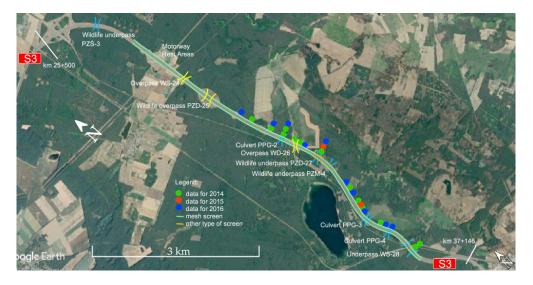
Figure 12. Location of bat carcasses, screens and road overpasses, underpasses and culverts along the study section No. 3 of the S3 expressway. (Visualisation by the authors based on bat mortality data given in the reports [60]).

The carcass distribution analysis showed (Figure 12) that in almost all cases, dead bats were found in the vicinity of underpasses or culverts. Where greater numbers of carcasses were found, in two cases it was an underpass, in one case it was a culvert, and in the fourth case it was a severed forest road (Appendix B—Figure A3).

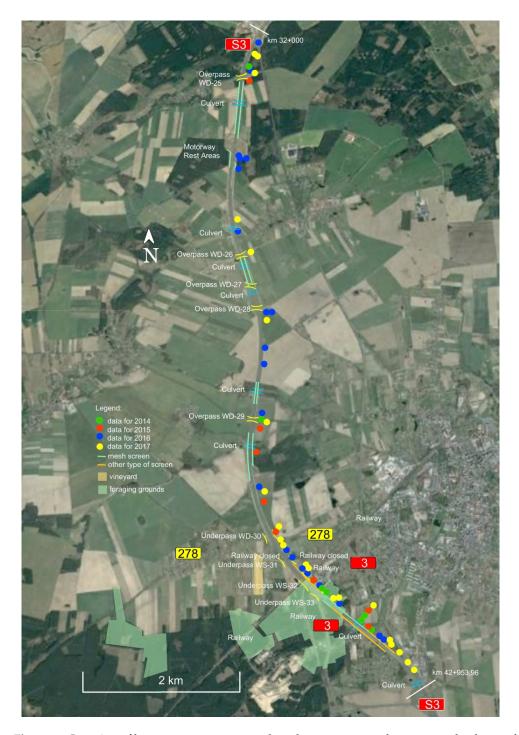
Figure 13. Location of bat carcasses, screens and road overpasses, underpasses and culverts along study section No. 4 of the S3 expressway. (Visualisation by the authors based on the bat mortality data given in the reports [61]).

An analysis of the distribution of the bat carcasses found along study section No. 4 shows (Figure 13) that, in almost all cases, the locations at which several dead bats were found were in the vicinity of wildlife overpasses or underpasses under the expressway, and near several culverts without screens or near culverts with screens yet without a natural funnel (Appendix C—Figure A4).

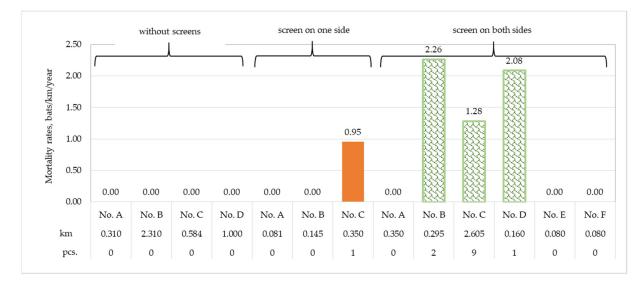
Figure 14. Bat mortality rate distribution across the study section No. 1 of the S3 expressway over the 2014–2016 period (with given length of the road section with or without a given type of screen and the number of carcasses confirmed by monitoring).

A cursory analysis of the graphs shown in Figures 14 and 15 demonstrates that, in the given case, the mortality rate data are not reliable in assessing the effectiveness of the use of mesh screens, as high values of the rate were obtained with one or two bat carcasses found on a short stretch of the road. On the other hand, almost twice as low mortality rates were obtained with 11–12 bat carcasses found on several-kilometres-long stretches of the road with mesh screens installed on both its sides. Study sections No. 1 and 3, shown in Figures 14 and 15, are characterized by long stretches of road with screens installed and with a preliminary cursory analysis, the data could be misread as proving the ineffectiveness of screens as a mitigating measure. However, this would be a very erroneous conclusion, as firstly, there are no confirmed bat commuting and migration routes on study sections No. 1 and 3 on the road stretches without screens, and secondly, Figures 14 and 15 give no additional information about the landscape and land development features in the surroundings of the given section, which perhaps had a more determining effect on bat mortality in the given location.

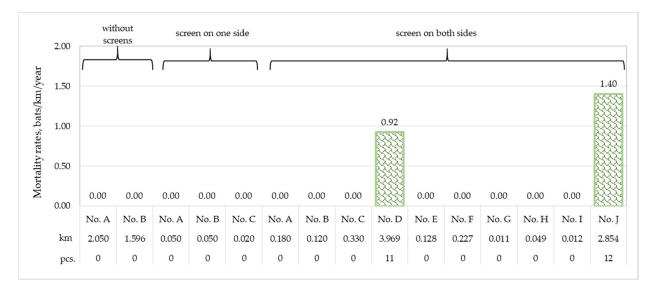
Figure 15. Bat mortality rate distribution across the study section No. 3 of the S3 expressway over the 2014–2016 period (with given length of the road section with or without a given type of screen and the number of bat carcass finds confirmed by monitoring).

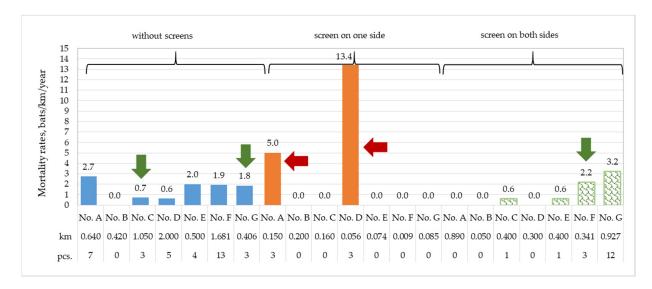
Figure 16. Bat mortality rate distribution across the study section No. 4 of the S3 expressway over the 2014–2017 period (with given length of the road section with or without a given type of screen installed and with the number of bat carcass finds confirmed by monitoring).

The data presented in Figure 16 are much more interesting in cognitive terms. Attention is drawn to two sections with screens installed on one of its sides and high mortality rates. In both cases, three bat carcasses were recorded on each of them with almost three times the difference between the lengths of these road sections (Figure 16—marked with a red arrow). The green arrow marks other stretches of the road, on each of which three bat carcasses were also found, but with very different lengths of these stretches.

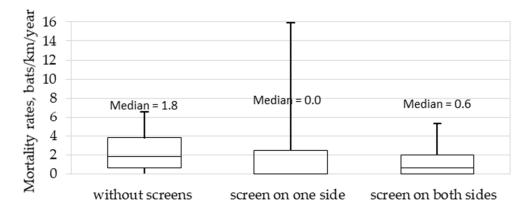
Figure 17. The boxplot of the bat mortality rate on the stretches of the road with various screens installed (data from section No. 4 only). Whiskers represent the minimum and maximum values; the lower and upper edges of the boxes determine the first and third quartiles; and the bold line designates the median value.

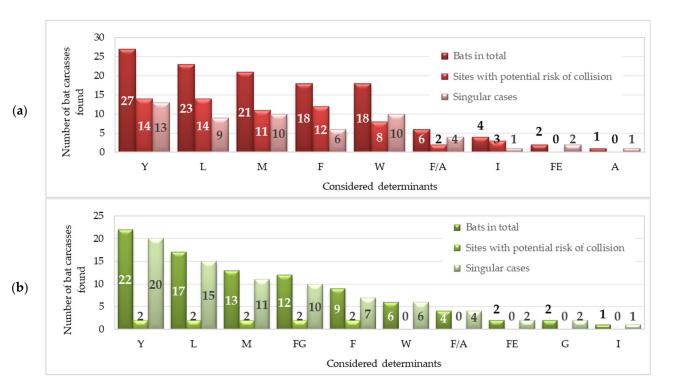
Figure 18. Distribution of determinants on sections with screens installed on both sides of the road: (a) 27 sites where bat carcasses were found in the immediate vicinity of a road structure; (b) 22 sites where bat carcasses were found outside road structure areas. Determinant designations: Y—lack of natural funnels for bats to fly through, L—distance from the screen to the nearest trees greater than 30 m, M—an existing bat commuting and migration route, either probable or confirmed in preconstruction monitoring, F—forest area on both sides of the road, W—water environmental conditions, F/A—forest land on one side and agricultural land on the other side of the road, I—artificially lit road, FE—forest edge, A—agricultural land on both sides of the road, FG—linear forest gap, G—garden allotments (foraging grounds).

An analysis of the data shown in Figures 18 and 19 indicates that the importance of the selected distribution factors is variable and depends on whether and where the screens are installed on the expressway. To determine possible additional determinants with the screens installed on the expressway, their percentage shares were estimated, as shown in Figure 20. A detailed analysis of the distribution of percentages demonstrated that the most important determinants likely to contribute to lowering the height of bat flight over the road and, in consequence, to creating a potential risk of bat–vehicle collisions are (Figure 20—red line—means over 50%): the lack of natural flight funnels on bat commuting and migration routes, the length of the gap between linear landscape features in close proximity to the road greater than 30 m, the presence of a road structure (overpass, underpass or culvert) without the extension of existing natural plantings along the bat commuting route up to the structure's wing walls, the presence of a linear forest gap without the extension of plantings up to the edge of the screen, the vicinity of a forest with new commuting and migration routes, and water environmental conditions, which provide potential foraging grounds without plantings extending treelines or installed natural funnels for bats to fly through.

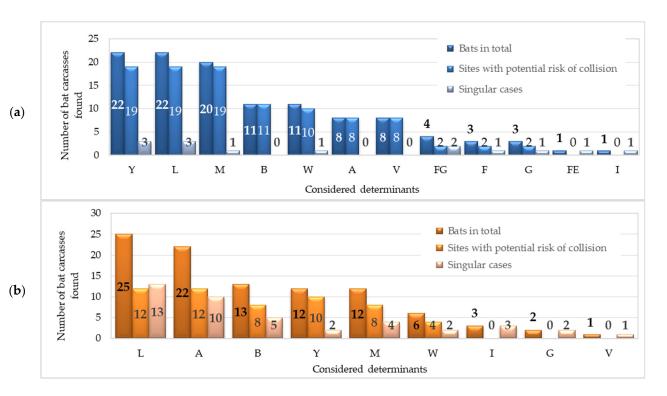
Figure 19. Distribution of determinants: (**a**) 22 locations where a screen was installed on one side of the road; (**b**) 25 locations where no screen was installed. Determinant designations: Y—lack of natural funnels for bats to fly through, L—distance from the screen to the nearest trees greater than 30 m, M—an existing bat commuting and migration route, either probable or confirmed in pre-construction monitoring, B—road structures, W—water environmental conditions, A—agricultural land on both sides of the road, V—vineyard (foraging grounds), FG—linear forest gap, F—forest area on both sides of the road, G—garden allotments (foraging grounds), FE—forest edge, I—artificially lit road, FA—forest area on one side of the road and agricultural land on the other side of the road.

As a result of an analysis of the locations at which bat carcasses were found on the expressway stretches with no screens installed (Figure 19b), the most significant determinants proved to be: the gap in the linear features of the landscape greater than 30 m, the presence of open agricultural land, and the presence of road structures without natural funnels installed on potential bat commuting and migration routes. According to the conclusions of the guidelines [19], not all bat species have commuting routes located in open agricultural terrain (a treeless uniform agricultural landscape devoid of any structure and including large areas of monoculture crops). In agricultural land, these may be high-flying bats, such as *Nyctalus* or, less frequently, *Eptesicus* or *Pipistrellus*. That is why in most pre-construction

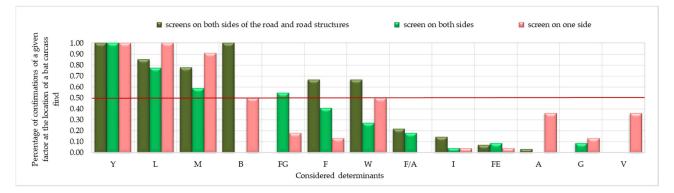
Figure 20. Percentage of locations of bat carcass finds on expressway stretches with screens installed. Determinant designations as in Figures 18 and 19. (Red line—means over 50%).

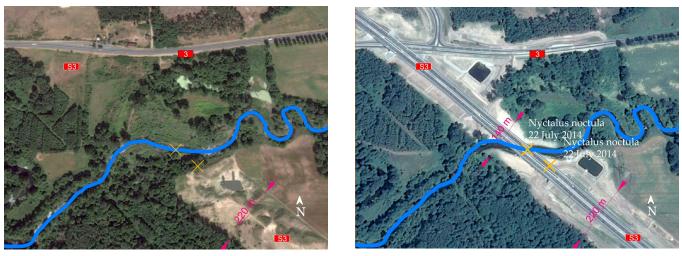
Figure A1. Bat commuting route across the Obra River valley (crosses mark where two *Nyctalus noctula* bat carcasses were found): (**a**) A 2010 view and a 220 m-wide swath of forest cleared for the S3 expressway right-of-way; (**b**) A 2014 view after the road was opened for traffic. (Visualisation by the authors pictured against a satellite image from Google Earth [53].) (blue line—river).

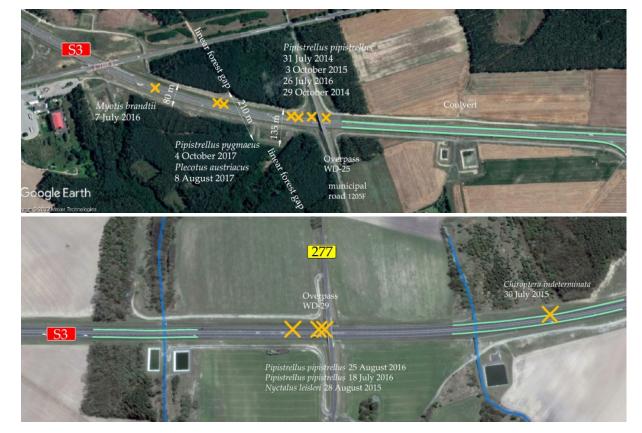
Figure A4. Landscape and land development features on study section No. 3 in the immediate vicinity of the overpasses with no screens installed, and locations at which bat carcasses were found over the 2015–2017 period (cross mark): (a) Surroundings of the WD-25 overpass with no screen and no natural funnel for bats to fly through; (b) Surroundings of the WD-29 overpass also with no screen or natural funnel for bats to fly through. (Visualisation by the authors against the background of satellite images from Google Earth [53]). (Blue line—stream; green line—mesh screen).

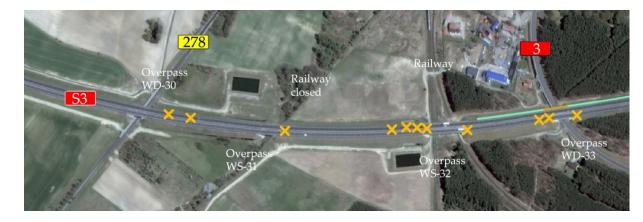
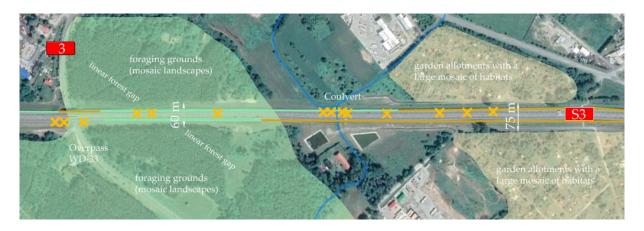
Figure A5. Two stretches of the S3 expressway on study section No. 4 with the largest number of bat carcasses found (locations of carcasses found over the 2014–2017 period are marked with a cross): (a) Very varied landscape and land development features with the highest density of overpasses over a short stretch of the S3 expressway, and an absence of screens and natural funnels for bats to fly through; (b) Very varied landscape and land development features around the S3 expressway (forest and garden allotments), with mesh screens and noise barriers installed on both sides of the road, double culvert 2×2 m. (Visualisation by the authors against the background of satellite images from Google Earth [53]). (Green line—mesh screen, blue line—streams, brown line—noise barrier).

In two cases, the carcasses were found in the surroundings of rail and road underpasses on the S3 expressway with no screens installed, although they probably could have served as linear landscape elements, providing a major navigation aid for bats (Appendix C—Figure A5a). However, the largest number of bat carcasses, accounting in total for 1/3 of all fatalities, were found on the stretch of this study section of the S3 expressway with mesh screens or noise barriers installed, located in the vicinity of a vineyard, forest, the Sulejówka and its tributary or garden allotments, which are extensive and very diverse foraging grounds (Appendix C—Figure A5b).

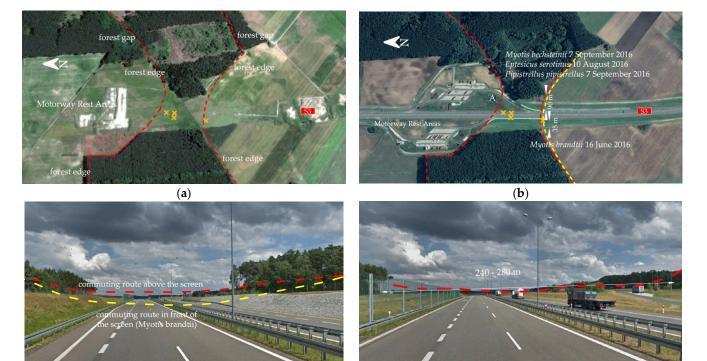
Figure A6. Landscape and land development features in the rest area: (**a**) Likely bat commuting routes existing up to 2010 and a swath of forest cleared over the width of the right-of-way (red dashed line—commuting route); (**b**) Landscape and land development features in the rest area in 2016 and the mesh screens installed (celadon line) and locations at which bat carcasses were found (orange cross mark), A—single trees on the eastern side; (**c**) View on the access road to the rest area from the south and open terrain, mesh screens visible further in the background, the location where 1 bat carcasses were found, the migration line existing so far (red dashed line), likely bat commuting line (yellow dashed line—5 m in front of the screen); (**d**) View on the rest area and the location where 3 bat carcasses were found, single trees visible on the eastern side behind the cut slope, open area over the length of 240–280 m; (**e**) The western side of the rest area and the mesh screen along the forest edge; the mesh screen located 40–55 m from the forest edge, measured from the carriageway edge; (**f**) The eastern side of the rest area, the carriageway edge spaced 125–150 m from the forest edge. (Visualisation by the authors against the background of satellite images from Google Earth [53]).

In two cases, bat carcasses were found along lit S3 expressway segments, i.e., within rest area (Appendix C—Figure A6) and along a stretch of the approach road to the interchange. Figure A6 in Appendix C shows: probable bat commuting routes along the edges of the forest forming linear landscape features in 2010 (red dotted line) and locations of bat carcass finds (orange cross mark), as well as the landscape and land development features within the expressway rest areas and the location of mesh screens in 2016, at the time when bat carcasses were found. An analysis of the distribution of screens and of the probable commuting route, with different bat species confirmed, indicates significant gaps in linear navigation features and the absence of a natural funnel. This section runs in a cutting with the edge of the forest situated 90 m away from the embankment slope crest on the eastern side and 35 m on the western side. The distance between the cutting slopes' crests is 55 m. Thus, the gap in the flight line at the southern end of the mesh screens is 180 m, i.e., according to the research conclusions formulated in [10,19,74], bats treat this area as an open terrain. Additionally, at the northern end of the installed mesh screens, there is no continuity of linear landscape features. The lighting at the rest area attracts many insects, which, in turn, attract foraging bats to areas where they face the risk of collision with vehicles.

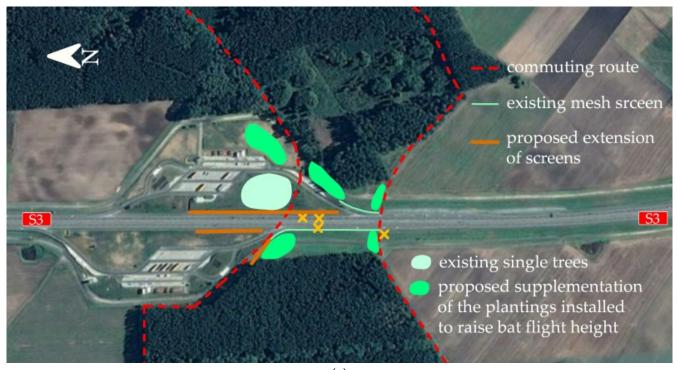
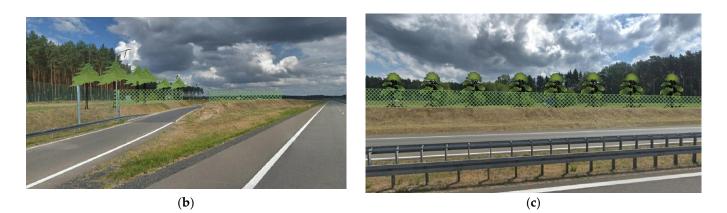
Figure A7. Proposals for the use of additional screens on the cutting slope and supplementary plantings to raise bat flight above 4 m over the rest area site: (a) Plan; (b) Western side; (c) Eastern side. (Visualisation by the authors against the background of satellite images from Google Earth [53]).

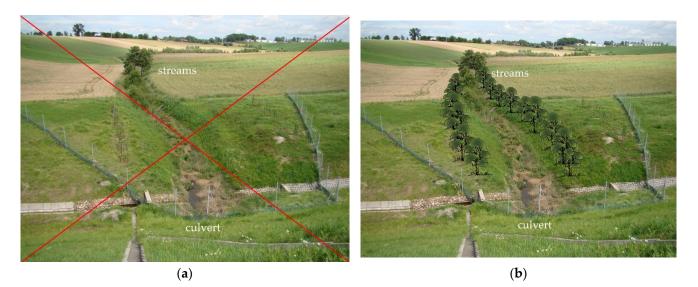
Figure A8. Landscape and land development features in the surroundings of a culvert: (**a**) Poor land development around the stream, one-year-old tree seedlings planted after the road was open for traffic, inadequate for the altitude of bat flight and the inside clearance distances of the culvert; (**b**) Proposed mature tree plantings adequate for the height of bat flight and the inside clearance distance distances of the culvert, directed straight at the wing walls of the culvert.

Examples of inadequate landscape and land development features at locations where several bat carcasses were found and suggestions for improving this land development are shown in Appendix D. Figure A8 in Appendix D shows a proposal for extending the treeline and the natural funnel installed at culverts. Figure A9 in Appendix D shows a proposal for a natural funnel to be installed before a small wildlife underpass, taking into account the minimum dimensions based on the study results given in [19,20,46,76,77,79–81]. Figure A10 in Appendix D shows a proposal for a natural funnel to be installed before a medium-size underpass, considering the minimum dimensions based on the study results given in [19,46,77]. Figure A11 in Appendix D shows a proposal for a natural funnel to be installed before a large-size underpass, considering the minimum dimensions based on the study results given in [10,19].

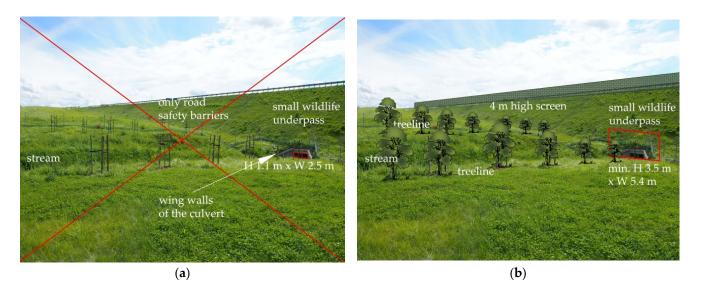
Figure A9. Landscape and land development features in the surroundings of a small underpass: (a) Poor land development around the stream, one-year-old tree seedlings planted after the road was open for traffic, inadequate for the altitude of bat flight and the inside clearance distances of the underpass; (b) Proposed installation of a mesh screen and planting of mature trees adequate for the height of bat flight and the inside clearance distances of the wildlife underpass, directed straight at the wing walls, larger cross-section of the underpass.

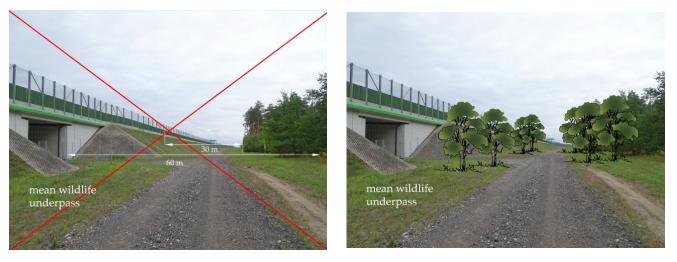
Figure A10. Landscape and land development features in the surroundings of a medium underpass: (a) Poor land development around a stream, one-year-old tree seedlings planted after the road was open for traffic, inadequate for the altitude of bat flight and the inside clearance distances of the underpass, absence of a screen raising the height of bat flight; (b) Proposed installation of a mesh screen and planting of mature trees adequate for the height of bat flight and the inside clearance distances distances of the wildlife underpass, directed straight at the wing walls of the underpass.

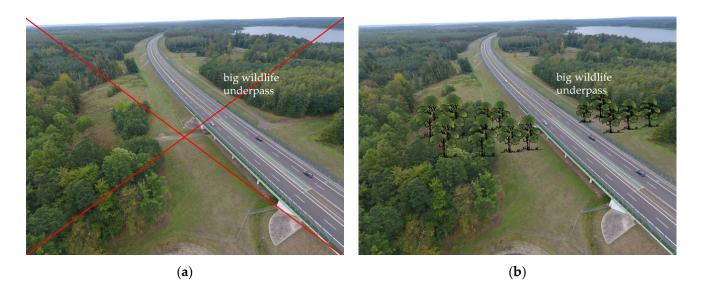
Figure A11. Landscape and land development features in the surroundings of a large underpass: (a) Poor land development around a stream, one-year-old tree seedlings planted after the road was open for traffic, inadequate for the altitude of bat flight and the inside clearance distances of the underpass, absence of a screen raising the height of bat flight; (b) Proposed installation of a mesh screen and planting of mature trees adequate for the height of bat flight and the inside clearance distances distances of the wildlife underpass.
