Concept Paper

# Vulnerable Road User Protection from Heavy Goods Vehicles Using Direct and Indirect Vision Aids

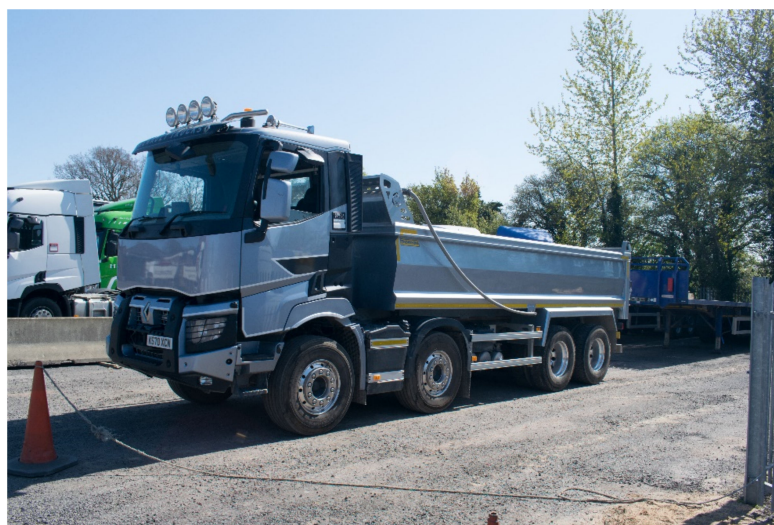
Figure 1. Renault C430 Test Vehicle.

Figure 1 shows the subject test vehicle. The vehicle was a Renault Trucks C430, with an  $8 \times 4$  axle configuration and fitted with a Tipper body. The axle layout means that two axles in close proximity were fitted at the rear with two axles, further apart, fitted at the front. It was of N3G-type approval class, indicating suitability for on- and off-road use. The gross vehicle weight was 32 tonnes; as such, it fell into the remit of the TfL Direct Vision Standard. The base vehicle was rated as 0 stars under the DVS Assessment Protocol. Therefore, additional safety equipment was already fitted to a level acceptable under the Safe System, consisting of a combination of cameras and sensors.

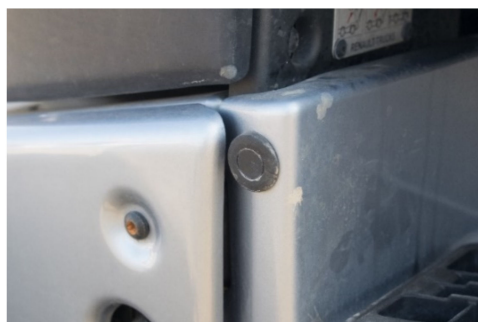
**Figure 2.** Sensor 1 (Front).

A series of 4 ultrasonic sensors were fitted along the nearside of the test vehicle. The system was supplied and fitted by the sensor manufacturer TVG [14]. This was fitted at point of vehicle delivery by an approved TVG technician and met the warning sensor coverage requirements for the TfL Safe System. Sensor locations were measured at each of the 4 locations along the vehicle. Measurements were taken relative to the front axle of the vehicle and all subsequent axles. Table 1 shows the sensor locations on the C430 test vehicle. Figures 2–5 show the four sensors fitted. Sensors are numbered from front to rear, with Sensor 1 being the most forward, and sensor 4 the most rearward.

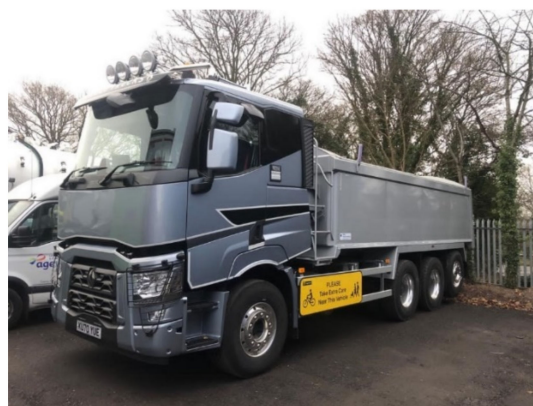
Figure 6. Renault Tridem comparison vehicle.

A Renault Trucks Tridem (Figure 6) also fitted with a TVG sensor system complying with Tfl requirements was available for comparison. The Tridem had an identical cab design to the C430 test vehicle but with a different axle configuration (1 × 3). This vehicle had three axles in close proximity fitted to the rear with one axle fitted to the front.

The Tridem was not used in the nearside sensor system tests but solely as a comparison vehicle to show how different axle configurations may affect where sensors can be placed. Table 2 shows the sensor locations on the Tridem, and Figure 7 compares sensor fitment on the C430 to that on the Tridem, both in relation to the required Tfl coverage area.

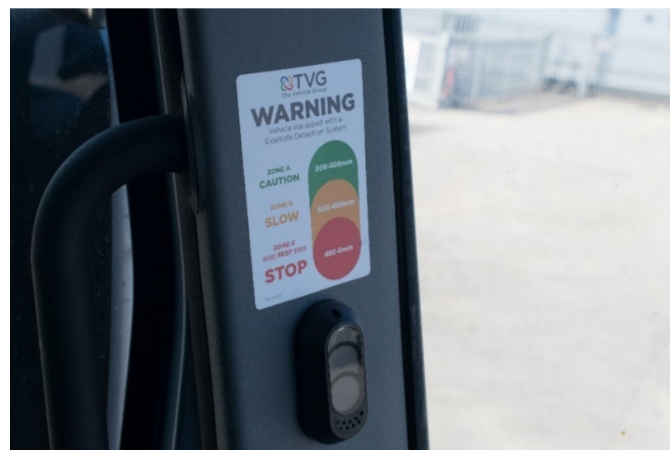
**Figure 8.** Warning lights and buzzer.

A red–amber–green warning light was mounted to the vehicle A-pillar on the passenger (near) side, with a self-contained audible warning buzzer in the component casing (Figure 8). The sensor detection information for each warning level is shown in Table 3.

Distance	Light	Audio	Recommended Action
$0 < 0.4$ m	Red	Continuous	Stop Vehicle
$0.4 < 0.6$ m	Orange	None	Slow Vehicle
$0.6 < 0.8$ m	Green	None	Proceed with Caution
$>0.8$ m	None	None	None

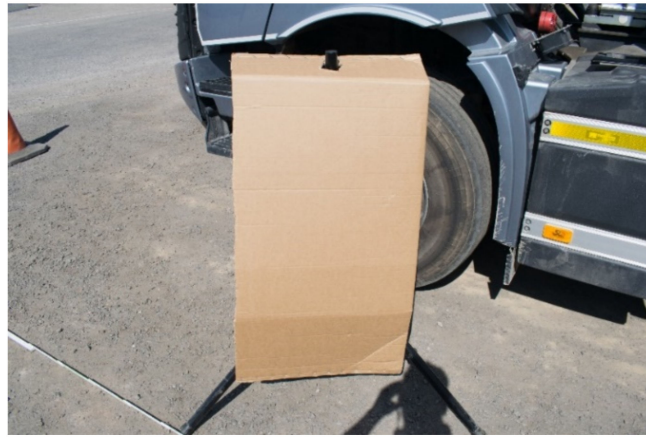
**Figure 10.** Pedestrian Target.

**Pedestrian target**—The pedestrian surrogate was set to a height equivalent to that of a 5th percentile Italian female—1267 mm. This is the same dimension used in both the CAD-derived and manual assessment methods of a vehicle’s direct vision [15,16] and essentially represents a worst-case scenario in terms of detection. A tripod was used, as this allowed height adjustment with a flat surface mounted to it to allow detection. The width of this surface was selected arbitrarily at 565 mm, but activation was found to reliably occur in initial practice tests. The target was moved with its wide side facing the side of the HGV. Figure 10 shows the test target used.

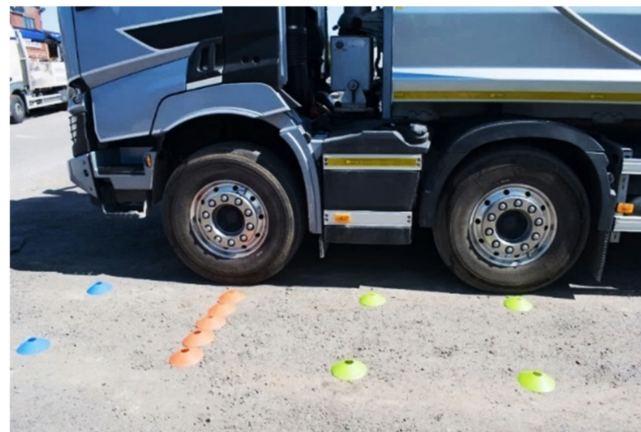
**Test procedure**—A number of small cones were placed in an array covering the test zone (Figure 11), and a test operative put the test target in place upon each of these cones, then proceeded to the driver's side to enter the cab and determine the activation status of the system. It was important that the operative entered through the driver's (offside) door so as not to interfere with the sensors and create a false-positive reading. Assessing activation at each point across the grid map allowed field of vision diagrams (optical detection maps) to be produced.

**Figure 11.** Marker cones placed along vehicle side.

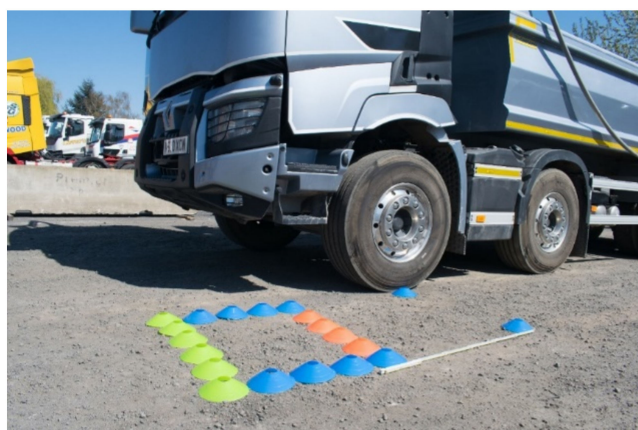
**Additional test area for forward coverage**—an additional test ahead of the vehicle was performed to detect the extent of forward coverage of the most forward sensor located on the front corner of the vehicle and obtain data outside the Safe-System-required area. Again, a grid map was formulated, and a test taken at every 0.2 m across this. Figure 12 shows the marker cones ahead of the vehicle. This extended grid area covered the front blind spot into which a pedestrian or cyclist could move.

**Figure 12.** Marker cones for testing forward coverage.
