# Comparative Life Cycle Assessment of a Historic and a Modern School Building, Located in the City of Naoussa, Greece

**Abstract:** Life Cycle Assessment is often applied as a methodological approach for evaluating the environmental performance and impact of the building sector, including building stock. In the present study, two school buildings, located in the city of Naoussa, N. Greece were analyzed, including a historic and a modern one. The survey concerned on-site inspection and documentation of the structures, data collection and analysis, Life Cycle Impact assessment, as well as comparative evaluation of the results. The objective was to indicate the constructional and performance characteristics of the buildings, as well as to comparatively evaluate their environmental performance and impact. Since historic school buildings still function as educational units, these aspects are crucial and may determine their future operation and use. For LCA, the expected life span of the buildings was taken into account (60 years for the modern school and 140 years for the historic one), as well as all life cycle stages (product, construction, use, end of life, beyond building life). V

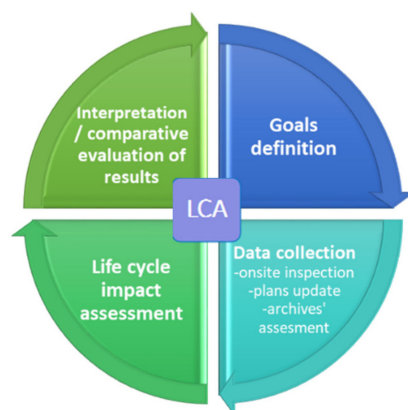
**Figure 1.** Chart depiction of the methodology followed for the assessment of the school buildings.

The methodology followed is presented in Figure 1.

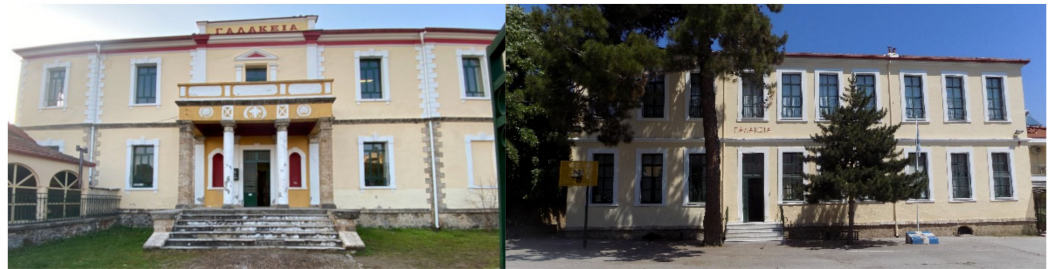
Figure 2. The NW (left) and SE facade (right) of the historic school building (Galakia).

The 3rd Primary School of Naoussa (Galakia) (Figure 2), built in 1921, is a three-story building, consisting of a semi-basement (extended only in the NE part), elevated ground floor (0.6–1.2 m above the ground level) and 1st floor. The floor plan is rectangular (dimensions: 28.3 × 11 m) (Figure 3), while the roof is wooden, covered with traditional ceramic tiles. The orientation of the main facade is northwestern. The ground plan is simple (Figure 3), with an elongated corridor, located on the NW side of the building and a transversal one in the SE part. Classrooms are successively arranged in the SE part of the ground and 1st floor, alongside the elongated corridor (Figure 3). Generally, there is a symmetric organization of the floor plan in both the elongated and vertical axis, mainly observed on the 1st floor, whilst openings are symmetrically distributed in the building shell. Externally, facades follow the plan, depicting the arrangement of the inner spaces, while decorative elements highlight construction.

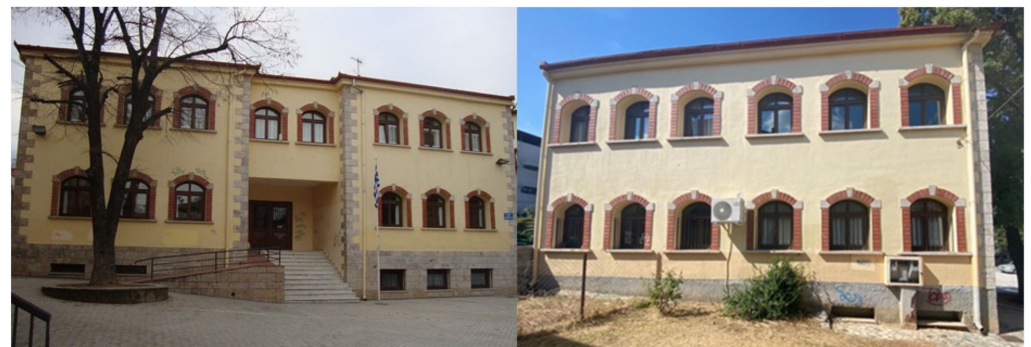
Figure 5. The Eastern (left) and Southern facade (right) of the modern school building (Sefertzio).

The 4th Primary school of Naoussa (Sefertzio) was built in 2001 (Figure 5). It is a modern, three-story building with a semi-basement, raised ground floor (0.85–1.5 m from the ground level), 1st floor and tiled roof. It has an approximate rectangular floor plan (dimensions:  $20.6 \times 12.4$  m) (Figure 6) and a total height of 10.5 m. The orientation of the main facade is eastern, whereas the internal height of the semi-basement is 3.8 m and 3.15 m is the height of the ground and 1st floor. The construction refers to reinforced concrete horizontal and vertical load-bearing elements, as well as brick masonries, 0.4 m thick. The thickness of the concrete plates is 0.25 m. The semi-basement hosts auxiliary spaces (storage rooms, library, gym), the ground floor has 3 classrooms and a WC, while on the 1st floor there are 3 classrooms and 2 offices (Figure 7). The floor plan is symmetric both in the

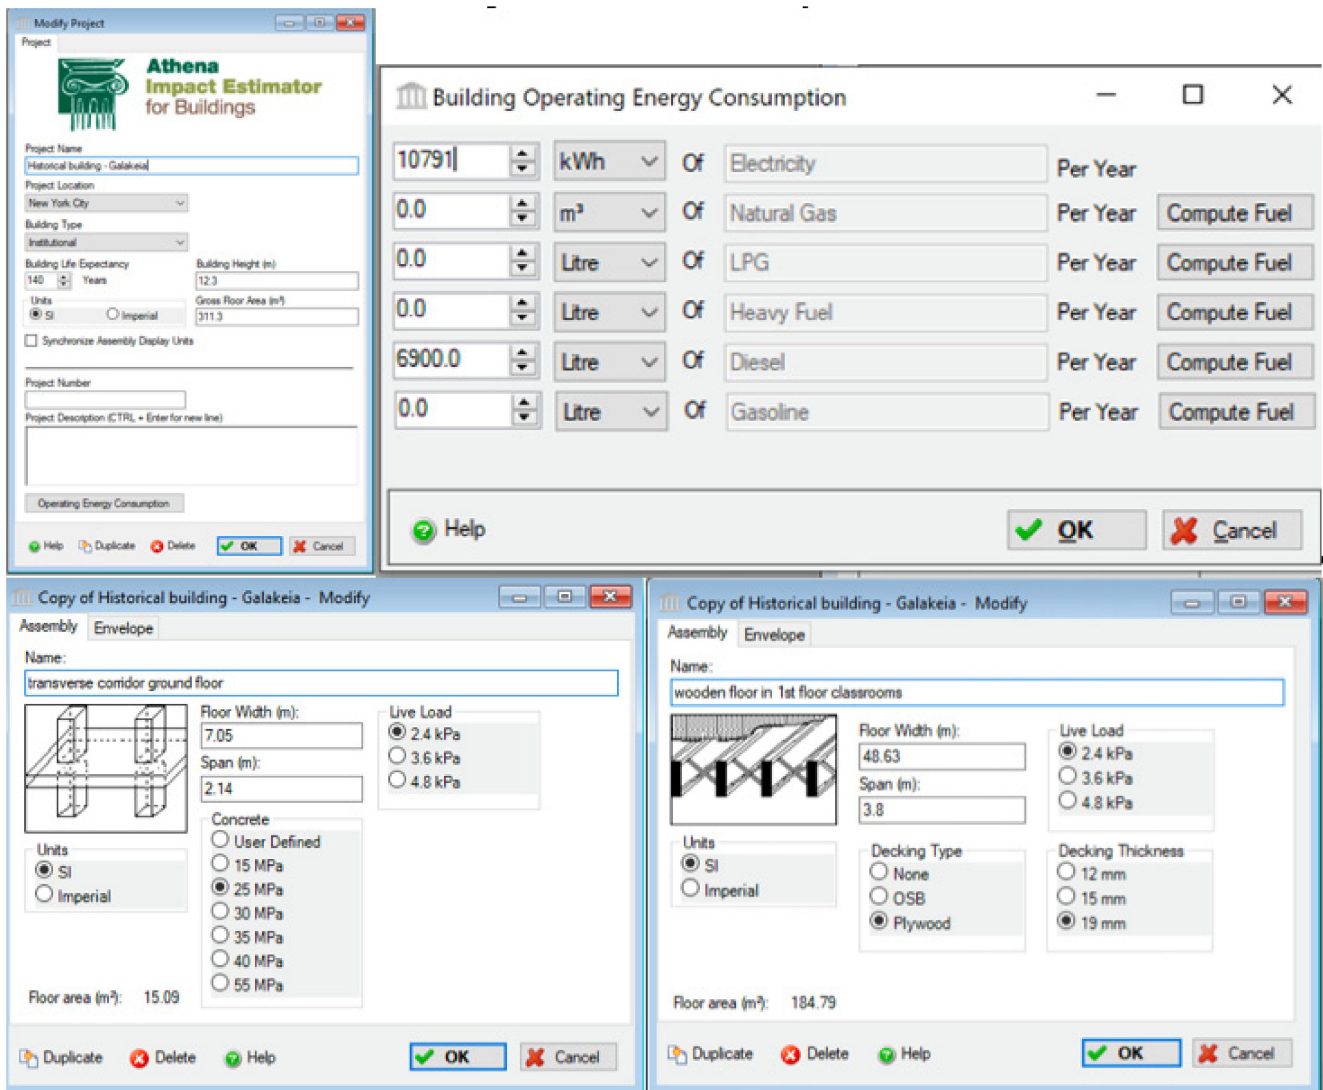
Figure 8. Data input for the historic school (Galakia).

All relevant data (Table 1) were input into the software, such as location, building type (institutional), total height, floor plan area, constructional aspects, as well as the annual electricity consumption for lighting and the diesel consumption for heating (Figure 8). Regarding the expected lifetime of the schools, the year 2061 was considered to be the time limit, taking into account 60 years of operation for the modern school (built in 2001). According to the literature [17,21–26,29], the lifespan of buildings may range from 50 to 150 years, while in the case of schools, a cycle of 60 years is promoted [25]. In this case, the historic school would have an operational use of 140 years (1921–2061).

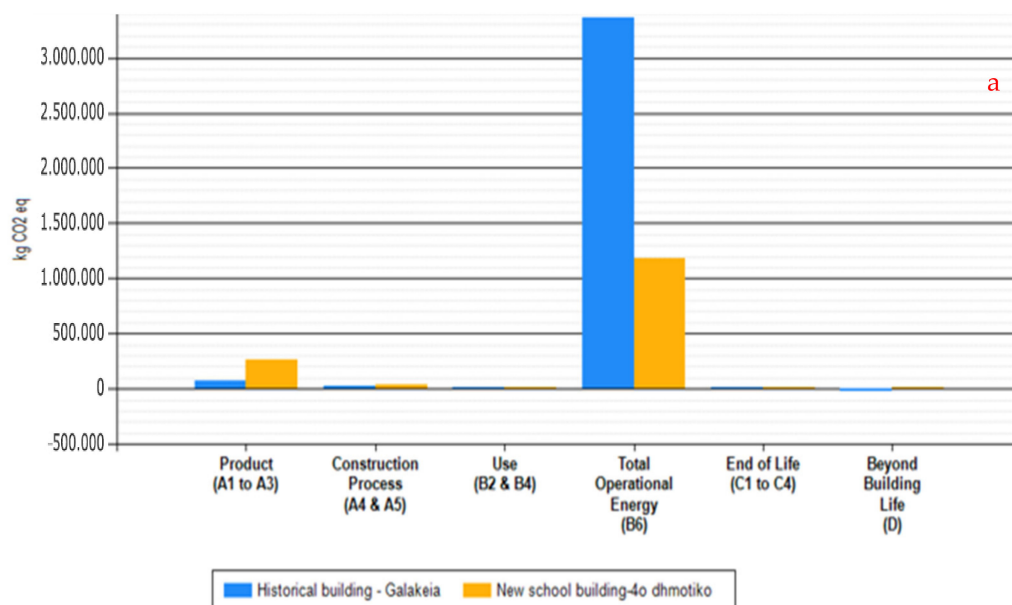
**Figure 13.** Fluctuation of GWP indicators for every life cycle stage of both schools. (a) operational GWP, (b) embodied GWP.

According to the operational and embodied values of some indicators (GWP, Fossil fuel consumption, Total primary energy, Non-renewable energy), it is observed that in the historic school, operational energy ranges from 28 (for GWP) to 38 (for non-renewable energy) times more than the embodied value, while in the modern one the operational value is 3.5 to 6.5 times higher than the embodied one (Figure 13). Meanwhile, the operational value of all 4 indicators for the historic school is 280% higher than those of the modern building, while the embodied value of the historic building is 36–50% higher.

It is therefore assessed that the operational needs of the historic building are much higher than the embodied values (concerning the materials in all life cycle stages), whilst in the modern school the operational needs are significantly lower. This could be related to the extended service life of the historic school (140 years), the lack of heating insulation, as well as its larger ground plan (>58 m<sup>2</sup>). The low embodied demand of the historic school may result from the natural building materials used for its construction (stone masonry).
