Deformation Capacity of RC Beam-Column Joints Strengthened with Ferrocement

Abstract: Beam-column joints constructed in the pre-seismic building code do not provide transverse reinforcement and good reinforcement detailing within the region. These cause the occurrence of brittle shear failure, which is one of the factors affecting the number of reinforced concrete (RC) moment resistance building structures collapsing during an earthquake. Therefore, in this study a brittle beam-column joint with a non-seismic building code was designed and strengthened by a ferrocement. Four layers of wire mesh with a diameter of 1 mm and a mesh size of 25.4 mm were installed on both sides of the beam-column joint and cement mortar was cast on it. As a comparison, a ductile beam-column joint was also designed following the current building code, which considers seismic effects. The test results by applying reversed cyclic loading at the beam tip showed that strengthening using ferrocement prevents crack propagation, increasing the deformation capacity, ductility, stiffness, and energy dissipation of beam column joint which are higher than those of the beam-column joint which is designed following

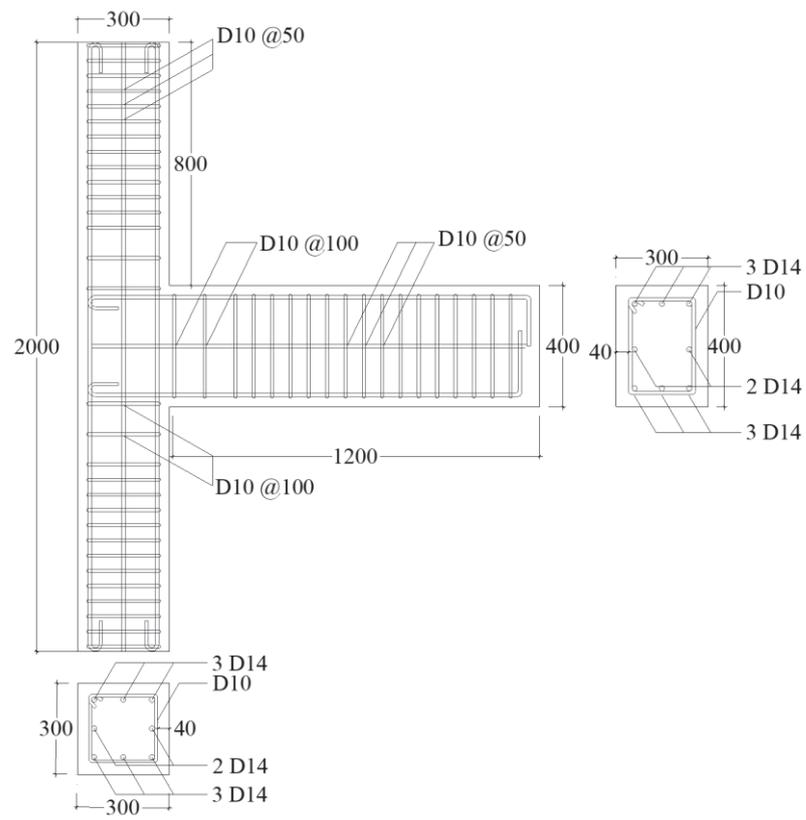
Figure 1. Detail specimen BCJ1.

BCJ1 is a beam-column joint specimen designed according to NI-2 [1] without using transverse reinforcement in the joint region. The beam longitudinal reinforcing bars are not continuously bent towards the upper and lower columns. Figure 1 shows details of specimen BCJ1. Specimen BCJ2 has a similar size and longitudinal reinforcement as BCJ1. The difference is that specimen BCJ2 added stirrups in the joint region using bars with a diameter of 10 mm placed at a spacing of 100 mm according to the current Indonesian building code [69]. The beam longitudinal reinforcing bars are also bent towards the upper and lower column with a length of 500 mm therefore their functions as anchors. Comprehensive details of specimen BCJ2 are shown in Figure 2. The specimen BCJ3 was designed in a similar manner as BCJ1. However, it was strengthened using ferrocement on both sides of the beam-column joint, as shown in Figure 3. Subsequently, the strengthening was provided in the following way. The first step involves disassembling the concrete cover of the specimen in the joint area, up to 400 mm in front of the beam and column, with a thickness until the reinforcing bars of the specimen is visible with the thickness of 40 mm. Furthermore, a T-shaped wire mesh with 1 mm diameter and 25.4 mm mesh size, similar to the beam-column joint area was cut. Four layers of wire mesh were installed and mounted on both sides of the specimen with the orientation angle of 0° to beam and column longitudinal axis as shown in Figure 4. Afterward, the wire mesh was anchored to the specimen using 4 dynabolts. Finally, a cement mortar was re-cast (Figure 5). Cement and sand with a volume ratio of 1:4 and water to cement ratio of 0.5 was used for the mortar mixture. A polycarboxylate-based superplasticizer having a specific gravity of 1.06 with a content of 1% of cement weight was also added to the mixture thereby enabling it flows easily when filling the cavities of the wire mesh during casting. Furthermore, the strengthening of the beam-column joint with ferrocement was carried out on both sides of the specimen by strengthening it on one side first, and after the mortar has hardened, the same procedure was performed on the other side.

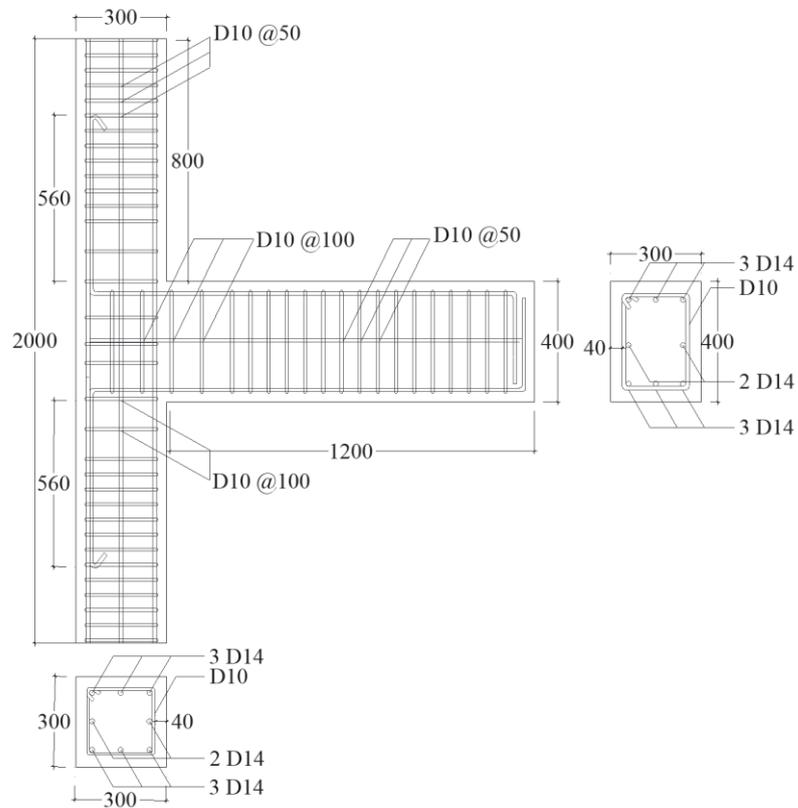
Figure 2. Detail specimen BCJ2.

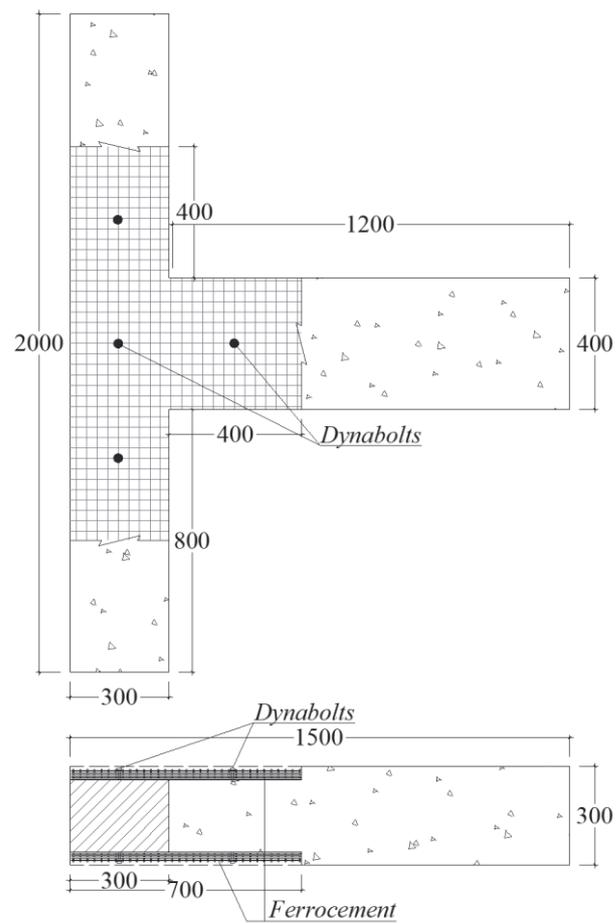
Figure 3. Detail specimen BCJ3.

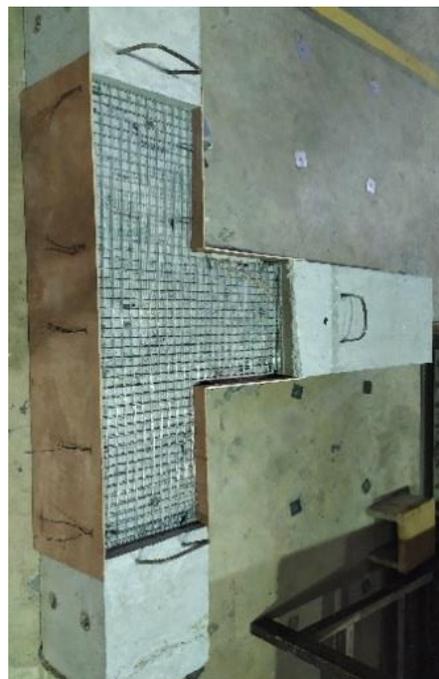
Figure 4. Wire mesh already installed on one side of the beam-column joint.

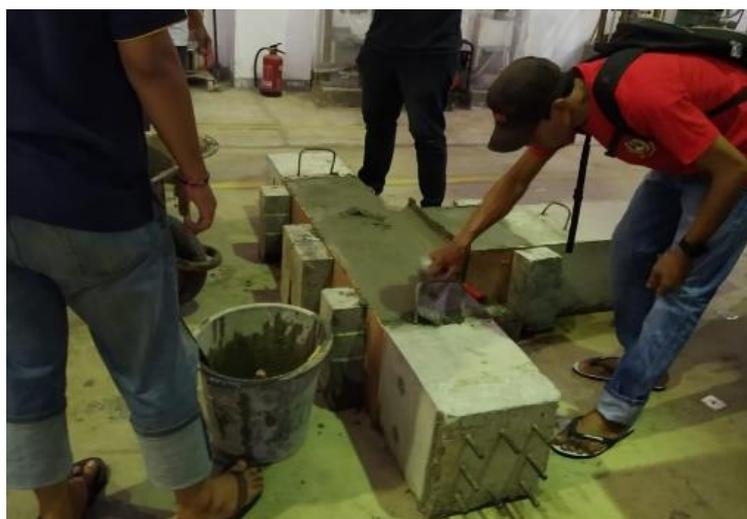
Figure 5. Re-casting the beam-column joint after installing the wire mesh.

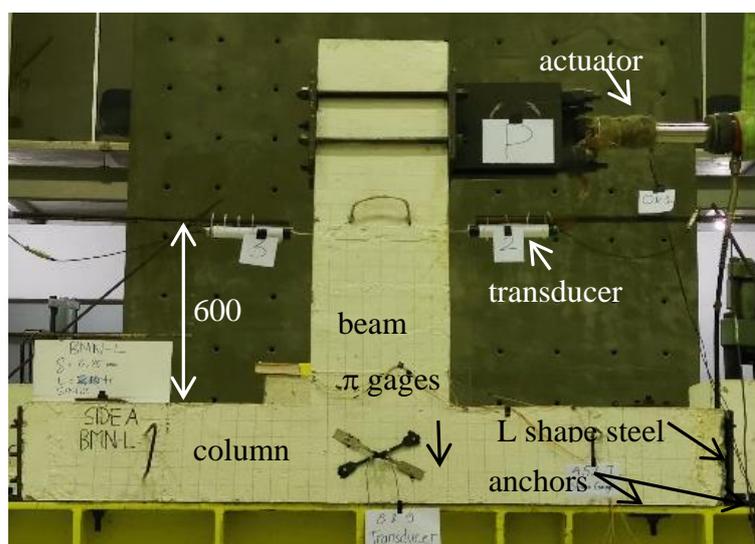
Figure 6. Loading set up.

The specimen was first set on the loading frame, as shown in Figure 6. The column was placed horizontally above the loading frame by anchoring it at a distance of 200 mm from both ends using bolts. Furthermore, at both ends of the column, L shape steel is installed, welded to its longitudinal reinforcement, and anchored to the loading frame using bolts. The load is applied through an actuator driven by a hydraulic jack placed on the beam tip. A steel plate is installed on the beam surface to fasten the actuator and specimen, thereby providing a reversed cyclic loading under deformation control. Unloading and reloading were performed at the displacement of 0.75 mm, 1.5 mm, 3 mm, 6 mm, 12 mm, and 24 mm while two loading cycles were applied for each displacement as shown in Figure 7. After 12 cycles, the loading was continued with monotonic until the specimen failed.

Beam displacement was measured by installing 2 transducers on both sides at a distance of 600 mm from the column face, as shown in Figure 6. In the joint area, two π gages were mounted to measure the width of the crack that occurs. Furthermore, strain gages were installed at the longitudinal reinforcement as well as on the stirrups of the beam and column to measure the strains. Moreover, the applied load was measured with a load cell. All information acquired during loading was recorded with a data logger and entered into a computer. In addition, the crack pattern during the loading process was also observed and drawn until the failure of the specimen.

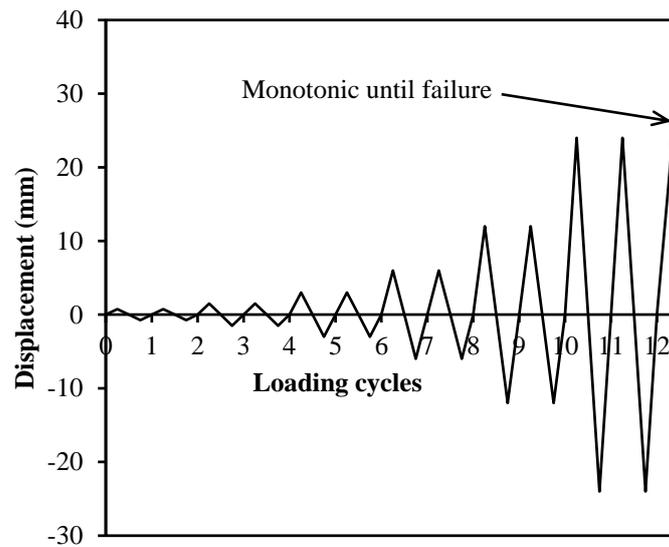
Figure 7. Displacement controlled loading history.

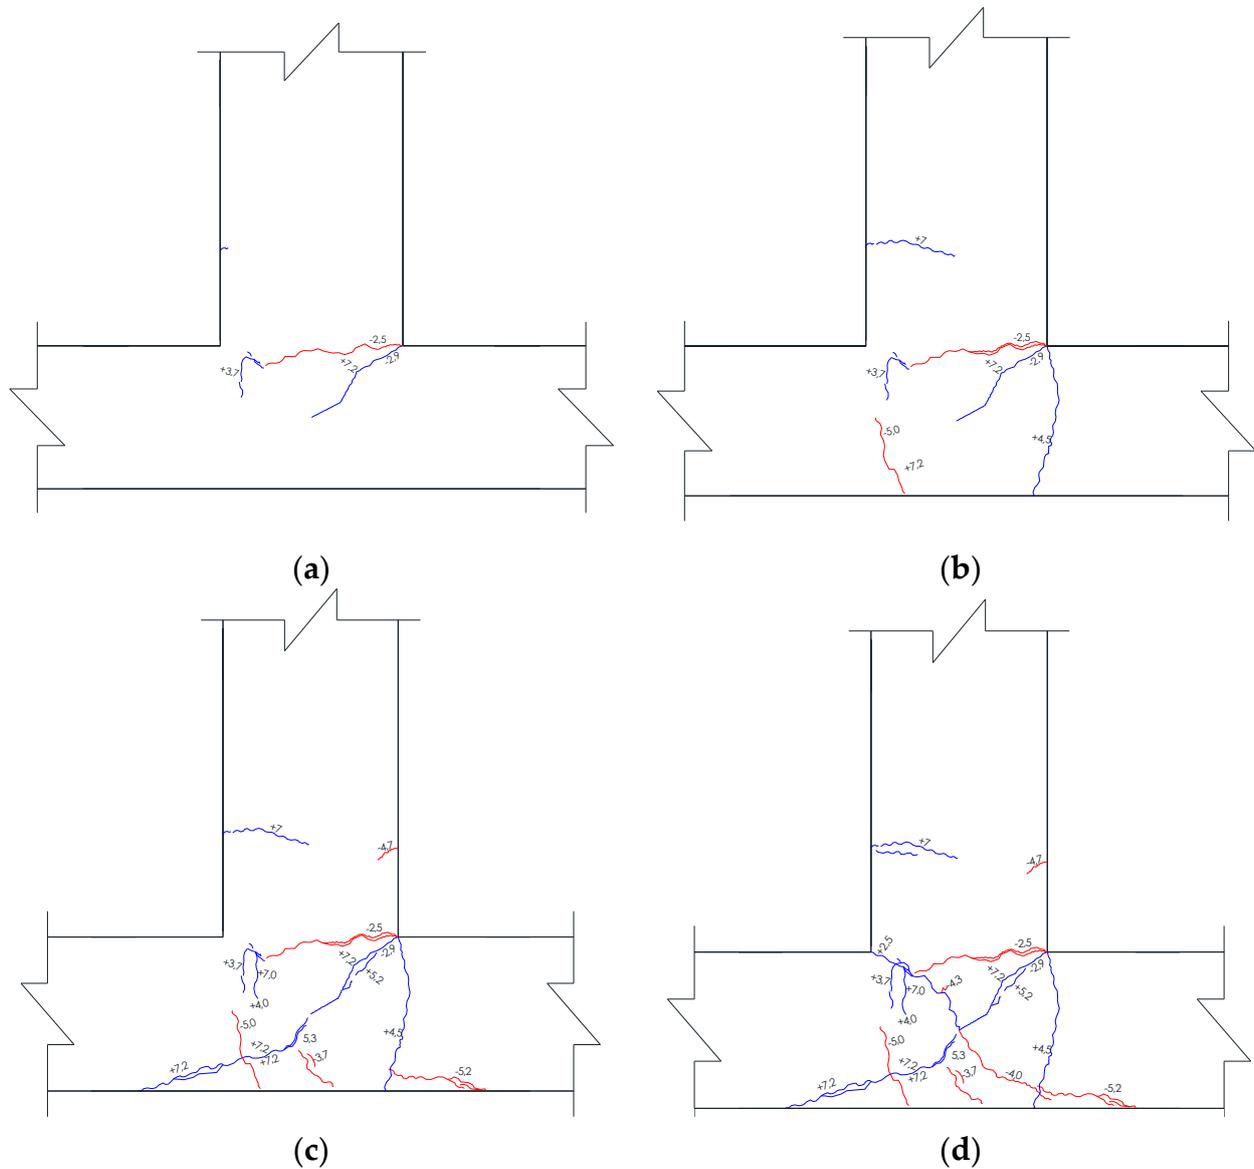
Figure 8. Crack propagation of specimen BCJ1 at displacement of: (a) 3 mm; (b) 6 mm; (c) 12 mm; and (d) 24 mm.

Figure 8 clearly shows an image of the cracks that occurs at the BCJ1 specimen when the displacement was relatively 3 mm, 6 mm, 12 mm, and 24 mm. The crack did not occur until the displacement was approximately 1.5 mm. The first crack occurred at the beam-column joint corner in the longitudinal direction of the column towards the center of the beam in the direction of the push load. Furthermore, when the displacement was relatively 2.3 mm, the length of the first crack was increased to 300 mm. Another crack appeared at the same corner, however it was directed towards the center of the beam-column joint (inclined crack). When the displacement was approximately 3 mm, the crack that appeared first has turned towards the center of the column with a crack length of 100 mm and the inclined crack has reached the center of the beam-column joint as shown in Figure 8a. Figure 8b illustrates that when the displacement has reached 6 mm, 3 more cracks appeared, and with one starting at the corner of the beam-column joint in the longitudinal direction of the beam, it reached the other side of the column. Furthermore, another one started from the opposite side of the column in a slightly inclined direction, and the final crack appeared in the beam on the opposite side with the load applied and propagated to its center. Meanwhile, the first and second appeared cracks only increased in width. Consequently, when the displacement is relatively 12 mm, the second crack, which was an inclined crack, was propagated to the other side of the column until relatively 150 mm in front of the beam, as shown in Figure 8c. This inclined crack, as well as the horizontal one at the column face, increased in width with increasing in displacement. In addition, when the displacement was approximately 24 mm, another inclined crack appeared at another beam-column joint corner and propagated to the reverse side of the column until it was relatively 150 mm measured from the face of the beam. This crack formed an X shape together with the previously occurred inclined crack as shown in Figure 8d. Furthermore, lack of stirrups in the joint region led to a rapid increase in the width of the X crack and horizontal cracks that first appeared, thereby

causing a decrease in load when the displacement reached 25.27 mm and structural failure in the subsequent cycle at 32.58 mm. The failure mode of the specimen BCJ1 is shown in Figure 9. This is a typical shear failure in the beam-column joints.

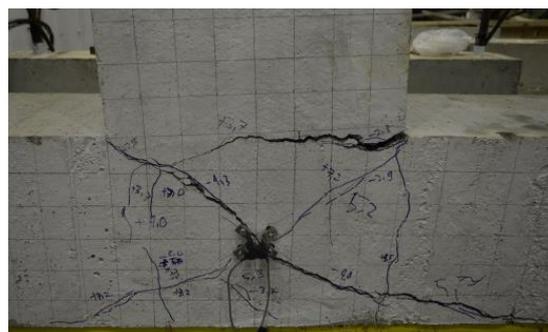
Figure 9. The failure mode of specimen BCJ1.

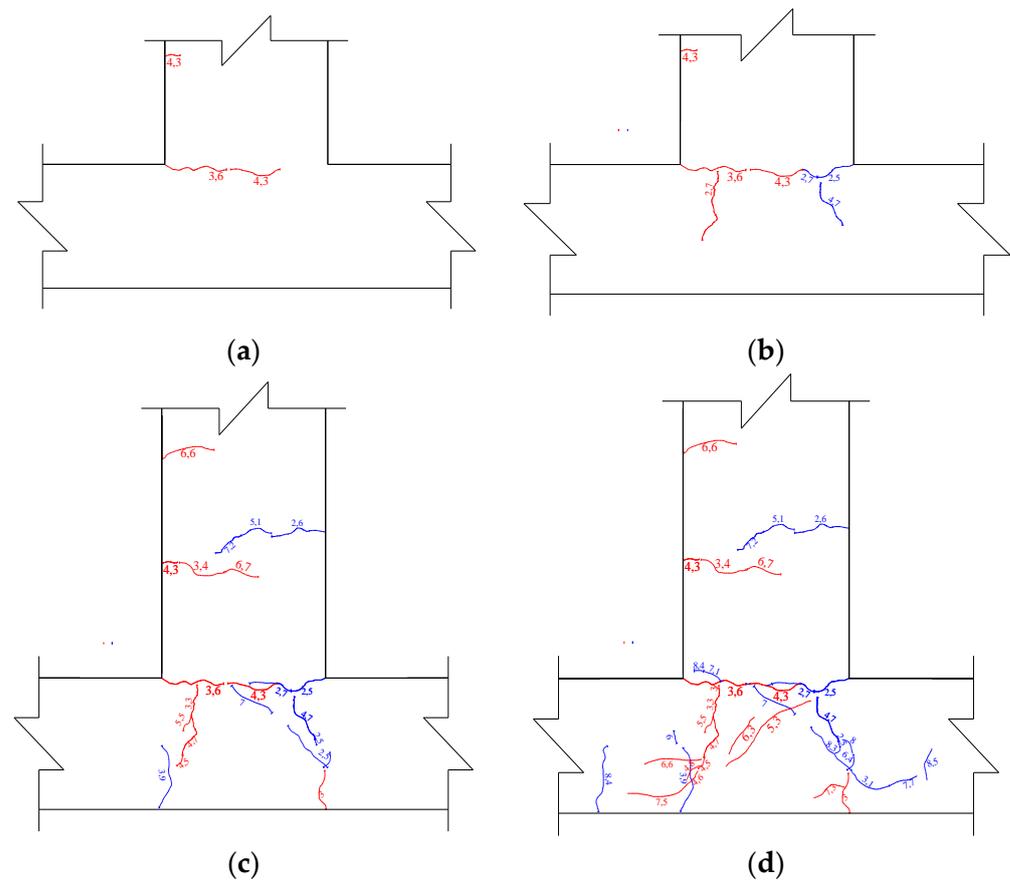
Figure 10. Crack propagation of specimen BCJ2 at displacement of: (a) 3 mm; (b) 6 mm; (c) 12 mm; (d) 24 mm.

Crack propagation of specimen BCJ2 at a displacement of 3 mm, 6 mm, 12 mm, and 24 mm is shown in Figure 10. A crack occurred when a displacement exceeded 1.5 mm at the beam-column joint corner on the opposite side of the applied loading side. The crack propagated parallel to the longitudinal direction of the column. However, when the displacement was approximately 3 mm, the crack length was relatively 190 mm, as shown in Figure 10a. Another crack with a length of 30 mm simultaneously appeared on the side of the beam opposite the load. The application of a compressive load in the same cycle led to the formation of new cracks at an opposite corner which was also horizontal towards the previous one, thereby causing the two cracks to meet. At the time of applying the tensile load for the next cycle, a new crack with a length of 220 mm occurred, starting from the first one, which was located 50 mm from the face of the beam towards column's longitudinal axis. Meanwhile, when the compressive load was applied in the same cycle, a similar incident where another crack occurred in the longitudinal axis direction of the beam leading to the inner joint, which started at the previous one with a length of 190 mm, as shown in Figure 10b. Besides, when the displacement was greater than 6 mm, inclined cracks started to occur at the joint. Furthermore, there were also cracks on the other side of the column and jointed with previous cracks in the column axis at the joint region when the displacement is relatively 12 mm, as shown in Figure 10c. In addition, when the crack in the beam propagated, its length was relatively 180 mm apart from the appearance of the other two cracks with similar lengths. Subsequently, when the displacement was approximately 24 mm, the cracks at the joint formed the X shape, as shown in Figure 10d. However, those X shape cracks did not increase in width when the displacement was greater than 24 mm, due to the stirrups provided in the joint region. This was different from specimen BCJ1, where the crack got wider and caused structural failure. In the BCJ2 case, the structure was still capable of deforming up to 52.39 mm and had only failed recently. Structural failure was also not caused by X-shaped cracks that occurred in the joints. However, it was caused by the widening of the cracks at the beam-column joint corner. The failure mode of specimen BCJ2 is shown in Figure 11.

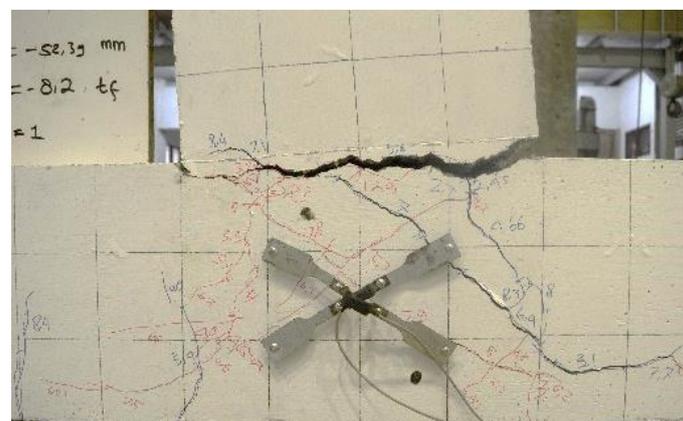
Figure 11. The failure mode of specimen BCJ2.

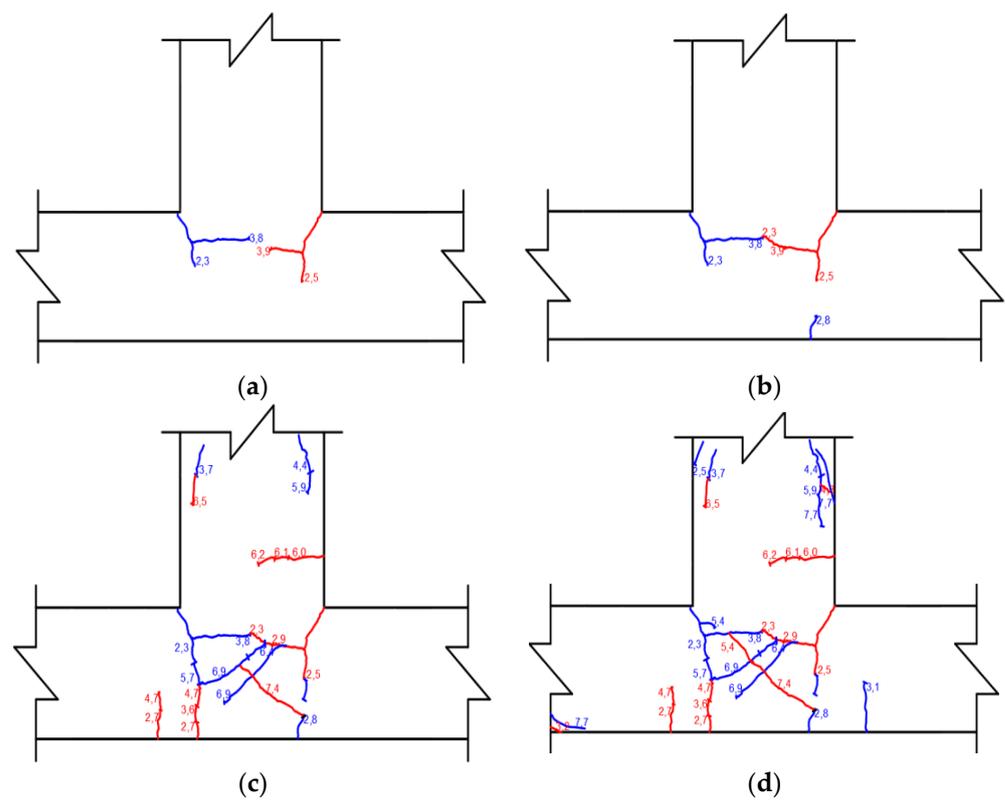
Figure 12. Crack propagation of specimen BCJ3 at displacement of: (a) 3 mm; (b) 6 mm; (c) 12 mm; (d) 24 mm.

Crack propagation of the specimen BCJ3 at displacement of relatively 3 mm, 6 mm, 12 mm, and 24 mm are shown in Figure 12. The first crack started immediately after the first displacement exceeded 1.5 mm. Cracks also started from the beam-column joint corner on the loading side. In contrast to the BCJ1 and BCJ2 specimens, which the first crack was initially directed horizontally, in the BCJ3 specimen, the first crack had an inclined shape directed towards the center of the beam-column joint. Changes in the load direction led to the formation of a second crack on the other beam-column joint corner, which also had an inclined shape towards the beam-column joint center. In the next cycle a displacement of 3 mm was reached, and the 2 inclined cracks met at the middle of the column, in a vertical direction, away from the center of the beam-column joints. There was a cracked branch at a depth of approximately 1/3 of the column height in a horizontal direction towards its center as shown in Figure 12a. This crack failed to propagate and increase its width until the displacement was relatively 6 mm due to the presence of wire mesh. This was installed as a strengthening to prevent the propagation and widening of the crack as shown in Figure 12b. However, when the displacement was approximately 6 mm, another fine crack with a length of 5 mm appeared on the side of the column. As the displacement increased, the newly emerged inclined crack propagated towards the center of the beam-column joints. The initial crack also propagated towards the other side of the column. Furthermore, 2 other inclined cracks were formed, starting with the horizontal one that appeared first. Additionally, vertical and horizontal cracks appeared on the side of the column and beam respectively. There were also 2 vertical cracks in the beam ferrocement section. The shape of the crack when the displacement was relatively 12 mm is shown in Figure 12c. The crack pattern remained the same as shown in Figure 12d till the displacement was relatively 24 mm. There was an increase in the number of cracks on the beam and an additional vertical one on the side of the column. In the beam-column joint area, there was no increase in the length and width of the cracks. It was due to the presence of wire mesh installed

on the beam-column joint as a strengthening way to prevent crack growth. This condition occurred in the next load cycle until the connection between the ferrocement and the old concrete surface was damaged at a displacement of 51.37 mm. This is almost similar to the maximum displacement of the BCJ2 specimen. The failure mode of the beam-column joints strengthened with ferrocement was delamination of the ferrocement from the old concrete as shown in Figure 13. Supposing the bond between the old concrete and ferrocement is made stronger, it is believed that the displacement achieved by this beam-column joint may increase, because at the time of failure the crack width in the joint area was less than 1 mm, thereby improves its deformation capacity and ductility.

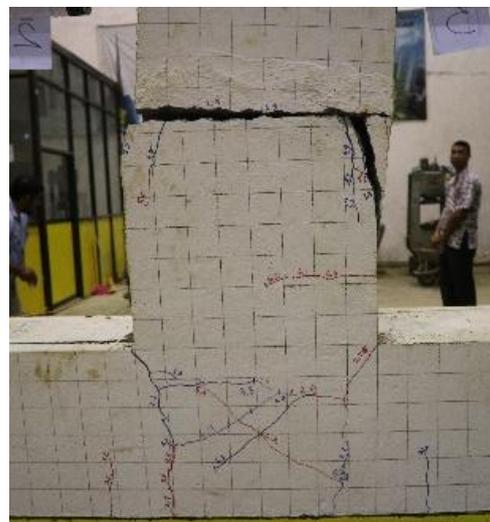
Figure 13. The failure mode of specimen BCJ3.

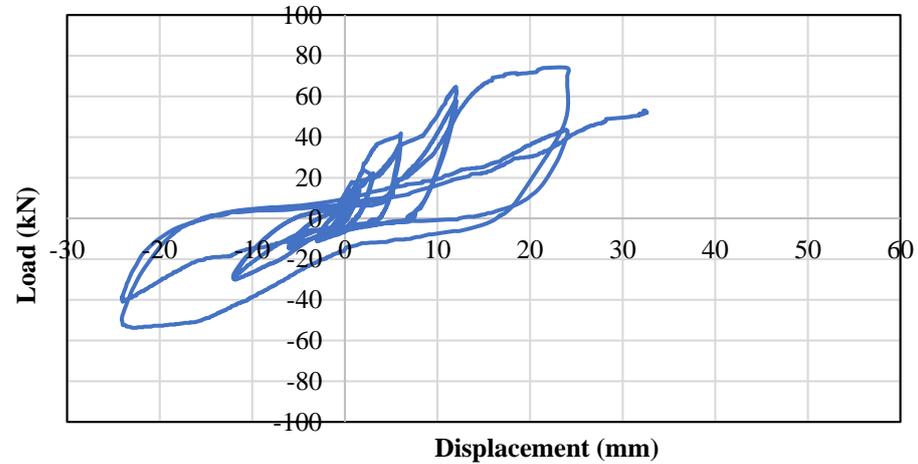
Figure 14. The hysteretic load-displacement curve for specimen BCJ1.

The relationship between the load and displacement measured with transducers mounted on the beam for specimen BCJ1 is shown in Figure 14. The maximum load of this specimen is 73.95 kN at a displacement of 25.74 mm. When displacement was 24 mm, there was an extremely wide crack on the column face with a length has reached along the beam height. This also includes an X-shaped crack in the beam-column joint area, as shown in Figure 8d. Therefore, in the next cycle, the load only reached approximately 51.6 kN, and the specimen failed at the displacement of 32.58 mm. The absence of the anchorage of beam longitudinal reinforcement to column as well as no transverse reinforcement in

beam-column joint region of this specimen led to the easy of crack propagation in this specimen, thereby leading to a small deformation capacity and ductility index. The first yield of beam's longitudinal reinforcement of specimen BCJ1 occurred at a displacement of 12.07 mm.

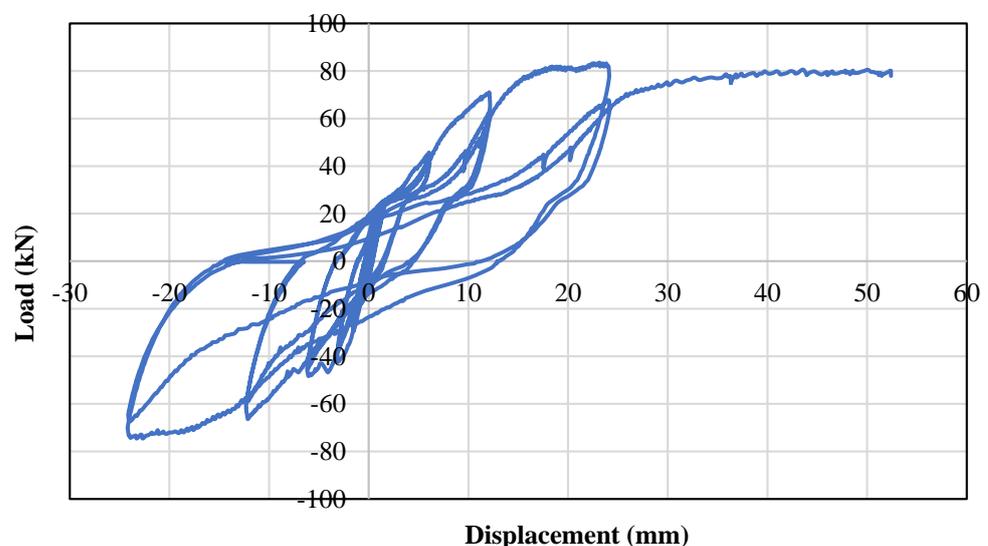
Figure 15. The hysteretic load-displacement curve for specimen BCJ2.

The hysteretic load-deflection curve for specimen BCJ2 is shown in Figure 15. The displacement at the first yield of beam's longitudinal reinforcement of specimen BCJ2 was 13.55 mm, which is similar to that of BCJ1. This is because both specimens have similar cross-sectional size and reinforcement. Due to the fact that specimen BCJ2 has a stirrup in the beam-column joint region, the maximum load is greater than that of the specimen BCJ1, which is 83.48 kN at a displacement of 23.15 mm. It is important to note that the presence of stirrups in the joint region and the anchorage of beam's longitudinal reinforcement to relatively 560 mm into the column, causing delays in the widening and propagation of cracks, therefore the specimen was able to withstand any suddenly load drop as in the case of BCJ1. As a result, this specimen was able to sustain the maximum load in the next cycle. Furthermore, the specimen failure occurred at a displacement of 52.39 mm with a maximum load at failure of 77.89 kN, which was decreased by 6.7%. Therefore, the presence of transverse reinforcement in the beam-column joint region and the anchorage of beam's longitudinal reinforcement in the column cause the deformation capacity to increase.

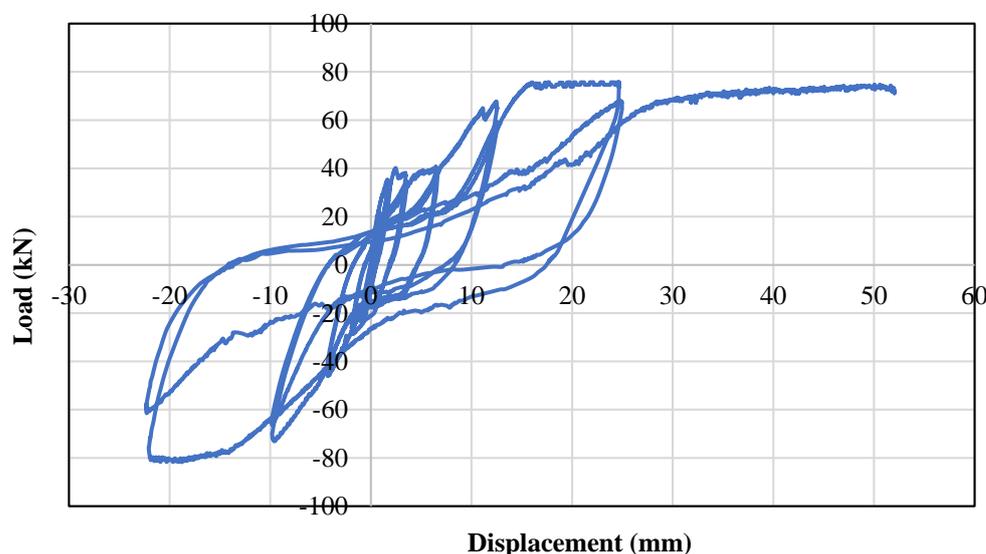
Figure 16. The hysteretic load-displacement curve for specimen BCJ3.

Figure 16 shows the hysteretic load-deflection curve for specimen BCJ3, which is a strengthening of the BCJ1 model using ferrocement. Similar to the cases of specimens BCJ1 and BCJ2, BCJ3 experienced its first yield of longitudinal reinforcing bars at a deformation of 12.00 mm. Installation of wire mesh in the beam-column joint area had an insignificant effect on the maximum load, although it increased the deformation capacity of specimen BCJ3. The maximum load was similar to BCJ1, namely 75.64 kN at a displacement of 16 mm. In addition, this load remained constant until the displacement was 24 mm. There was no increase or decrease in load after a displacement of 16 mm because the specimen had significant number of cracks without any crack propagation and widening. The propagation and widening of cracks was prevented by wire mesh which was installed as a structural strengthening. As a result of the ferrocement strengthening, in the following cycle, the load did not decrease immediately as was the case of BCJ1, rather BCJ3 was able to undergo deformation even without increasing the load till a failure occurred at displacement of 52.04 mm with a load reduction of only 5%, which was equivalent to 71.86 kN. However, in the opposite direction, the maximum load of BCJ3 was 81.68 kN, which exceeded that of BCJ2 relatively 74.56 kN in the same loading direction. Therefore, the strengthening of beam-column joint designed with non-seismic building code using ferrocement improves the deformation capacity and ductility. The deformation capacity and ductility of strengthened beam-column joint even was higher than those of beam-column joint designed with current code. However, in this case, as previously reported, a failure occurred due to the delamination of the ferrocement from the old reinforced concrete beam-column joint. Furthermore, it is necessary to establish a good bond between the old concrete and the ferrocement, either by increasing the dynabolt anchor numbers or by providing a bonding adhesive between these old concrete and new mortar. Cases with a higher number of anchors and bonding adhesive between the old concrete and new mortar were not reviewed in this study and need to be further investigated.

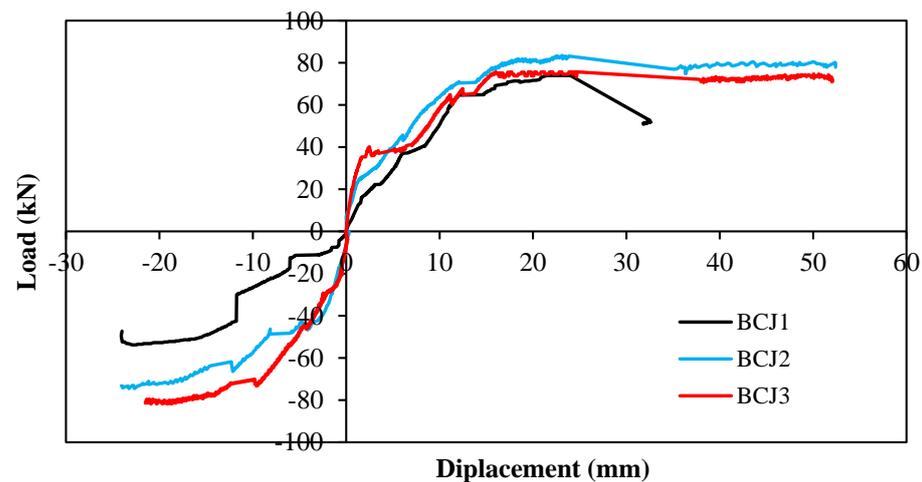
Figure 17. Envelope load-displacement curves.

The enveloped load-displacement curves of the 3 specimens tested in this study were compared as shown in Figure 17. It also shows that strengthening the beam-column joints designed with a non-seismic building code using ferrocement increases the deformation capacity. Therefore it is similar to a beam-column joint designed with a new building code that takes into account the effects of seismic.

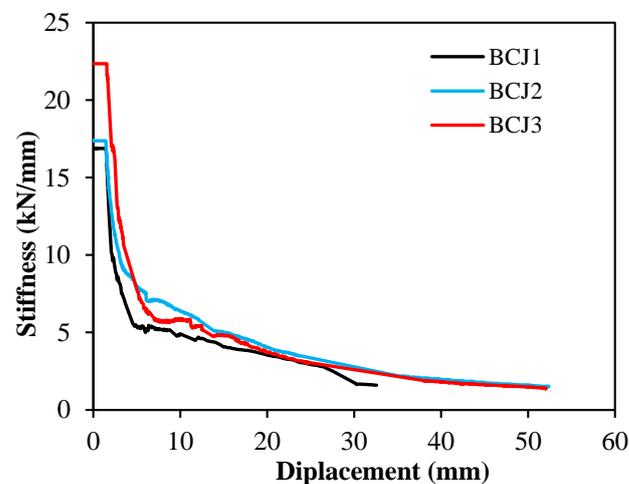
Figure 18. Degradation of stiffness.

Stiffness is one of the parameter that can show the seismic performance of reinforced concrete members which is the ability to resist deformation [75,76]. In this study, the stiffness was calculated as secant modulus of envelope load-displacement curves in positive direction shown in Figure 17. Figure 18 shows the comparison of the stiffness of all beam-column joint specimens tested in this study. It further shows that the presence of wire-mesh in the beam-column joint strengthened with ferrocement tends to increase its initial stiffness due to the higher elastic modulus of wire-mesh compared to the elastic modulus of concrete. Since there was no crack and the linear load-displacement relationship at the initial stage of loading, the stiffness was constant until the displacement of around 1.5 mm. The presence of cracks that occurred due to loading leads to stiffness degradation along with an increase in beam displacement, as shown in the figure. The stiffness degradation of all tested specimens is similar and closely related to the existent crack propagation.

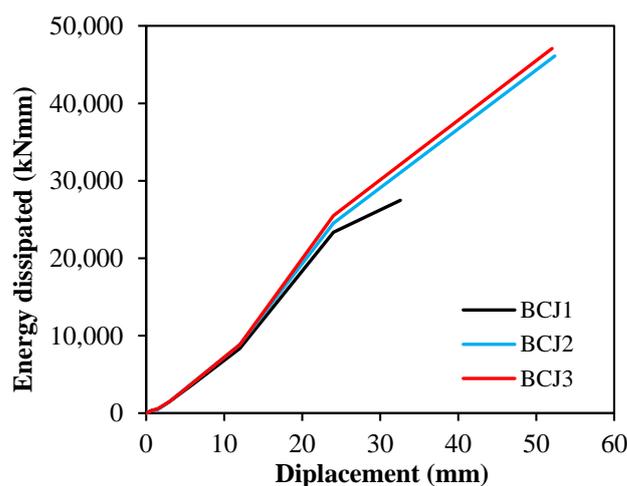
Figure 19. Cumulative energy dissipation.

Energy dissipation at each cycle can be calculated from the enclosed area within load-displacement loop at this cycle. The cumulative energy dissipation is calculated by summing energy dissipated in previous cycles [68]. Figure 19 shows the cumulative energy dissipation of all beam-column joint specimens tested in this study as a function of displacement. Furthermore, when there was slight deformation, the energy dissipation of all the specimens was similar. As the displacement increased, the beam-column joint specimen strengthened with ferrocement provided greater cumulative energy dissipation than the unreinforced. The energy dissipation of ferrocement-reinforced specimens was almost similar to the specimens designed with the new seismic building code. Even at the displacement greater than 20 mm, the strengthened beam-column joint had a greater cumulative energy dissipation, which shows the effectiveness of beam-column joint strengthening using ferrocement in resisting earthquake loads.
