Article

Experimental Study on the Seismic Behavior of a Modified Adobe-Brick-Masonry Composite Wall with a Wooden-Construction Center Column

Keywords: adobe constructions; wooden-construction center column; modified mud; composite wall; quasistatic test

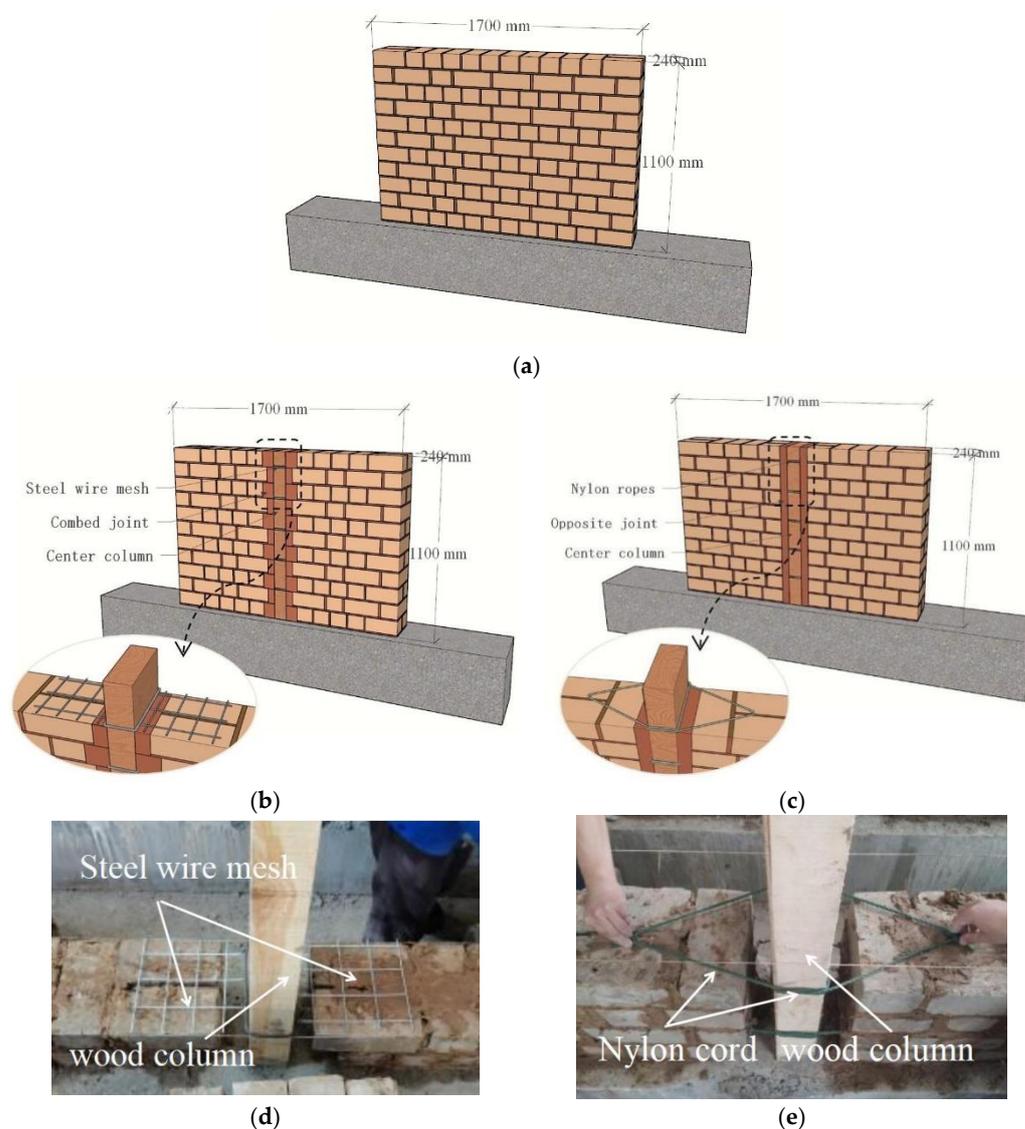
Figure 1. Wall models: (a) EAW, (b) EAW-MS/UAW-MS, (c) EAW-MN/UAW-MN, (d) tie method (EAW-MS/UAW-MS), and (e) tie method (EAW-MN/UAW-MN).

The specimens EAW-MS, UAW-MS, EAW-MN, and UAW-MN were equipped with wooden structural columns in the middle of the wall, and the wooden columns were inserted into the reserved holes of the floor beams when the specimens were made. The wood required for the test was taken from the natural poplar wood of the Zhongzhi Wood Processing Plant in Shihezi City. The width of each wood column was 240 mm and the thickness was 90 mm, according to the requirements of the Chinese code for seismic design of buildings (GB 50011-2010) [27].

The synergistic effects of the wooden-construction center column and of the walls on both sides depended on the tie measures, to a certain extent. For this reason, different details were designed for the steel-wire mesh and nylon-rope ties in this study. For the specimens EAW-MS and UAW-MS, predetermined combed joints were made in the walls on either side of the wooden columns. Then, mud was poured into the space between the walls and the columns, as shown in Figure 1b. Steel-wire mesh with a diameter of 4 mm and a spacing of 50 mm was set to tie the walls on both sides of each of the two layers of blocks along the height direction (a horizontal tie length of 500 mm). In addition, after welding of the steel-wire mesh to the reinforcement hoop, it was installed on the wooden column, as shown in Figure 1d. For the specimens EAW-MS and UAW-MS, predetermined opposite joints were made in the walls on either side of the wooden columns. Then, mud was poured in the space between the walls and the columns, as shown in Figure 1c. Nylon ropes with diameters of 3 mm were set to tie the walls of every two layers of blocks on both sides along the height direction (horizontal tie length of 500 mm). The nylon ropes were tied by winding the wooden column twice, as shown in Figure 1e. The EAW specimen was an unconstrained-structural-measurement wall. The walls of all specimens were made of adobe bricks with dimensions of 240 mm × 115 mm × 90 mm, masoned with 10 mm-thick modified mud and unmodified mud.

According to the conditions at the test site, the scale-reduction ratio of the specimens was determined to be 1/2.5, considering that the masonry structure in the wall would usually exhibit shear deformation and the aspect ratio of the specimen was designed to be 0.65. The test-specimen-specific working conditions and the specimen sizes are shown in Table 1 and Figure 1.

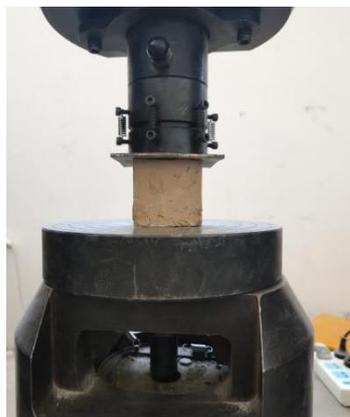
Figure 2. Compressive-strength test of the mud test block.

Compressive-strength tests (Figure 2) were performed on modified and unmodified mud according to the Chinese standards for test methods of performance on building mortar (JGJ/T70-2009) [30]. The size of the mud test blocks was 70.7 mm × 70.7 mm × 70.7 mm, and two groups of six specimens were made. Six groups of adobe blocks with dimensions of 240 mm × 115 mm × 90 mm were selected for the compressive-strength tests (Figure 3), according to Chinese test methods for wall bricks (GB/T 2542-2012) [31]. The results of the compressive tests on mud and adobe blocks are shown in Table 4.

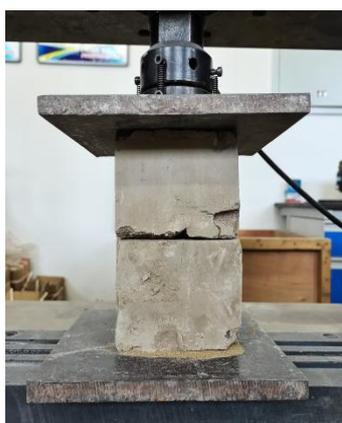
Figure 3. Compressive-strength test of the adobe block.

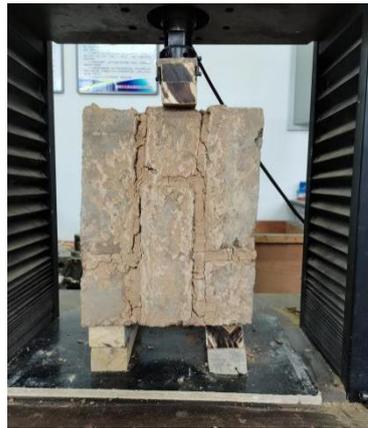
Figure 4. Shear-strength test of masonry.

For the masonry shear-strength test (Figure 4), shear-test specimens were made using unmodified mud and modified mud in accordance with the Chinese standards for test methods for basic mechanical properties of masonry (GB/T 50129-2011) [32]. Each specimen was made of nine adobe blocks. A total of eight modified-masonry shear specimens and eight unmodified-masonry shear specimens were designed. The test results are shown in Table 5.

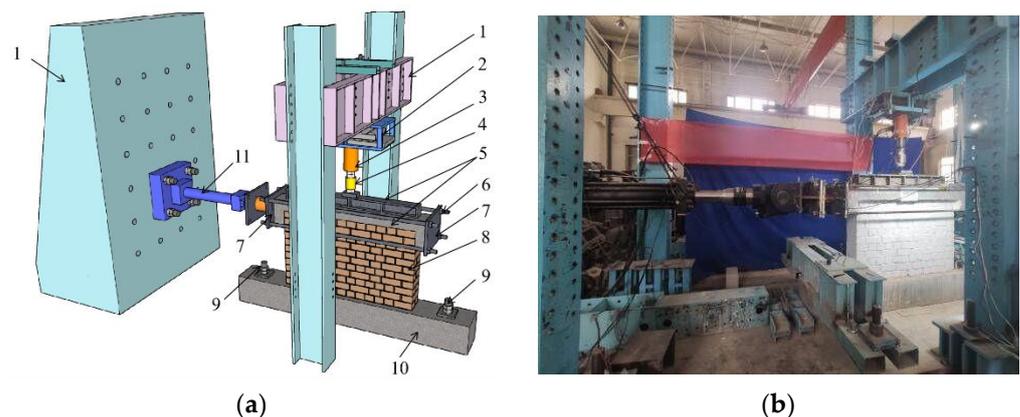
Figure 5. Test setup and instrumentation. (a) Schematic of the test setup: 1. Reaction wall; 2. Sliding roller; 3. Vertical jacks; 4. Vertical force sensor; 5. Distribution beam; 6. Tie rod; 7. Splint; 8. Wall; 9. Ground anchor bolts; 10. Floor beams; 11. MTS. (b) Test site.

The quasistatic, cyclic in-plane loading test in this paper was carried out in the structural laboratory of Shihezi University. The loading device consisted of a horizontal loading system and a vertical loading system, as shown in Figure 5. The horizontal loading system adopted a hydraulic servo loading device (thrust of +1000 kN, tension of −600 kN) from the American MTS company to perform horizontal reciprocating loading on the specimens, and the loading point was at the center of the end of the U-type loading beam. The vertical loading system used hydraulic jacks with a range of 1000 kN, and the vertical loading point was at the center of the top rigid distribution beam, simulating the upper homogeneous wiring load.

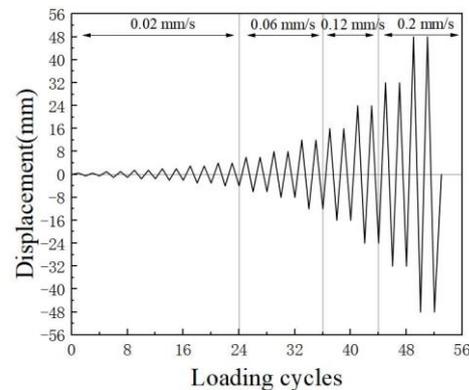
Figure 6. Loading scheme.

Horizontal loading was performed using displacement-controlled loading, and the cyclic loading scheme was based on the Chinese specifications for seismic tests of buildings (JGJ/T 101-2015) [33]. Before formal loading, the specimens were preloaded to ensure that the test apparatus and the data collection system were in good working order. In the early stages of the test loading, the displacement increments were 0.5, 1, and 2 mm, and in the later stages, they were 4 and 8 mm until the wall collapsed due to stress. Figure 6 displays

the particular loading technique. Because most adobe farmhouses are one-story structures, the vertical load was empirically estimated to be 0.1 MPa and the vertical load applied to the wall specimen was determined to be 36.2 kN.

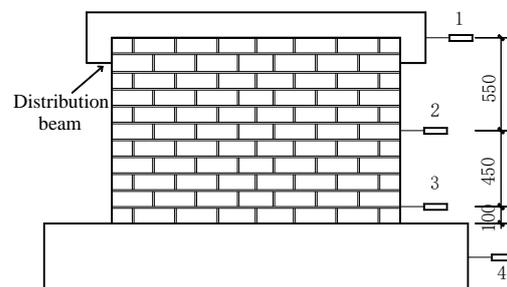
Figure 7. Layout of displacement gauge.

The data for the five specimens were collected in the same way: mainly, collecting the lateral deformation and horizontal force of the wall. The horizontal displacements of the upper, middle, and lower portions of the wall were measured with displacement gauges 1, 2, and 3, respectively. Displacement gauge 4 measured the horizontal slip of the floor beam. The pressure sensor was installed on the vertical hydraulic jack. The measurement data from the displacement gauges and the pressure sensors was collected with the TDS-530 data-acquisition system. The specific measurement-point layout is shown in Figure 7.

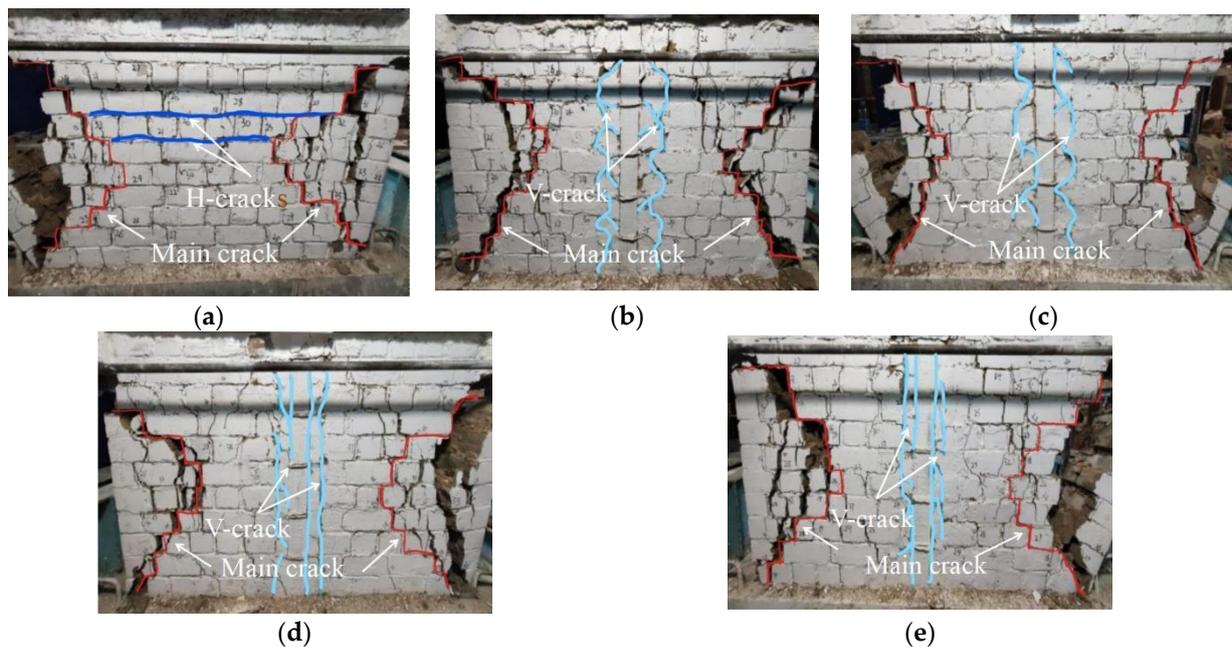
Figure 8. Collapse failure modes of specimens: (a) EAW, (b) EAW-MS, (c) UAW-MS, (d) EAW-MN, and (e) UAW-MN.

The overall collapse failure modes of the five wall specimens were relatively similar, as shown in Figure 8. In the early stages of horizontal loading, cracks first appeared at both ends of the wall. With the increase in loading, the cracks at both ends developed from the upper and lower parts of the wall along the mud joints, in a stepped manner, toward the middle to form oblique main cracks. The width of the main cracks gradually increased with the loading process. After reaching the peak load, the outer side of the oblique main crack formed a triangular area that gradually separated from the core area in the middle of the wall. From loading to the collapse stage, shear damage occurred in the composite wall specimens (EAW-MS, UAW-MS, EAW-MN, and UAW-MN), with masonry collapse in the triangular area at both ends of each wall and masonry remaining near the middle column. Shear damage occurred in the specimen of adobe wall (EAW), with masonry collapse in the triangular area at both ends and horizontal penetration cracks in the middle of the wall.

For the unconfined adobe-wall specimen EAW, at a loading displacement of 1.00 mm ($\theta = 1/1100$), oblique cracks appeared at the upper and lower ends of the wall. A triangular area with a tendency of detachment at both ends formed at a loading displacement of 6.00 mm ($\theta = 1/183$). As the loading displacement increased, the specimen reached the peak bearing capacity, at 15.45 mm ($\theta = 1/71$), corresponding to a peak value of 38.40 kN. The specimen's bearing capacity started to decline once it reached its peak value. The triangular area at both ends of the specimen separated from the main wall when the loading displacement reached 24.00 mm ($\theta = 1/46$). At this point, a horizontal through-crack along the mud joints formed in the center of the wall, and the specimen bearing capacity fell below 85% of its peak. When the loading displacement was 32.00 mm ($\theta = 1/34$), the bearing capacity of the specimen dropped to 50%, the wall blocks collapsed in the triangular area at both ends, and the wall was declared to have collapsed, as shown in Figure 8a. θ is the story drift ratio, i.e., the ratio of the horizontal lateral displacement value of the wall to the height of the wall.

For the composite-wall specimens EAW-MS, UAW-MS, EAW-MN, and UAW-MN, there were similar crack-development and failure processes. When the loading displacement was 1.50 mm ($\theta = 1/733$), cracks began to appear at both ends of each of the four specimens. With the increase in loading displacement, the cracks at both ends of each of the four specimens developed obliquely and widened to form a triangular area with a tendency to detach. The four specimens showed vertical cracks along the mud joints, at the connection between the center column and the masonry, at loading displacements of 4.02 mm ($\theta = 1/274$), 2.00 mm ($\theta = 1/550$), 4.01 mm ($\theta = 1/274$), and 3.00 mm ($\theta = 1/367$). The four specimens reached their peak bearing capacities at loading displacements of 16.12 mm ($\theta = 1/68$), 15.60 mm ($\theta = 1/71$), 16.10 mm ($\theta = 1/68$), and 15.80 mm ($\theta = 1/70$), corresponding to peak loads of 41.69 kN, 33.59 kN, 37.12 kN, and 33.11 kN, respectively. When the loading displacement was 31.70 mm ($\theta = 1/35$), 31.99 mm ($\theta = 1/34$), 31.40 mm ($\theta = 1/35$), and 32.07 mm ($\theta = 1/34$), both ends of the triangular-area wall were separated from the middle-area wall. This point was at which the bearing capacities of the four specimens started to fall after reaching their peaks. At this time, the bearing capacities of all specimens were reduced to less than 85% of their peak values. When the loading displacement was 39.98 mm ($\theta = 1/28$), 40.00 mm ($\theta = 1/28$), 39.98 mm ($\theta = 1/28$), and 40.12 mm ($\theta = 1/27$), the bearing capacities of all four specimens decreased to 50%. The

wall blocks collapsed in the triangular area at both ends, and each specimen collapsed, as shown in Figure 8b–e.

In general, horizontal through-cracks appeared in the central region when the adobe wall was finally damaged. The central region of each composite wall was relatively well-preserved due to the tie effect of the central column on both sides of the wall. Modified-mud-masonry walls had less crack development than unmodified-mud-masonry walls. The composite walls of the two types of different tie material had vertical through-cracks at the connection between the central column and the masonry. However, in the final failure, the steel-wire-mesh tied walls were less damaged than the central regions of the nylon-rope-tied walls.

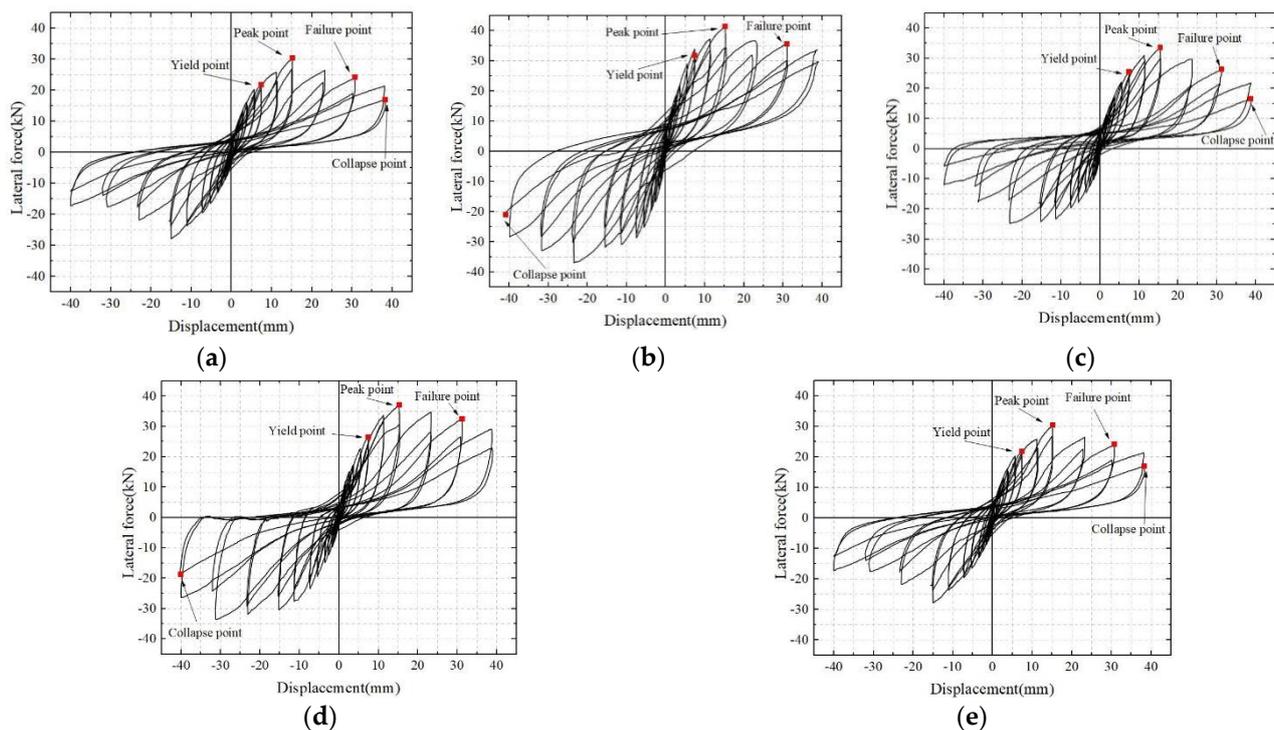
Figure 9. Hysteretic curve of each specimen: (a) EAW, (b) EAW–MS, (c) UAW–MS, (d) EAW–MN, and (e) UAW–MN.

The hysteresis curves of the five wall specimens are shown in Figure 9. The shape of each curve was an inverse S-shape. In the early stage of loading, the hysteresis curves were all approximately straight lines. Each specimen's ability to dissipate energy increased as the loading displacement increased. Additionally, the hysteresis loop area increased, and the bearing capacity eventually reached its peak. With a further increase in loading displacement, when the bearing capacity fell below 85% of the peak value, its fullness gradually decreased, and the energy-dissipation capacity weakened.

Due to the restraint effect of the central column, which delayed the degradation of the composite-wall bearing capacities and increased specimen ductility, the displacement of the composite-wall specimen at the characteristic points of damage and collapse was greater than that of the adobe-wall specimen. The hysteresis loop of the specimen EAW-MS was fuller than that of the specimen UAW-MS, which indicated that the modified-mud specimen had better energy-dissipation capability. By comparing the specimens EAW-MS and EAW-MN with the test phenomenon, the crack-development rate of the specimen EAW-MS was slower, indicating that the steel-wire-mesh ties were more effective in restraining the walls on both sides of the wood center column.

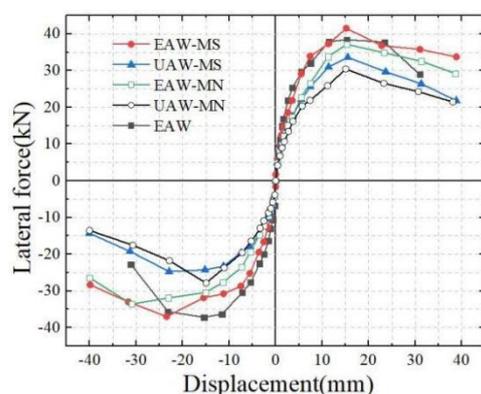
Figure 10. Skeleton curve of each specimen.

The skeleton curve of each specimen could be obtained by connecting the extreme points of each load in the same direction on the hysteresis curve, as shown in Figure 10. The skeleton curves of the five specimens were roughly divided into the elastic stage, the yield stage, the failure stage, and the collapse stage. In the elastic stage, there was little difference in the stiffness of each specimen, and the curves were similar to oblique lines. After entering the yielding stage, the slope of each curve began to decrease, and the stiffness difference between each specimen increased; however, the curves were still rising. After entering the failure and collapse stage, each curve began to drop to a different degree. The yield point was found with the energy equivalence method. The failure point was defined as when the load dropped to 85% of the peak. The collapse point was defined as when the triangular area on both sides was disconnected from the central main wall. Table 6 displays the load levels for each specimen's characteristic spots.

The slope of the initial curve of the composite-wall specimen EAW-MS was slightly lower than that of the adobe-wall specimen EAW, which was caused by the differences in properties between the central structural column and the masonry material. The slopes of the curves of the two specimens were basically the same after entering the yielding stage, and the peak load capacity of the specimen EAW-MS was increased by 9% relative to that of the specimen EAW. After entering the failure stage, the curve of the specimen EAW-MS decreased more smoothly than that of EAW. Combined with the experimental phenomenon, the restraining effect of the middle column on the wall slowed the degradation of the wall's bearing capacity. When the wall collapsed in the triangular area at both ends, the middle column tied the wall as the second line of defense to continue to bear the earthquake's shear force. The initial curve slope of the specimen EAW-MS was larger than that of the specimen EAW-MN, and the peak bearing capacity increased by 12.3%, indicating that the steel-wire-mesh tied walls had high bearing capacities. The bearing capacity of specimen EAW-MS was increased by 24.1% relative to that of the specimen UAW-MS, indicating that modified mud could effectively improve the seismic bearing capacities of walls by increasing block-bond strength.

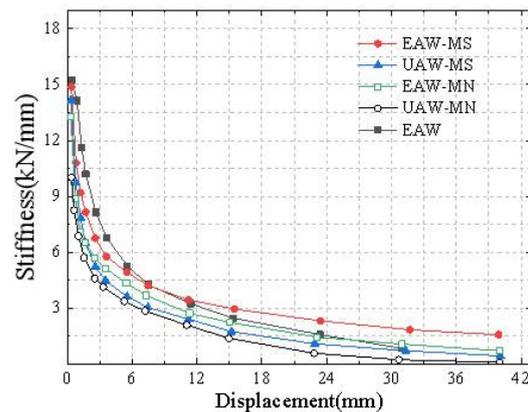
Figure 11. Stiffness degradation curve of each specimen.

The stiffness degradation curves of the five specimens are shown in Figure 11. The initial stiffness of the adobe-wall specimen EAW was slightly higher than that of the composite-wall specimen EAW-MS because the composite wall was divided into two independent parts by the wooden column in the middle of the wall. In the elastic and yielding stages, the stiffness degradation rates of the two specimens were essentially the same; however, the stiffness degradation rate of the composite-wall specimen EAW-MS was much slower once it entered the failure stage. This finding suggests that the wooden middle column tied the walls on both sides to slow the stiffness degradation of the composite wall. In the elastic and yielding stages, the stiffness degradation rates of the composite-wall specimens were slightly higher than those of the adobe-wall specimen; however, after entering the yield and failure stages, the stiffness degradation rate of the composite-wall specimen EAW-MS was slower than that of the adobe-wall specimen EAW. This finding suggests that the wooden middle column tied the walls on both sides to slow the stiffness degradation of the composite wall. The modified mud could increase initial stiffness and slow stiffness deterioration of adobe walls, as shown by specimen EAW-MS, which had a higher initial stiffness and a slower rate of stiffness degradation than the UAW-MS specimen. The stiffness degradation rate of the specimen EAW-MS was slower than that of the specimen EAW-MN, which indicates that the steel-wire mesh had a stronger tensile effect and slowed the stiffness degradation of the specimen more.

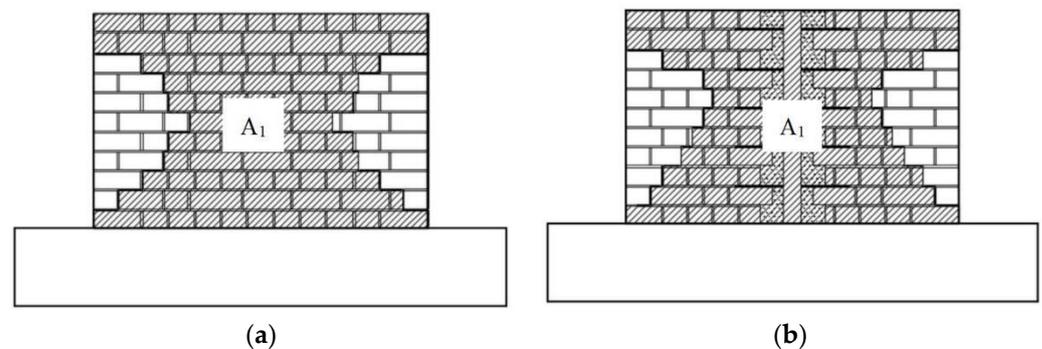
Figure 12. Schematic diagram of wall residual-area calculation: (a) adobe wall and (b) composite wall.

Due to the low shear strengths of adobe-brick-masonry walls, they are prone to block-scattering damage in earthquakes. Especially when walls are long and unrestrained, they are more likely to collapse over a large area. Therefore, it is important to assess the collapse of a wall after an earthquake [34]. The previous test phenomenon and analysis of seismic performance indicators show that the wooden structural column proposed in this paper could effectively improve this situation. To evaluate the improvement effects of different restraint measures, the collapse residual facade area (the facade area of the residual wall in the central region after the collapse of the wall in the triangular region on both sides) was used in this paper for evaluation, as shown in the shaded parts in Figure 12. The residual facade area facilitated visual observation of the residual part of the wall after it entered the collapse stage. A larger residual area indicated a stronger restraint capacity of the central structural measures and a higher collapse resistance of the structure under seismic effects.

The collapse residual areas of the five specimens are listed in Table 9. Each wall had a residual area at the point of collapse that was less than half of its initial size; however, the collapse residual areas of the four composite-wall specimens were larger than that of the adobe-wall specimen. The collapse residual areas of the specimens EAW-MS and UAW-MS comprised a maximum value of approximately 40%, which was an improvement of approximately 20% over the specimen EAW; however, the collapse residual areas of the specimens EAW-MN and UAW-MN were only slightly better than that of the specimen EAW, at approximately 8.5%. When compared to the unmodified-mud-masonry walls, the collapse residual areas of the modified-mud-masonry walls only improved by approximately 3%. This finding shows that composite walls could display improved collapse resistance under a strong earthquake, the steel-wire-mesh ties were slightly better than the nylon-rope ties, and the modified mud contributed less to collapse resistance, which mainly depended on the strengths of the ties between the central structural column and the wall.

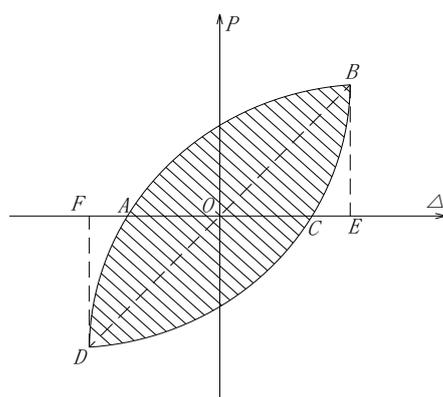
Figure 13. Calculation diagram of each coefficient.

where $S_{(ABC+CDA)}$ is the area of the hysteresis curve and $S_{(\Delta OBE+\Delta ODF)}$ is the sum of the areas of ΔOBE and ΔODF , as shown in Figure 13.

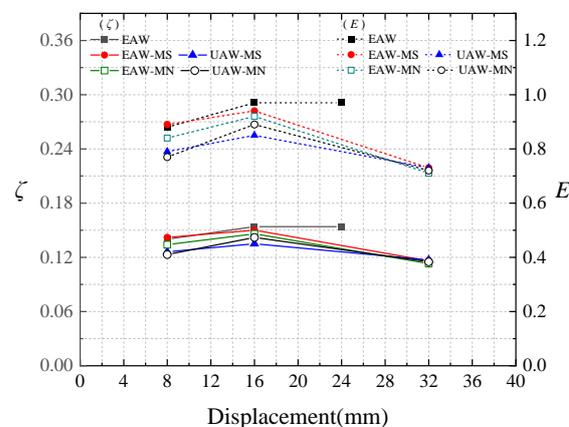
Figure 14. Curves of the energy-dissipation coefficients and damping coefficients at characteristic points of each specimen.

The curves of the energy-dissipation and damping coefficients for each specimen, as seen in Table 10 and Figure 14, typically showed upward and then downward tendencies. However, the curve for the adobe-wall specimen had a smooth development trend in the later stage of loading. It is evident that at each force stage, the composite-wall specimens' energy-dissipation coefficients and corresponding viscous-damping coefficients were, on average, lower than those of the adobe-wall specimen that was unconfined. The difference

between the energy-dissipation capacities of the two types of wall at the yield and peak points was small, but it increased at the failure point. At that time, the energy-dissipation capacity of the composite-wall specimen was about 75% of that of the adobe-wall specimen. The reason for this phenomenon was that the energy-dissipation capacities of the walls were mainly related to the development of cracks. In the early stage of loading, the cracks of the two types of wall were mainly concentrated in the adobe-block masonry at both ends, and the difference in the degrees of damage between the two types of wall was not large. After this stage, the adobe blocks and masonry at both ends basically stopped working, and the middle column of the composite wall reduced the damage degree of the middle wall and its energy consumption; however, the energy-consumption reserve in the later collapse stage was higher. The modified-mud-masonry specimens (EAW, EAW-MS, and EAW-MN) had higher energy-dissipation capacities in the early stage of loading, which was 10% higher than the unmodified-mud-masonry specimens (UAW-MS and UAW-MN). The reason for this phenomenon was that the shear strength of the modified mud was higher, and the frictional energy-dissipation capacities of the mud joint between the adobe blocks during the earthquake were stronger.

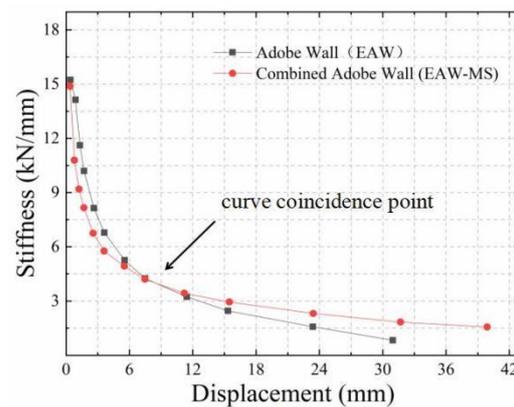
Figure 15. Composite-wall and adobe-wall stiffness degradation curves.

Figure 15 shows a comparison of the stiffness degradation curves of the composite wall (EAW-MS) and the adobe wall (EAW). When the loading was small, the stiffnesses of the two specimens were close to each other. The initial stiffness of the composite wall was slightly lower than that of the adobe wall due to the arrangement of the central structural column, and its stiffness degradation rate was slightly faster. As the loading gradually increased after the wall damage developed, the wooden structural columns gradually participated in bearing the seismic shear, and the stiffness gap between the two types of wall decreased. After loading to 7.5 mm (the curve coincidence point), the stiffness of the composite wall began to exceed that of the adobe wall, and its degradation rate was slow. The stiffness degradation curve was smooth and its curve length was long, indicating that it reached the collapse stage at a relatively late time.

As seen, the modified adobe-block-masonry wall, which could be thought of as the first line of defense, would carry the majority of the horizontal seismic shear force during the elastic stages of small earthquakes. However, during the medium- and large-earthquake elastic-plastic stages, the contribution of the adobe blocks and masonry to the stiffness of the composite wall gradually decreased. As a second line of defense at that time, the wooden structural column gradually contributed to bearing the seismic shear stress, and the percentage of this bearing increased with the severity of the wall damage. The degree and extent of the tie material's constraint on the wall determined how the composite-wall bearing capacity and stiffness degraded.
