Article

Regeneration of Panel Housing Estates from the Perspective of Thermal Technology, Sustainability and Environmental Context (Case Study of the City of Ostrava, Czech Republic)

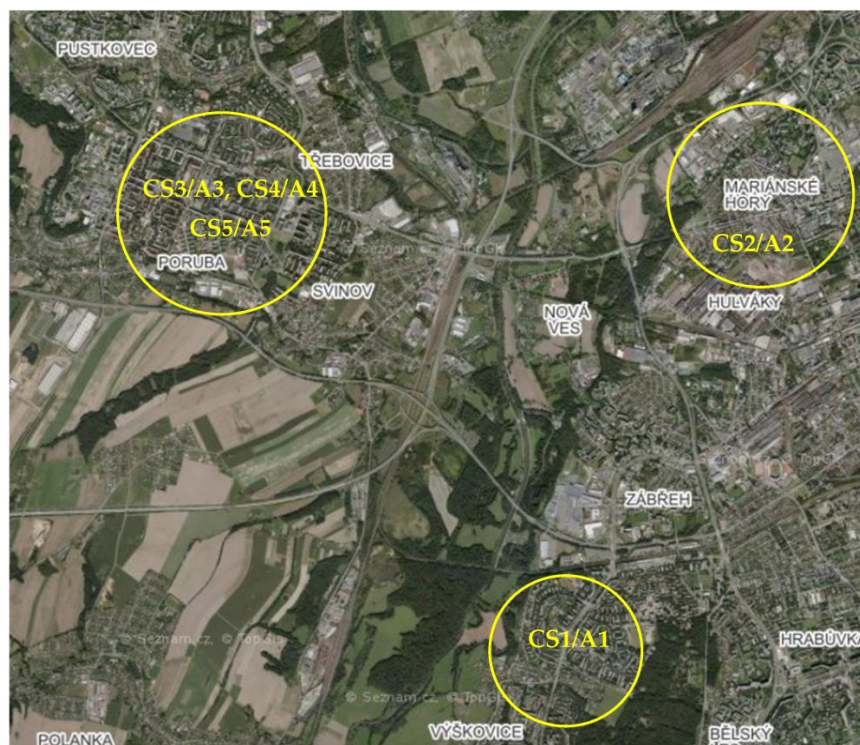
Figure 3. Locations: (a) Locations A1–A5 for case studies CS1–CS5 [52]; (b) Urban composition of the city of Ostrava (CZ) with four residential sectors, an industrial (orange colour) and a recreational zone in the Oder river valley (green colour), [32].

The field reconnaissance of settlement sites focused on the territory of the city of Ostrava in the Czech Republic (Case studies CS1 to CS5, geographical coordinates (49°50'8" N, 18°17'33" E), monitored sites marked A1 to A5, Figure 3a). The urban concept with the main locations of the housing estates, implemented between 1955 and 1985, is documented in Figure 3b; large scale prefab residential housing developments are located in these housing estates. The concept includes an urban sector of heavy industry and also a recreational area in the valley of the Oder river. The city of Ostrava, historically an industrial location with heavy industry is characterised by the fact that heavy industry was centralised in the middle of Ostrava, with new housing developments after 1955 concentrated to the west, east, and south. Gradually, satellite settlements were created, but they have a very well-built transport infrastructure and are, thus, well connected to the city centre. Within the case studies CS1–CS4, selected prefab residential housing in the form of block or point buildings, with a height level of 4–12, upper floor, where the ETICS composite with thermal insulation layer of EPS was applied, were monitored. From 50 mm to 120 mm on the original slag–concrete (SC) panel cladding or gas–silicate (GS) cladding. The monitoring followed the manifestations of biodegradation of the cladding of prefab residential housing, always with an area greater than 0.50 m².

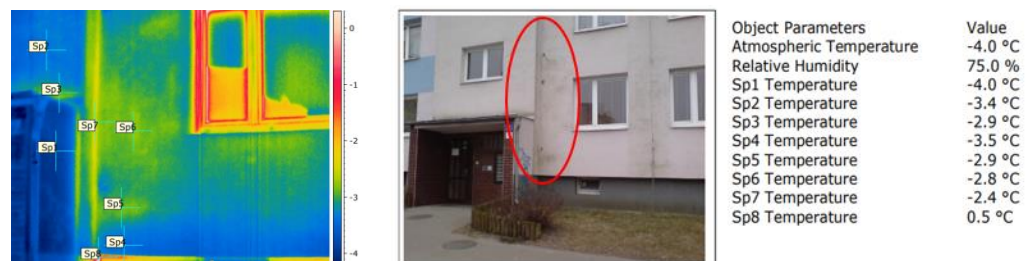
Figure 5. Biodegradation of the facade at the point of expansion of a panel apartment building and thermographic determination of temperature inhomogeneity [107,109].

The diffusion resistance factor μ [-] for external silicone renders reached values of 20–40 [-] \varnothing 30 [-]; the diffusion resistance factor μ [-] for EPS reached values of 20–70 [-]; \varnothing 45 [-]; the thermal conductivity coefficient λ [W/(m.K)] for the external silicone render reached values from 0.029 to 0.042 [W/(m.K)]; \varnothing 0.035 [W/(m.K)]; and the thermal conductivity coefficient λ [W/(m.K)] for EPS reached values from 0.033 to 0.039 [W/(m.K)], \varnothing 0.360 [W/(m.K)]. The coefficient of thermal conductivity of ETICS will significantly affect humidity. If the humidity increases, the thermal conductivity will increase and its thermal insulation capabilities will decrease. The load on the facade with ETICS moisture will affect the declared values of the materials, although they can be considered correct from the point of view of the design.

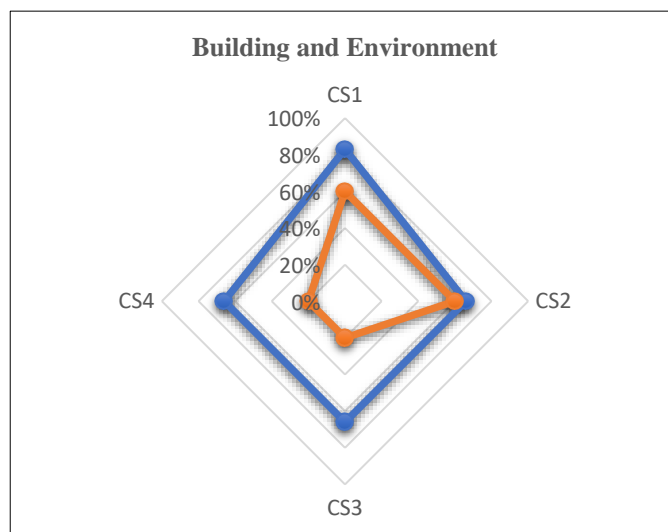
Figure 7. Percentage in relation to the prediction of biodegradation for environmental and building characters (for CS1–CS4), orange colour—environmental part and blue colour—building part.
