Analysis of the Interaction Damage Mechanism and Treatment Measures for an Underpass Landslide Tunnel: A Case from Southwest China

Wangwang Zhou, Xulin Xu, Xiaoqing Li * and Shiyun Li

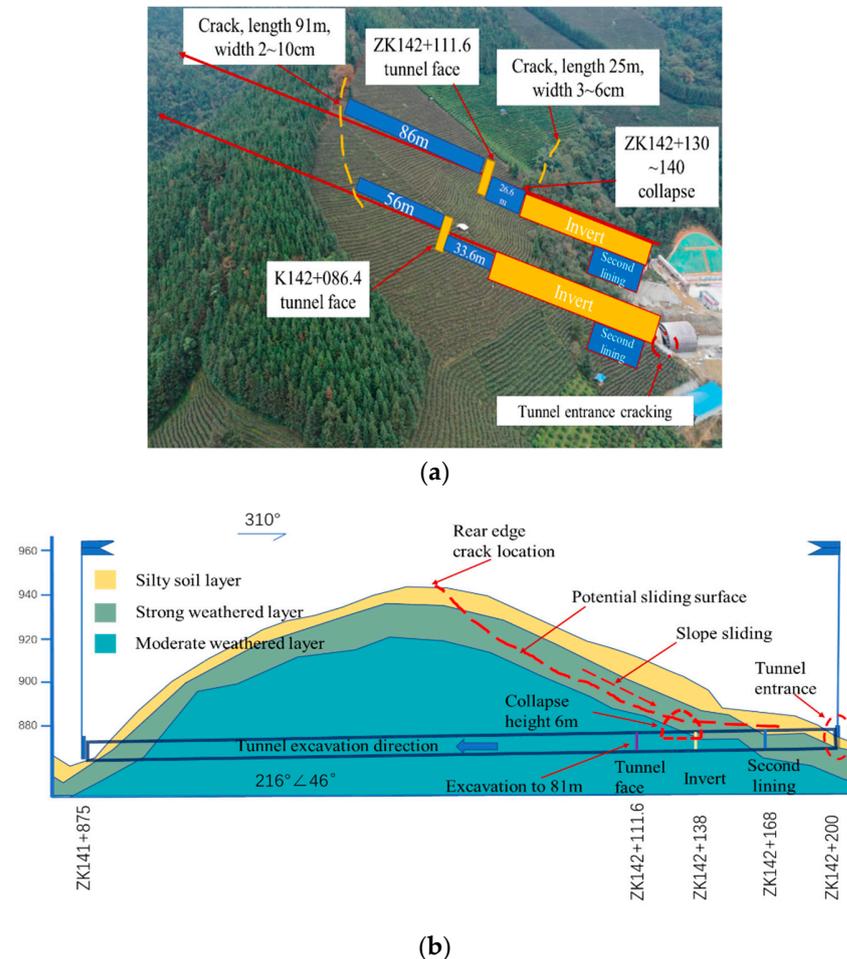
Figure 1. Schematic diagram of the damage to the underpass landslide tunnel. (a) Schematic diagram of the overall damage to the underpass landslide tunnel. (b) Schematic diagram of the damage to the longitudinal section of the underpass landslide tunnel.

25–35°, the vegetation on the mountain is more developed, the lower part of the slope is planted with orange trees and other economic forests, and the upper part of the slope is dominated by weeds and orange trees. A schematic representation of the underpass landslide tunnel hazard is shown in Figure 1.

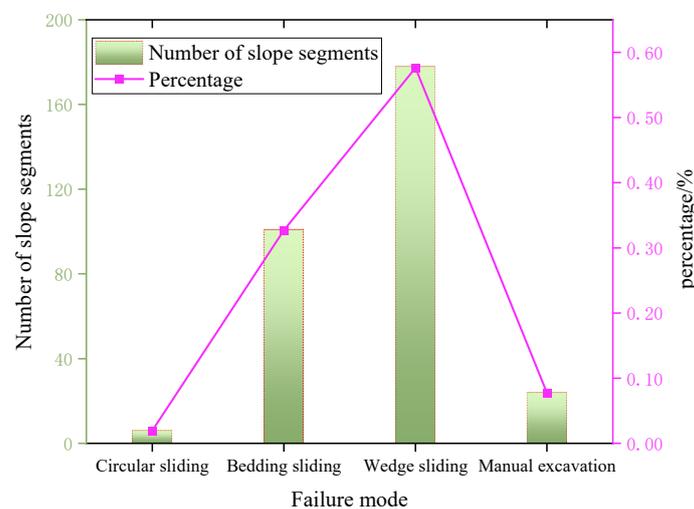
Figure 2. Slope damage pattern.

A total of 309 slope sections were investigated in a site exploration survey of highway slopes greater than 30 m in height in southwest China, and the damage patterns of the slopes were counted, as shown in Figure 2. The slope sections with circular sliding, parallelogram sliding, wedge sliding, and manual excavation damage accounted for approximately 2%, 33%, 57%, and 8% of the slope sections, respectively. Combined with the comprehensive analysis of the slope investigation where sliding and slumping have occurred on-site, the number of slopes where large-scale parallelogram sliding occurred on-site is relatively small, and more landslides are localized reverse-layer or cut-layer wedge sliding, although reverse-layer or cut-layer working conditions are conducive to slope stability. According to field research, most of the sections in southwest China are Tertiary sandstone slopes, and some of the rock masses are strongly disintegrated, with thicker strongly weathered layers, so wedge sliding occurs more often. The landslides investigated in this study are wedge slides, which are typical in southwest China.

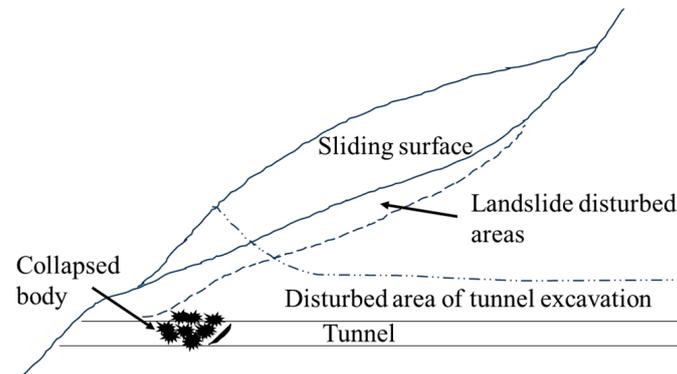
Figure 3. Spatial location relationships.

A large number of engineering examples show that the relative position of the tunnel and the landslide structural form will have a greater impact on the force deformation and damage mode; therefore, to determine the spatial location of the tunnel and landslide for the study of tunnel–slope interaction, a damage mechanism is essential. In this paper, the tunnel landslide system is a subway landslide tunnel, whose damage is dominated by the deformation of the arch, which is affected by the additional load of the landslide thrust to induce extrusive deformation and cracking. The misplaced platform, the crack width of the cavity section, is large with an extended length; the closer the cavity section deformation is, the more likely it is that a more serious collapse and roofing and other accidents may occur [37,38]. The spatial location of the tunnel through the landslide is shown in Figure 3, and the force pattern is shown in Figure 4. Based on the strength reduction method, the slope safety factor F_s is used as an indicator to evaluate the stability of the slope, and its physical meaning is the ratio of the slip resistance of the soil to the sliding force, where $F_s < 1$ means that the slope has been destabilized and damaged [39]. The maximum disturbance radius R_{pmax} of the tunnel excavation, the maximum additional load max on the lining corresponding to the thickness H_0 , and the minimum safe undercutting distance H_{min} of the tunnel can be calculated according to the following equations [40,41]:

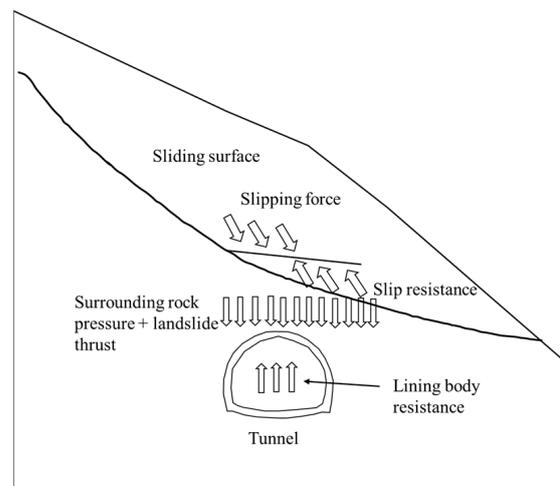
Figure 4. Force pattern.

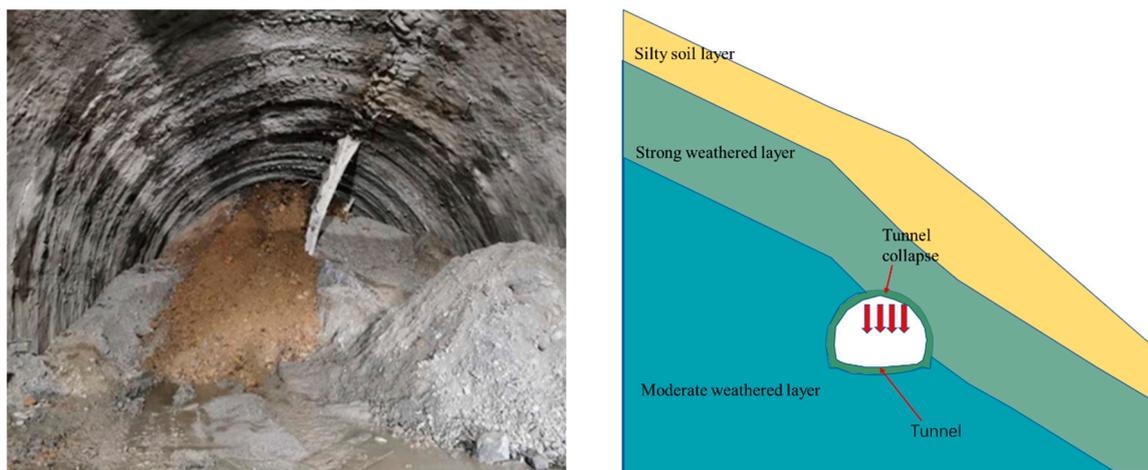
On 16 November 2020, a small collapse occurred at ZK142 + 130–140 in the left cavern of the tunnel, with a volume of approximately 200 m³, forming a 6 m high collapse cavity at the top of the palm face, which extended along the side of the ridge. A photograph of the collapse at the palm face is shown in Figure 5. The lower and middle parts of the palm face are medium-weathered rocks, while the upper part is strongly weathered.

Figure 5. Collapse map of tunnel face.

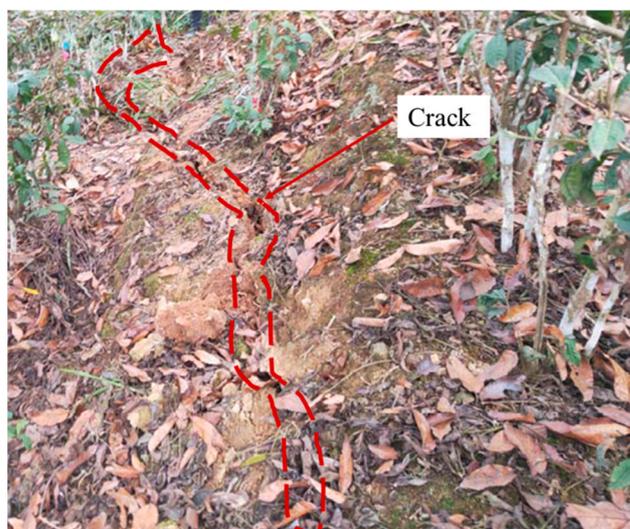
On 20 December 2020, a crack of approximately 25 m in length and 3–6 cm in width appeared on the left side of the mountain at a location of approximately 45–70 m. The crack was presumed to be caused by the collapse of the left tunnel, as shown in Figure 6.

Figure 6. Crack map on the left side of the mountain.

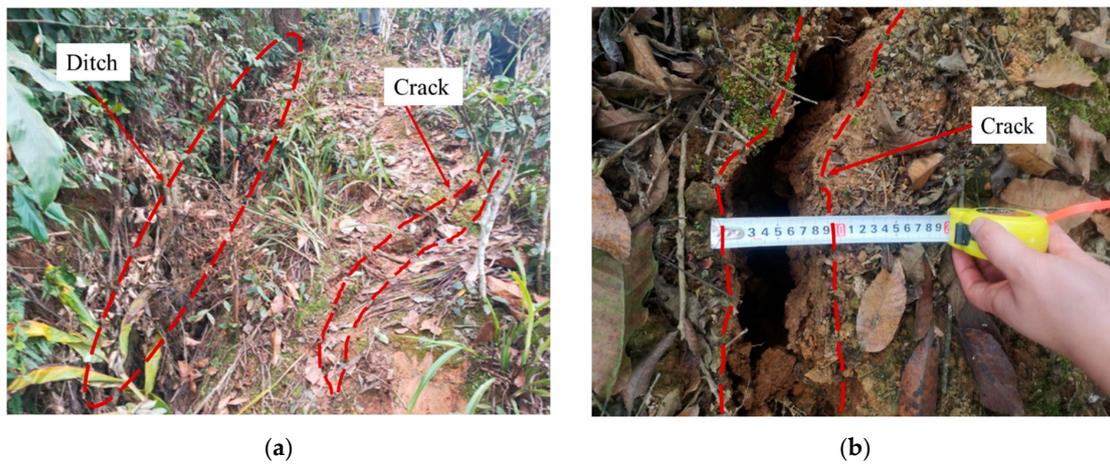
On 30 December 2020, deformation and cracking damage occurred on the elevation slope of the back edge of the tunnel cavity, which was found after an investigation with all parties. The crack was approximately 91 m long and varied in width from 2 to 10 cm. The crack extended along the ridge against the side of the large pile number, 86 m from the left cave and 56 m from the right cave. The side of the small pile number of the crack was a temporary ditch excavated by the villagers, and the ditch was long in scope, extending from the top of the hill to the foot of the hill. The back edge elevation slope of the site is shown in Figure 7.

Figure 7. Deformation and crack diagram of the slope at the rear edge of the tunnel. (a) Slope of the rear edge and (b) the maximum deformation crack.

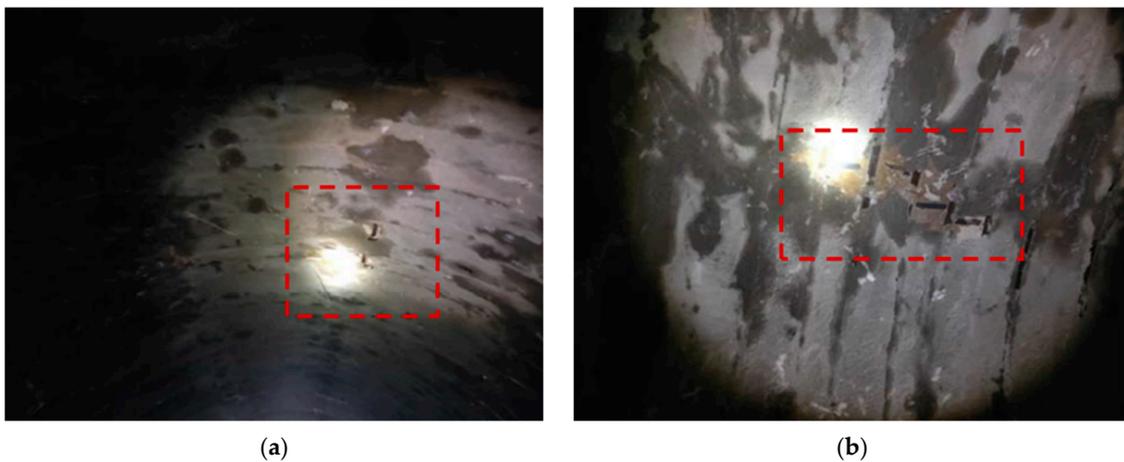
After the instability of the elevation slope, the site investigation and survey found that cracks appeared in the initial support at the top and waist of the arch of the left hole ZK142 + 130~ZK142 + 140, and cracks appeared in the top and waist of the arch of the right hole K142 + 115. The second lining section of the left cavern was poured in November 2020, and according to the on-site investigation, the second lining section was cracked and damaged, and there was the phenomenon of flaking of the initial support. The cracking of the right lining is shown in Figure 8, and the cracking of the left lining is shown in Figure 9.

Figure 8. Cracking diagram of the lining of the right hole of the tunnel: (a) Peeling phenomenon of the primary support at the left vault of the right hole K142 + 115; (b) peeling of the initial branch at the left arch waist of the right hole K142 + 115.

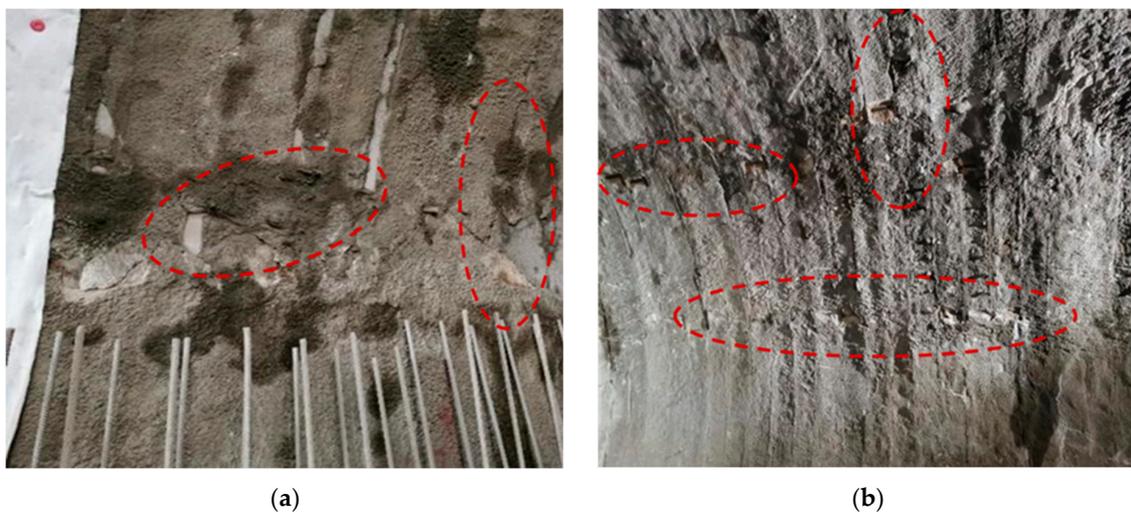
Figure 9. Cracking diagram of the lining of the left hole of the tunnel: (a) Cracks in the arch waist on the right side of the left hole ZK142 + 130–140; (b) cracks in the arch wall on the right side of the left hole ZK142 + 130–140.

Rescue measures: Stop tunnel palm face boring and use A8 reinforcement mesh and 10 cm thick C25 shotcrete to seal the palm face. To ensure that the initial support cracking and spalling of the tunnel was serious in the ZK142 + 120 to ZK142 + 140 section of the left cavern and the K142 + 100 to K142 + 120 section of the right cavern, the reinstatement arch was added to strengthen the support system, using I18 I-beams with a spacing of 80 cm. After the erection of the re-arch in section K142 + 120 was completed, backfilling was carried out in sections ZK142 + 110 to ZK142 + 150 in the left cavern and section of K142 + 090 to K142 + 130 in the right cavern using gravel or cavern slag, with the top surface of the backfilling elevated above the design height of 5 m. The backfilling surface was then leveled and, finally, 50 cm thick C25 plain concrete was poured on the top surface.

- (1) The lining type of section ZK142 + 070~080 and section ZK142 + 030~040 of the left cave was adjusted from Sd4-b to Sd4-a for strengthening treatment.
- (2) The concrete standard of the lining of section ZK142 + 120~140 of the left cave and section K142 + 100~120 of the right cave was upgraded from C35 to C40, and the lining of section ZK142 + 130~140 of the left cave was changed from XSd5-a to XSd5-c for strengthening treatment.
- (3) The lining type of section K142 + 000 to K142 + 030 of the right cave was adjusted from Sd4-b to Sd5-b, and I-beams were added to the elevation arch of section K142 + 030 to K142 + 070 to close the initial support into a ring to improve the integrity of the initial support and strengthen the locking foot of this section.

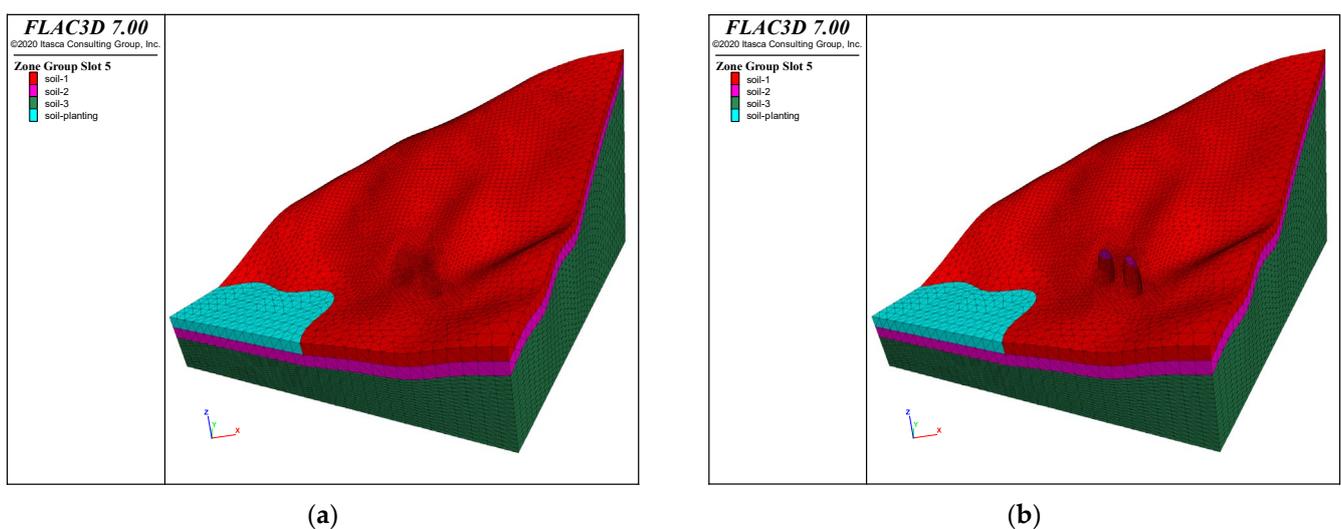
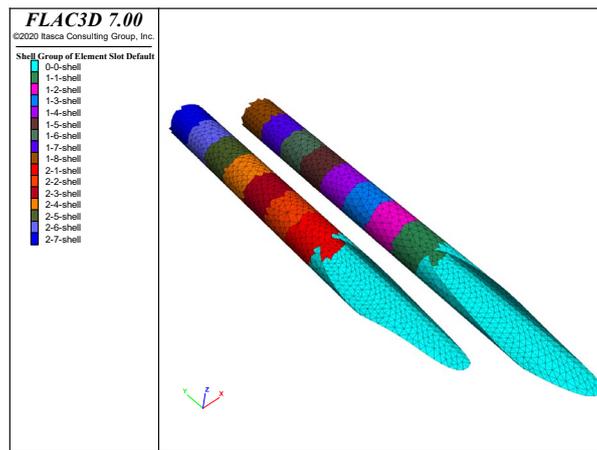
In this paper, a finite difference simulation model of the underpass landslide tunnel was established using FLAC3D by the detailed survey report. Considering the large variation in thickness of the powdered soil layer, the large workload and low accuracy of setting up a separate layer of material for simulation and the vegetation roots to enhance its strength, the powdered soil layer was combined into a strongly weathered layer for simulation. The model was divided into 138,580 blocks and 34,874 nodes, extending 266 m from north to south and 640 m from east to west, with an elevation difference of approximately 160 m between the top and bottom. The solid unit was used for the surrounding rock, the thin shell unit was used for the lining structure, and the boundary conditions were imposed as fixed at the bottom and as normal constraints on all the other faces. The dominant joint material was simulated over the entire joint, and the dominant joint yield was set at $-35^\circ/28^\circ$ with a joint spacing of 4 m. The rest of the material was simulated by using Moore Cullen. The physical and mechanical parameters of the surrounding rocks were adopted from the ground investigation report, and the parameters of each surrounding rock are shown in Table 1. The tunnel slope model is shown in Figure 10, where Soil-1 is a medium-weathered rock body (powdered clay), Soil-2 is a strongly weathered rock body, Soil-3 is a medium-weathered rock body, and Soil-planting is a plantation soil.

Figure 10. Model drawing of the underpass landslide tunnel. (a) Slopes in their natural state and (b) slopes after tunnel excavation. (c) Lined structural body.

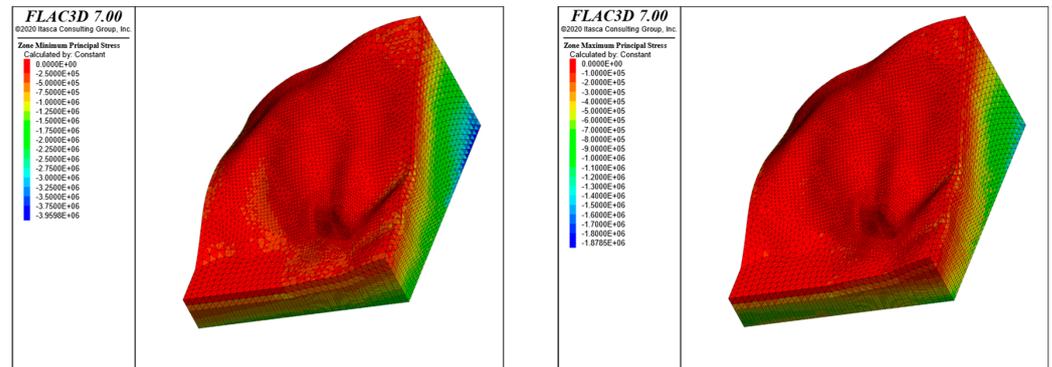
Figure 11. Stress zones.

From Figures 11 and 12, it can be seen that the stress values of the slopes within the area of investigation were greater than 0, indicating that there was no tensile stress nor plastic damage zone on the slopes within the area of investigation. In addition, the presence of tree roots on the slope surface, which provided a relatively large anchorage force, indicated that there was no local landslide on the actual slopes and that the stability of the slopes before tunnel excavation was good.

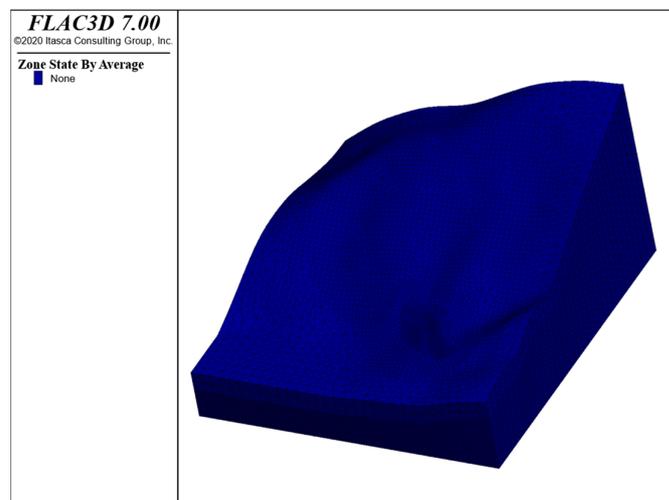
Figure 12. Plastic damage zone.

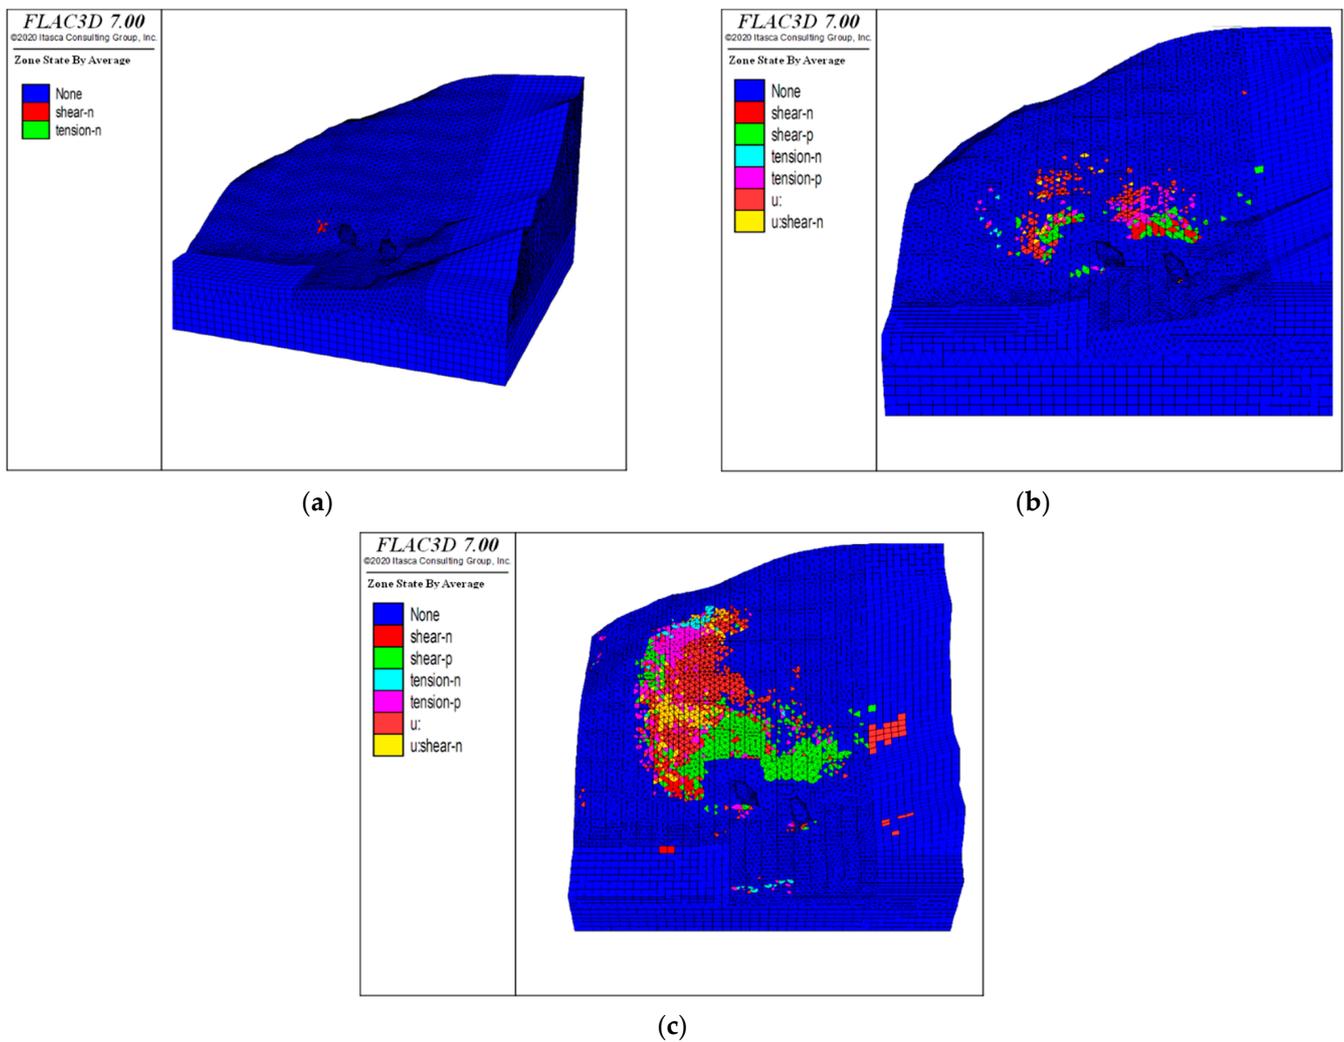
Figure 13. Zone of plastic damage: (a) First paragraph, (b) second paragraph, (c) third paragraph.

As can be seen in Figure 13, after the completion of the first section of tunnel construction, the plasticity zone existed in a very small range and was not connected to a piece; so, it can be seen that, at this time, the stability of the tunnel surrounding rock and slopes was good. After completion of the second section of tunneling, the plastic damage zones were created from the edge of the tunnel, reaching the surface and connecting into pieces, which could easily lead to surface cracks. The actual situation was that a section of approximately 25 m long cracks was created on the surface of the ground near the top of the collapsed section of the left tunnel. After the completion of the third tunnel section, the plastic damage zone grew from the surface above the right tunnel front and reached the surface above the left tunnel front and further expanded. The actual situation was that a 90 m long crack was created in the adjacent surface location, which showed that the calculation results were more consistent with the actual situation.

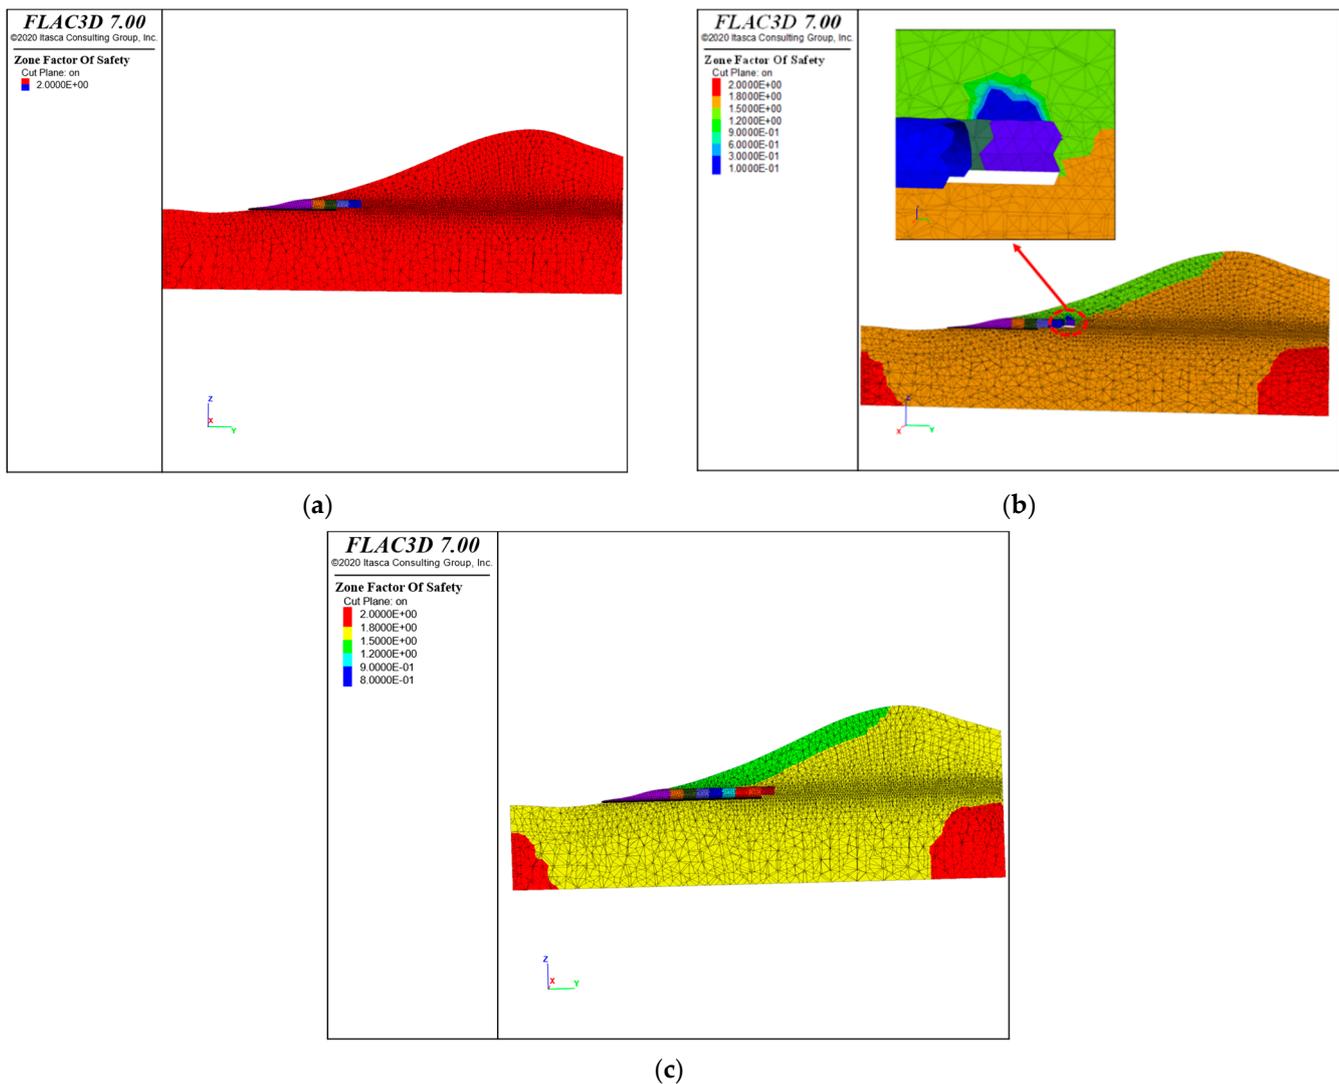
Figure 14. Distribution of slope safety factors: (a) First paragraph, (b) second paragraph, (c) third paragraph.

As can be seen from Figure 14, after the first section of tunnel construction, the slope safety coefficient was greater than 1, indicating that the slope was in a stable state. After the second section of tunnel construction, due to the failure of timely support after the excavation of the left line, the slope safety coefficient decreased, and the safety coefficient of a small range of slopes above the tunnel's unsupported place was less than 1. At this time, the tunnel was prone to cave-in damages, and the actual situation was that a small cave-in did occur here, with a volume of approximately 200 m³, forming a 6 m high collapse cavity at the top of the palm face. After the construction of the third section of the tunnel, the safety coefficient of some slopes was lower than 1. At this time, the surface was prone to tension cracks, and the actual situation was that a section of 90 m long cracks was produced in the similar surface position, which showed that the calculation results were more consistent with the actual situation.

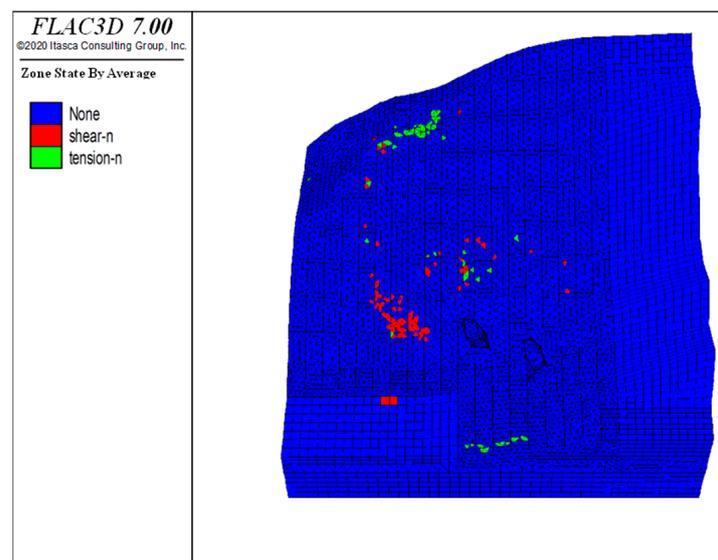
Figure 15. Distribution of plastic damage zones.

As can be seen from Table 5 and Figures 15 and 16, compared with the simulation results of the tunnel collapse, the maximum stress value in the same section was significantly reduced, indicating that the tunnel collapse caused the potential sliding surface to slide down, and the slip body generated thrust to act on the tunnel lining structure body, resulting in an increased stress and a significant tunnel–slope interaction effect. The plastic damage zone near the left line tunnel did not appear to be connected to a patch, the plastic damage zone at the back edge of the mountain body, the relative increase in slope safety factor. This comparison shows that the collapse of the left tunnel was the main cause of a 25 m long crack in the ground surface near the top of the collapsed section of the left tunnel, and this hurt the ground surface at the back edge of the mountain, which showed a significant tunnel–slope interaction effect.

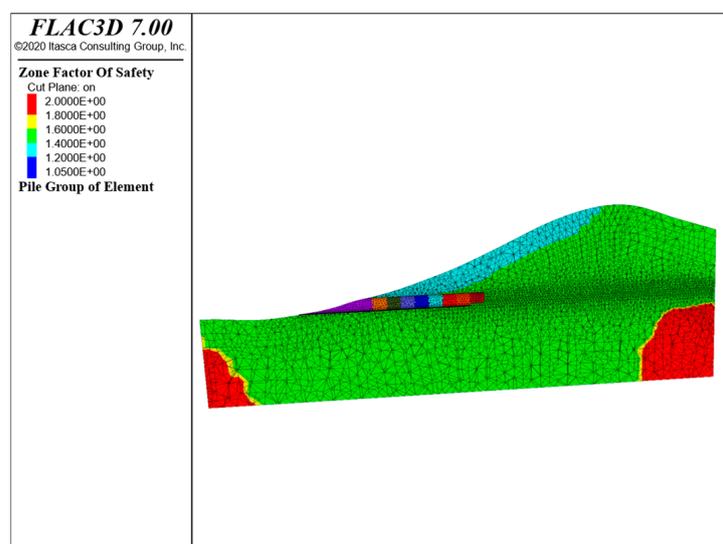
**Figure 16.** Distribution of slope safety factors.

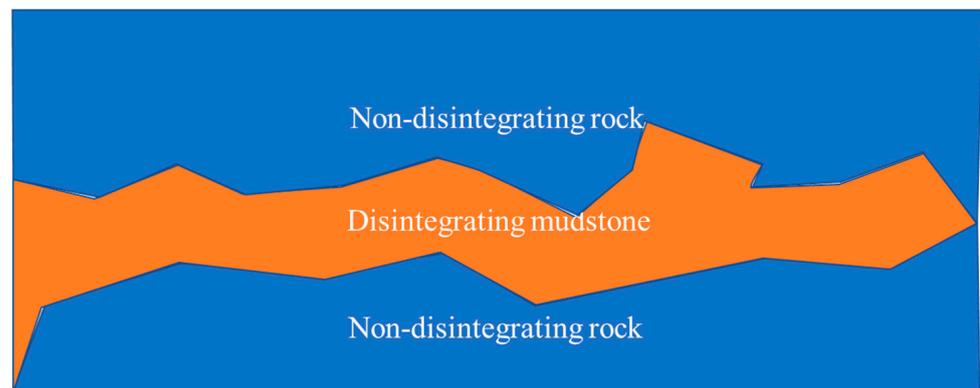
was broken (left line tunnel cracks), and not having timely support after the blasting excavation resulted in a potential sliding surface creep–slip action on the tunnel lining structure body. This resulted in tunnel convergence, sinking of the arch footings, and cracking of the lining. The presence of disintegrating mudstone caused the rock and soil on the slope to be less strong and more susceptible to deformation and damage; on the other hand, some of the disintegrating mudstone and hard rock, in the form of interlayer, was affected by weathering camp forces after excavation. The disintegrated mudstone and non-disintegrated rock produced differential weathering and formed a soft interlayer, as shown in Figure 17, which easily led to wedge-shaped sliding damage of the elevation slope and was not conducive to the stability of the debris rock elevation slope.

Figure 17. Form diagram of weak interlayer.

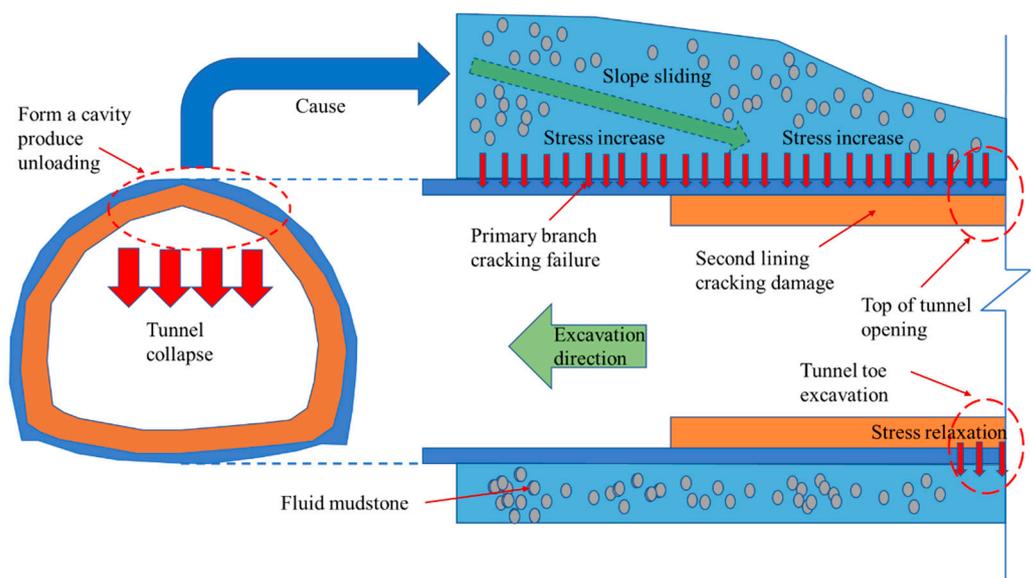
The interaction between tunnel damage and slope instability was magnified by the rheological nature of the mudstone contained in the tunnel envelope. When the tunnel was excavated to 50 m, the left tunnel collapsed, and a cavity was formed at the top of the collapsed cavity, resulting in some unloading, which led to the potential sliding surface of the elevation slope sliding down. The sliding stresses generated by the slope sliding down were applied back to the tunnel, further increasing the stresses in the lining structure and at the top of the cavity slope. The excavation at the foot of the cavern caused a relaxation of the lower structural stresses, which eventually led to the cracking of the lining structure and the cavern opening, with the cracking damage pattern as shown in Figure 18.

Figure 18. Failure mode diagram of lining structure.

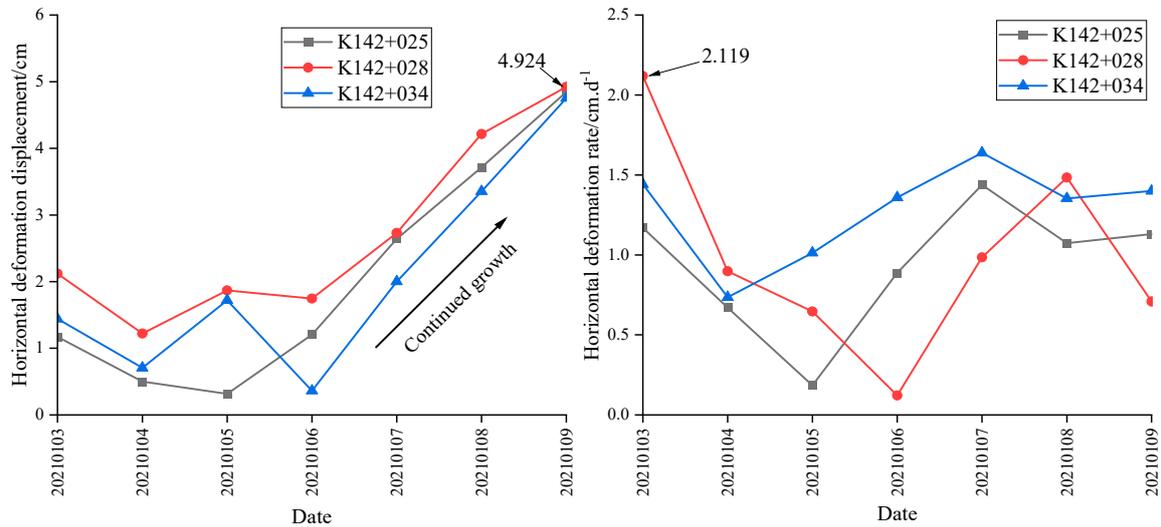
Figure 19. Horizontal monitoring map of the slope section.

From the deformation monitoring results shown in Figures 19 and 20, it can be seen that the horizontal deformation displacement of each section monitoring point showed a rising trend; the maximum horizontal deformation displacement value was 4.924 cm, and the horizontal deformation displacement was large, indicating that the stability of this section of the slope body was poor. The horizontal deformation rate was greater than 0 cm.d^{-1} , the maximum deformation rate was 2.119 cm.d^{-1} , and the overall deformation was 1 cm.d^{-1} , which indicated that the horizontal deformation of the slope would continue to increase.

In summary, the monitoring and measurement results showed that the horizontal deformation displacement and settlement deformation displacement of this section of the tunnel slope was increasing, indicating that the stability of this section of the slope body was poor and prone to instability, which would require emergency treatment measures and a permanent treatment plan to prevent further instability of the tunnel slope, resulting in serious consequences.

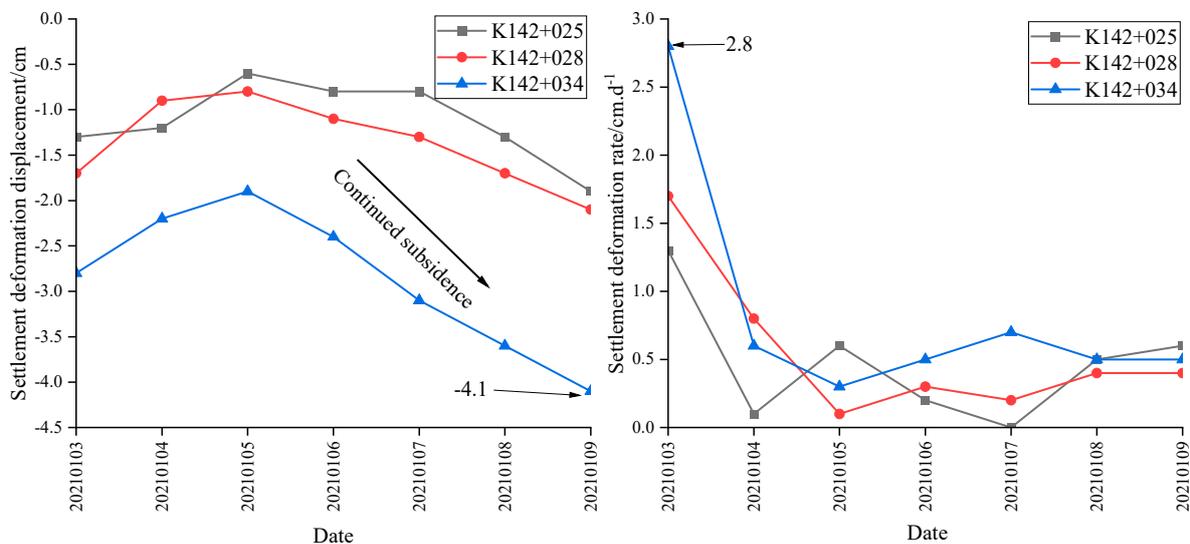
Figure 20. The subsidence monitoring map of the slope section.

The settlement deformation displacement of each section monitoring point showed a continuous sinking trend, the maximum settlement displacement value was -4.1 cm , and the sinking displacement value was large, indicating that the stability of this section of the slope was poor. The settlement deformation rate was greater than 0 cm.d^{-1} , the

maximum deformation rate was 2.8 cm.d^{-1} , and the overall fluctuation in the upper and lower sections was 0.5 cm.d^{-1} , which indicated that the amount of slope settlement would continue to increase.

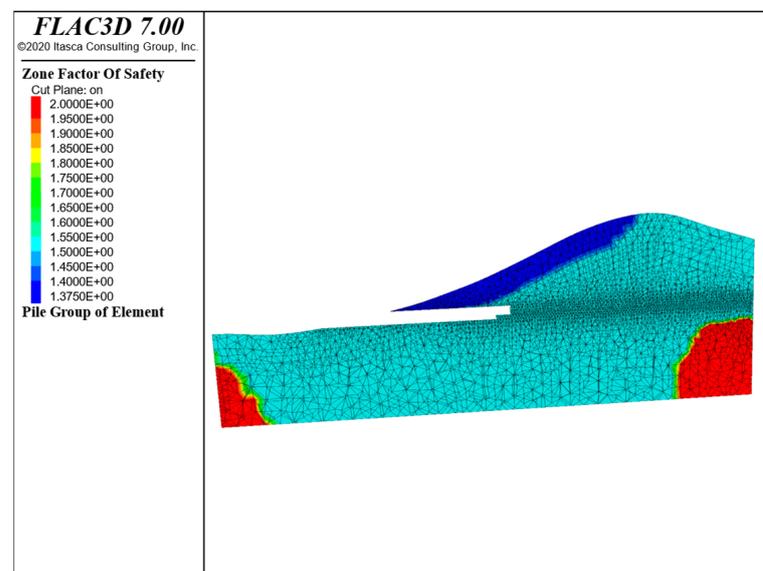
As can be seen from Figure 21, the minimum safety factor after the reinforcement solution was 1.375, which was greater than the code requirement of 1.25. The slope of the tunnel after treatment met the stability requirements, and the treatment solution was feasible.

Figure 21. Distribution of safety factors of the treated tunnel slopes.

This study simulated the treatment of tunnel slopes in FLAC3D to guide the actual reinforcement and treatment on site. The simulated solution to meet the slope stability control requirements consisted of slurry reinforcement, interception and drainage, surface grassing, toe counter-pressure, and anti-slip piles for areas where plastic zones may occur. The treated tunnel slope should meet the requirements of the Technical Specification for Construction Slope Engineering [42], which requires a permanent slope safety factor of more than 1.25.

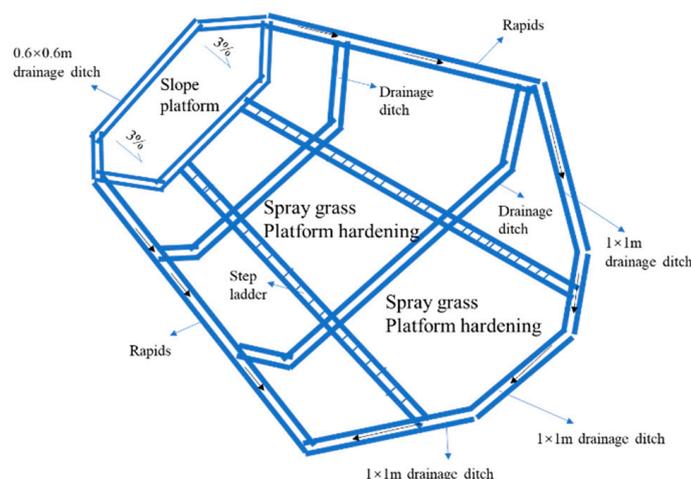
Figure 22. Design drawing of anti-pressure body treatment.

The treatment measures for the underpass landslide tunnel mainly included backfilling and backpressure, application of anti-slip piles, surface grouting, drainage treatment, and grass planting. The design of the treatment is shown in Figure 22.

- (1) Anti-slip piles: At a 880 m elevation, four square anti-slip piles with a length of 15 m (potential sliding surface depth of approximately 10 m), a pile cross section of 2 m × 4 m, and a pile spacing of 6 m were added to the back edge of the mountain; two square anti-slip piles with a length of 15 m (potential sliding surface depth of approximately 8 m), a pile cross section of 2 m × 4 m, and a pile spacing of 6 m were added to the right side of the left cavern.

- (2) Surface grouting: The length of grouting of the disturbed area caused by the collapse of the left tunnel at ZK142 + 140 was from mileage ZK142 + 120 to 130 on the left line and from mileage K142 + 112 to 120 on the right line. The width of grouting was from 30 m outside the outline of the left tunnel to 10 m outside the outline of the right tunnel, and the accumulated grouting area was approximately 600 m². The grouting material was P.O.42.5 cement net slurry, cement slurry with a water–cement ratio of (0.6–0.8):1, the initial pressure of grouting was 0.5–1.0 MPa, and the final pressure was 1.0 MPa.
