Pollutant Removal Efficiency in a Rainwater Treatment System in Roztocze National Park (Poland)

Abstract: The aim of this paper was to determine the efficiency of a rainwater treatment installation located near the farm buildings of Roztocze National Park (RNP), Poland. The rainwater treatment system, consisting of two polypropylene filters, one activated carbon filter and a UV lamp, was examined. Samples of raw and treated rainwater were collected once a month from June to December 2023. The study shows that average efficiency of pollutant removal in the analysed rainwater treatment system was not very high and amounted to 38.8% for ammonia, 29.6% for turbidity, 27.9% for NO₂, 19.8% for NO₃, and 6.9% for copper. The low efficiency values can be explained by the low concentration of these parameters in rainwater from the tanks. The efficiency of removing microbiological contaminants was very high and ranged from approximately 98% to 100%. It was shown that the UV lamp ensures very good disinfection of rainwater. The study shows that rainwater treated using filtration and disinfection (UV lamp) can be used for watering the Polish Konik horses living in the park, as well as for wash

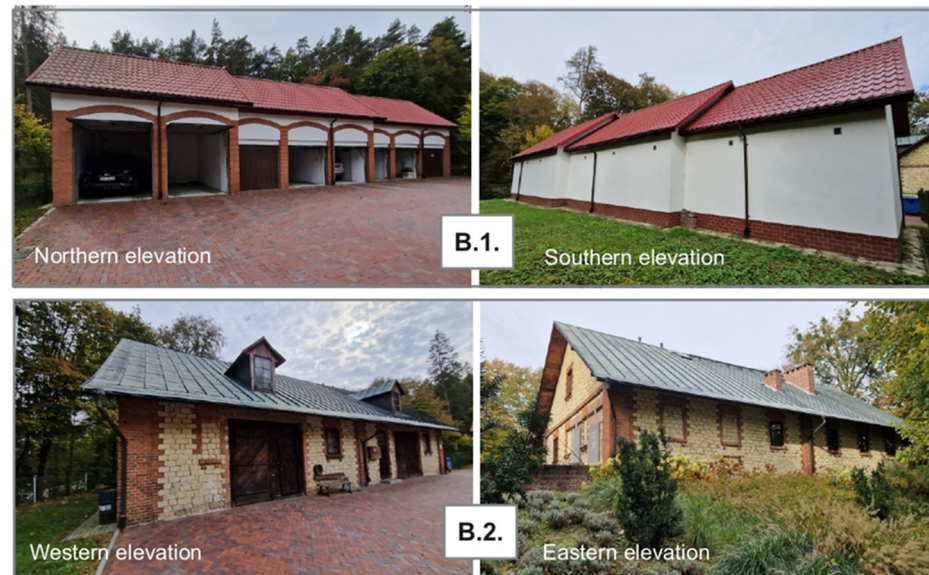
Figure 2. View of the garage (B1) and workshop (B2) in the Roztocze National Park Headquarters.

Figure 2. Building B1 occupies an area of 24.6 m × 6.5 m; its roof area in plan view is approximately 185 m² and the roof pitch angle is 40°. The dimensions of building B2 are 21 m × 12.4 m, and the roof area in plan view is approximately 302 m², with a pitch angle of 37° [30]. The roof coverings are shown in Figure 3. The two outbuildings have gabled roofs, with gutters on both sides of the buildings. Water from the two guttered sides of each building runs into the pumping station and from there to two concrete tanks that are joined together to form one large water storage tank.

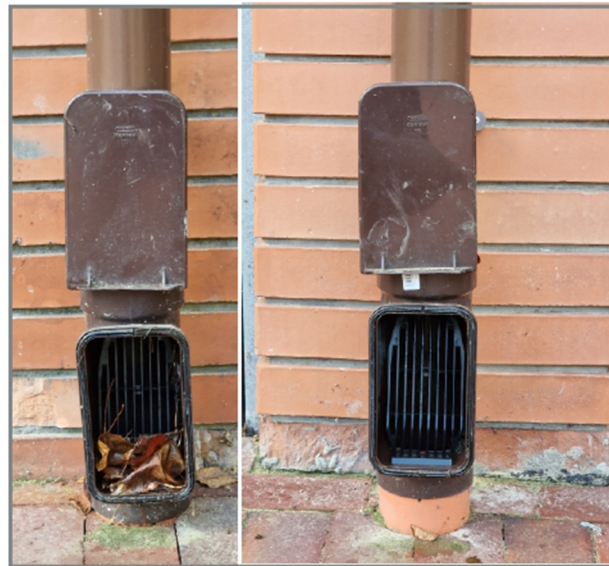
Figure 4. Photographs of cleanouts for removing dead leaves and debris from rainwater.

To ensure the best possible quality of the water flowing into the concrete tanks, each of the downpipes was fitted with a downspout cleanout, as shown in Figure 4.

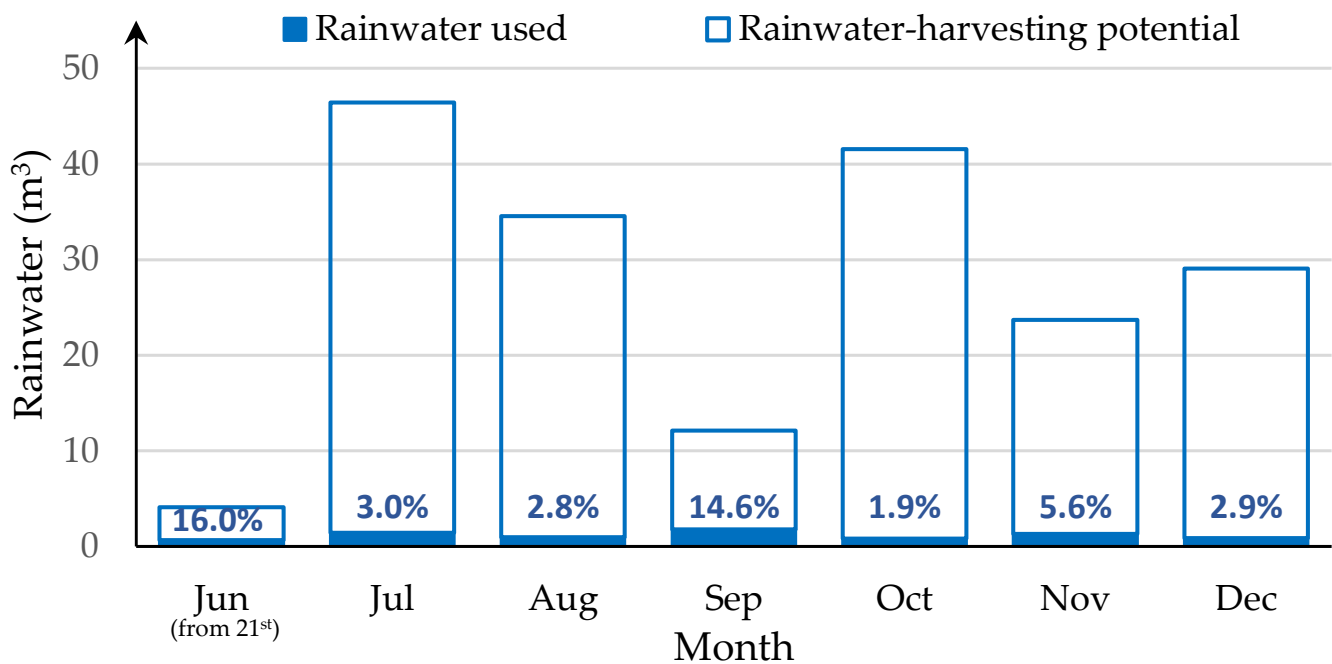
Figure 8. The amount of rainwater that can be captured and its use in the analysed period of 2023.

Figure 8 shows the estimated amounts of water flowing into the tank each month, as well as the amount of water used for washing cars. The largest amounts of influent were recorded in July (46.42 m³) and October (41.55 m³), and the smallest in September (12.14 m³). A small amount was also recorded in June (4.12 m³), because the installation was launched late in that month, and it only operated for a few last days of June. The large amounts of water in July and October theoretically exceeded the capacity of the tank, but there was no risk of overflow, because some of the water was used for washing cars, and excess rainwater ran through the overflow and soaked into the ground.

At that time, according to water meter readings, from 0.81 to 1.77 m³ of rainwater from the tanks was used monthly (except for June). The smallest amounts of water were used in October (0.81 m³) and December (0.84 m³), and the largest in September (1.77 m³), July (1.41 m³), and November (1.32 m³). Overall, only 1.9% to 16% of rainwater from the tanks was utilised. This indicates that there is great potential for additional use of this water.

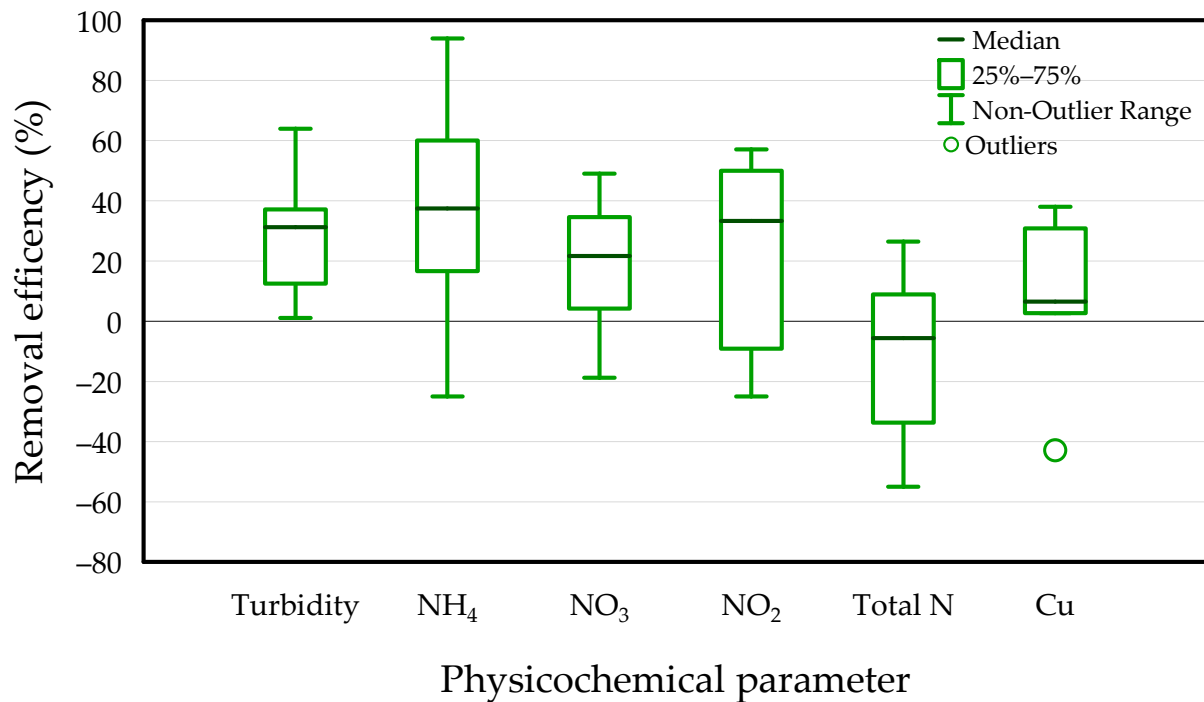
Figure 10. Efficiency of removal of selected chemical contaminants.

Figure 10 shows changes in the efficiency of the treatment system at removing selected physical and chemical contaminants from rainwater.

The median pollutant removal efficiency of the analysed rainwater treatment system was not very high at 38.8% for ammonia, 29.6% for turbidity, 27.9% for NO₂, 19.8% for NO₃, and 6.9% for Cu (Figure 10). The low efficiency values can be explained by the low concentrations of these parameters in rainwater from the tank. A similar study on the performance of a rainwater treatment system using various filters was performed by Teixeira and Ghisi [65]. These authors demonstrated that a sand filter removed turbidity, ammonia, and nitrates at efficiencies of 13, 34, and 10%, respectively. To compare, a membrane filter removed 11, 32.1, and 13.6% of those contaminants. Other authors [66] found that the use of filters with expanded clay (ceramsite) and activated carbon did not ensure a very high efficiency of removing nitrogen compounds. Our results and the literature data both indicate that in rainwater treatment systems, filtration processes should be followed by disinfection, which provides the effective elimination of microbiological contaminants.

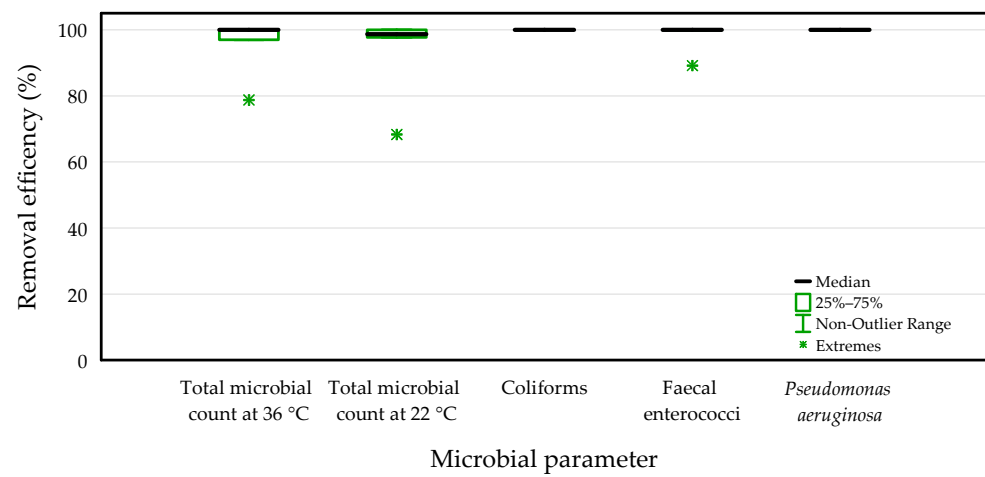
Figure 12. Efficiency of removal of selected microbial contaminants.

outlet from the treatment train, the disinfection efficiency was very high, in the range of approximately 98% to 100% (Figure 12). Incidentally, in August, the effectiveness of the removal of psychrophilic bacteria and mesophilic bacteria dropped to 78.8% and 68.3%, respectively. This is surprising since the water from the tank contained only 160 cfu/cm³ of psychrophilic bacteria and 120 cfu/cm³ of mesophilic bacteria at that time. Small counts of *E. coli* and coliform bacteria were only recorded in the water from the tank in November and were completely absent in samples of treated rainwater. Faecal enterococci were found in samples from the tank in counts of several dozen organisms. Water treatment, and especially disinfection, was so effective that only four faecal enterococci were detected in treated rainwater in the sample taken in August. Similarly to coliform bacteria, *P. aeruginosa* bacteria were recorded in a tank water sample in September 2023 but were not found in treated water samples.

As regards the overall performance of the rainwater treatment system, the median efficiency over the entire measurement period was 99.3% for psychrophilic bacteria and 98.6% for mesophilic bacteria. The installation used eliminated 100% of *E. coli*, faecal enterococci, and *P. aeruginosa* (Figure 12). To sum up, the application of a rainwater treatment system using filtration processes and a UV lamp has shown that this technology is quite effective and provides an effluent suitable for use in technical and agricultural applications and animal breeding. Additionally, the system can be regulated by changing the flow rate and thus the energy dose. It is known from the literature that the effectiveness of disinfection expressed in logarithmic form is a linear function of the radiation dose [71] and depends on the UV lamp used, or more precisely on its wavelength [72].
