Article

Multi-Technique Approach for the Sustainable Characterisation and the Digital Documentation of Painted Surfaces in the Hypogeum Environment of the Priscilla Catacombs in Rome

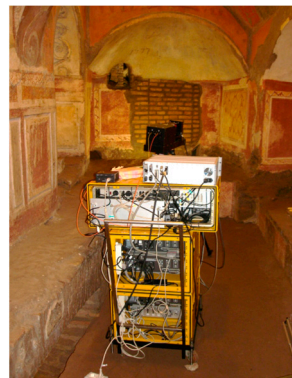
Figure 2. RGB-ITR scanner at work inside the Greek chapel.

The RGB-ITR system is an active method of 3D acquisition based on laser sources for the target digitalisation. This apparatus was developed by ENEA (the Italian National Agency for New Technologies, Energy and Sustainable Economic Development) for inspections and digitisation of long-range targets, also in critical and not easily reachable environments, such as nuclear reactors [17]. Over the last twenty years, the instrument was also used in the CH field for the study and documentation of decorated surfaces, such as paintings, frescoes, and coffins [18–20]. In particular, the RGB-ITR scanner allows to obtain 3D colour models of the scanned surfaces, also of large dimensions and/or at great distance. The technology of the system is based on the amplitude modulation (AM) technique of the laser sources [21,22], combined with the Lock-In detection [23], which can acquire signals also in noisy environments, estimating at the same time the amplitude and the phase shift of the signals coming from the target. The system is composed of two units: an optical head, consisting of a system of lenses and mirrors for focusing, steering, and acquiring both the incident laser beam and the back-reflected light; the electronic unit includes the elements for the optoelectronic signal conversion, data acquisition, and storage. The two modules are physically separated but connected by fibres for the emission of the launching beam and the collection of the back-reflected signals from the target. The laser spot is swept onto the target through a motorised mirror with a TV raster-like movement of the beam. The great advantages of using such a system are mainly the capability of remotely analysing either small or large objects, also at great distances, without scaffolding and without any influences of surrounding illumination, allowing to perform the scans also during the night. Indeed, with the use of the active approach provided by the use of laser sources instead of passive ones that use CCD sensors, the RGB-ITR 3D models are not affected by the ambient light, avoiding the most common camera issues such as glare and/or shadow effects [24]. The acquisition and the post-processing procedures are controlled by custom tools developed in the MATLAB 2024 environment, namely ScanSystem and itrAnalyzer, respectively. The first software allows the configuration of the scanning parameters (area, resolutions, timing, and more) and runs the acquisition; the second one consists of image processing algorithms for the elaborations of the images from the reflectance data, improving the mapping quality and post-processing images, which can be exported in the most common file formats. Since the complexity of the Greek Chapel architecture consisted of several niches, the complete colour digitalisation was obtained in eight working days, moving the instrument to four stations within the room. The instrumentation was installed in the tower configuration with the optical head mounted on a tripod (Figure 2). The acquisition resolution was differentiated on the basis of the importance of the scanned element, as indicated by the conservators: higher scanning speed and lower resolution (0.004°) for the low and sparsely decorated parts of the chapel; lower speed and higher resolution (0.002°) for the most important decorations with greater iconographic relevance. Furthermore, the system worked also during the night hours in order to reduce the scans in the visiting time.

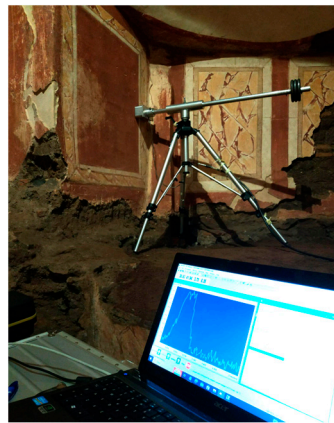
Figure 3. NMR system during the acquisition process.

In the study of masonry structure, the NMR technique is mainly adopted for water content evaluations. Indeed, in the NMR methodology, the intensity of the signal is directly proportional to the percentage of H atoms inside the masonry, making it easily linked to the presence of water [25]. In portable NMR sensors, the geometry of the magnet is defined as open geometry. In these sensors, the magnetic field is generated using two anti-parallel permanent magnets mounted on an iron yoke with the radio frequency (RF) coil positioned in the gap. By tuning the RF, the depth or the distance to the sensor surface where the sensitive volume is generated can be shifted. By optimising the magnet and the RF coil geometries, a flat, sensitive volume can be generated at a variable distance from the sensor surface. In this configuration, the magnetic field is external to the device and allows us to non-invasively study large objects by placing the sensor on one side of the object. In the Greek Chapel, NMR measurements were performed with a portable NMR instrument from Bruker Biospin (Figure 3), operating at 16 MHz and at a depth of 0.5 cm from the surface, fully disregarding the signal from the surface. The maximum echo signal corresponding to a $\pi/2$ pulse was obtained with a pulse width of 10.4 μs and a deadtime of 15 μs .

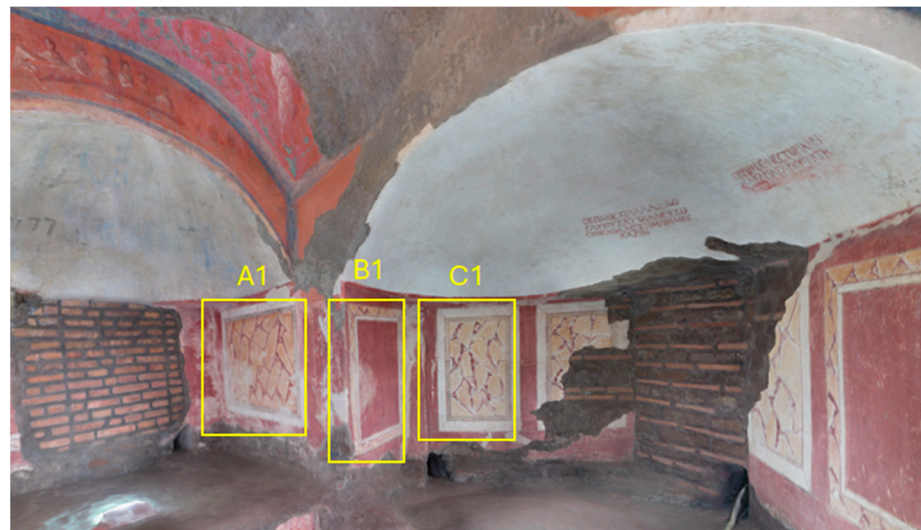
Figure 8. Investigated areas with diagnostic techniques indicated on the 3D RGB-ITR model with yellow rectangles (A1, B1, C1).

The 3D model was also used for better contextualising within the room structure the focused NMR, AF–AI, LIF, and IRT measurements. The areas investigated with the different techniques are reported in Figure 8: such areas were chosen following the suggestion of the restorers and curators of the catacombs, who indicated the areas as particularly delicate and frequently restored, evidently corresponding to a critical zone of the catacombs (A1, B1, C1).

The thermographic survey carried out on the C1 area (Figure 8) had the aim of confirming and/or identifying the areas or elements where the degradation phenomena are already in progress. The investigations were carried out in active mode by Lock-In Thermography (LIT) based on the application of periodic thermal waves. In particular, the experimental data were acquired using a square wave with a fundamental frequency of 0.005 Hz, using three repetitions in order to get closer to the steady state. Each thermogram was recorded at a frame rate of 5 Hz. The C1 area was analysed by acquiring data in several framings, then stitched in the final images shown in Figure 17. The C1 area shows different situations at different heights: in the upper part of both amplitude and phase images, the different bluish colour suggests a possible presence of moisture. In the centre of the area, phase and amplitude images confirm the presence of an inhomogeneity, probably structural defects. Indeed, the variations in the signal's amplitude or phase relative to

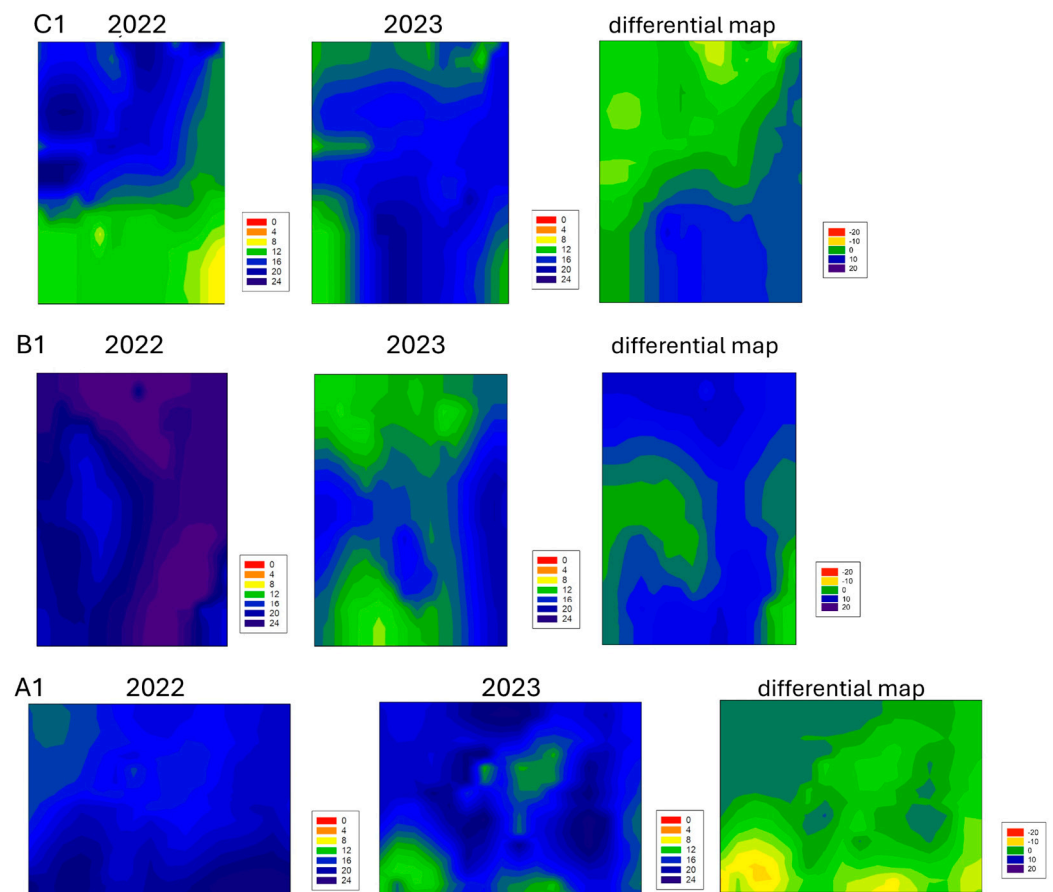
seasons, such as autumn and spring. In Figure 9, the moisture distribution maps obtained on the three areas by unilateral NMR at a depth of 5 mm from the surface are shown. As explained in Par. 3.2, collected data on the three areas are processed to obtain contour plots. A contour plot is a 2D representation of a 3D surface, and it allows an easy visualisation of the distribution of the moisture in masonries. In these maps, the difference in the moisture level is shown as a gradient colour: red indicates the lowest water content, while dark blue indicates the highest water content. In Figure 9 (C1), the moisture distribution maps obtained on area C1 in July 2022 and in March 2023 are shown. In July 2022, moisture content is confined in the upper part of the wall painting with a percentage of about 20–22%, while the lower part of the map shows lower humidity levels, about 8–10%. In March 2023, the highest levels of humidity, about 20–23%, were localised in a wide central area of the wall painting. Figure 9 (B1) presents the moisture distribution maps obtained on area B1 in July 2022 and in March 2023. In this area the levels of humidity in 2022 are quite high (16–24%), while in March 2023 a decrease in the water content is observed in some areas, in particular at the top and bottom of the area, with levels of humidity between 10–12%.

Figure 9. Humidity maps recorded by NMR sensors at a depth of 5 mm from the surface in July 2022 and in March 2023, respectively, in area C1, in area B1, and in area A1. The legend provides the humidity content range (%) obtained by calibrating the NMR signal. For each area, a differential map is also reported.

These differential maps are the documentation of different situations in two months with slight changes of water content in the masonry. For example, in the differential map obtained for area C1, two areas can be identified, one yellow-green and one blue, evidencing two areas where evaporation or wetting processes can take place.

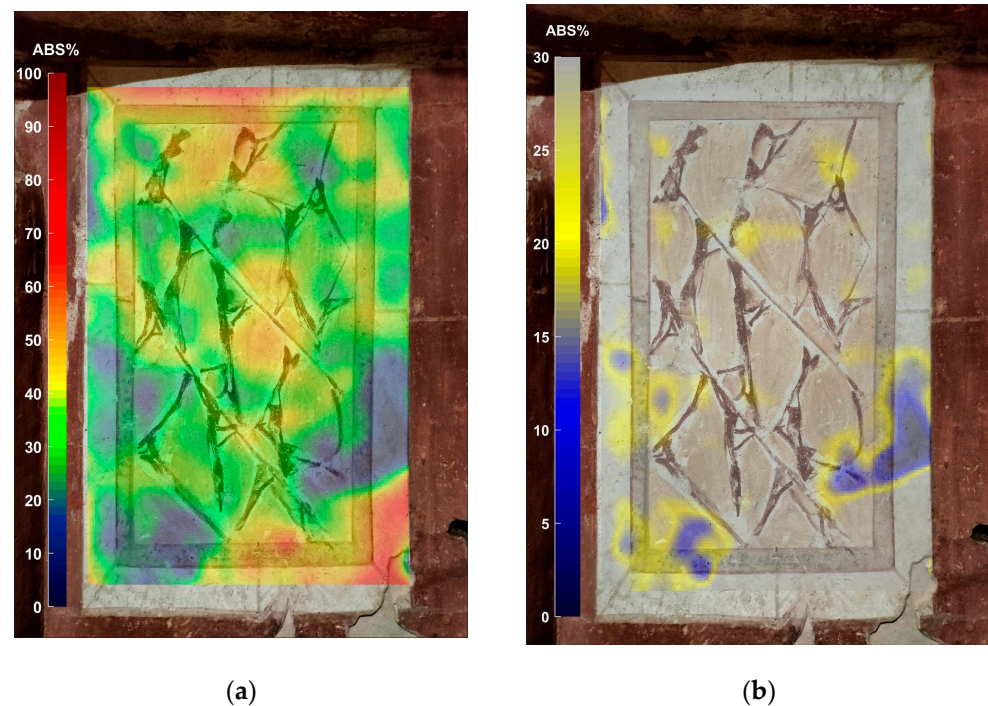
Figure 11. The resulting acoustic image of the C1 area (a) and the high reflecting points evidenced in the low ABS% region (b).

deduced by qualitatively comparing the two images on the C1 panel, in Figure 10, and the detailed one in Figure 11, acquired almost one year apart. Comparing the results with information related to the last restoration in this area dated back to more than 25 years, it can be inferred that the unusually isolated and highly reflective blue spots are parts that underwent restoration interventions, realistically using materials with different elastic properties with respect to the ancient plaster, such as acrylic resins. Figure 11b evidences the most reflecting areas, also encompassing these isolated spots, by applying an upper threshold to the ABS% map at 30%.
