# Manor and Park Estates—Resilience to Transformation and the New Management of Space Due to Political Changes: The Case of Western Pomerania (Poland)

Magdalena Rzeszotarska-Pałka

**Abstract:** The historical landscape reveals diverse social, economic, political transformations that create an identity of place, one which should be protected for future generations. Manor and park estates have been and continue to be valuable parts of cultural heritage and a distinguishing feature of the rural landscape in Europe. Since 1945, however, they have often failed to resist negative changes, especially in Eastern Europe where, after the Second World War, countries adopted the socialist system, which abolished private property and placed many historical buildings under the management of state institutions for several decades. In this context, it is important to study their current state of preservation. This study analyzes the condition of manor and park estates in Western Pomerania, Poland, that became the property of State Agricultural Farms (PGRs) after the Second World War. For this purpose, it was necessary to determine the extent of their transformation brought about by the State Agr

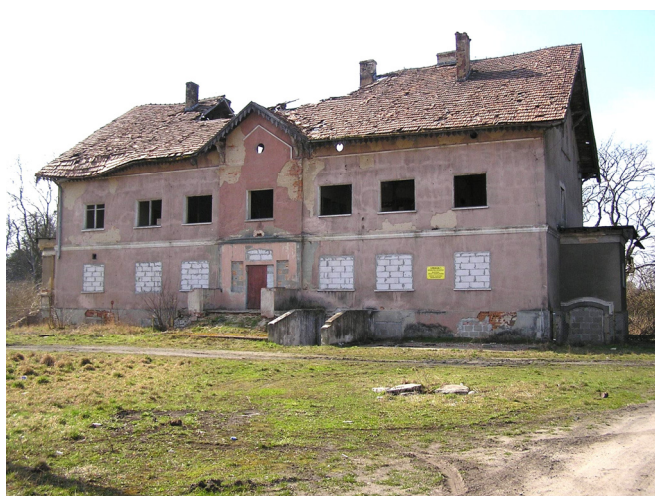
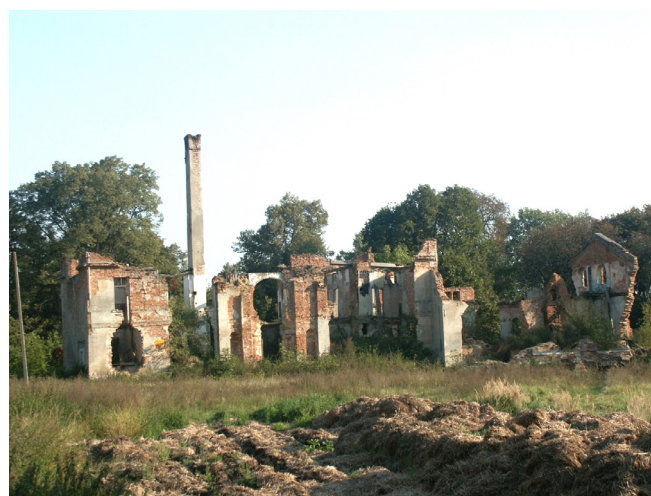
The adaptation to new functions often required major intervention in both the interior and exterior of the building. The development of several independent units within a single house brought irreversible changes to the interior. Large rooms were divided into smaller ones which destroyed the original interior design, including stuccowork, wall paintings, and paneling, as well as furnishings such as fireplaces and tiled cookers (Dębogóra, Dreżewo, Karnice, Kładno, Krasne, Mosty, Skarbimierzyce, Trzyglów, Unimie, Unin, Wirówek). When adapting premises for new functions, window openings were often changed and architectural details in window frames removed (Dębogóra, Karnice, Krasne, Lekowo, Wirówek). This completely changed the layout of the facades. Moreover, the process also involved sometimes partial or complete demolition of buildings (Dreżewo, Kraśnik Koszal., Modlimowo, Samlino) (Figure 2a,b).

**Figure 2.** (a) Manor house in Dębogóra, 2016. (b) Ruin of manor house in Kąkolewice, 2016 (source author).

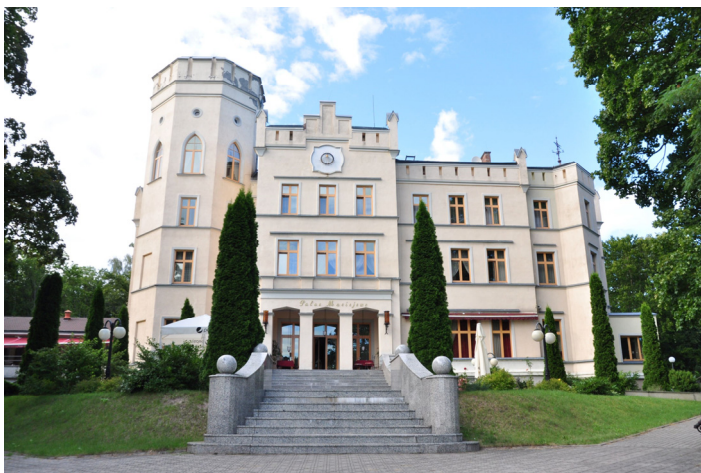
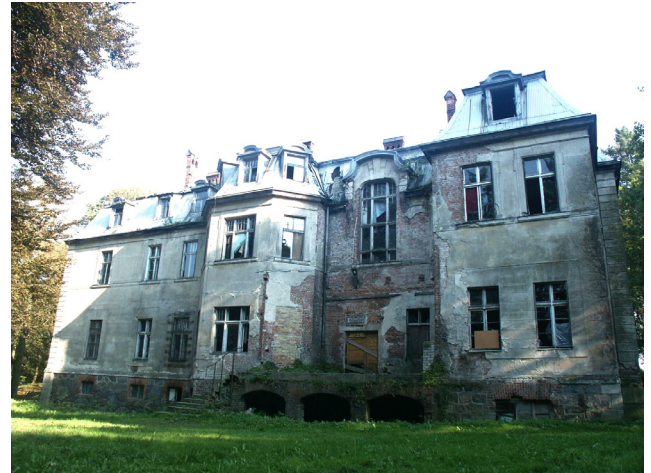
Inadequate building repairs brought further unfavorable changes, such as the replacement of ceramic roof tiles with fiber cement (Eternit) or tar paper (Bolkowice, Budzistowo, Karnice, Krasne, Laski Koszal., Lekowo, Mosty, Przelewice, Skarbimierzyce, Unimie, Wiesiółka), plastering over half-timbered facades (Dobropole, Sienno Dolne), and removing gutters and downpipes, leading to the destruction of external and internal plaster and sometimes the deterioration of foundations. As the research has shown, from 1949 to 1989, many of the buildings went unmaintained, resulting in their technical status becoming disastrous. Only a few houses underwent proper comprehensive renovation (Bielin, Darskowo, Krzymów, Maciejewo, Mechowo) (Figure 3a,b).

**Figure 3.** (a) Manor house in Maciejewo, 2016. (b) Manor house in Lesiecin, 2004 (source: author).

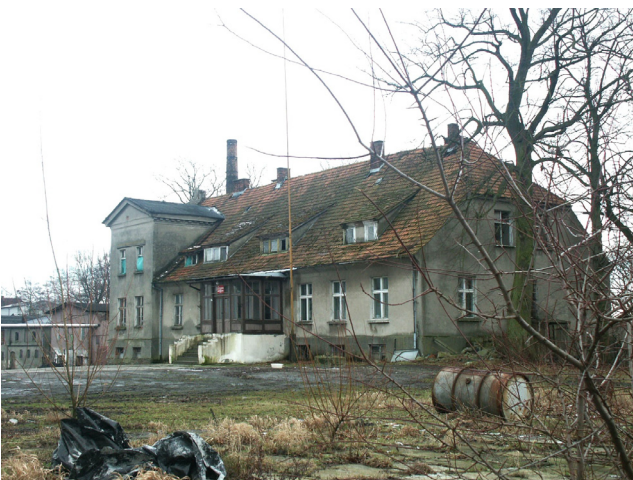
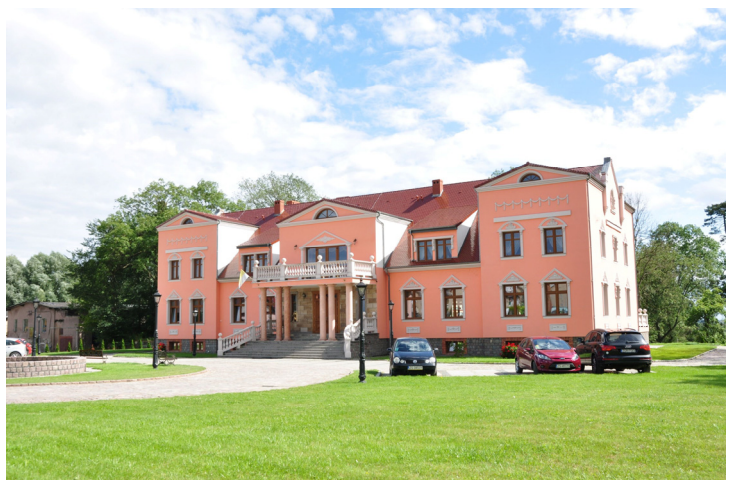
In the aftermath of the collapse of the state agricultural sector, some manors and stately homes lost their users in the early 1990s. Twelve buildings (Bolkowice, Czerników, Dobropole, Dreżewo, Glinna, Kładno, Krzymów, Laski Koszal., Samlino, Sienno Dolne, Unin, Wiesiółka) were abandoned and gradually fell into disrepair. The stately home located in Samlino was demolished in 1999, and its bricks were used to build a church in the village. Fortunately, the stately home in Glinna was acquired by an agricultural company and underwent extensive renovation after 2014 (Figure 4a,b).

**Figure 4.** (a) Manor house in Glinna, 2004. (b) Manor house in Glinna, 2023 (source: author).

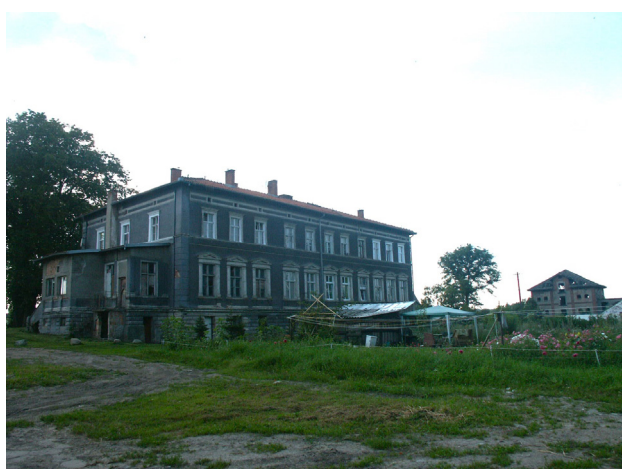
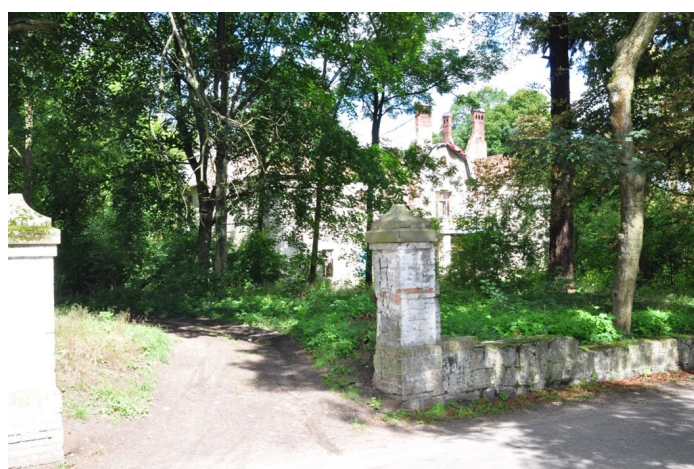
However, the most significant changes to the composition of the entire historical park were caused by the addition of new buildings such as garages, workshops, warehouses (Krasne, Lubogoszcz, Siemczyno, Margowo, Modlimowo, Unimie, Wierzbiczin, Wiesiołka, Wirówek), fire stations, and complexes of residential buildings (Lubogoszcz, Mechowo). The inclusion of sub-standard buildings, such as wooden sheds and pigsties, further contributed to the park's decline (Figure 5a,b).

**Figure 5.** (a) Park in Kraśnik Koszaliński, 2004. (b) Park in Lesięcin, 2016 (source: author).

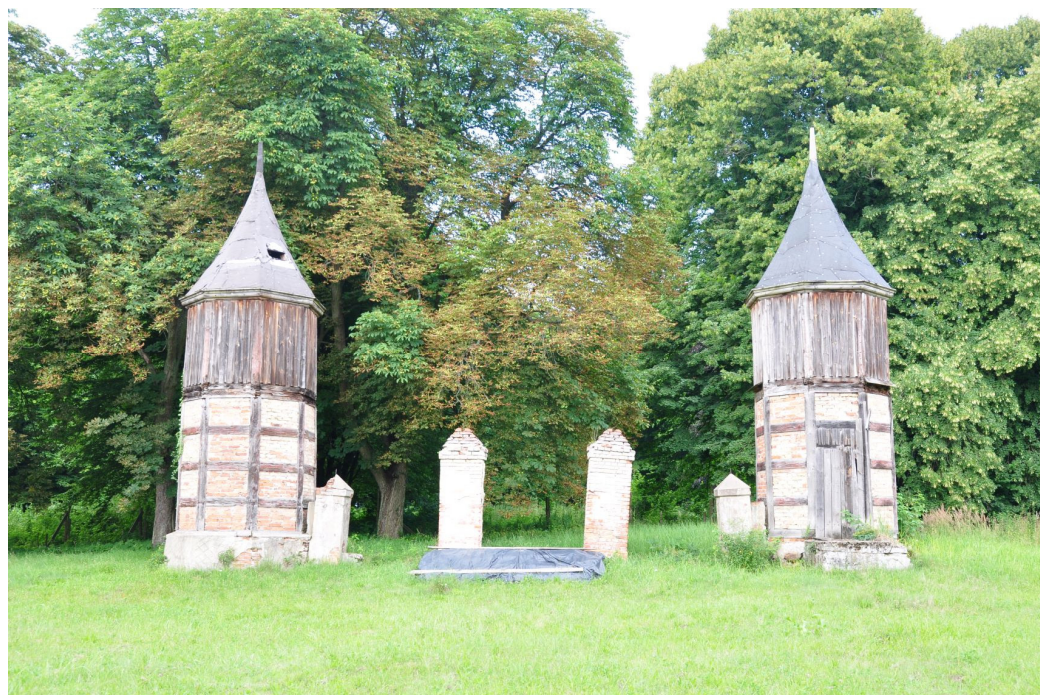
The condition of historical water systems is extremely poor. Ponds have silted up, become swampy, and their banks are overgrown (Dobropole, Mosty, Skarbimierzyce, Sokoliniec, Unimie, Kozia Góra). In fact, the parks analyzed do not contain any surviving historical garden buildings or small architectural features. Some of the remaining gardens have only ice houses, mostly hidden under dense vegetation. Many parks were used as cemeteries by the estate owners. Unfortunately, after the Second World War, ornamental gravestones became easy targets for thieves. Surviving gravestones were deliberately destroyed by new settlers (Stuchowo). The only cemeteries to survive were those located near a church or a chapel (Parsowo, Krzymów). In many instances, the original stone or brick fences surrounding the parks have been demolished, with only a few surviving in fragments that continue to be vandalized (Figure 6).

**Figure 6.** Park in Świerzno, 2016 (source: author).
