Article

# Impact of Volcanic Ash on Road and Airfield Surface Skid Resistance

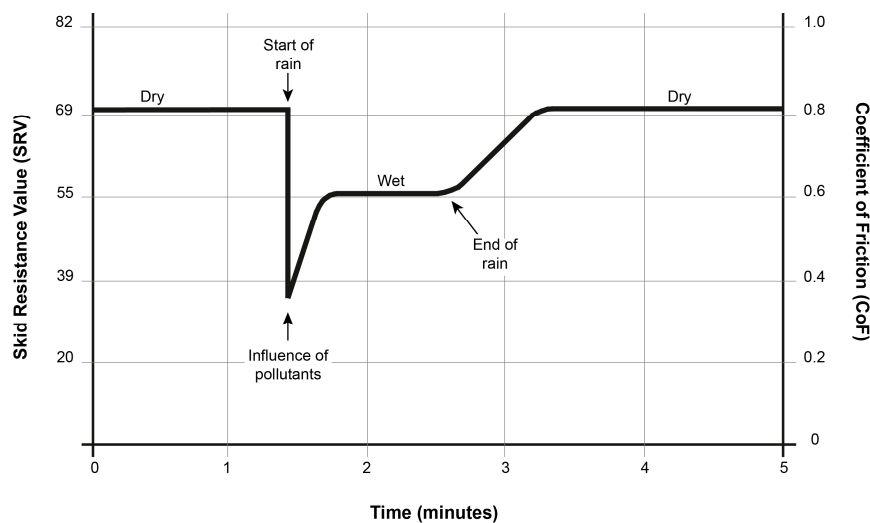
**Figure 1.** Variation in Coefficient of Friction (CoF) during a rain event [16,49–51].

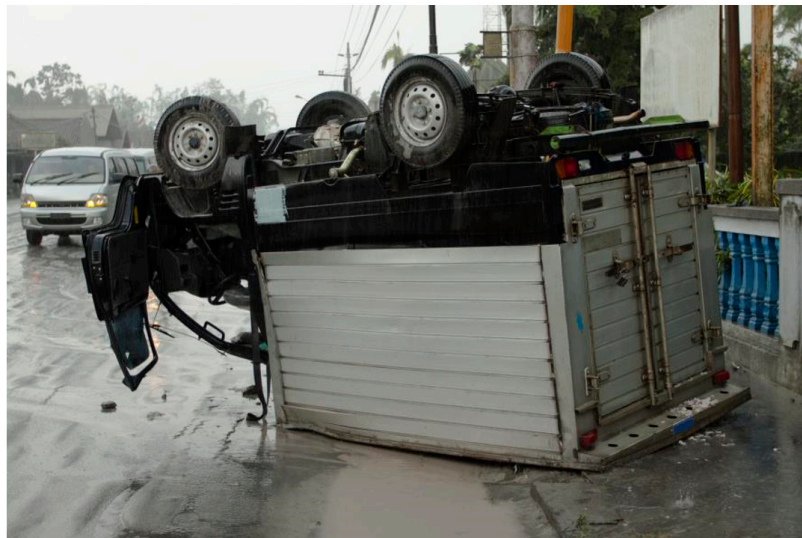
**Figure 2.** Vehicle accident attributed to reduced skid resistance after ashfall from Merapi volcano, Indonesia, 2010 [68].

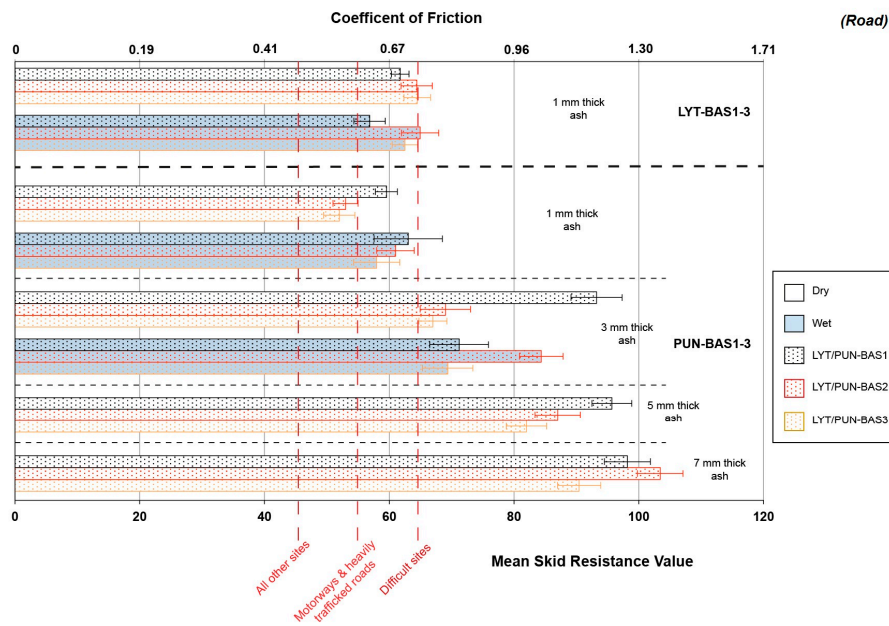
**Figure 7.** Mean SRVs and CoFs for the road asphalt covered in non-dosed and dosed LYT-BAS and PUN-BAS ash sieved to 1000  $\mu\text{m}$ . Both samples dosed in RCL and WICL fluid under dry and wet conditions are displayed. Red dashed lines indicate the minimum recommended SRVs for different road network sites (Table 2).

There are no clear differences in SRVs observed between non-dosed and dosed LYT-BAS ash at 1 mm thick (Figure 7). However, the highly crystalline properties of this ash type may reduce the impact that dosing has on SRVs. SRVs for the dosed scoriaceous PUN-BAS ash used on road asphalt (Figure 7) and dosed scoriaceous PUP-BAS ash used on airfield concrete (Figure 8) are generally less than those which are not dosed. For all ash thicknesses, the PUN-BAS3 sample (i.e., that dosed in WICL fluid) produce mean SRVs 2-20 lower than the PUN-BAS2 sample (i.e., that dosed in RCL fluid), suggesting that the skid resistance of non-crystalline ash-covered road surfaces decreases if the soluble component of the ash increases. This corresponds with findings for other road contaminants [50], demonstrating a friction drop at the transition between no rain and rain due to the high-viscosity mix of rainwater and road debris. As such, only WICL fluid was used to dose the PUP-BAS sample (used for airfield concrete) to assess results representative of a 'likely worse-case' SRV scenario.

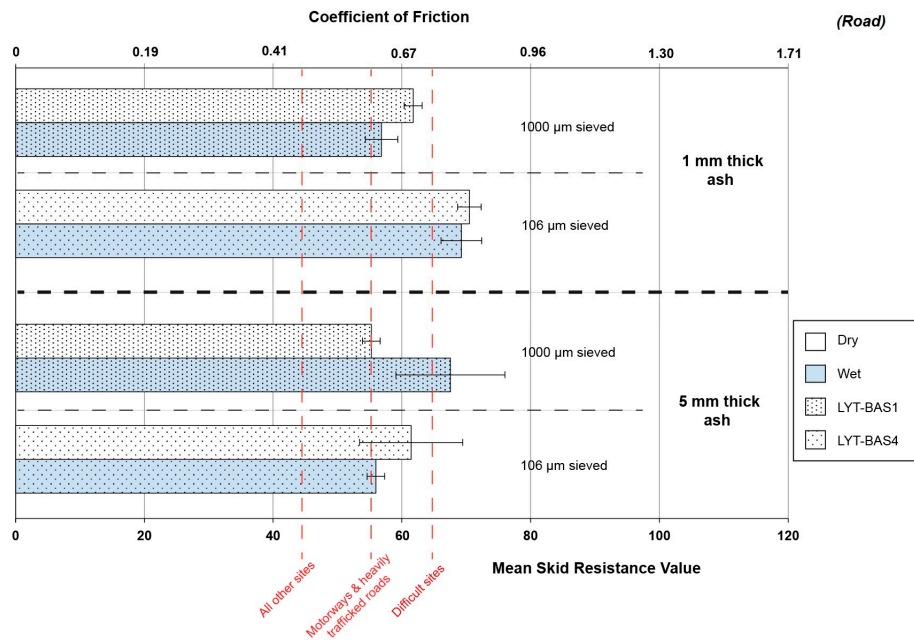
**Figure 9.** Mean SRVs and CoFs for the asphalt covered in coarse-grained (i.e., LYT-BAS1, 1000 µm sieved) and fine-grained (i.e., LYT-BAS4, 106 µm sieved) samples at 1 mm and 5 mm ash thickness under both dry and wet conditions. Also displayed (as red dashed lines) are the minimum recommended SRVs for different road network sites (Table 2).

The mean SRVs for fine-grained basaltic ash (LYT-BAS4) are slightly higher than those for the coarse-grained ash of the same type (LYT-BAS1) when at 1 mm thickness on roads, with mean values for both wet and dry samples above the minimum recommended SRVs for difficult sites (Figure 9). This concurs with field observations made by the Kagoshima City Office staff following frequent volcanic ash deposition on roads from the multiple eruptions of Sakurajima volcano, Japan (since 1955). These observations suggest that the finer ash from the recent eruptions at the Showa crater resulted in less slippery roads than the generally coarser-grained ash produced during past eruptions from the

Minami-daki summit area [83]. We hypothesise that this difference between fine- and coarse-grained ash is due to the finer particles being more easily mobilised and displaced at the tyre-asphalt interface, allowing improved contact between the tyre and asphalt. However, no clear correlations exist between the fine- and coarse-grained ash when at 5 mm thick, perhaps due to both types covering the asphalt surface when the tyre makes contact.

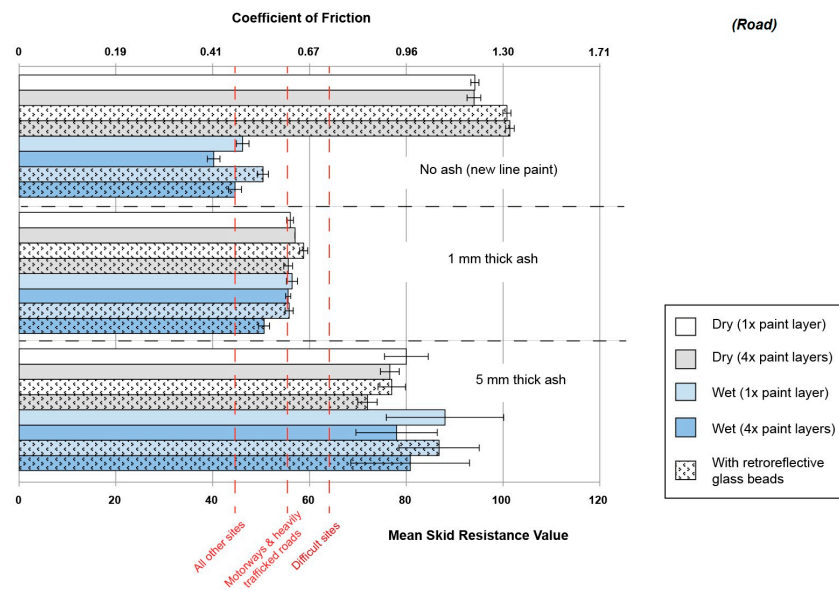
**Figure 10.** Mean SRVs and CoFs for the road asphalt with line-painted surfaces. Conditions of no ash, 1 mm thick ash, and 5 mm thick ash (using the LYT-BAS1 ash type) were analysed under both wet and dry conditions. Also displayed (as red dashed lines) are the minimum recommended SRVs for different road network sites (Table 2).

SRVs can be reduced substantially as a result of road markings, although the addition of retroreflective glass beads can increase values to more acceptable levels [76]. This is demonstrated in our findings for wet conditions, in which BPT analysis is typically conducted, with mean SRVs on line-painted asphalt surfaces with no beads and no ash the lowest of all our results. SRVs for these wet surfaces range from 40 to 46, and lie below the minimum recommended skid resistance for ‘all other sites’ when 4× coats of line paint have been applied (Figure 10). The addition of glass beads does increase SRVs (by around 5), although values are still relatively low. SRVs for ‘clean’ and dry line-painted asphalt surfaces are very high, but as with non-painted surfaces, the addition of a 1 mm ash layer decreases SRVs substantially. Conversely, the SRVs for wet asphalt concrete increase with a 1 mm ash layer to similar levels as for dry conditions. With the thicker (5 mm) ash layer on top of line-painted surfaces, SRVs increase further by around 20 (Figure 10).

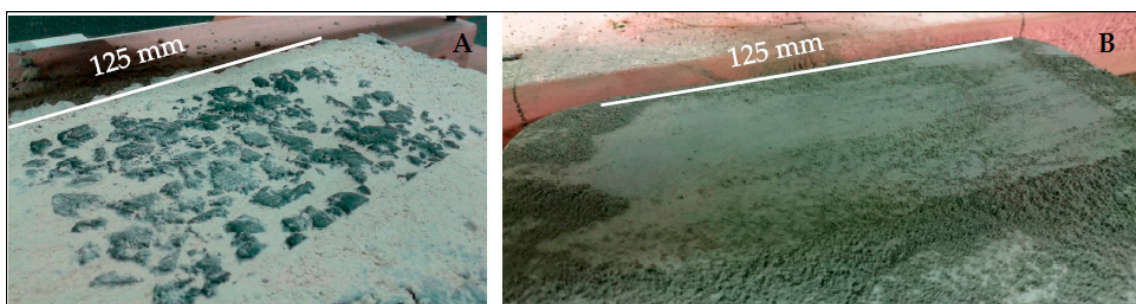
**Figure 12.** Dry ash displacement from the BPT slider-surface interface after  $8 \times$  swings of the pendulum arm for (A) SMA and (B) airfield concrete. Dry ash was displaced from the surface more readily than wet ash. Note that white lines indicate length of slider contact path (i.e., 125 mm).
