# Terraced Landscapes as NBSs for Geo-Hydrological Hazard Mitigation: Towards a Methodology for Debris and Soil Volume Estimations through a LiDAR Survey

**Abstract:** Terraced landscapes are widely applied in many mountainous regions around the world as a result of the necessity to practice subsistence agriculture. Hence, they can be regarded as one of the most diffused anthropogenic modifications of the Earth's surface. Different techniques have been used for their implementation leading to the artificial immobilization of debris and soil along the slopes whose surface is interrupted by a sequence of sub-horizontal and sub-vertical areas often using stone walls. In some areas of the world, such interventions are thousands of years old and their resistance to the degradation caused by the morphogenetic system can be attributed to the permeability of the stone walls as well as to their regular maintenance. In some other areas, the lack of maintenance has been the main cause for degradation processes ending with their collapse. The effects of climate change manifested through higher intensities and higher frequencies of rainfall are likely to accelerate the degradation process furt

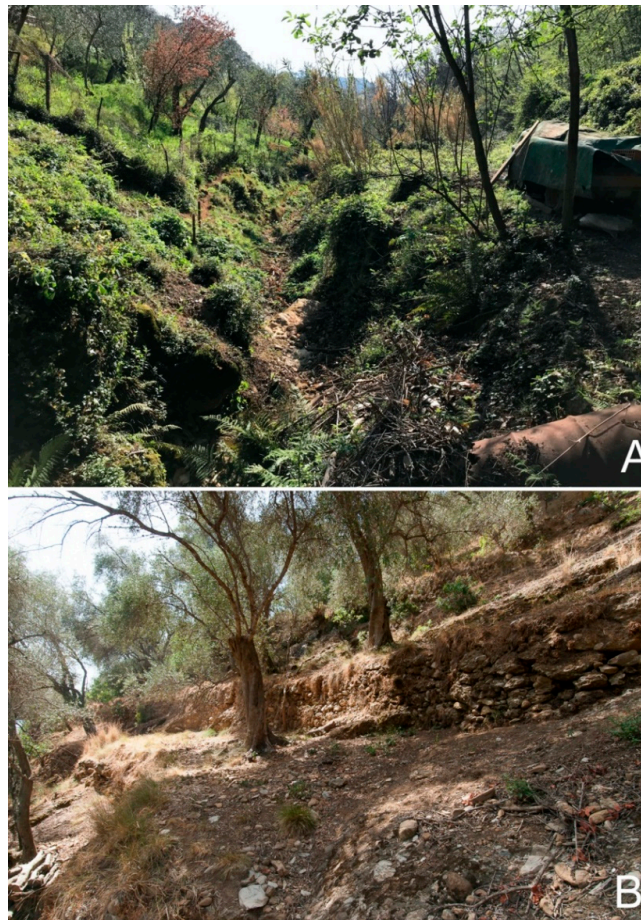
**Figure 4.** Terraces in the case study area: (A) not maintained in Paraggi catchment (n. 8 in Figure 1) close to the stream, and (B) partially maintained in San Fruttuoso (Figure 1, catchment n. 3).

The identification of terraces and relative dry-stone walls was obtained using the three methods that have been controlled on the ground in areas across the study area catchments (Figure 4). These were selected in accordance to the more critical ones in terms of: (i) difficulties in identifying terraces with semi-automatic methods due to the presence of high vegetation quantities, and (ii) abandonment and discontinuous structures caused by partial collapse or by the presence of outcrop morphological features, such as sedimentary rock masses or tectonic structures.

Finally, the condition and maintenance of terraces are important factors for evaluating their possible collapse [13,53]. Figure 4A shows abandoned and partially collapsed terraces near the stream. These debris volumes close to the stream are prone to erosion as they are directly connected to the flow path. Hence, their condition is highly critical. Similarly, Figure 4B shows abandoned terraces in San Fruttuoso that have been deeply incised by erosion, and therefore a partial collapse is possible. These terraces belong to the historical olive orchard and their presence is protected by the Landscape Superintendence control. Moreover, their eventual collapse would affect both one of the most beautiful and populated trails in the Portofino Park and the newly realized wastewater treatment plant that resides below.

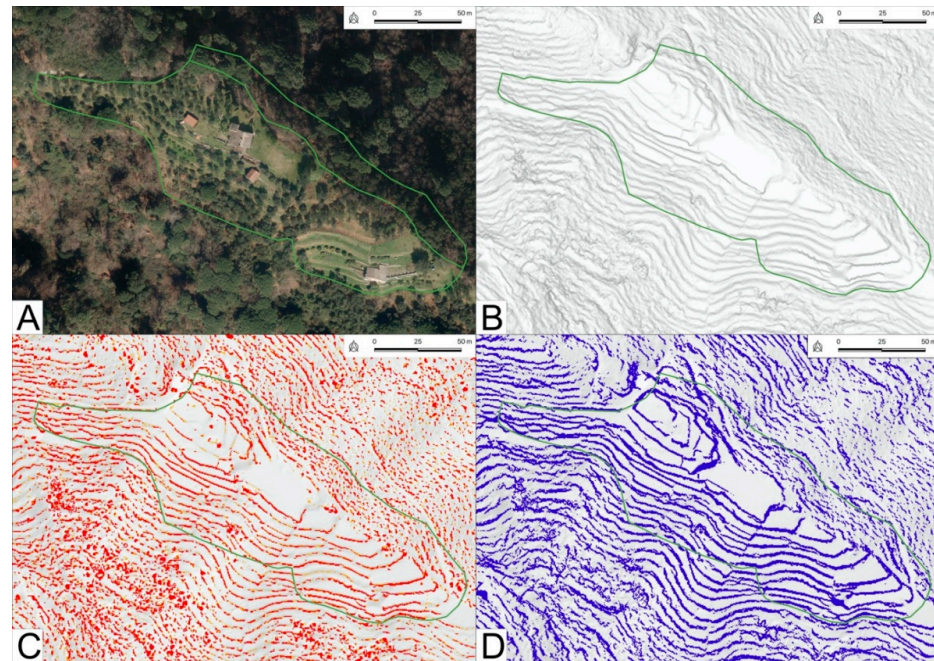
**Figure 6.** Terrace identification error assessment (refer to Figure 1). (A) The green-bordered polygons show the test areas: in the southern one, terraces are present, while in the northern one, terraces are absent. The other figure parts show terrace features obtained through the three methodologies: in (B) SKF, in (C) LUC and in (D) LIHA.

The high-resolution ALS data and methods used to assess the presence of terraces enabled us to update the results obtained in a preliminary state of the research when more rough and older data were used [24]. To assess the accuracy of identification with SKF, LUC and LIHA methods, the test area in Figure 6 was identified.

Following the previously described approach, both quality index and Cohn's kappa were computed (please refer Table 2). The application of LIHA presents more reliable results: both the quality index and Kappa reached the highest values, whereas the SKF method shows a lower degree of accuracy.

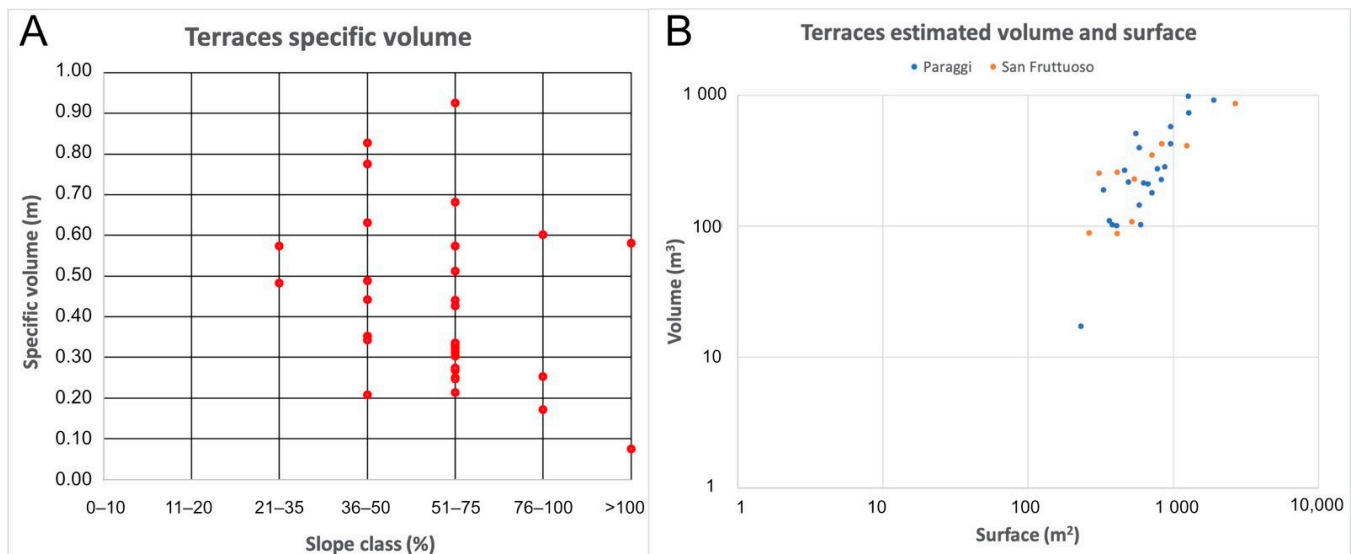
**Figure 11.** (A): Terraces' specific volume and slope class (for slope classes, refer to Figure 1) for the 32 sample areas. (B): The relationship between total volume and surface of the sample areas.

With relation to the specific volume data to the slope steepness and according to the classes defined in Figure 1B, evidence of eventual relationships between specific volume and the slope gradient can be observed. A steeper slope allows us to accommodate only small surface terraces with high walls, while a milder slope accepts larger terraces with shorter dry-stone walls containing them. In Figure 11A, the specific volumes are shown with respect to the slope classes. No evidence of a relationship between specific volume and slope gradient can be observed. In fact, specific volumes were accommodated in quite a wide range of values independently from the slope gradient, but this amplitude tended to reduce the higher slope gradient classes. Additionally, specific volumes were related to the terraced slope areas (Figure 11B) considered as distinct data obtained from the San Fruttuoso and Paraggi areas. The bi-logarithm diagram shows that figures that tend to be aligned suggest a possible scale invariance behavior between the specific volume and relative surface area. No differences can be observed between values belonging to the San Fruttuoso or Paraggi areas.
