Article

Experimental Analysis of Changes in Cement Mortar Containing Oil Palm Boiler Clinker Waste at Elevated Temperatures in Different Cooling Conditions

Keywords: elevated temperature; oil palm boiler clinker; curing condition; cement mortar; mechanical properties; microstructure; thermal conductivity

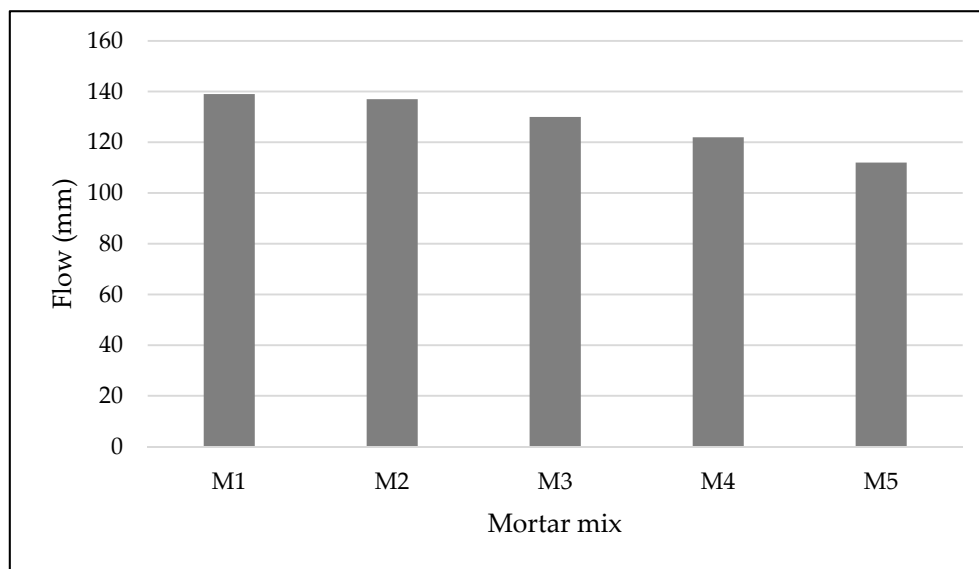
Figure 2 shows the flow test results of all of the mortar mixes. Although the SP dosage was higher in the mortar mixes with the OPBC aggregates, their flow value was less than that of the control mix (M1). Substantial SP was used in the OPBC mortar mixes because the OPBC aggregates were lightweight (the specific gravity of the OPBC aggregates was 1.96 and 1.89 kg/m³ in apparent and saturated surface dry conditions, respectively) with higher water absorption capacity than natural sand and porosities on the surface texture. Therefore, when the replacement level was increased, the flowability was decreased. To maintain mortar mixtures with good workability for all mixtures (a

workability of approximately 125 ± 15 mm), more SP was used when the replacement level was increased. In the OPBC replacement levels of 25%, 50%, 75% and 100%, the flow values decreased by approximately 1.4%, 2.2%, 12.2%, and 19.4%, respectively, compared to those of the control mix. On the basis of the results, similar findings to those of prior studies conducted by other researchers were reached, i.e., the water absorption increased, and the workability of the OPBC mortar decreased compared to normal cement mortar [42,43].

Figure 2. Flow table test results of mortar mixes.

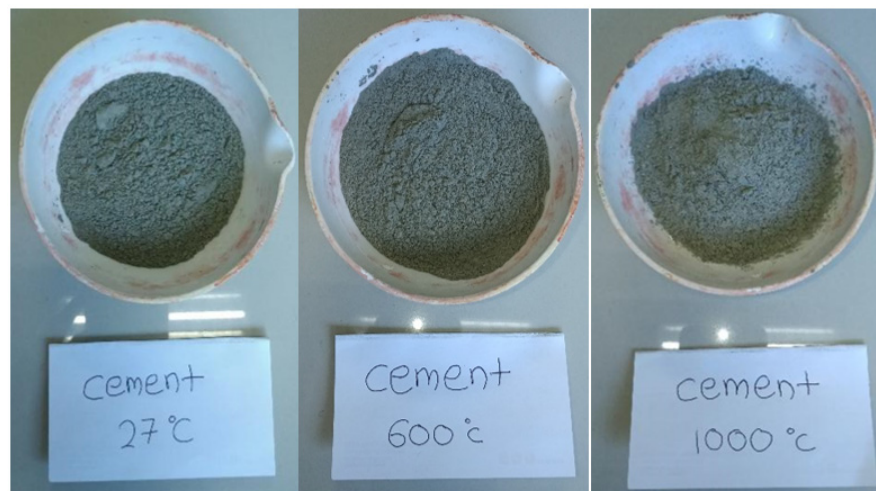
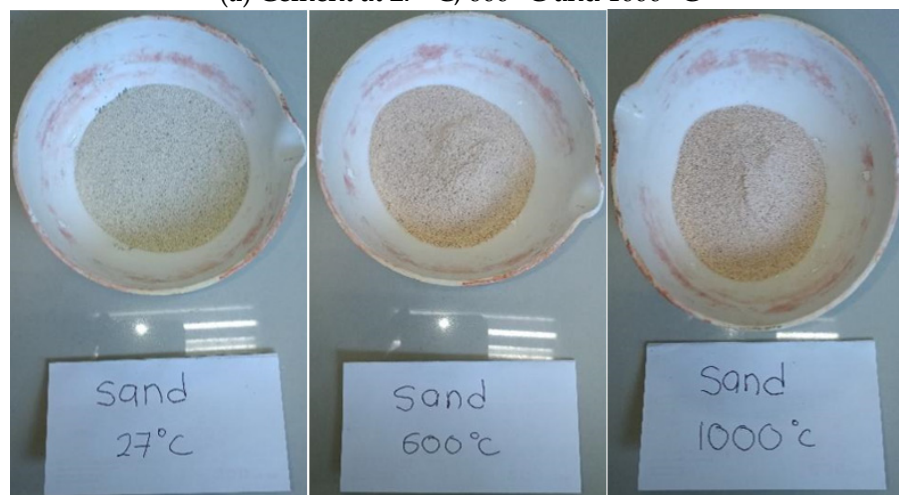
Moreover, the colour changes of constituent materials inside the mortar samples were studied. Figure 4 illustrates the colour changes of the OPC materials, natural sand, and OPBC aggregates at ambient temperature, 600 °C, and 1000 °C. From the ambient temperature to 1000 °C, the OPC powder experienced colour changes from light grey to dark grey, as shown in Figure 4a. Owing to the high temperature, the mineral compound inside OPC oxidised during heat reactions [48,49]. Figure 4b depicts the colour changes of sand aggregates from pale orange to pink. The possible reason behind the colour changes of sand aggregates at the temperatures of 600 °C and 1000 °C was the loss of moisture content within the pore space, leading to the dehydration of iron deposits from goethite to hematite [50]. As observed in Figure 4c, the OPBC aggregate changed from blackish to pale grey at 600 °C. Later, as the temperature increased to 1000 °C, the OPBC aggregate changed its colour from pale grey to light grey. This reaction occurred due to the iron ion that was activated whilst reducing the carbon ion content. Iron is usually perceived as dull and grey.

(a) Cement at 27 °C, 600 °C and 1000 °C

(b) Sand aggregate at 27 °C, 600 °C and 1000 °C

(c) OPBC aggregate at 27 °C, 600 °C and 1000 °C

Figure 4. Colour changes at different temperatures: (a) cement; (b) sand aggregate; (c) OPBC aggregate.

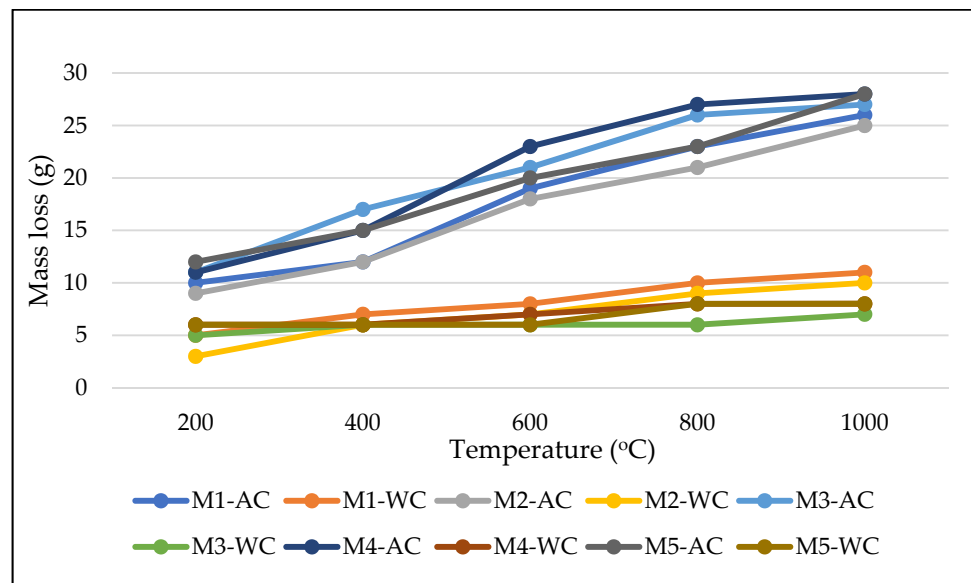
When heated at elevated temperatures, all of the mortar samples experienced mass loss. Figures 5–7 show the relative mass loss of the samples under different curing conditions when exposed to various elevated temperatures. This loss was associated with the cracking formation in the samples caused by the expulsion of water at elevated temperatures. The water disturbances inside the samples degraded the strength, and further discussions on this mechanism will be provided in the next section. From the ambient temperature to the temperature of up to 400 °C, a slight reduction in the mass of the samples was observed in all the curing conditions. When the temperature rose to 600 °C, the samples lost considerable moisture resulting from the evaporation of free and binding water and the subsequent decomposition of the C–S–H bond structure of the samples [34].

Figure 7. Mass loss of air-cured samples at elevated temperatures (where AC is air cooling, and WC is water cooling).

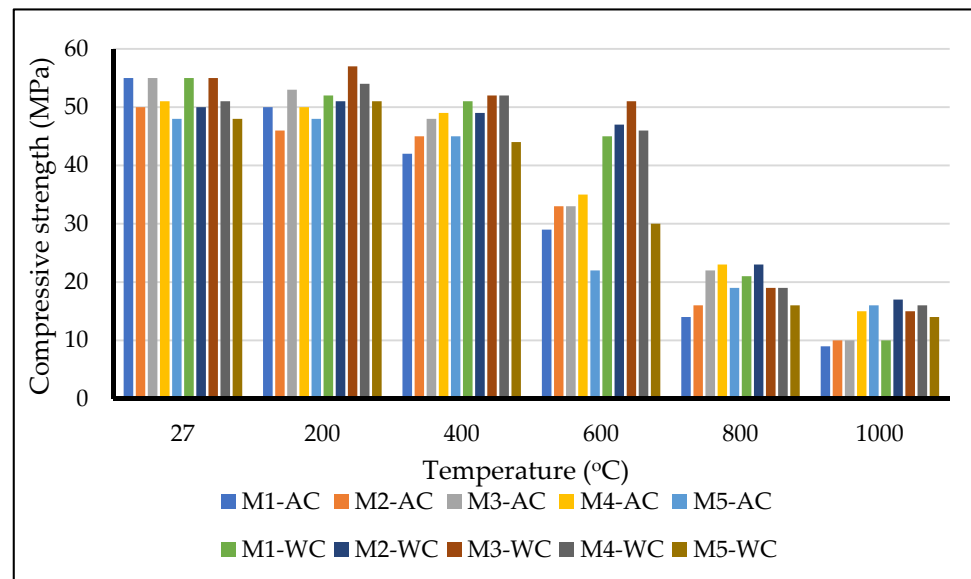
At ambient temperature, the compressive strength of the samples tested in all three curing conditions was measured. From Figure 8, the control and M3 samples in full water curing had the highest compressive strength. However, in partial water and air curing conditions, the M4 sample exhibited the highest compressive strength, as shown in Figures 9 and 10. By contrast, the control sample tested in air curing conditions exhibited the lowest compressive strength of 43 MPa.

Figure 8. Compressive strength of full-water-cured samples at elevated temperatures (where AC is air cooling, and WC is water cooling).

Figures 8–10 show the compressive strength variation of samples with different percentages of OPBC cured in three different curing conditions exposed to elevated temperatures followed by cooling under air and water. A significant increase in the compressive strength of the OPBC samples cured in full water and air was observed as the temperature increased to up to 200 °C. This increase indicated that the OPBC mortars could resist a temperature of up to 200 °C without any deterioration in strength. This statement is strongly supported by the findings of Karim et al. [37], who determined that the compressive strength of OPBC mortars increased with rising temperatures up to 300 °C. The small reduction in the compressive strength of the samples in all of the curing conditions could be attributed to the removal of free water during the heating process. As mentioned by other researchers, the thermal effect at this temperature causes water migration [37,51,52]. As observed in partial-water-cured samples, the percentage reductions in compressive

strength for the M1, M2, M3, M4, and M5 samples were approximately 18%, 26%, 18%, 21%, 19% and 18%, 18%, 13%, 16%, 12% for the AC and WC conditions, respectively.

As the temperature rose to 400 °C, a reduction in the compressive strength of the samples in all of the curing conditions was observed. The reduction in compressive strength at this temperature was probably due to the acceleration of the hydration reaction when the samples reached the temperature of 300 °C [37]. The OPBC samples under air and water cooling in all of the curing conditions showed no or the least reduction in compressive strength compared to the control sample. This phenomenon was probably an effect of internal autoclaving and a reaction of the OPBC aggregate inside of the mortar [14,37]. The physical properties and rough surfaces of the OPBC aggregate play significant roles in the

By contrast, all of the mortar samples lost significant compressive strength when the temperature of 600 °C was reached. Cracks were also observed in the samples at this temperature, which resulted in the weakening of cement matrix and aggregate adherence. The compressive strength reduction was attributed to the decomposition of C–S–H. The reduction in strength for samples cooled by air was greater than that for samples cooled by water. As observed, the M1 (control) and M5 samples in all of the curing conditions showed a high compressive strength reduction compared to the other OPBC samples. The highest reduction in compressive strength occurred in partial water curing, with more than a 50% reduction from the original strength. The results in the partial curing condition demonstrated that the high percentages of OPBC aggregate contributed to the high compressive strength reduction in air cooling conditions. On the contrary, the samples cooled by water showed a low reduction in compressive strength. The OPBC samples were found to have lesser compressive strength reduction compared to the control sample. The presence of water after high temperature exposure aids in stopping the heat and in rehydrating the calcium hydroxide found in cement [53]. These actions increased the strength compared to the AC samples.

Further compressive strength degradation in samples continued when the heat exposure reached the temperature of 800 °C. The formation of cracks in the samples increased at this temperature, due to the similar rapid expansion and shrinkage rates inside mortar mass. As discussed and pointed out by other researchers, the drastic compressive strength reduction of the samples at this temperature was due to the propagation of these cracks [52,54,55]. As observed, the control sample cooled by air showed the highest compressive strength reduction compared to the OPBC samples in all three curing conditions. The compressive strength reduction of the control sample was the highest with 75%, 73%, and 86% in full water, partial water, and air curing conditions, respectively, compared to the sample with 100% OPBC aggregate. However, for the WC samples, the M5 samples in all three curing conditions showed the highest compressive strength reduction compared to the control sample. The compressive strength reductions of the M5 samples were 67%, 73%, and 68% in full water, partial water, and air curing conditions, respectively.

From the figures, the control sample had the highest compressive strength reduction at 1000 °C compared to the OPBC samples in both cooling techniques. The control sample was almost completely destroyed, whereas the OPBC samples still possessed some strength at this temperature. The OPBC samples cooled by air and water recorded compressive strengths within 10–13 MPa and 11–15 MPa, respectively. The lowest compressive strength was recorded for the control sample cooled by air and water with 3 and 10 MPa, respectively. The results obtained for the control sample at this temperature were almost the same as the results achieved by other researchers [56,57]. Basically, the strengths shown in the OPBC samples were higher than those in the control samples, probably due to the pores of the OPBC aggregates. When the OPBC samples were subjected to a high temperature, these pores released the built-up internal pressure, thus reducing internal structure damages [58].

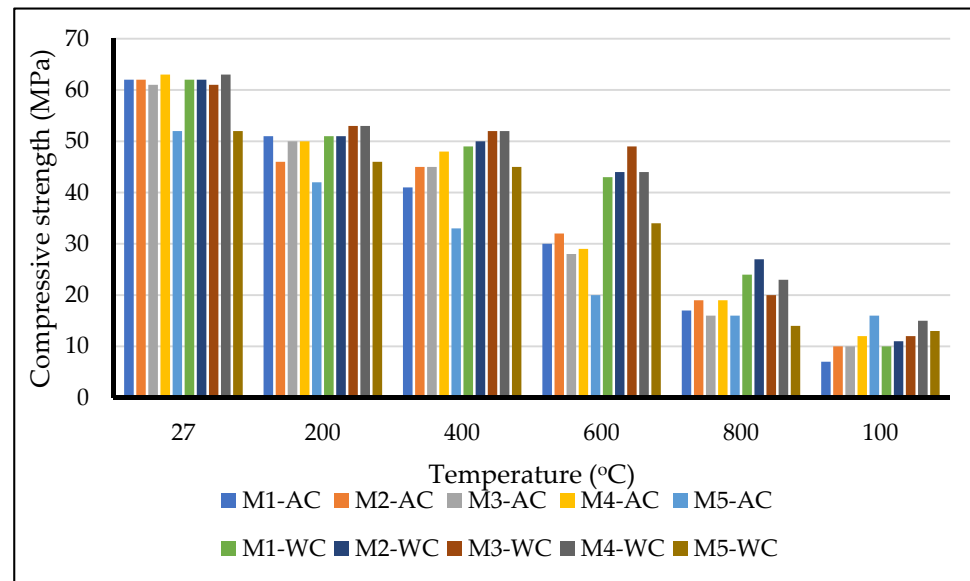
Figure 9. Compressive strength of partial-water-cured samples at elevated temperatures (where AC is air cooling, and WC is water cooling).
