Article

Improving Restorative Maintenance Practices for Mature Permeable Interlocking Concrete Pavements

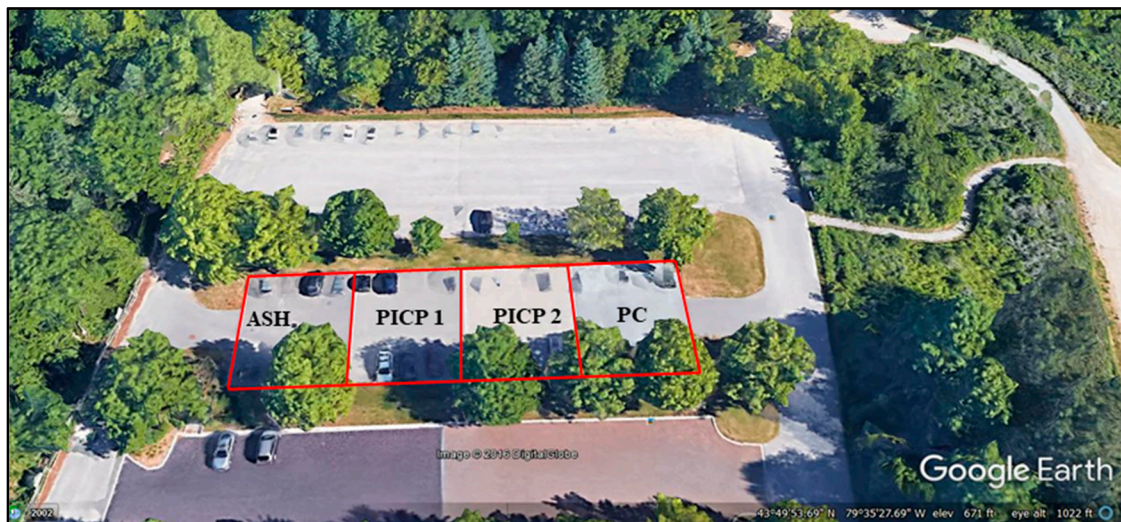
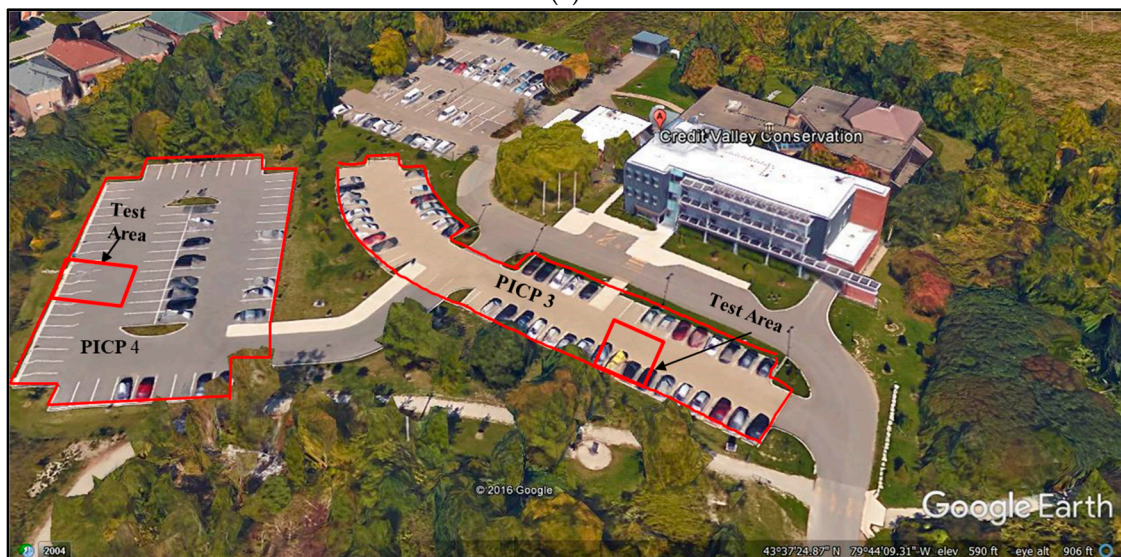
Figure 1. Field Sites (a) Parking lot at Toronto and Region Conservation Authority (TRCA), Vaughan (b) Credit Valley Conservation (CVC), Mississauga. Mapping Source: Google Earth 2016.

Field Site 1 is located at the TRCA's Kortright Centre in Vaughan, Ontario. The parking lot was constructed over the fall of 2009 and the spring of 2010 (Drake et al., 2014) and consists of four isolated sections (one traditional asphalt, two PICP cells (AquaPave® and Eco-Optiloc®) and one pervious concrete cell). The aerial view of the location and test cells are shown in Figure 1. The total surface area of each section is approx. 230 sqm. The maintenance evaluation was conducted on two PICP sections, marked as PICP 1 and PICP 2 (Figure 1), and one pervious concrete section, marked as PC. Results from the maintenance evaluation of the pervious concrete section is available through a technical brief on the Sustainable Technologies Evaluation Program (STEP) website. This paper deals exclusively with the results of the PICP sections.

The parking lot at TRCA is an experimental setup initially constructed for evaluation of the hydrologic and water quality benefits of permeable pavements [4,6]. Aggregate base and sub-base layer were constructed of 19 mm and 50 mm diameter clear stone for a total depth of 400 mm. PICP 1 is constructed with High Performance Bedding (HPB, ASTM # 9 aggregate) as the bedding layer and Engineered Joint Stabilizer as the joint material (2–3 mm size) whereas PICP 2 has the HPB as joint and bedding material. PICP 1 also has a geotextile layer placed between the bedding and aggregate layers with an opening size of 0.145 mm and a mean flow rate of 4800 L/min/m². Both PICP sections include an underdrain. It has a high usage intensity and serves as the parking space for TRCA employees and visitors. A one-time vacuum maintenance with an Elgin-Whirlwind[®] was completed in 2012 and regular winter maintenance is conducted using a combination of plowing and salting, as needed.

The second field site is the employee parking lot located at the office complex of the Credit Valley Conservation (CVC) in Mississauga, Ontario. Maintenance evaluation was conducted on two sections of the parking lot during May and June 2016. The two parking lots and the test sections are shown in Figure 1. PICP 3 was constructed in 2010; while PICP 4 was constructed in 2012. The total area of the parking lots is 3862 sqm, where PICP 3 is 1462 sqm and PICP 4 is 2400 sqm. Both the sections were

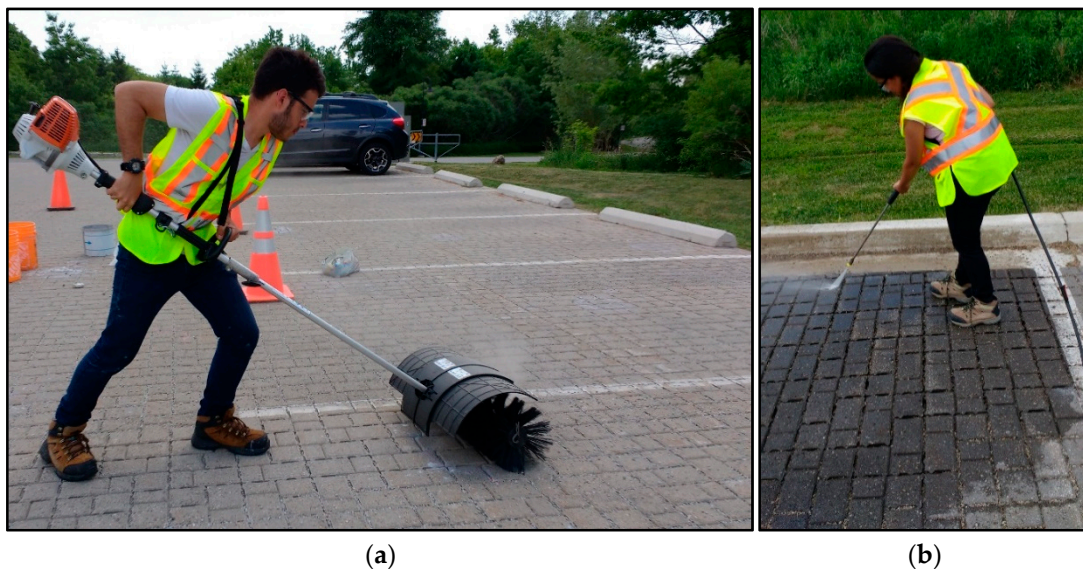
Figure 2. Surface Treatment Technologies (a) Power Brush (b) Pressure Wash at CVC, Mississauga.

For surface treatment, a bristle brush (Stihl KB KM46017404905) attached to a motor (Stihl KM130 engine) was used as the power brush, providing a power of approximately 1.4 kW and a BE pressure washer with a water pressure of 3000 psi was used at two subsections of each PICP test section (Figure 2), while the third subsection was kept as control.

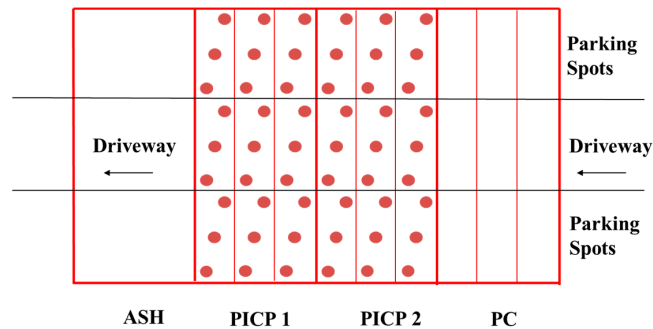
Figure 4. Infiltration testing scheme at permeable interlocking concrete pavement (PICP) 1 and PICP 2.

At Field Site 1, each PICP section was divided into three subsections (shown in Figure 4) consisting of both side parking spots and the central driveway lane. At Field Site 2, test areas (shown in Figure 1) consisting of three parking spots and an equal area on the adjacent driveway were selected on both PICP 3 and PICP 4 (shown in Figure 5). Figures 4 and 5 also show the schematic of the infiltration testing scheme for PICP 1 and 2 and PICP 3 and 4 respectively. The three subsections were subjected to a different surface treatment, that is, either power brush, pressure wash or no surface treatment. Infiltration measurements were performed before the surface treatment (referred to as pre-maintenance infiltration), followed by the surface treatment chosen and a vacuum street sweeper. A second set of infiltration measurements (referred as post-maintenance infiltration) was performed at the same infiltration test spots points after maintenance. In all, twenty-seven infiltration test spots were selected at PICP 1 and PICP 2 and eighteen test spots were selected at PICP 3 and PICP 4.

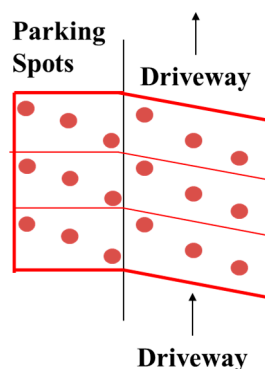
Figure 5. Infiltration testing scheme for PICP 3 and PICP 4.

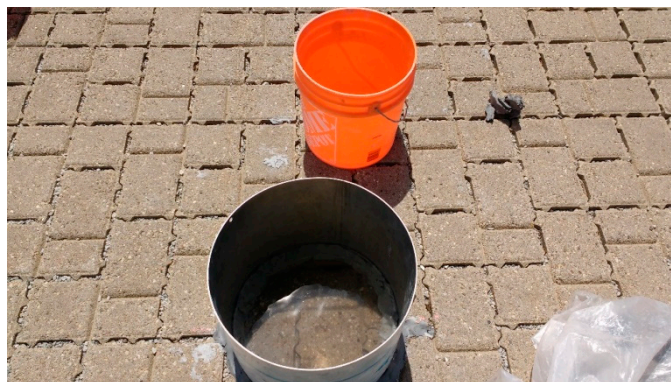
Figure 6. Standing water during a failed Infiltration test at CVC, Mississauga, Canada.

Infiltration measurements were conducted in conformance with ASTM Standard C1781 [26] using single ring infiltration tests (Figure 6). To provide a temporary seal to the pavement surface, modelling clay was used instead of plumber's putty, which is recommended in ASTM Standard C1781. Plumbers putty was found to be less effective in the Ontario climate causing inability to provide a perfect seal. Care was taken to prevent any removal of the joint material during testing by adding water on the paver surface and not on the joints. Since certain PICP sections were heavily clogged a cut-off time of 30 min was considered at the prewetting stage and of 90 min during the infiltration test. All the infiltration tests were preceded by a dry period of at least 48 h. As per ASTM standard C1781, the surface infiltration is calculated by:

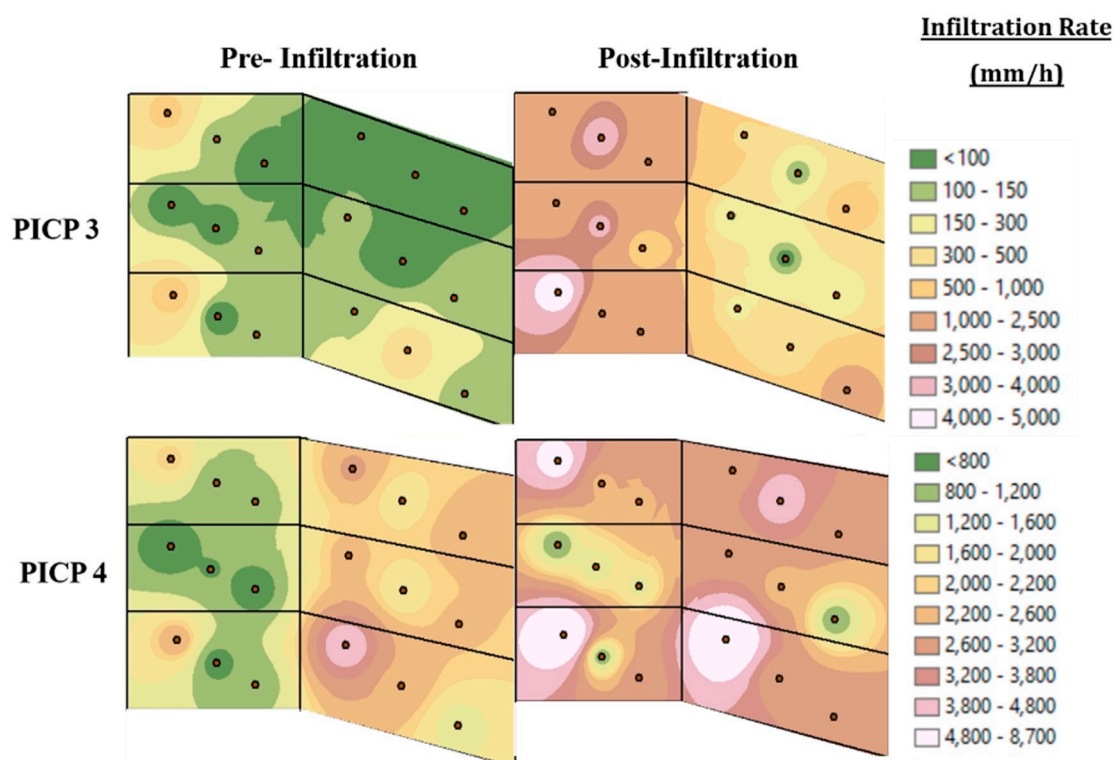
Figure 10. Spatial Variability of Infiltration Capacity at Field Site 2.

A final comparison was conducted to evaluate the effect of maintenance on areas with different usage characteristics, that is, parking lots and driveways. Spatial variability is illustrated through a contour map generated in ArcGIS 10.4.1 using the Inverse Distance Weighing method. Figure 9 presents the spatial variability at PICP 1 and PICP 2 (Field Site 1), whereas Figure 10 provides the spatial variability at PICP 3 and PICP 4 (Field Site 2) at both pre and post-maintenance. Most of the parking spot sections had higher surface infiltration capacities than the adjacent sections on the driveway emphasizing the fact that usage intensity also influences the surface degradation and maintenance requirements for PICP.

The usage intensity observed in driveways was more than the parking spots with continuous inflow and outflow of vehicles looking for parking space. These areas were more prone to receiving fines and debris in comparison to the parking spots. The significance results of generalized Wilcoxon one-sided tests are presented in Table 11 comparing the pre and post maintenance infiltration rates at both parking spots and driveways. Overall, it was observed that effect of maintenance was significant for all the parking spots. The effect of maintenance was significant driveway section of PICP 2 only. The results in Table 11 reemphasize that high usage intensity areas require frequent preventive maintenance. Restoration of infiltration capacity was possible for wider joint spaced and highly used PICP 2 and 3. The change in infiltration capacity was not significant for PICP 4 as the infiltration capacity was very high during the pre-maintenance stage.
