**Table S1.** Summary of collector wells and construction parameters<sup>1</sup>.

**Table S2.** Summary of laterals' construction parameters<sup>1</sup>.

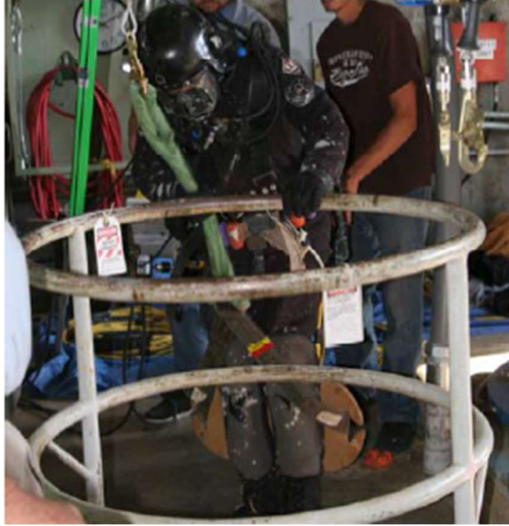
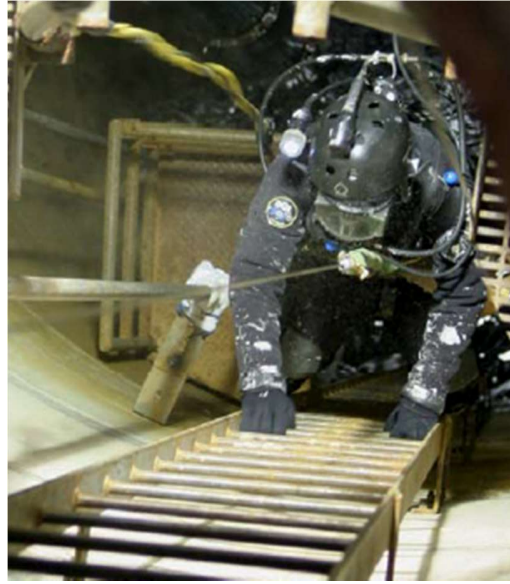
**Figure S1.** Diver preparing to enter one of the collector caisson (left) and diver climbing down one of the collector caisson ladder (right) [Source: 3].

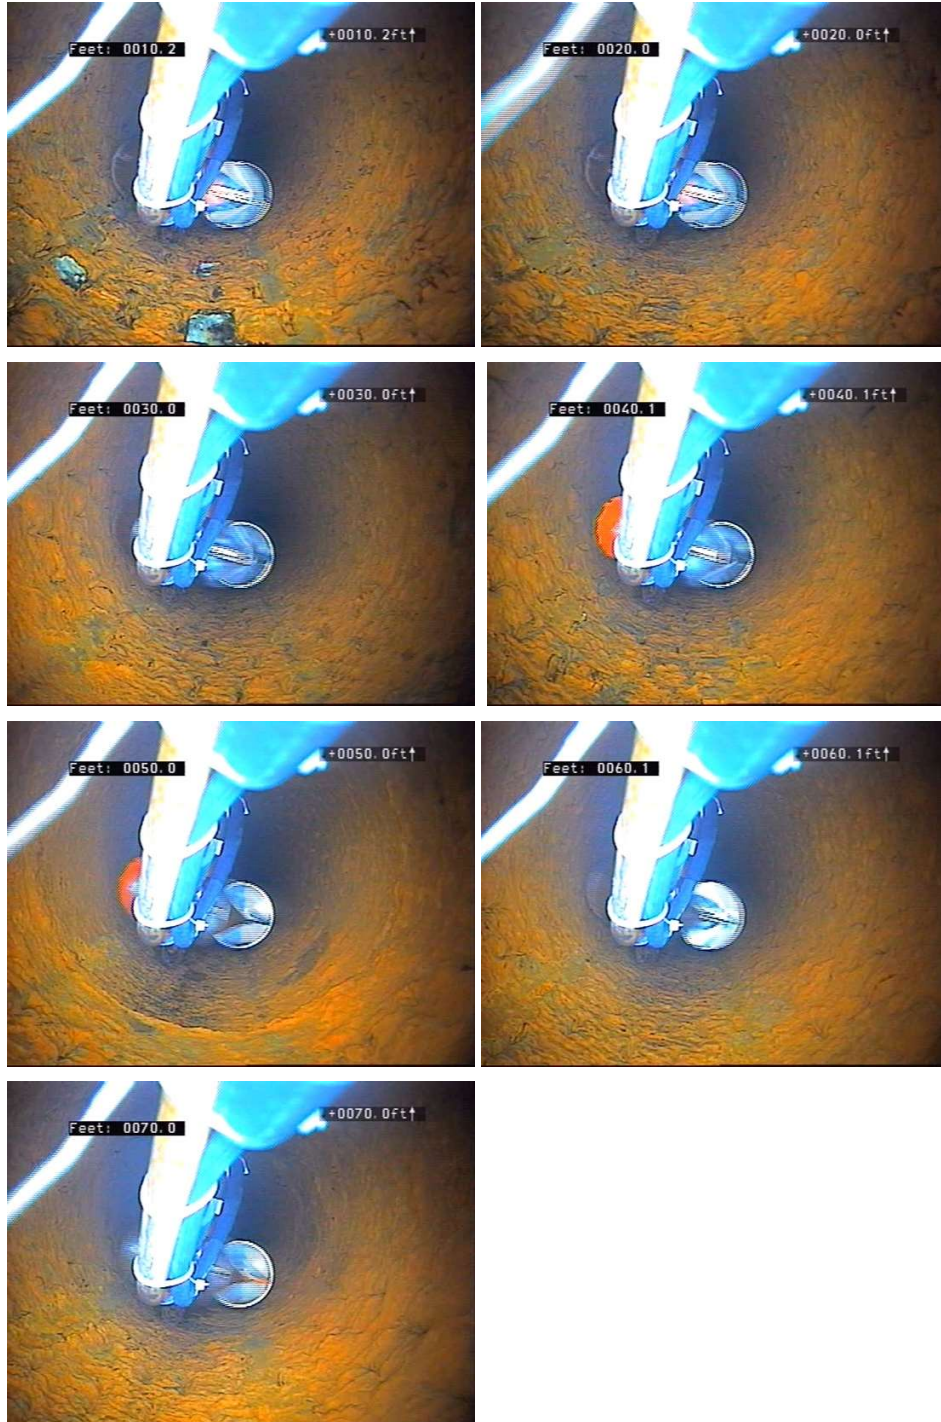
**Figure S2:** Collector Well 3, Lateral 4: 10 ft (3.048 m) progression from the lateral video inspection, 2015 (Source: Sonoma County Water Agency).

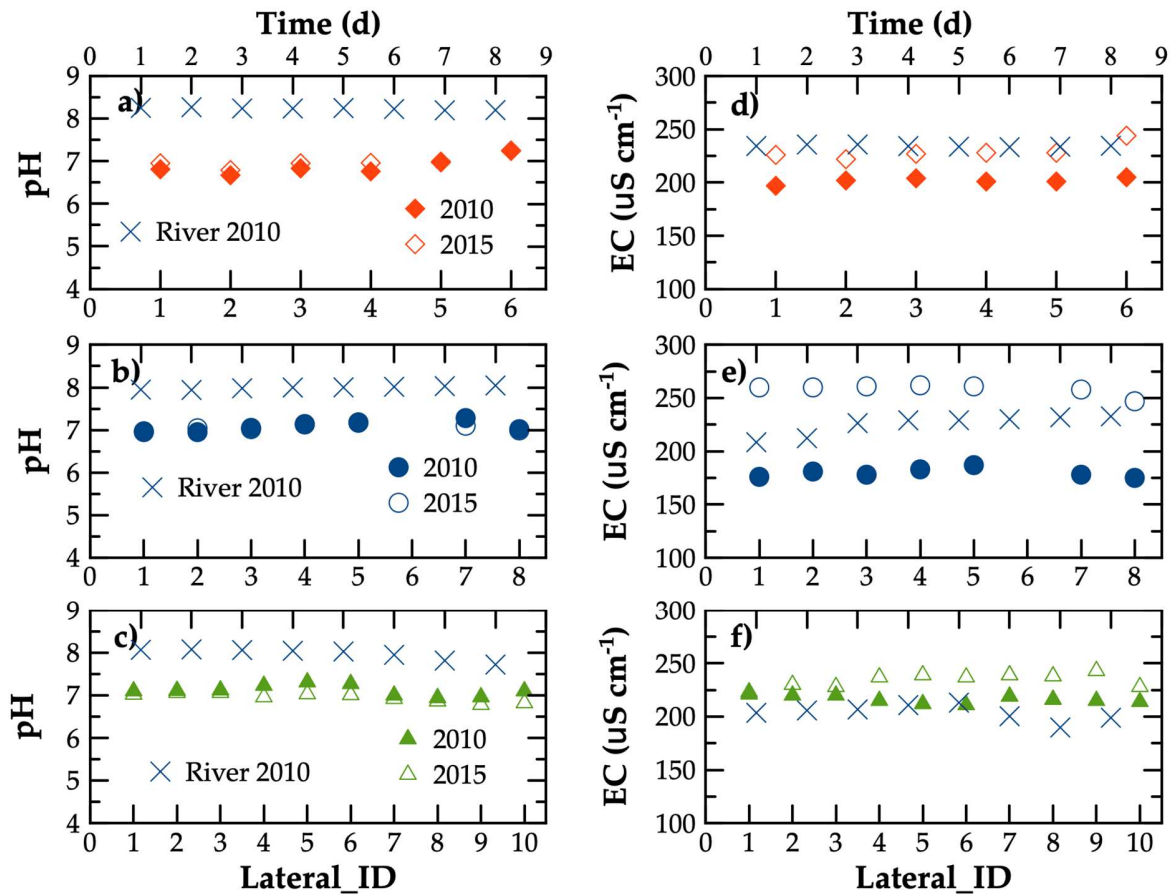
**Figure S4.** pH at a) Collector 3, b) Collector 4, and c) Collector 5; electrical conductivity (EC) at d) Collector 3, e) Collector 4, and f) Collector 5 (Source: [1, 3]). Daily average pH and EC values associated to the Russian River were collected between 4 October (day 0) and 11 October (day 8) 2010, between 8 November (day 0) and 15 November (day 8), and between 18 October (day 0) and 25 October (day 8) 2010 during the capacity testing for Collector 3 (S4a and S4d), Collector 4 (S4b and S4e), and Collector 5 (S4c and S4f), respectively.

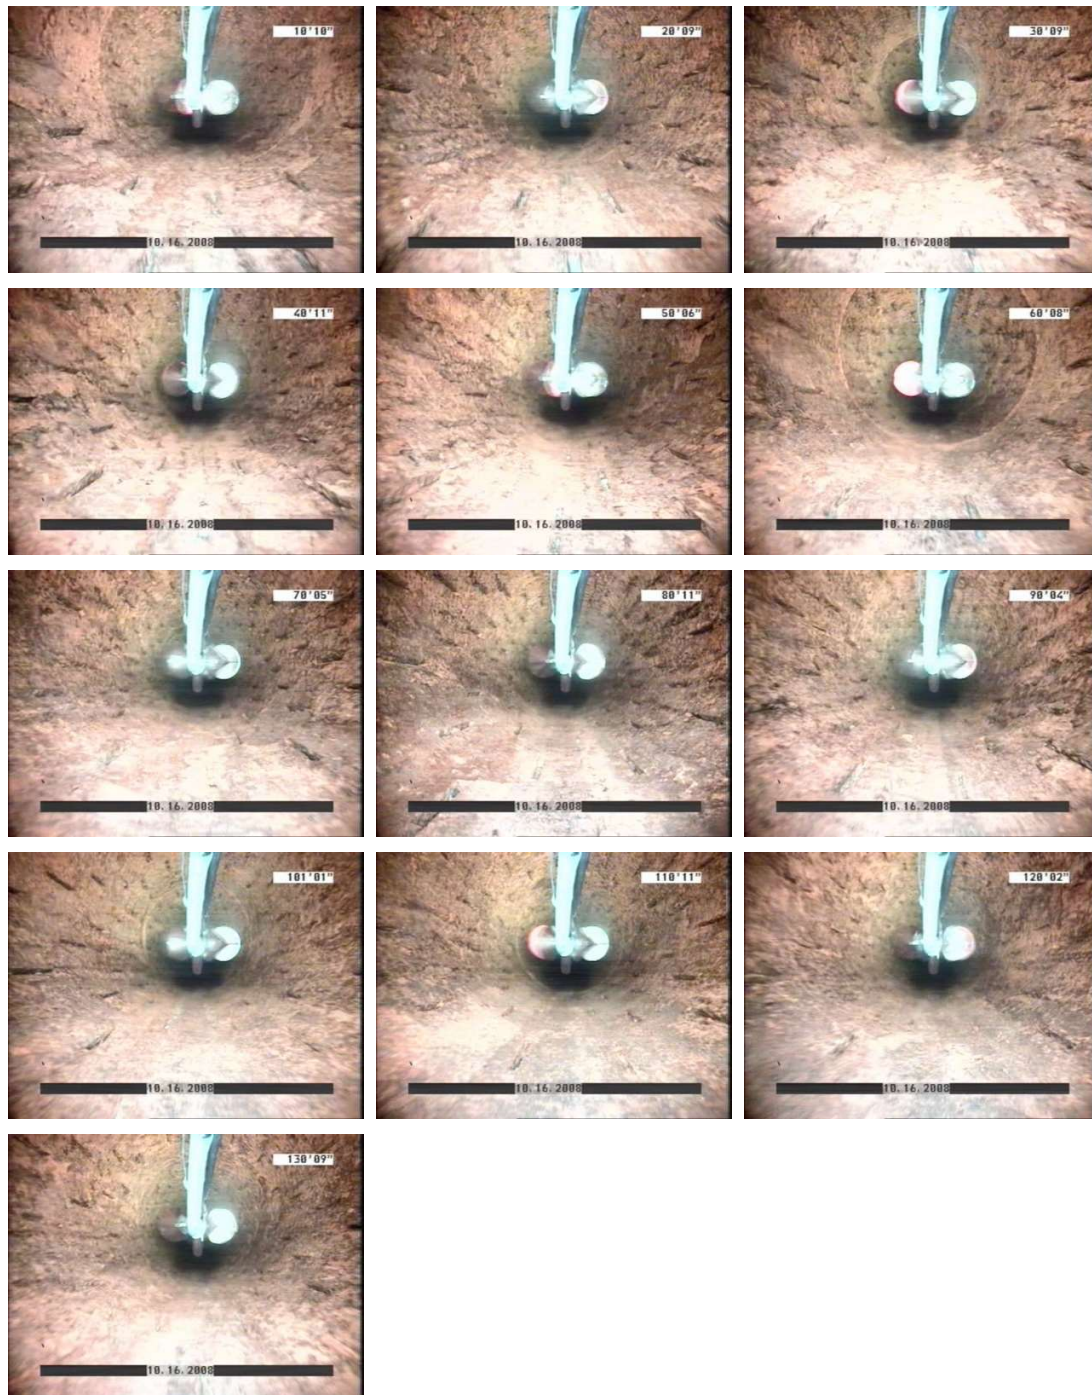
**Figure S6:** Collector Well 6, Lateral 4: 10 ft (3.048 m) progression from the lateral video inspection, 2008 (Source: Sonoma County Water Agency).
