Case Report

Emergency Disposal Solution for Control of a Giant Landslide and Dammed Lake in Yangtze River, China

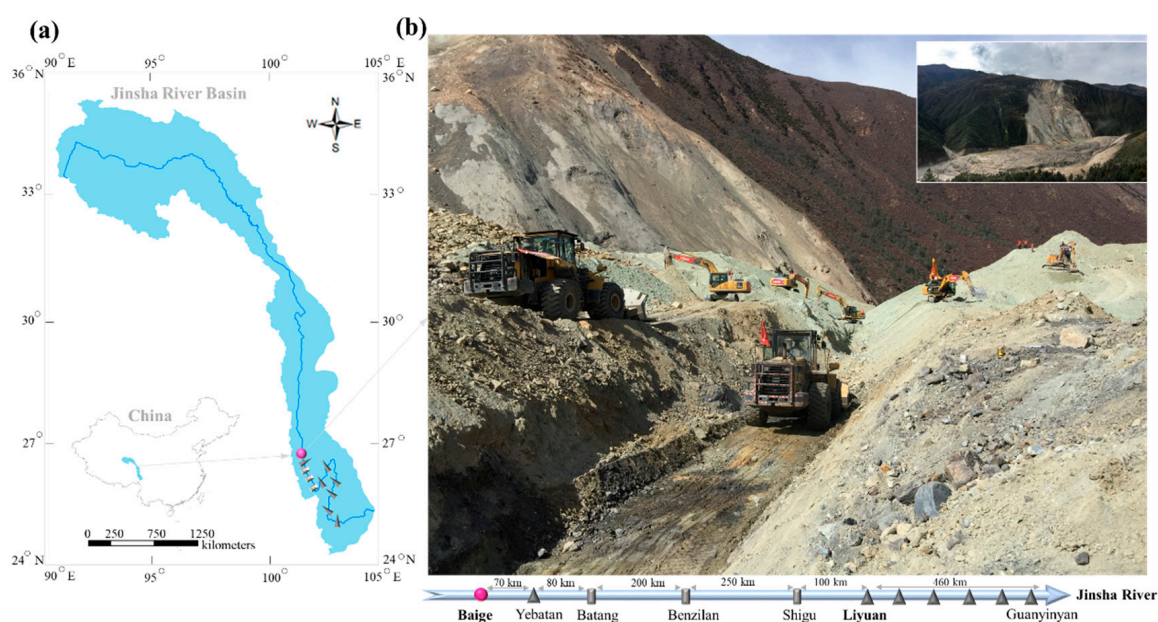
Figure 1. Location of landslide and excavation of floodgate. (a) Location of landslide; (b) workers carved out a diversion channel through the landslide blocking the Jinsha River. Baige is the place where the landslide occurred, and Yebatan is a hydropower station. Batang, Benzilan, and Shigu are hydrological stations. Liyuan and Guanyinyan are the first and the last reservoirs of the six cascade reservoirs in the midstream of the Jinsha River, respectively.

In the stream nearby the Baige Village of the Tibet Autonomous Region, which suffers from the obstacles caused by massive landslides, bulldozers are excavating a diversion channel to reduce the risk of flooding due to the fast-rising water levels of the blocked Jinsha River, which is situated in the upper reach of the Yangtze River (Figure 1). On 3 November, 2018, the landslide following the first landslide, which occurred on 11 October, 2018, caused about 25 million cubic meters of debris to hurtle down a mountainside, which created a natural dam that was 58.24 m high, 195 m wide and 273 m long, situated above the elevation of 2966 m along the Jinsha River. “I was surprised that the water level of the lake increased so fast at a speed of 0.7 m per hour” said one of the hydrologists from the Changjiang Water Resources Commission (CWRC) who first glimpsed the dammed lake. In the next few days, the water volume of this dammed lake increased from 300 million cubic meters and reached 770 million cubic meters.

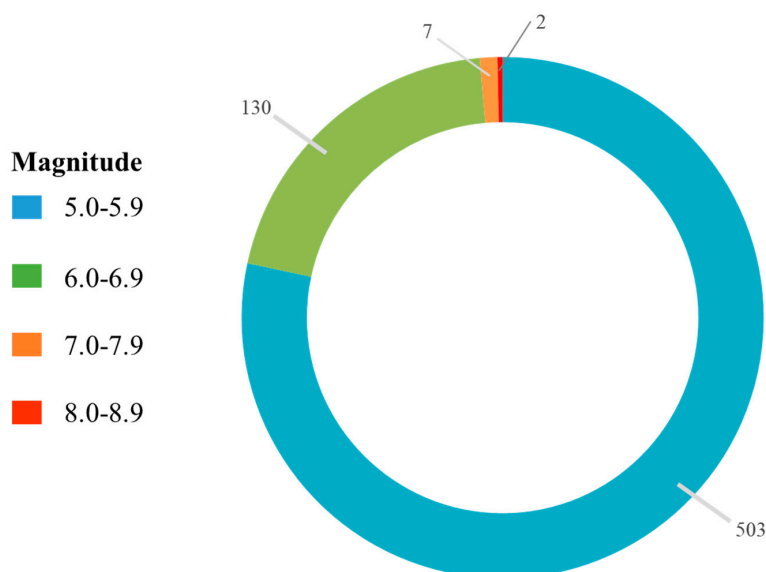
Figure 3. Data on earthquakes in Tibet. Data on earthquakes larger than magnitude 5.0 in Tibet during 1900 and 2017, extracted from the United States Geological Survey (USGS) [26] and the China Earthquake Networks Center (CENC) [27].

First—considering the earthquake factor—Tibet in China is an earthquake-prone area, and a great number of earthquakes (642, respectively) larger than magnitude 5.0 occurred in Tibet during 1900 and 2017. Out of these earthquakes, there were 503 measuring a magnitude of 5.0–5.9, 130 measuring 6.0–6.9, 7 measuring 7.0–7.9, and two measuring 8.0–8.9 (Figure 3).

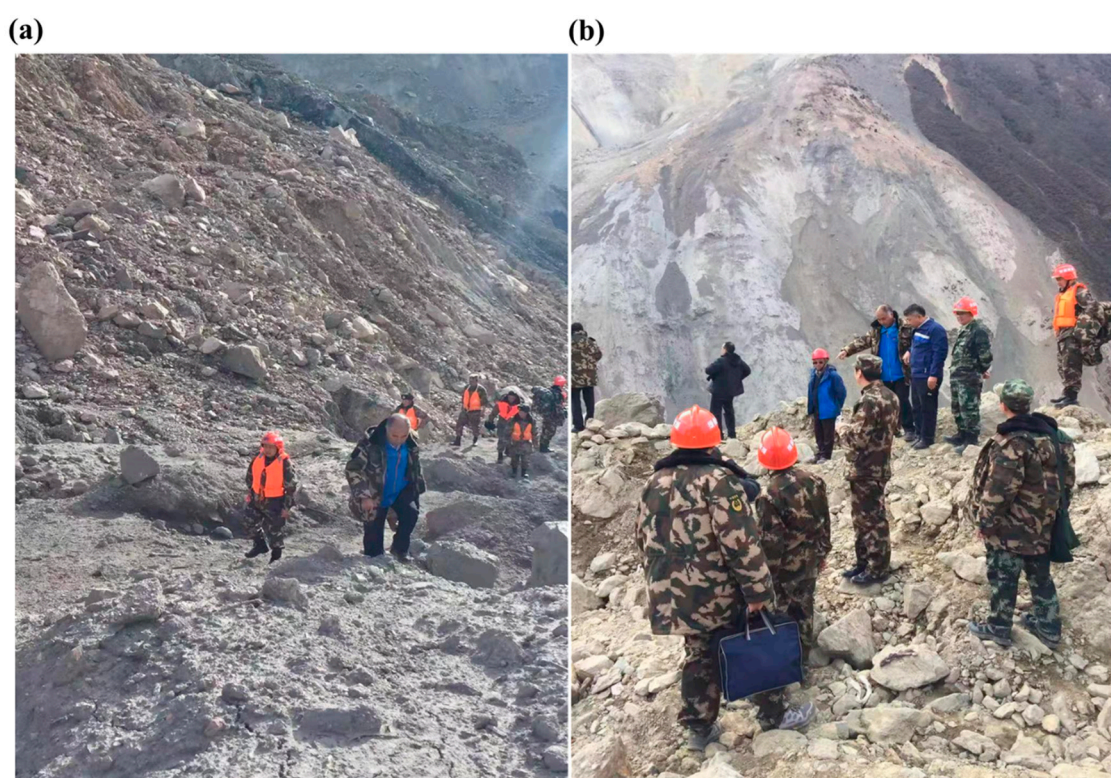
Figure 4. Field survey of the Baige landslide. Engineering geologists and hydrologists carried out a field survey of the Baige landslide during (a) 4 November, 2018 and (b) 5 November, 2018.

On 4 and 5 November, 2018, combining the aerial videos, images and in-situ measurement data collected by drones with the development of the water storage in the dammed lake, it was concluded that without human intervention, the possibility for the dammed lake to collapse would be very high. Besides, the anticipated magnitude of the flood-induced by such a collapse would be enormous, and would bring significant economic losses to the downstream. During 4 and 5 November, 2018, after a comprehensive site-specific survey of the landslide (Figure 4), the director of the CWRC said, “in such emergency case, we only have a few days to assess landslide hazards and figure out what to do”.

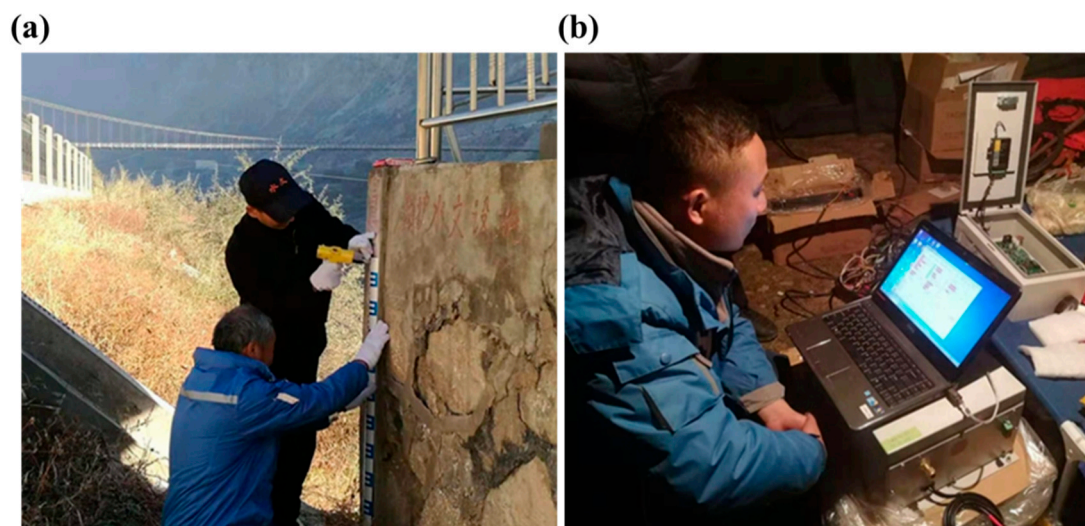
Figure 5. Hydrological monitoring in the downstream of Baige landslide. (a) Installation of water level ruler; (b) testing hydrological monitoring equipment.

dam break as well. On 10 November, 2018, about 80 sets of equipment—including automatic gauges designed for high water level and water gauges—were installed and the forecasts of water level, flow, and possible inundated areas were made (Figure 5). On 11 November, 2018, the engineering team succeeded in digging out a diversion channel with a length of 220 m, the maximum depth of 15 m, a width of 42 m at the top, and a width of 4 m at the base so that floodwater could be released for decreasing the lake water level as well as reducing the flood risks at downstream areas (Supplementary Video S1). Meanwhile, the government quickly evacuated more than 50,000 people downstream of the Baige area and at least 18,657 people in Lijiang City of Yunnan Province.

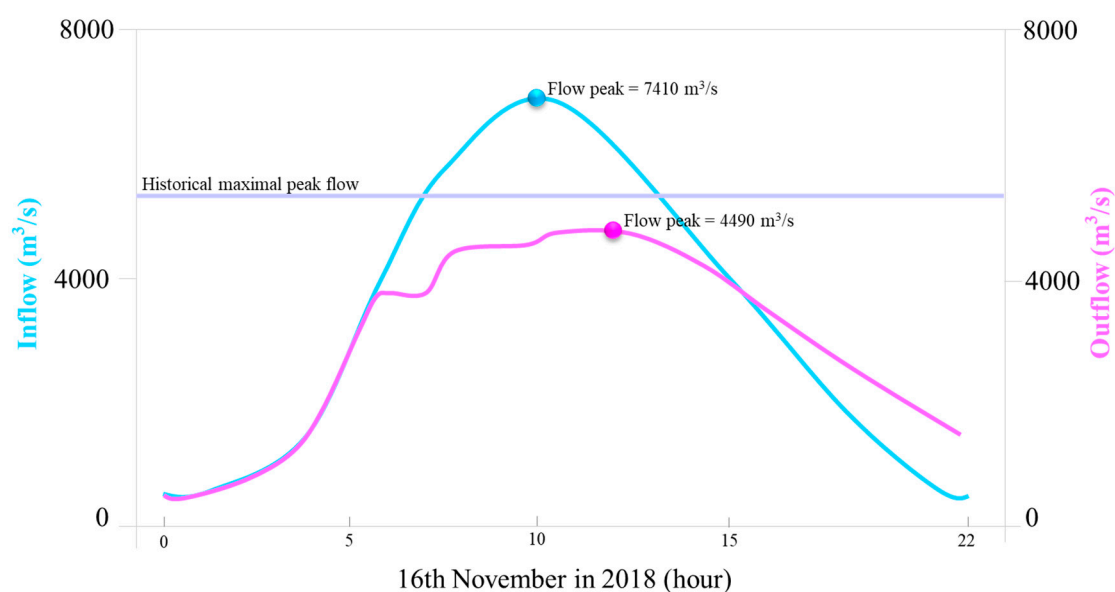
Figure 6. Sketch map of reservoir operation for releasing water in the Liyuan Reservoir.

Before the dam broke on 13 November, 2018 (Supplementary Video S2), four operational commands on cascade reservoirs were issued by the CWRC to cope with the dam break based on in-situ survey and hydrological forecasting, as described below. To deal with the floods caused by dam break, a series of reservoir operation was implemented started from 5 November, 2018. Three cascade reservoirs (Liyuan, Ahai, and Jinanqiao) vacated a total storage capacity of 0.62 billion cubic meters on 5 November, 2018. It followed six cascade reservoirs (Liyuan, Ahai, Jinanqiao, Longkaikou, Ludila, and Guanyinyan) that vacated a total storage capacity of 1.03 billion cubic meters on 10 November, followed by 1.189 billion cubic meters on 14 November, and finally reached 1.3 billion cubic meters on 15 November.
