# Impact of Hydropower Dam Operation and Management on Downstream Hydrogeomorphology in Semi-Arid Environments (Tekeze, Northern Ethiopia)

**Abstract:** Due to renewed interest in hydropower dams in the face of climate change, it is important to assess dam operations and management in combination with downstream impacts on rivers in (semi-)arid environments. In this study, the impacts of the Tekeze hydropower dam on downstream hydrology and river morphology were investigated, including impacts under normal and extreme reservoir operation conditions. Field observations, in-depth interviews, repeat terrestrial photographs, multi-year high-resolution satellite images, daily reservoir water levels and data on hourly to daily energy production were collected and studied. The results show that high flows ( $Q_5$ ) have declined (with factor 5), low flows ( $Q_{95}$ ) have increased (with factor 27), seasonal flow patterns have smoothed, river beds have incised (up to 4 m) and locally aggraded near tributary confluences. The active river bed has narrowed by 31%, which was accelerated by the gradual emergence of *Tamarix nilotica* and fruit plantations. A new post-dam equilibrium had been

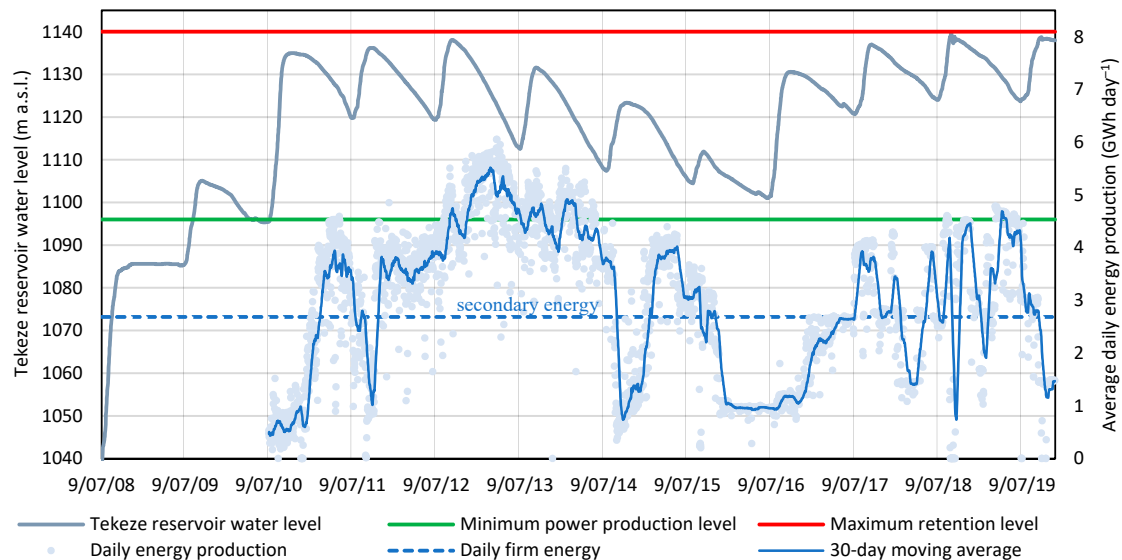
**Figure 2.** Evolution of the Tekeze Reservoir water levels from July 2008 and daily energy production from July 2010 to November 2019 (for this research, no energy production data are available before July 2010; Data source: [37,39]).

Over time, numerous technical (operational) problems were encountered at the Tekeze Dam. Commonly, one to three out of the four turbines were under maintenance, leading to a very variable

power production (Figure 2). Mostly, only one turbine was used for electricity generation (46% of the days), as compared to two (24%), three (27%) or four turbines (3%). Despite these numerous problems, the Tekeze Dam has generated 1082 GWh year<sup>-1</sup> on average, exceeding the targeted (firm energy) of 981 GWh year<sup>-1</sup>. In hydrologic years 2010, 2015 and 2016 the power production target was not met due to incomplete transmission lines (2010) and a severe drought in 2015. In hydrologic year 2012, on the other hand, the production has exceeded the planned target with 80%, as 1753 GWh had been generated. At the scale of daily and monthly generated power, the firm energy was not met for 40% of the observed days and in 16.5% of the observed months between July 2010 and November 2019, as compared to the 97% reliability criterion.

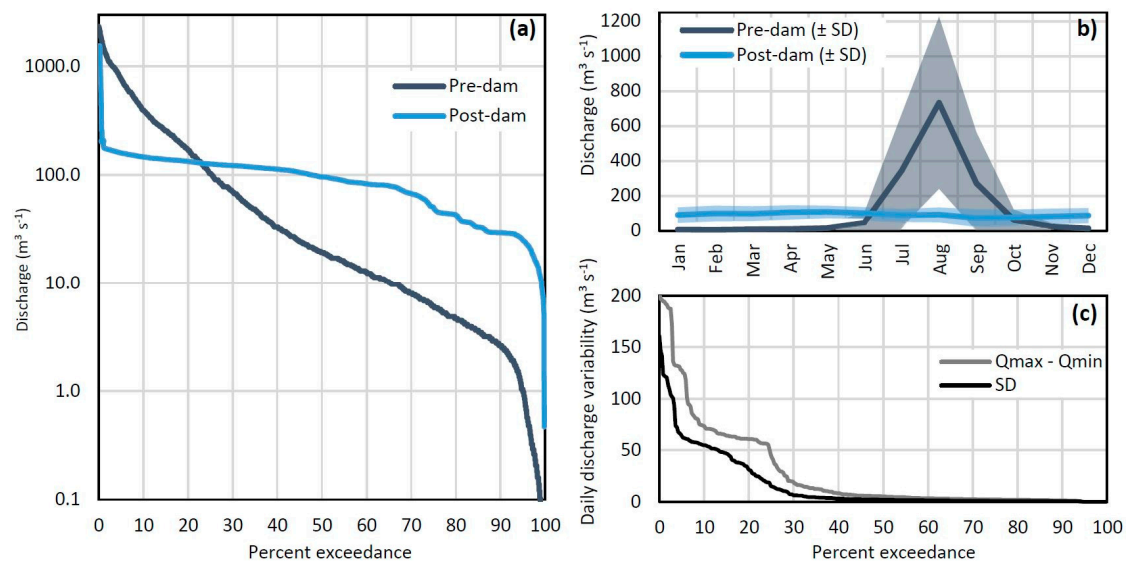
**Figure 3.** Hydrologic changes of the Tekeze River near the dam site: flow duration curves for average daily discharges (a), average pre-dam and post-dam monthly discharges (b) and daily post-dam variability in discharges for hydrologic year 2018, expressed as the observed maximum jump ( $Q_{\max}-Q_{\min}$ ) and standard deviation in hourly discharges within a one day-timeframe (c) (Data sources: [38,39,49]).

Since the Tekeze Dam became operational, low flows ( $Q_{95}$ ) have significantly increased (with a factor of 27, from  $0.9 \text{ m}^3 \text{ s}^{-1}$  to  $25.3 \text{ m}^3 \text{ s}^{-1}$ ), whereas high flows ( $Q_5$ ) have been significantly reduced (with a factor of 5, from  $743 \text{ m}^3 \text{ s}^{-1}$  to  $155 \text{ m}^3 \text{ s}^{-1}$ ). Over time, the median flow ( $Q_{50}$ ) has increased by a factor of five (from  $18 \text{ m}^3 \text{ s}^{-1}$  to  $95 \text{ m}^3 \text{ s}^{-1}$ ), with an average released flow of  $92 \pm 44 \text{ m}^3 \text{ s}^{-1}$  for electricity production and a maximum observed flow of  $185 \text{ m}^3 \text{ s}^{-1}$  (discharges above this value stem from the emergency releases using the MLOs) (Figure 3a). Discharges were highest during the dry season months and lowest during the months succeeding the rainy season, with a maximum monthly average in May ( $108 \text{ m}^3 \text{ s}^{-1}$ ) and minimum monthly average in September ( $73 \text{ m}^3 \text{ s}^{-1}$ ). Consequently, the seasonality of flow patterns was inverted downstream of the dam site, but also became much less pronounced than before dam construction (Figure 3b). On a daily basis, the recorded variability in post-dam discharges frequently has been considerably high, with jumps ( $Q_{\max} - Q_{\min}$ ) up to  $200 \text{ m}^3 \text{ s}^{-1}$  within a one day-timeframe, and above  $45 \text{ m}^3 \text{ s}^{-1}$  for 25% of the recorded days (Figure 3c). Over time, the released flows have been above the demanded environmental flows ( $Q_{95}$  with a maximum of  $60 \text{ m}^3 \text{ s}^{-1}$  [28]), except for the months of July, August, September and October, when the targets were not met for 6.8%, 8.3%, 15.1% and 13.7% of the days respectively. For downstream ecosystems, it is important to reach these environmental flows also during the rainy season months, however, as the first large tributary (Giba) joins the Tekeze River only at RK36.

Due to dam-induced hydrologic alterations, the impact of the 2018 emergency release—with discharges up to  $1554 \text{ m}^3 \text{ s}^{-1}$  for several consecutive days (see Figure 3)—was worse than it would have been before dam construction, as floodplains had been considered safe from flooding. During this emergency water release, the plantations (especially) at the lowest river terraces were damaged by extreme high water levels (Figure S3). A total of 179 ha of farmland was reported damaged to the local agricultural specialists. This corresponds to 11% of the total irrigated area along the Tekeze River [26]. While most plants were damaged by high water levels, muddy depositions on banana leaves also caused numerous plants to die, as photosynthesis was hindered. Clearly, this caused serious economic losses for the farmers, as monetary and time investments were lost to the flood and were not compensated. Due to radio warnings, however, no flood-induced deaths were reported, although several persons already had lost their lives in the post-dam Tekeze River. This problem mainly occurred closer to the dam, where communities of both river sides were used to interact and river crossing before dam construction did not require swimming during the dry season. Despite the impacts of the 2018 water release, at the beginning of the rainy season of 2019, the reservoir water levels were as high as those of 2018 (Figure 2), even though a (small) preventive release was performed in the month of May. If the reservoir inflow had been as high as that of 2018, a similar risky situation would have been created with severe downstream flooding and economic losses in the riparian fruit plantations as a consequence. A total volume of water of 450 MCM eventually was spilled in 2019.

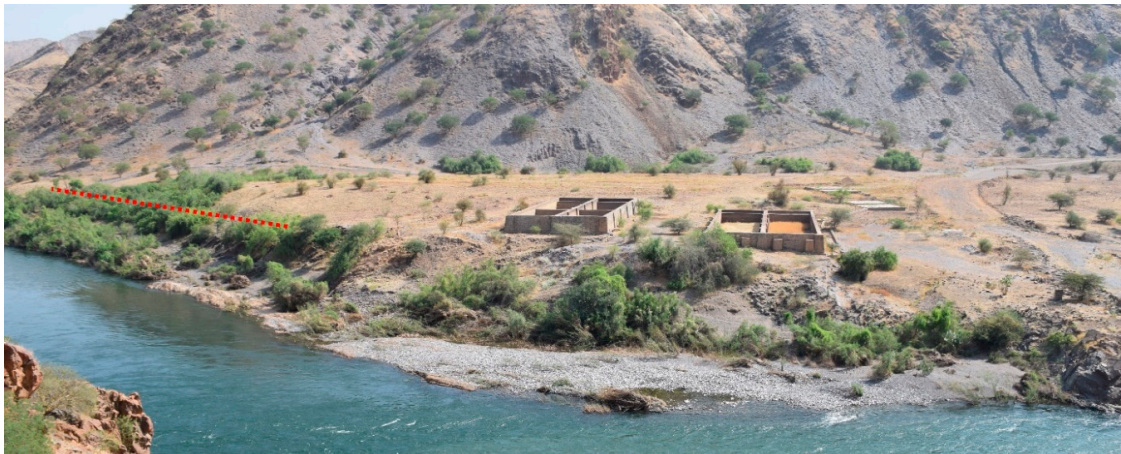
**Figure 4.** The Tekeze River has incised at least 4 m. Evidence for this was provided by a river terrace (dotted red line) and deep lateral gullies that were dated “pre-dam” and “post-dam” respectively by local inhabitants during field interviews (Photo: 15 October 2018).

Around RK3, the Tekeze River incised at least 4 m after the dam became operational. Evidence for this was provided by a river terrace and several deep lateral gullies that were dated “pre-dam” and “post-dam” respectively during the field interviews (Figure 4). The height of the river terrace (and hence gully heads) was measured above the 2019 water level, and consequently provides a lower bound estimation. The rate of incision consequently was calculated as at least 0.4 m per year. Further downstream, the Tekeze River flows through a deeply incised gorge, where the absence of alluvial plains and river terraces makes it difficult to estimate incision rates. Near Embamadre (RK100), however, flow data potentially point out that the Tekeze River has incised up to there as well, although probably to a lesser extent. Since the dam became operational, the stage–discharge curve for the Embamadre station has not been updated. River bed degradation consequently could have led to an underestimation of actual discharges, and could be responsible for the observed decreasing trend in runoff volume downstream of the dam between 2010 and 2015 (Figure 5). During this period, no corresponding declining trend in reservoir inflow was observed—the inter-annual rainfall variability is expected to be similar as in the upstream catchment—and the extracted amount of water between the two stations is estimated to have remained invariable, as irrigated agriculture is absent along this stretch of the river [26]. In addition to river bed degradation, localized river bed aggradation also was observed in the first 150 RKs downstream of the dam. Over time, extensive alluvial cones have developed near the confluence of several large tributaries with the Tekeze River. Due to strongly reduced high flows and consequently reduced stream power [42], the Tekeze River has largely lost its ability to seasonally remove the debris cones of its affluents, usually consisting of large boulders with an average maximum diameter ( $D_{10}$ ) above 40 cm ( $42.7 \pm 9.0$  cm for  $n = 11$ ). Therefore, in many places, the river has been “pushed” towards the opposite side of the valley, where it has further deepened its channel (see Figures in Section 4.4.2).

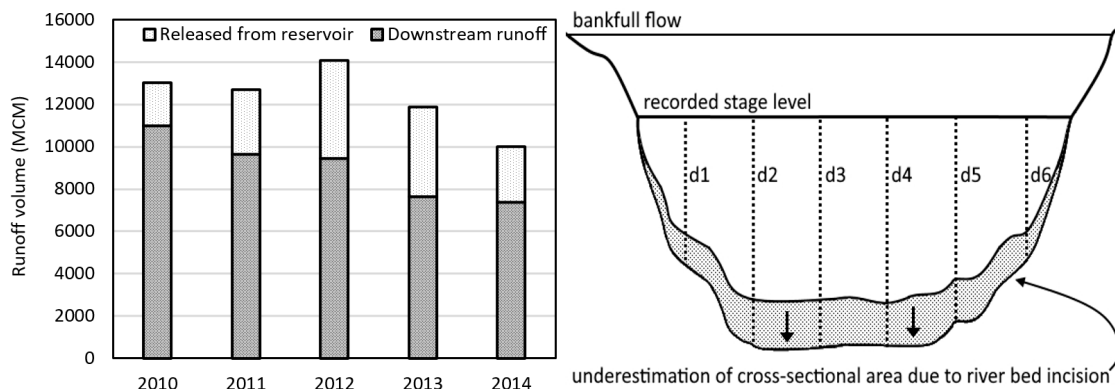
**Figure 5.** The decreasing trend in observed runoff volume at the Embamadre station (RK100) (left) potentially indicates an underestimated cross-sectional area caused by dam-induced river bed degradation, as the stage–discharge curve has not been updated after dam implementation (right) (Data source: [39,49], own conceptual diagram).

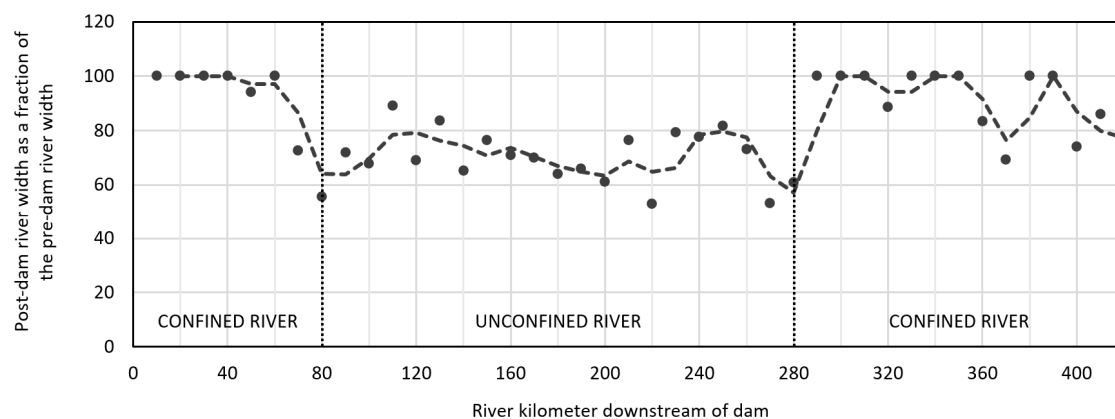
**Figure 6.** Post-dam river narrowing along the Tekeze River:  $-7\%$  in the confined areas versus  $-31\%$  in the unconfined areas (dashed line = 20 km-moving average).

Since the Tekeze Dam became operational, the width of the active river bed has declined with on average 7% in the laterally confined areas (from 164 m to 144 m for RK0–RK80 and RK280–RK420) and 31% in the partly confined to unconfined areas (from 241 m to 162 m for RK80–RK280), where the bed gradient is low (0.98 m km<sup>-1</sup> vs. 1.35 m km<sup>-1</sup> for RK0–RK80 and 1.10 m km<sup>-1</sup> for RK280–RK420) and the river has a lot of freedom to flow (Figure 6 and Figure S2). First, due to the clear water effect,

the river has incised along the first 100 RKs downstream of the dam, leading to a reduced width/depth ratio and hence decreased required width to allow discharges of the same magnitude as compared to the pre-dam situation. Second, due to reduced high flows, increased low flows and changing water tables, riparian vegetation has expanded along the abandoned floodplains of the Tekeze River, with *Tamarix nilotica* as the dominant observed pioneer species. Different generations of tamarisk can be observed, with years-old trees located up to hundreds of meters away from the active river bed and young bushes of tamarisk located much closer to and even in the active river bed. Whereas the meters-high old trees indicate the pre-dam flooded perimeter, the young generation of tamarisk bushes indicates the (gradual) post-dam retreat of the maximum flooded perimeter (Figure 7). The presence of new tamarisk bushes triggers a continued narrowing of the river, as depositions are trapped more easily, allowing the accumulation of sediments (vertical accretion) and hence stabilization of the largely abandoned floodplain [45,46]. Third, dam-induced reduced high flows and increased low flows have also caused humans to increasingly occupy floodplains for irrigated agriculture. Since the Tekeze Dam became operational, the irrigated area along the river has expanded from 433 ha to 1698 ha, mainly consisting of fruit plantations, and even the lower river terraces have become cultivated [26]. Similarly to natural vegetation expansion, fruit trees reduce flow velocity during floods, what leads to sediment trapping and temporary runoff storage. Fourth and last, to better protect their fruit plantations, some farmers plant the fast-growing elephant grass (*Pennisetum purpureum*) at the edge of the river bed, which leads to increased bank stability [50] and hence accelerated river narrowing. Although the narrowing of the river is initially dam-induced, it is accelerated by the expansion of riparian vegetation and anthropogenic land use changes.

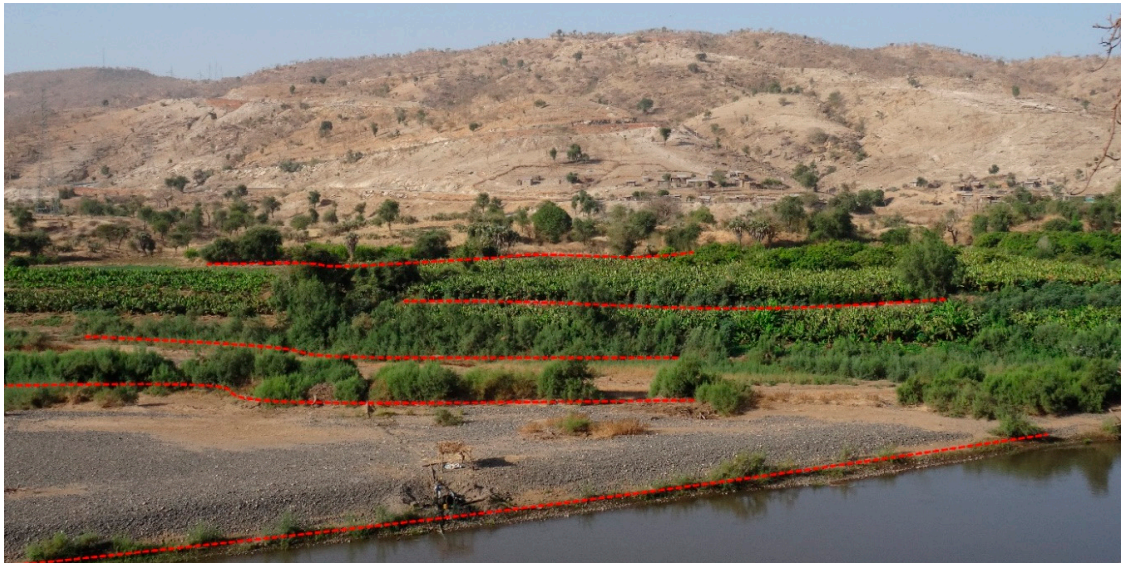
**Figure 7.** Five generations of *Tamarix nilotica* can be observed at RK208, indicated by the dotted red lines. Root crowns of the tamarisk trees and bushes typically follow the (maximum) flooded perimeter, which clearly has displaced towards the river after the Tekeze Dam became operational (Photo: 30 January 2017).

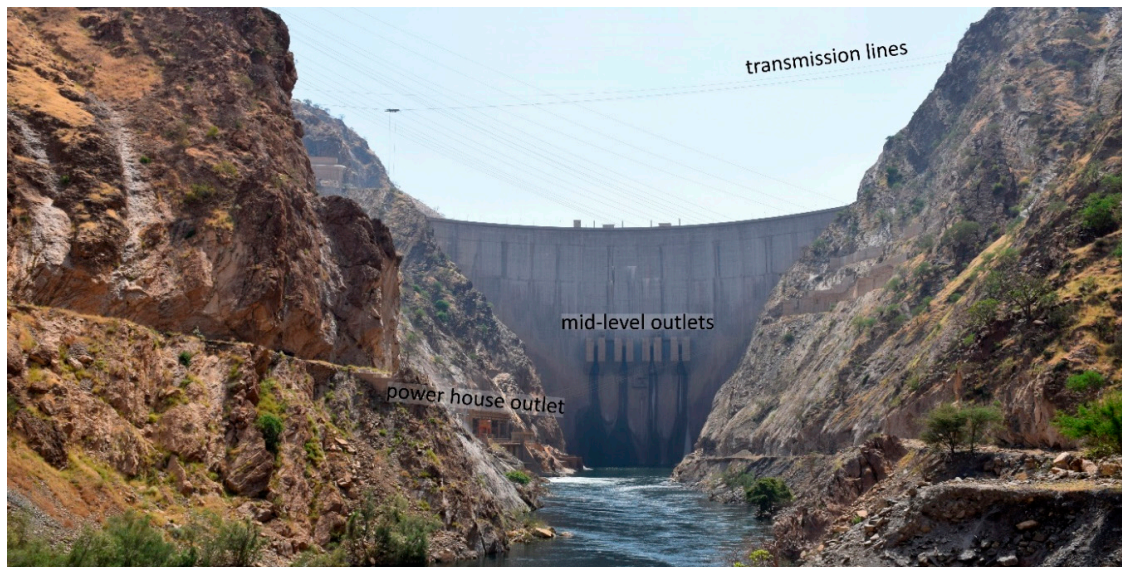
**Figure 8.** Downstream view on the 188 m high Tekeze arch dam with its four mid-level outlets and transmission lines crossing the narrow gorge (Photo: 15 October 2018).

When the reservoir water levels are too high at the beginning of the rainy season or when the Tekeze Reservoir nearly reaches the maximum retention level (1140 m ASL), the four MLOs can be opened to avoid the overtopping of the dam as there is no spillway. When water is spilled (released) from these MLOs, however, no power can be generated simultaneously because the released water creates a foggy shower and wind just downstream of the dam, where the transmission lines cross the narrow gorge on their way to the transformer, anchored on the opposite side of the valley, and on their way back to the switcher (Figure 8). This could potentially cause damage to the transmission lines [51] and consequently threaten electricity production in the period that follows. The transmission lines crossing the gorge too close to the MLOs are considered technical errors in dam design (personal communication). In addition, when too much water is released from the MLOs, both water and debris can enter the powerhouse from outside, which can disrupt and even damage the turbines. This occurred after spilling water from the MLOs in 2019, for example, when debris from a landslide just downstream of the dam had entered the powerhouse. The use of the MLOs will hence be avoided as long as possible, as it is uneconomic and potentially involves damage to the turbines. The dam operator consequently must make a constant trade-off between power generation and dam safety when reservoir water levels become high. The MLOs were used over time, in 2012, 2018 and 2019. In 2018, a vast amount of water was discharged at the end of the rainy season, whereas in 2019, the MLOs were used as a preventive measure, rather.

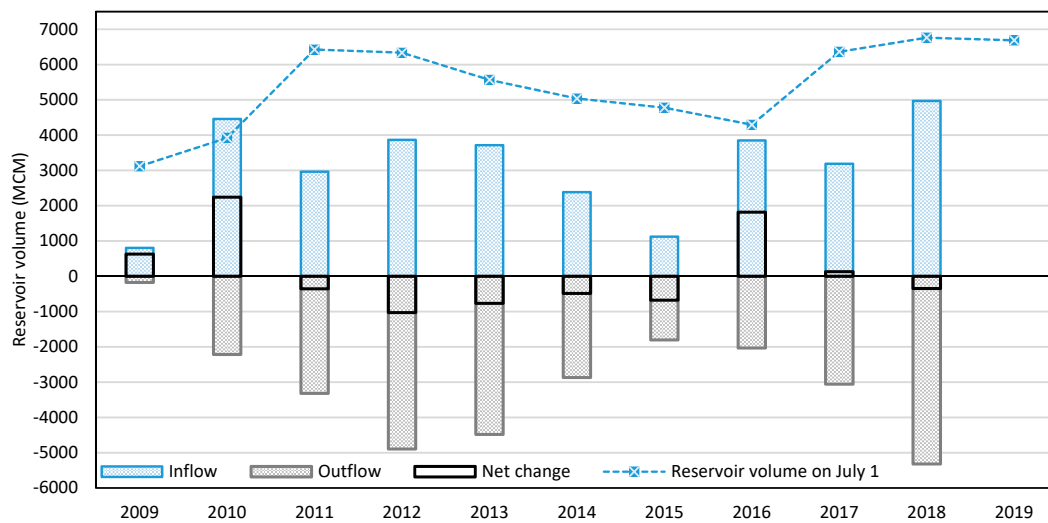
**Figure 9.** Yearly reservoir volume inflow and outflow, with corresponding net volume change from July 2009 to November 2019 (Data sources: [37,39,40]).

At the beginning of the rainy season of 2018, the reservoir water level was the highest ever recorded for that time of the year (Figure 9). With a water level of 1124 m ASL, the reservoir stored 75% of the 2018 reservoir volume of 9023 MCM (discounted for reservoir sedimentation). Over time, an average yearly reservoir inflow of 3392 MCM was observed, whereas on average only 673 MCM was released for electricity generation during the rising limb of the seasonal reservoir fluctuations (July to September). This should have highlighted the need for preventive actions to release a certain volume of water using the MLOs. The rainy season of 2018 appeared to be the wettest rainy season since the Tekeze Dam became operational, as 4970 MCM water entered the reservoir. Initially the reservoir volume growth rate had remained relatively low ( $20 \text{ MCM day}^{-1}$ ), but starting from August 8 the growth rate more than quadrupled ( $84 \text{ MCM day}^{-1}$ ) and the reservoir water levels increased rapidly. It was not until August 25 that EEP decided to open the MLOs in order to release water at fast pace. After this, the reservoir levels continued to increase and reached an absolute maximum of 1139.75 m ASL on 1 September, when an additional volume of 41 MCM would have been enough to overtop the maximum retention level, potentially putting dam safety at risk (Figure 10). Between 25 August and 16 September, a volume of 1693 MCM was released from the reservoir using the MLOs. This corresponds to 58% of the average yearly released volume of water for electricity generation (2896 MCM) and the pre-dam observed runoff for the entire month of August [49].

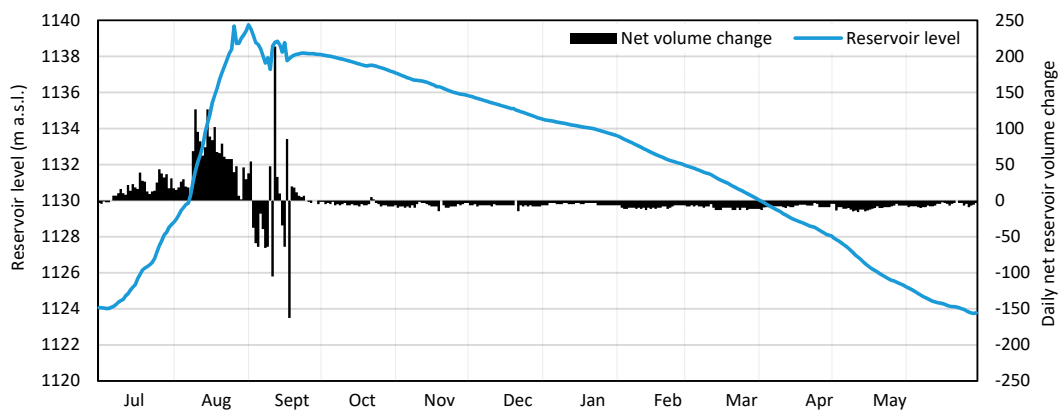
**Figure 10.** Evolution of the reservoir water levels and daily volume changes for hydrologic year 2018 (Data sources: [37,39,40]).

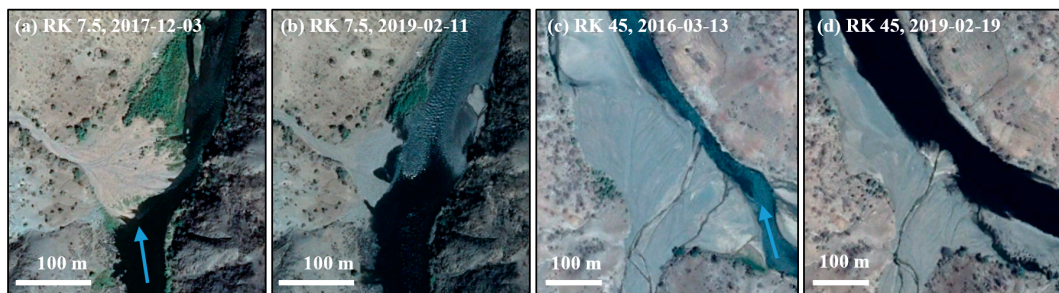
**Figure 12.** Examples of large alluvial cones that were (partially) eroded during the 2018 emergency release, after they had been gradually expanding for several years. Although discharges vary slightly on the photos, it does not impact the observed results: (a)  $85 \text{ m}^3 \text{ s}^{-1}$  vs. (b)  $127 \text{ m}^3 \text{ s}^{-1}$  and (c)  $29 \text{ m}^3 \text{ s}^{-1}$  vs. (d)  $126 \text{ m}^3 \text{ s}^{-1}$  (Data source: [39], Google Earth).

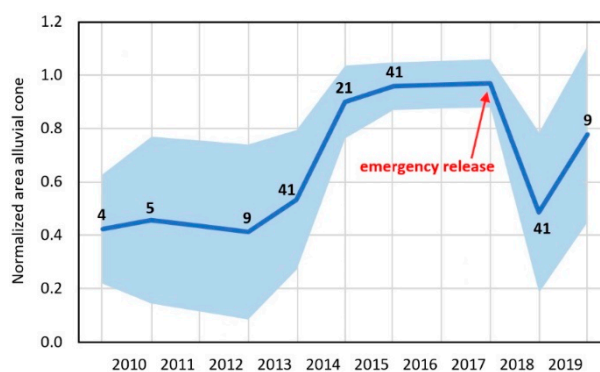
**Figure 13.** Evolution in the normalized area of alluvial cones—calculated as a fraction of the maximum extent of the alluvial cone—up to RK150. A total of 41 alluvial cones were mapped at different time steps according to the (non-continuous) availability of high-resolution satellite images in Google Earth (no data were available for hydrologic years 2011, 2016 and 2017). The number of studied alluvial cones is indicated for each time step.

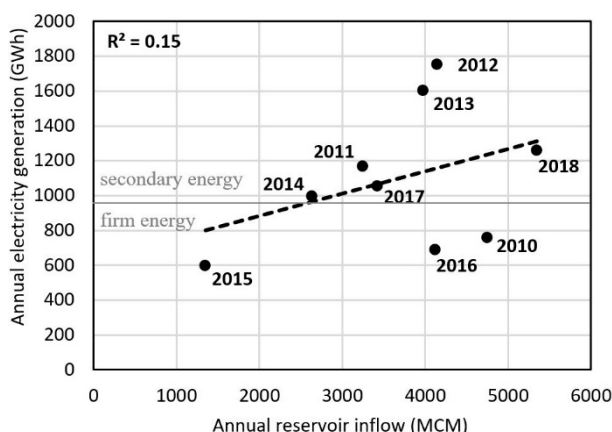
**Figure 14.** Correlation between annual reservoir inflow and annual energy production.

Although most studies on the impact of climate change consider a positive correlation between reservoir inflow and electricity generation, energy production was only slightly correlated with the annual reservoir inflow for the Tekeze Reservoir ( $R^2 = 0.15$ ) (Figure 14). However, correlations are markedly higher for years with below-average reservoir inflow ( $R^2 = 0.91$ ) than for those with above-average inflow ( $R^2 = 0.06$ ) (although there is a limited amount of observations only). This shows that no full use was made of above-average reservoir inflows, whereas below-average inflows have directly impacted the amount of electricity generated (as is also modelled by Basheer et al. [60]). The latter is not really surprising as the effect of low flows can be quite pronounced in annual-storage reservoirs [31] (Tekeze Reservoir active storage =  $1.56 \times$  annual inflow) and in case of the Tekeze Dam, the operators have to deal with extreme uncertainty produced by inter-annual inflow variability (e.g.,  $I_{2018} = 4.42 \times I_{2015}$ ). The observed poor correlation consequently also highlights that water availability in the reservoir is not the only limiting factor for electricity production. For the Tekeze Dam, the frequently recurring technical issues probably were as equally important. Yet, during the water release from the MLOs in the months of May, July and August 2019, EEP continued to generate electricity at the same time, although this could induce serious damage. From this, it is clear that electricity generation in the short-run is prioritized over sustainable and reliable dam operation in the long-run, which can be considered a “high-risk–high-reward” type of behavior. In order to improve future dam operation, the focus consequently should be on optimal reservoir management in combination with solving of the frequently occurring problems in a sustainable way, while respecting downstream riparian water users and ecosystems.
