The Terraces of the Anti-Atlas: From Abandonment to the Risk of Degradation of a Landscape Heritage

Mohamed Sabir

Citation: Sabir, M. The Terraces of the Anti-Atlas: From Abandonment to the Risk of Degradation of a Landscape Heritage. *Water* **2021**, *13*, 510. <https://doi.org/10.3390/w13040510>

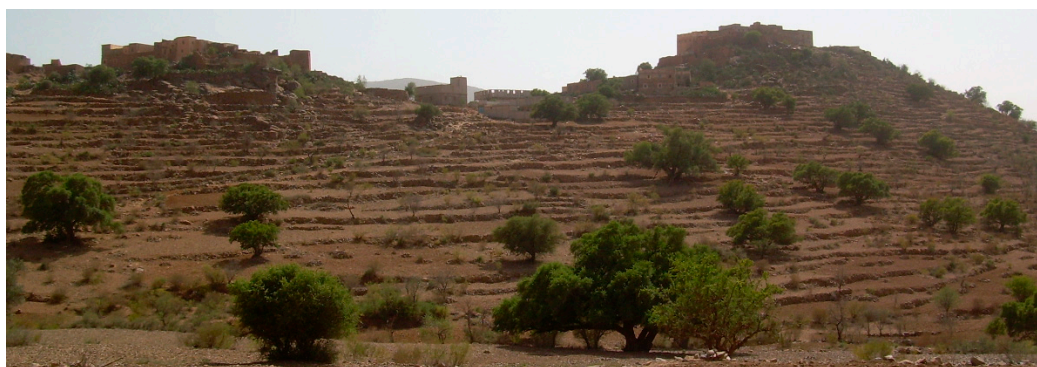
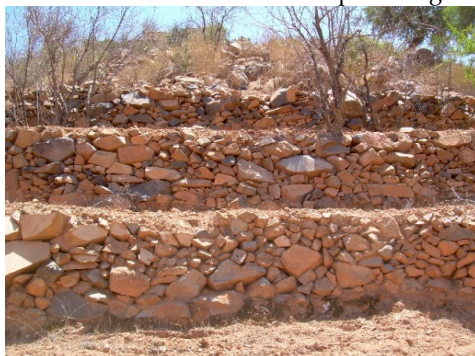
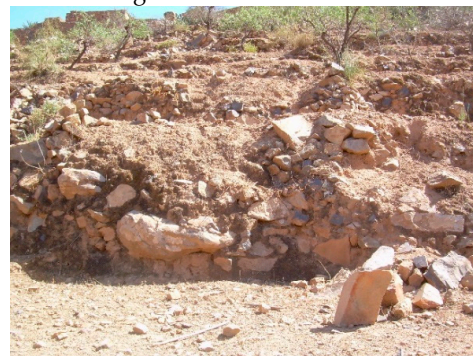
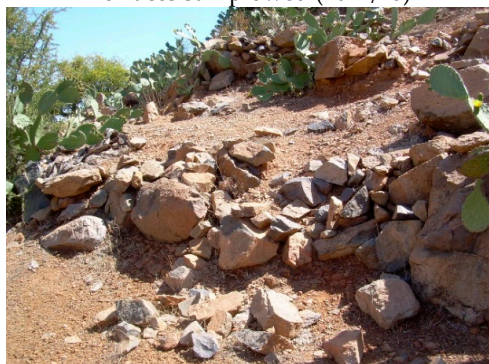
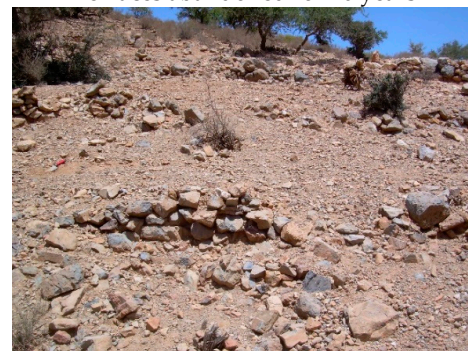
Slope managed in terraces near the villages.

Terraces still plowed (2017/18)

Terraces abandoned for 10 years

Terraces abandoned for >20 years

Terraces abandoned for >50 years

Figure 3. States of the terraces in the territory of Tizerkine–Timzemzit.

The abandonment of terraces is, therefore, not a recent phenomenon in this region. However, it is now that the negative consequences for the soil and the landscape are starting to appear and are becoming spectacular. Other authors have shown it in the Anti-Atlas as well [17]. The abandonment of terraces, mainly due to social driving forces (little exchange between generations and emigration) rather than natural or ecological (droughts or a lack of water resources), is leading to land degradation and the loss of an important cultural heritage (Figure 3).

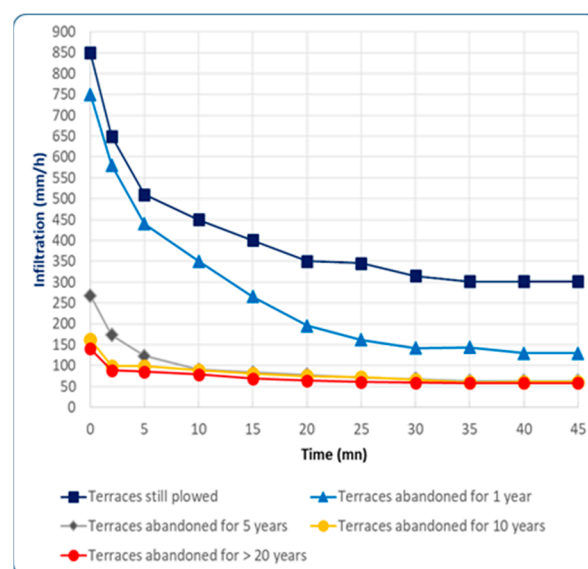
Figure 4 shows the change in the water infiltration capacity (if, mm/h) in the soil as a function of time for the different abandonment ages studied. It is notable that the abandonment of the terraces reduces, in addition to the final infiltration capacity, the volume of water infiltrated over time in a drastic manner. The rate of infiltration stabilizes from the 25th minute for 1 year of abandonment at a very low rate compared to that for terraces still plowed. For 5 years of abandonment, the threshold is reached from the 10th minute. Even more impacted for the ages of 10 and >20, it reaches the plateau at 5 min with a very low value of around 60 mm/h. These reductions are explained by changes in the surface conditions of the soils of abandoned terraces: surface closure (crust), compaction, less vegetation and litter. With the reduction in infiltration capacity, the abandoned terraces over large areas are believed to be responsible for the increasingly flashing, intense and frequent floods in the Anti-Atlas and the surrounding plains.

Figure 4. Water infiltration curves in the soil according to the age of abandonment of the terraces in the village of Tizerkine and Timzemzit, Ait Baha, Western Anti-Atlas, Morocco.

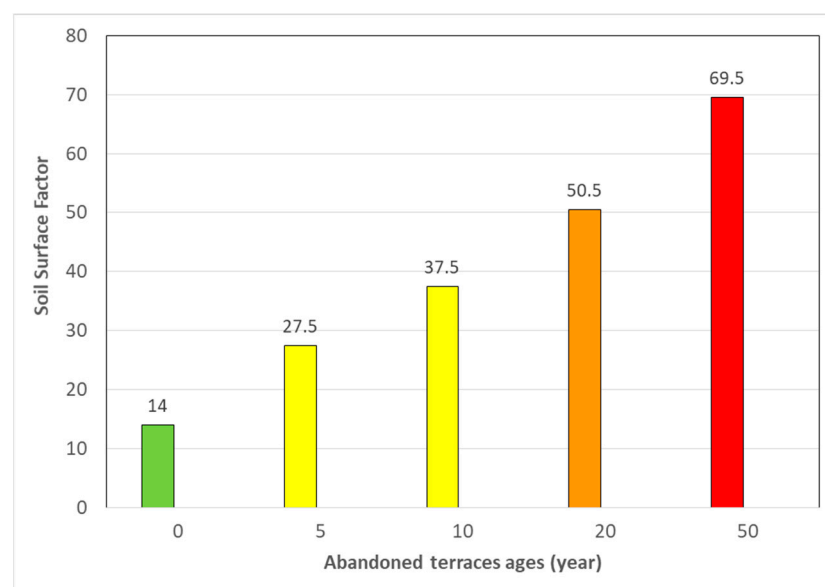
The results of the qualitative method of PAP/CAR [13] show that the longer a terrace has been abandoned, the more active the erosion process. Thus, a plot with a wall in good condition will have a stable degree of erosion. The initial stage of the erosive process on plots with degraded walls is characterized by the appearance of white spots and a sparse and undeveloped distribution of rock fragments. The diffuse runoff appearing on the abandoned terraces washes the surface of the soil and carries away fine elements and organic matter. The stones appear and become numerous on the surface. Therefore, in just 5 years of a lack of maintenance, a plot may already have a degree of erosion, but low. After 20 years, the signs of erosion (the accumulation of stones, the abrasion of the surface layer of the soil, and rills) double in intensity, and we reach a moderate erosion stage. Linear erosion becomes active through rills, which can develop into gullies, due to the concentration of runoff. Finally, after 50 years of neglect, the soil surface factor, "SSF", is multiplied by five, and the intensity of the erosive process reaches a critical stage characterized by the frequent presence of gullies. Some abandoned slopes are transformed into badlands (Figure 5).

Figure 5. The average change in the SSF according to the years of abandonment of the terraces in the hamlets of Tizerkine and Timzemzit, Ait Baha, Western Anti-Atlas, Morocco.
