Article

Physical Model Study of an Intermittent Rainfall-Induced Gently Dipping Accumulation Landslide

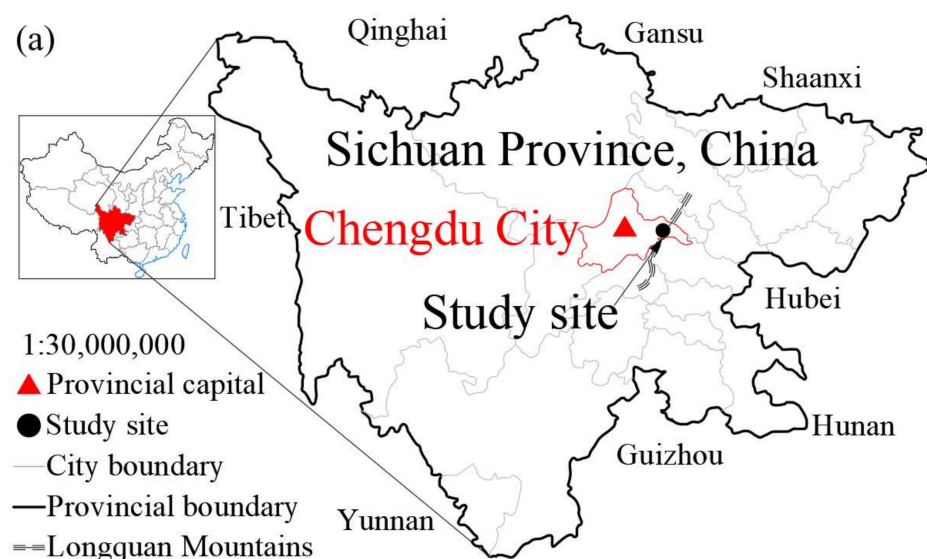
Figure 1. (a) Location of the study area; (b) first failure in 2015; (c) second failure in 2018; and (d) photograph of the Yingtaogou landslide.

Longquanyi District is located in the middle of the Longquan Mountains, 28 km east of Chengdu City (Figure 1a). In this region, the mountainous area is about 12 km wide, and the ridge is 20 km long, accounting for 40% of the area. Landslide hazards are frequent and very destructive in this area. More than 30 landslides of gently dipping accumulation slopes have occurred over the past eight years. The locations of these landslides are mainly distributed over the front side of the mountain. For instance, Zhongjiashan landslide has a slope length of 192 m, width of 70 m, and a volume of 87.360 m³ [21].

Data from the Yingtaogou Landslide Survey Report shows that the first local failure occurred at the foot of the slope in June 2015 (Figure 1b), and that the deformation was controlled after backfilling and drainage treatment. The slope began to slide again in stages

due to multiple rainfall events in June 2018 (Figure 1d), and the failure characteristics are consistent with those of the model slope (Figure 10d). During the model test, many micro-cracks appeared on the slope. These quickly opened and connected as the adjacent soil failed, forming the boundary of the next landslide (Figure 12). Figure 13 shows that the pore pressure at the toe of the slope (S1) increased during the interval after the slope toe cracked. This shows that the cracks enhanced the infiltration capacity of the slope surface runoff and the drainage capacity of the slope. During drainage, fine particles in the middle and upper soil were deposited in the cracks and invade the sliding zone, leading to differences in the permeability of each layer of soil (Figure 10d). On site, numerous tension cracks were observed on the slope surface (Figure 15a). A section of one of these cracks was obtained by slope cutting, as shown in Figure 15b. Although the physical model is much smaller than the actual slope, these deformation and failure features are similar, indicating that this test method is effective and that the test results are reasonable.

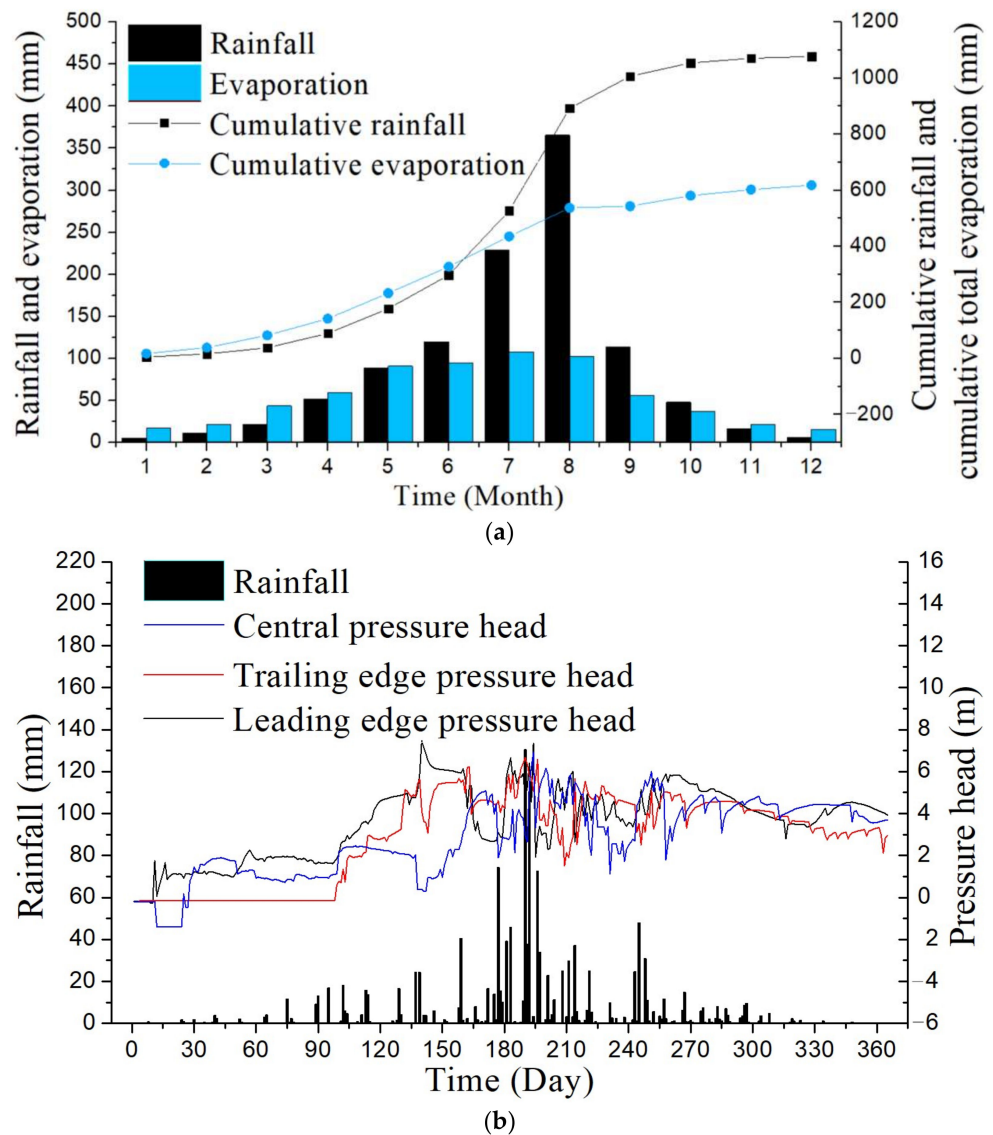
Figure 2. (a) Variation in evaporation and rainfall for each month; (b) rainfall distribution and pressure head in 2018.

In this area, the average annual rainfall is 1077 mm, while the average annual evaporation is 668 mm. May to September are the months with the highest rainfall [1] (Figure 2a), therefore a large number of landslides of gently dipping accumulation slopes would occur during and after this period of time. The occurrence of landslides after heavy rainfall indicates that the shear strength of the accumulation layer changes throughout the infiltration of rainwater.

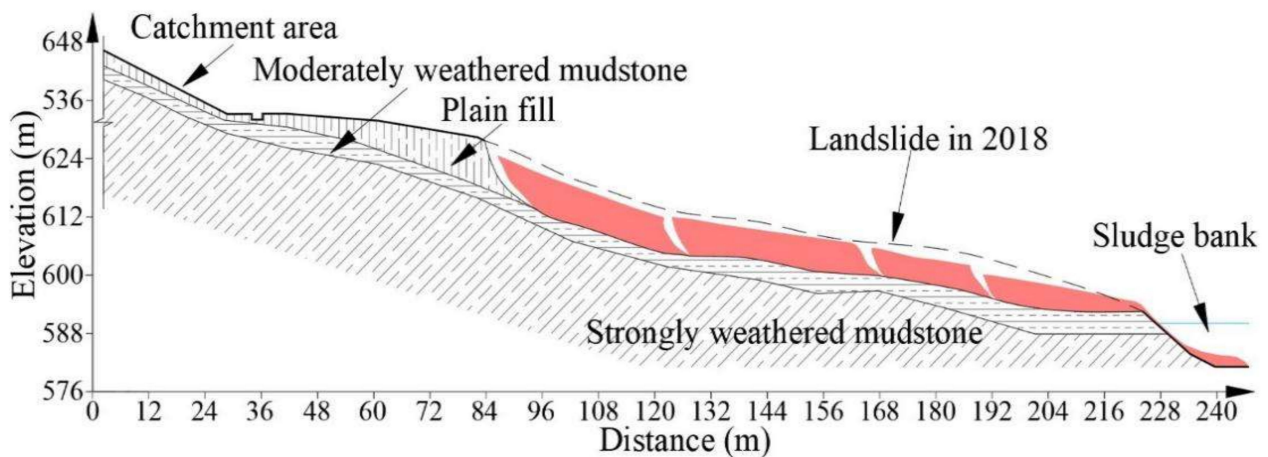
Figure 3. Landslide profile.

A new gently dipping accumulation landslide occurred at Yingtaogou on 23 June 2018. This landslide was located on a gentle slope (gradient: 0° – 16°) on the east side of the sludge reservoir in Longquanyi District (location: N $30^{\circ}39'07''$, E $104^{\circ}21'39''$) (Figure 1b–d). Figure 2b shows the daily rainfall data for Yingtaogou in 2018 and water table data obtained using numerical simulation [1]. This landslide was a typical retrogressive failure caused by intermittent rainfall, with an overall length of 200 m and height of 47 m. The deposition buried the exposed bedrock at the foot of the slope and further sliding occurred down to the sludge reservoir (Figure 3). The remaining deposition was distributed along the gradient slip zone in blocks (Figure 1d). The accumulation was composed of the Quaternary Holocene artificial fill layer and slope residual layer. The main components were silty clay, weathered sand, and mudstone fragments, with an average thickness of 6 m. The bedrock was composed of argillaceous sandstone from the Penglaizhen Formation of the Upper Jurassic. The main sliding zone was a thin clay layer (Figure 3). Several transverse tension cracks and landslide steps were observed at the surface of the landslide.

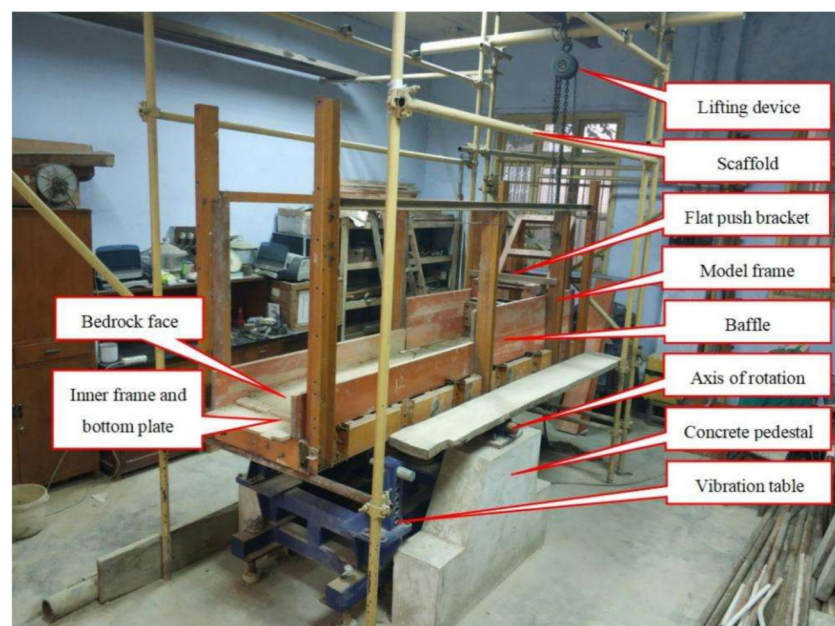
Figure 4. Model test bench.

Physical model tests were conducted using the self-designed landslide model test bench facility at the Key Laboratory of Mountain Surface Processes and Ecological Regulation, Chinese Academy of Sciences at the Institute of Mountain Hazards and Environment (CAS) (Figure 4). A rectangular soil box of length 3 m, width 0.5 m and depth 1 m with an adjustable longitudinal slope was used for the test. The axis of rotation and a lifting device were used to adjust the longitudinal slope of the soil box. The borders on both sidewalls of the model were made of transparent plexiglass and baffle. The test soil mix included barite grains, silty clay, mixed sand, surfactant, and talcum. Figure 5 shows the material composition ratio of the test soil. At the bottom of the test box, wood grids and silty clay were used instead of bedrock (Figure 6). A groundwater simulator was installed at the bottom of the soil box to control the water table. A slope surface runoff simulator was installed on the back wall of the tank to control the water flow on the slope surface. The upper accumulation layer was constructed using test soil with a moisture content of 30%. The model was assembled to form the final slope geometry (as shown in Figure 6), i.e., a slope model of length 2.3 m, width 0.52 m, height 0.3 m, and with 14° inclination angle.

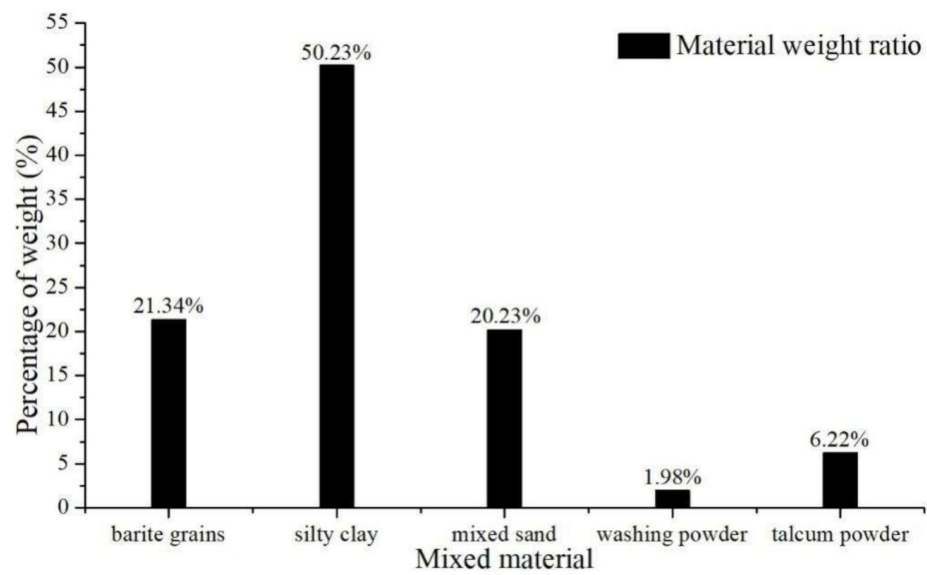
Figure 5. Composition and ratio of soil mixture.

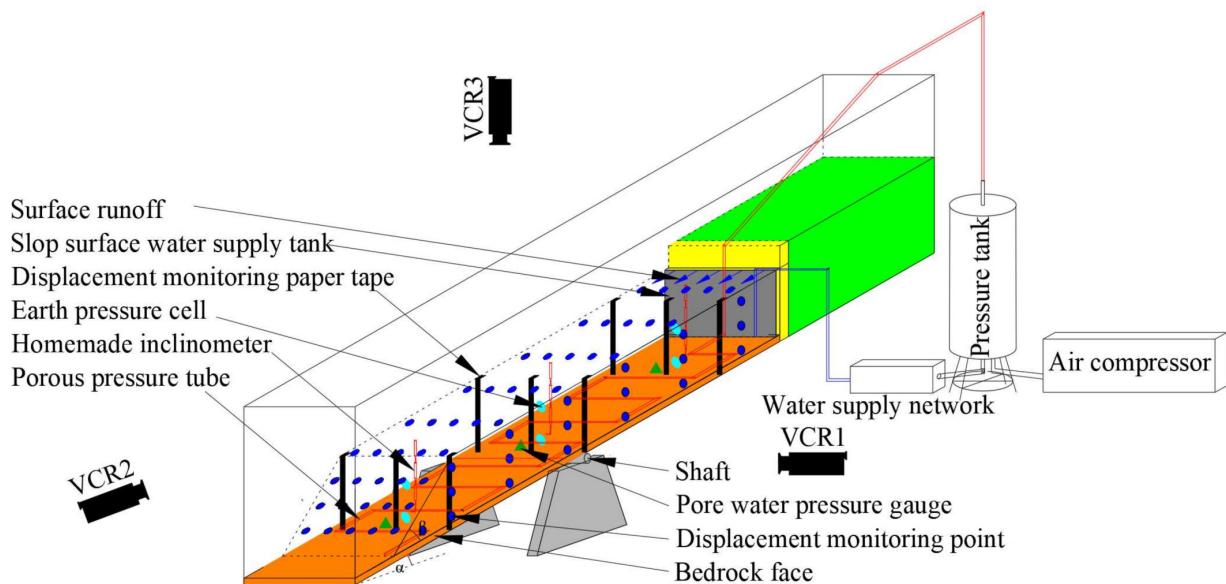
Figure 6. Schematic of the model.

The pore pressure transducers were cylindrical, with a length of 150 mm and a water inlet aperture of 18 mm. They were able to measure pore pressures of up 300 kPa, with a resolution of 0.1 kPa. The steel belt underwent bending with the deformation of the soil, and the relative displacement of the soil layers could be obtained from the strain gauges on the steel belt (Figure 6). The earth pressure sensor was a cylinder 25 mm in diameter and 15 mm in thickness, with a maximum measurement value of 200 kPa. Three digital cameras were used to capture the slow deformation and transient failure of the slope, and these were placed at the front, side and top of the soil box (Figure 6).

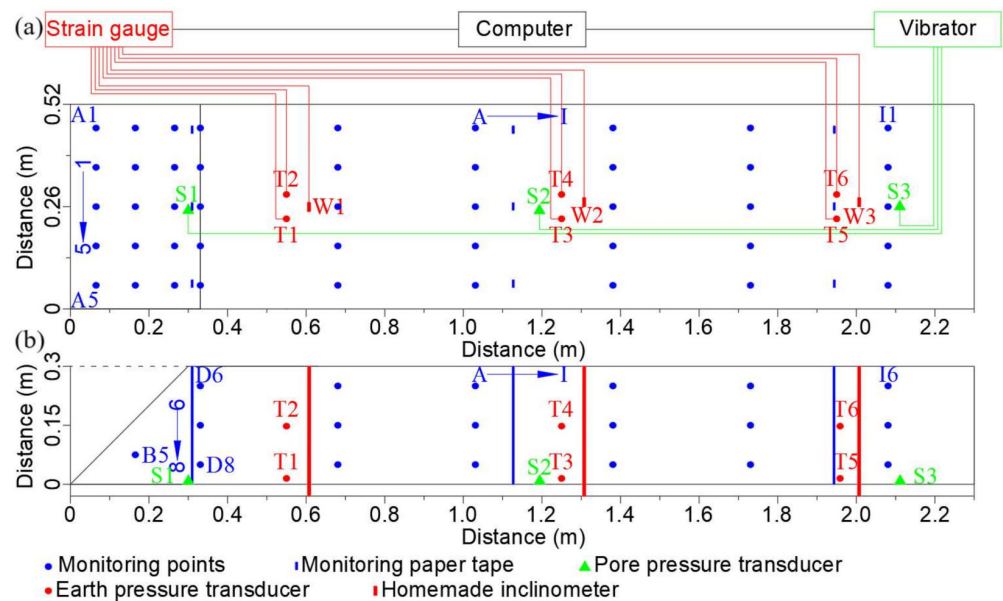
Figure 7. Distribution map of monitoring equipment (a) plan view; (b) side view.

The measurement system included an observation system, transducers, and an image capture system. The observation system used nine paper tapes and 45 monitoring points to monitor the displacement of the soil, and the exact locations are shown in Figure 7. The displacement of the paper tape and paper points was regularly measured to determine the deformation characteristics of the slope. Three pore pressure transducers (S1–S3), three inclinometers and six earth pressure transducers were embedded in the model over three longitudinal sections (Figure 7).

The position of the pore pressure transducer in the model is shown in Figure 7, in which S2 and the pressure gauge were used for water table control. The pore water pressure monitoring data is shown in Figure 13. The pore water pressure curves for the pore water pressure transducers S1 and S2 began to flatten after approximately 22 min of the test, indicating that the soil at the front of the slope was saturated. The S3 pore pressure curve at the rear of the slope began to flatten after approximately 28 min, indicating that the water table had stabilised. Over the course of the intermittent rainfall, the pore pressure curves at S1 and S2 increased and decreased periodically, indicating the generation and dissipation of pore pressure. However, the pore pressure at S3 in the back of the slope was almost constant. The first and the third local failures resulted in the pore pressure at S1 and S2 first increasing and then continuously decreasing, but there was no obvious response of the pore pressure transducers to the second local failure. This is because the first and third local failures were triggered near the pore pressure transducers, and the pore pressure transducer was pulled out after local failure.

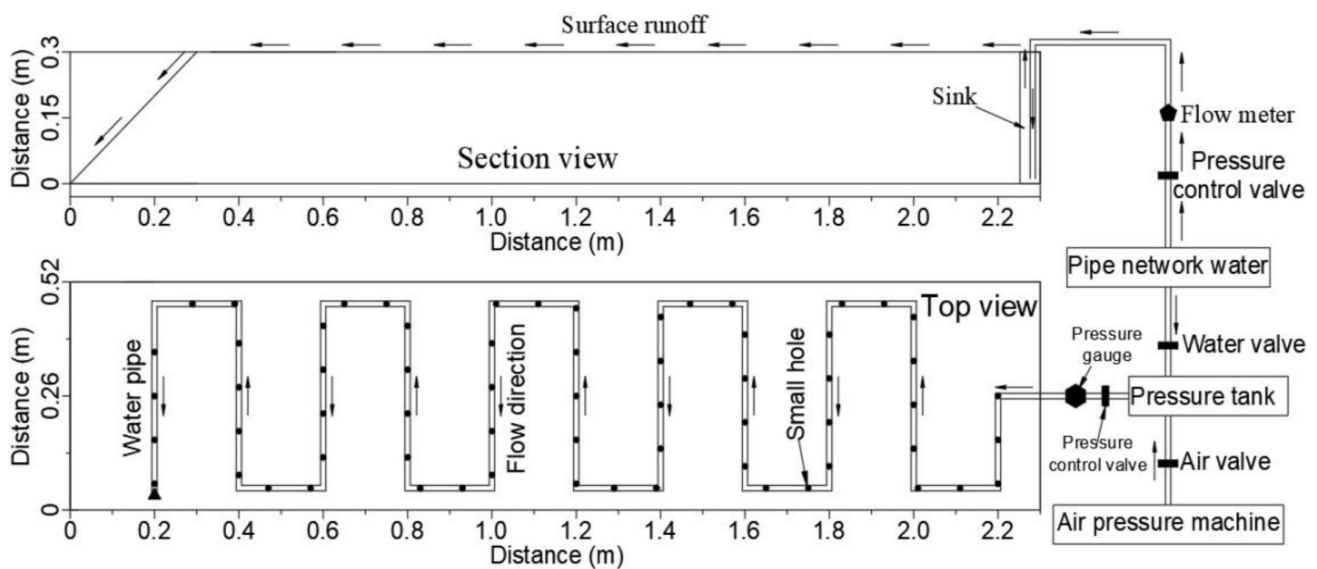
Figure 8. Equivalent rainfall simulation system.

along the cracks and flows within the basal layer until it emerges at the foot of slope. This has a strong influence on the water table of the accumulation layer slope under the action of intermittent rainfall (Figure 2b). Therefore, slope surface runoff and the water table are controlled instead of the impact of rainfall on a slope. (Figure 6). To simulate surface runoff caused by rainfall, a sink of length 52 cm, height 60 cm and thickness 3 cm was designed and placed at the back of the model slope (Figure 8). Rectangular holes 5 cm long and 1 cm wide were distributed over the upper wall of the sink. These holes were distributed so water in the sink could be discharged to the slope surface. The amount of overflow runoff could be controlled by the flow meter and pressure valve (Figure 8). To simulate the water table caused by rainfall, a perforated pipe of 10 mm in diameter was designed and embedded under the model slope (Figure 8). Two rows of holes 1 mm in diameter were distributed on both sides of the pipe, through which water in the pipe could be introduced to the slope. The water pressure in the porous pipe could be adjusted by air compressors, pressure tanks, and pressure valves to control the water table.

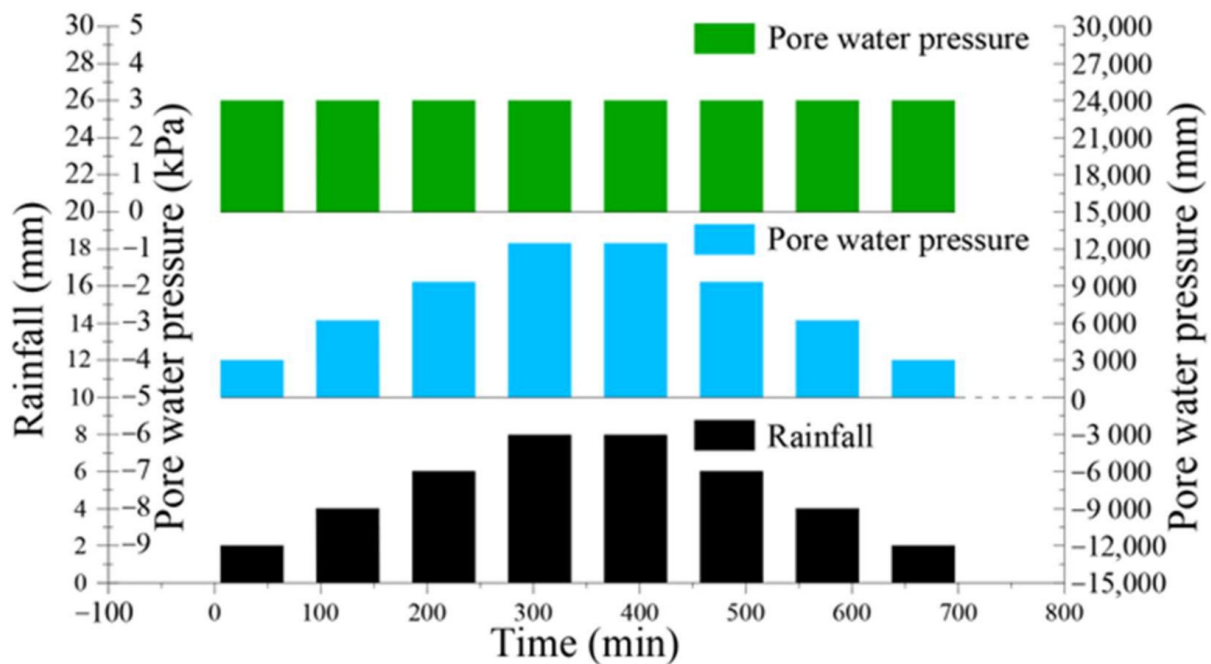
Figure 9. Intermittent rainfall test programme.

The runoffs for the model slope were calculated as 3120 mm³/min, 6240 mm³/min, 9360 mm³/min and 124,800 mm³/min, and the water table control pressure was 3 kPa (Figure 9).

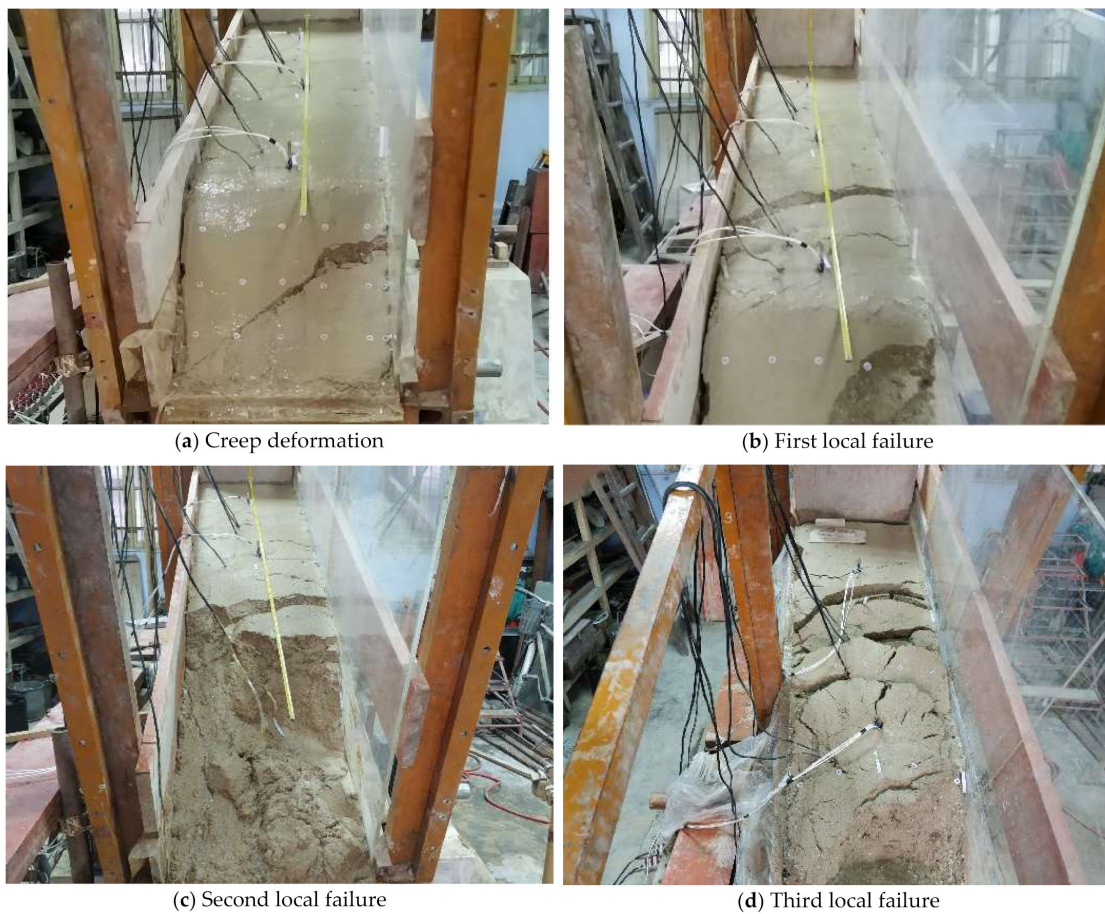
Figure 10. (a) 130 min, (b) 280 min (c) 340 min and (d) 600 min.

The slope subsided and gradually slipped during the intermittent rainfall test (Figure 10). The toe of the slope subsided during the first rain (Figure 11c,d), and the subsidence and slip increased rapidly during the period after the first rainfall, with slip and subsidence occurring at the foot of the slope and slip at the middle of the slope (Figure 11a,c). During the interval between 90 and 180 min of the test, the slip curve rose sharply, indicating that the model had entered a creep slip stage, and the maximum slip was 40.8 mm at the front surface of the slope. Between 180 and 340 min, the subsidence increased by 30 mm and the slippage increased by 57 mm at the foot of the slope (Figure 11). Between 340 and 430 min, the subsidence curve of the trailing edge of the slope, indicating that the trailing edge slope had reached a new equilibrium (Figure 11c,d). The trailing edge slope was deformed again after 430 min, due to failure of the middle slope. After 500 min, the displacement curve converged, indicating that the residual slope had reached a new equilibrium. There was a minor amount of slip and subsidence after 500 min (Figure 11).

In this test, no sudden local failure occurred during the first rainfall, even when the soil at the foot of the slope was fully saturated (Figure 10a). The first local failure occurred during the third rainfall period after the shear deformation of the slope foot and the formation of the main crack (Figure 11). Hence, the test results indicated that the sudden failure of the slope is not only related to the rise in the water table and the development of pore-water pressure, but also to the creep displacement, cracks and permeability of the slope. Although the rainfall and water tables changed during our physical model tests, the second and third failures both occurred in the interval during which the possibility of a rise in the water table was limited. Figure 11a,b show that the slope underwent long-term horizontal shear deformation at the position of the sliding belt before local failure. This provides evidence that the influence of the rise in the water table can be eliminated during the model test. It may be speculated that these local failures are caused by liquefaction of the soil in the sliding zone due to shear deformation. The gradual decrease in earth pressure due to the shear deformation in the sliding zone in test results confirms this hypothesis. Firstly, this physical model test showed that transverse tension cracks are first formed on the slope, and that the first local failure is triggered at the toe of the slope. Following this, the second local failure at the front of the slope is triggered. Secondly, the third local failure is triggered in the middle of the slope. Finally, the main cracks spread to form multiple sliding steps and sliding surfaces on the slope. These processes are characterised by regressive landslides.

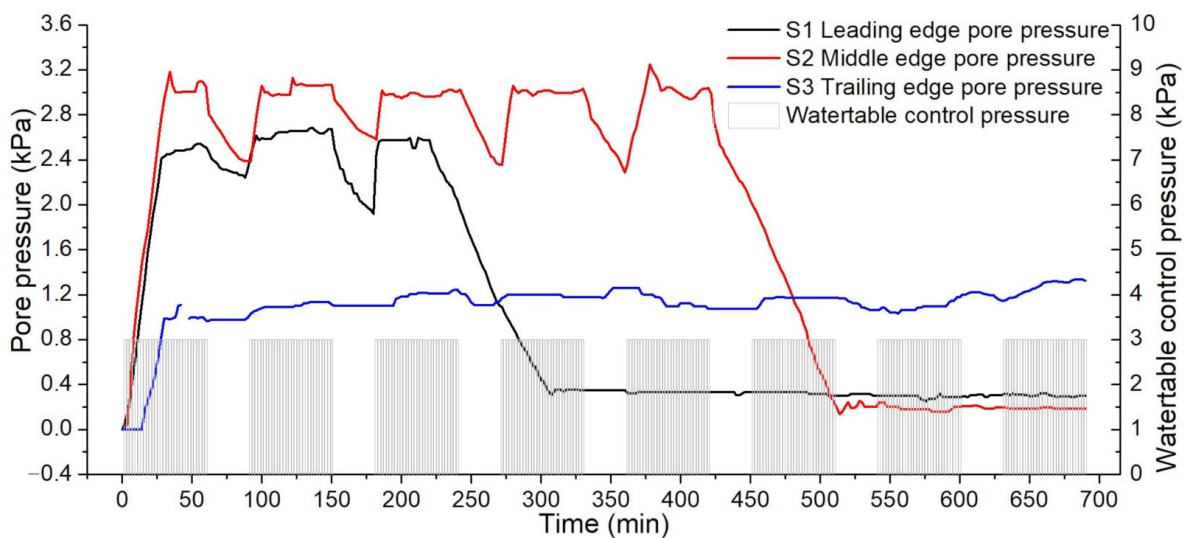
Figure 13. Pore water pressure time history.

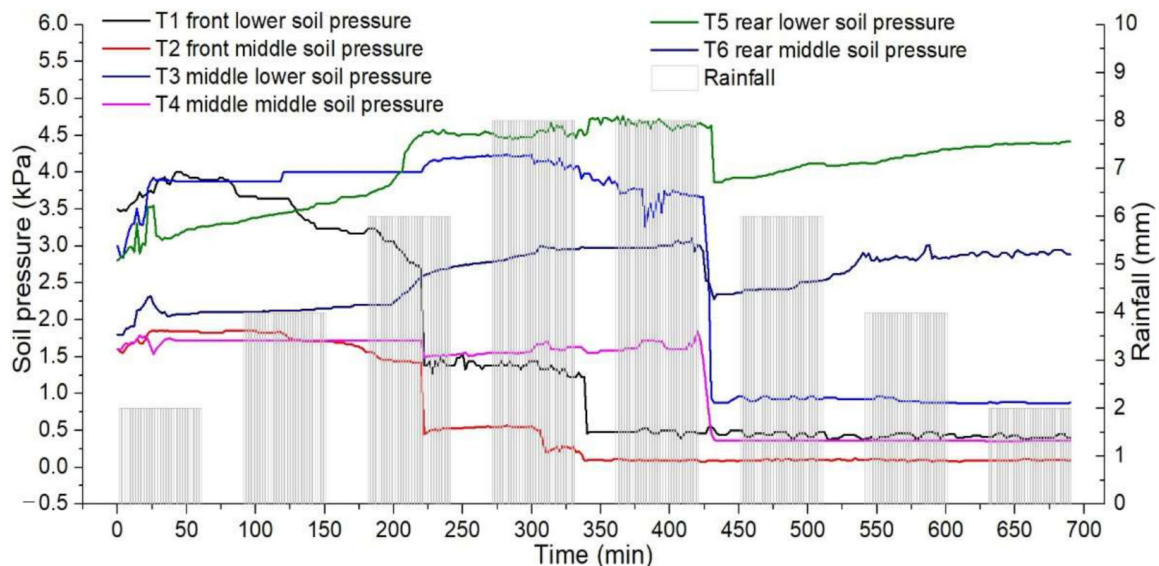
Figure 14. Earth pressure measurement time history.

The earth pressure data is shown in Figure 14. The earth pressure on the bedrock surface increased significantly, according to the all transducers, with the continuous rainfall at the beginning of the test. Following that, T1 and T2 showed that pressure decreased gradually, indicating the occurrence of local creep slip at the front of the slope. When the first main crack occurred (Figure 10a), T1 and T2 showed a sudden pressure decrease (Figure 14), which was due to the soil on the upper part of the transducers becoming separated by the main crack. When the second local failure occurred, the transducer T1 was pulled out and exposed to the air, causing the earth pressure at the S1 transducer to decrease rapidly, while the earth pressures at the transducers distributed at the middle and back of the slope did not change significantly. After the second local failure, the earth pressure on the middle bedrock surface (T3) decreased unsteadily until the third local failure occurred. When the third local failure occurred, the pressure on T4 (in the middle part) firstly increased rapidly, and it was pulled out during failure. At the same time, the earth pressure on T5 and T6 decreased suddenly, due to cracking of the rear slope. As the intermittent rainfall continued, the pressure on T5 and T6 gradually recovered, due to the gradual subsidence of the slope and the filling of cracks by the liquefied soil.

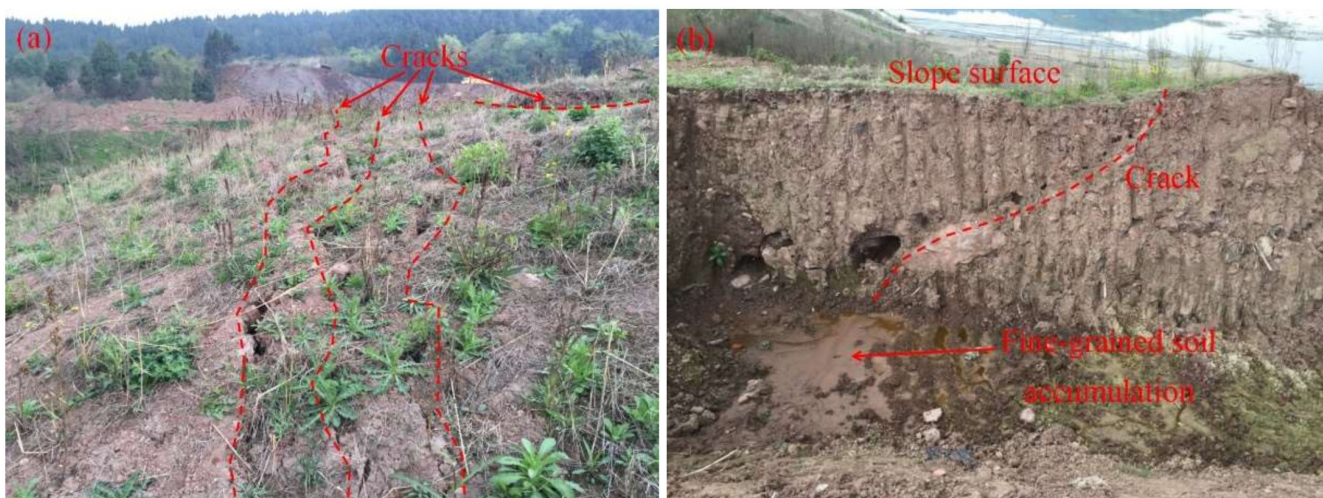
Figure 15. Characteristics of crack development before slope failure: (a) characteristics of slope surface cracks; (b) characteristics of section cracks.

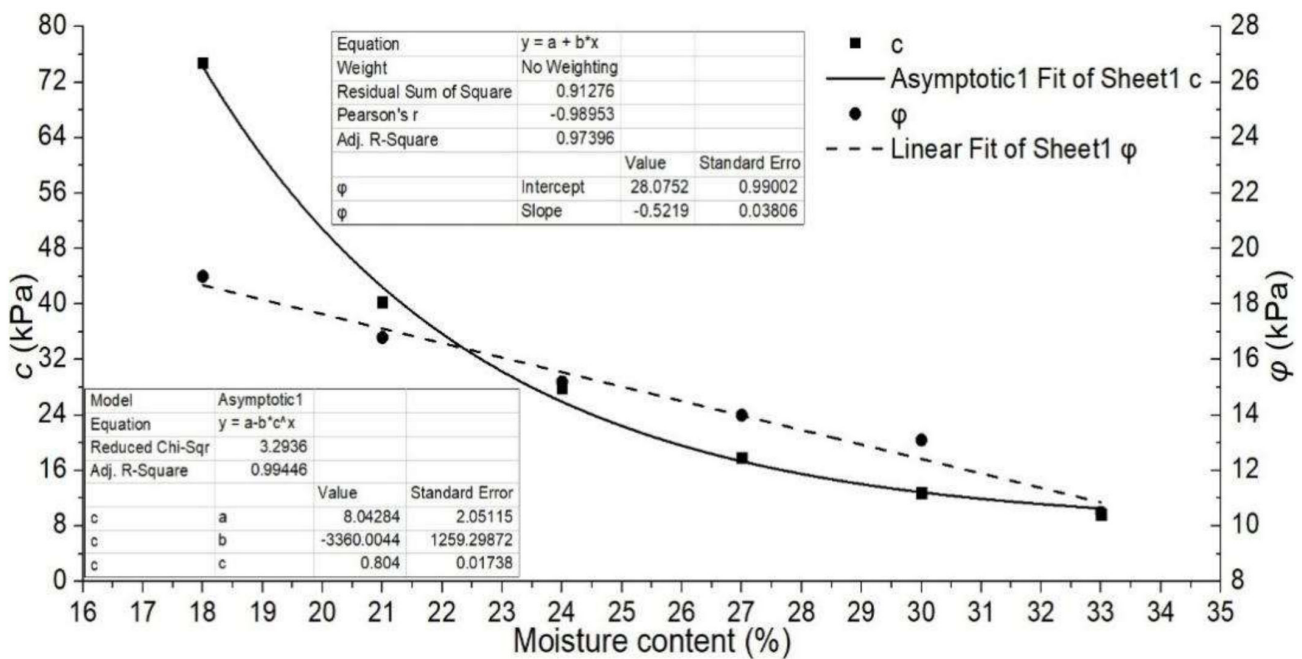
Figure 16. Relationship between soil moisture content of the slope and shear strength.

The reduced shear strength due to the increase in moisture content is insufficient to resist the sliding force, a highly unstable zone develops, and failure may be induced (Ram et al. 2014). This shows that the shear strength of the soil is important for the stability of the slope. The relationship between the soil moisture content of the slope and shear strength was investigated (Figure 16). The results showed that the shear strength parameters decreased rapidly with increasing moisture content. When the moisture was increased from 18% to 33%, the apparent cohesion decreased from 74.8 kPa to 9.7 kPa, and the internal friction angle decreased from 19° to 10.5°. Due to the decrease in shear strength, creep occurred on the slope. The uneven subsidence and shear creep deformations of the slope may be responsible for the micro-cracks on the slope surface. Vanapalli et al. (1996) obtained a simple equation for predicting soil strength through a large number of experiments:

Equation (1) indicates that the increase in soil weight, increase in pore-water pressure and decrease in suction have a major effect on the reduction in shear strength. The model test found that no local failure occurred when the soil was first saturated. That showed that the reduction in shear strength due to the increase in the degree of saturation was still sufficient to stabilise the slope. Figure 12 shows that the thickness of the saturated layer and the soil immersion time of the slope gradually decreased from the front edge to the rear edge due to intermittent rainfall and seepage. With an increase in the saturation time, the shear strengths for different initial dry densities and initial moisture content showed different decreasing trends. The larger the initial dry density, the smaller the initial moisture content, and the greater the drop in the shear strength of the soil sample. The decrease in the cohesion accumulation of soil after saturation was due to the softening and dissolving effect of water, which destroys the cementation of soil particles (Deng et al. 2013). The clay particles in the soil mass gather in the main cracks, slip zones and slope toe during the seepage process (Figures 10d and 15b). The shear strength and permeability of the soil decreased with the increase in the clay content [26].
