# Risk Reduction Measures and Monitoring Analysis of Deep Foundation Pit with Water in a Metro Station in Hefei

**Abstract:** The construction of an urban metro will inevitably involve deep excavation. Risk assessment before deep excavation, risk reduction measures, and real-time monitoring during excavation can effectively ensure the safety of deep excavation. Taking the deep excavation pit of Lingbi Road Station of Hefei Rail Transit Line 8 as the research object, this paper first analyses and evaluates the self-risk, groundwater risk, and surrounding environmental risk of the deep excavation pit, and gives the corresponding measures to reduce the risk of the deep excavation pit. Then, the monitoring content of the excavation process is determined according to the environment of the excavation, the hydrogeological conditions, and the type of supporting structure, and the monitoring scheme is designed. Finally, the entire excavation process is monitored in real time. By analyzing the monitoring data of 13 projects, such as horizontal displacement of the wall top, axial support force, groundwater level, etc., it is found that the monitoring values of 13 projects do not exceed the

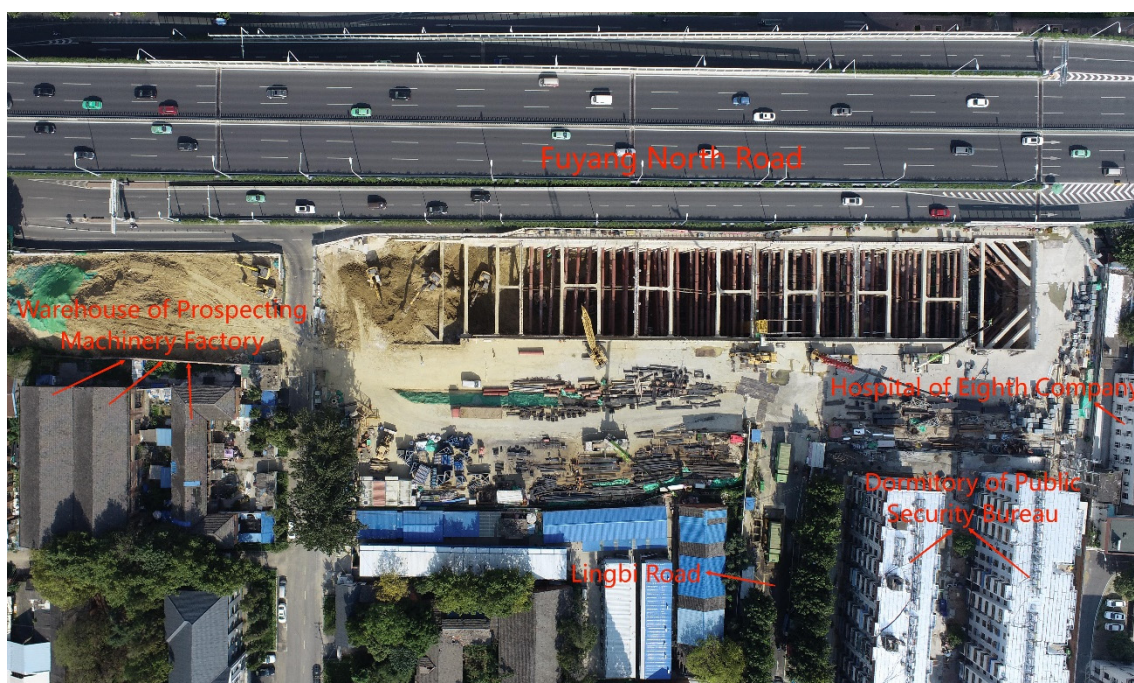
Figure 1. Surrounding environment plan of foundation pit.

Lingbi Road Station is the second station of the first phase of Rail Transit Line 8 in Hefei City, Anhui Province, China. The station is located at the intersection of Fuyang North Road and Lingbi Road, and is built along Fuyang North Road. The station is an open-cut underground three-story double-column and three-span island station. The east side of the station is Fuyang North Road viaduct. The northeast quadrant of the station is the dormitory of Hefei Prospecting Machinery Factory. The southeast quadrant of the station is Anhui Survey and Design Institute. The southwest quadrant of the station is the second dormitory of the Municipal Public Security Bureau. The northwest quadrant of the station is the warehouse of Hefei Prospecting Machinery Factory. The red line width of Fuyang North Road in this site is 60 m, which is the main road of the city. The viaduct of Fuyang North Road is laid along the road, and the deck width of the standard section of the viaduct is 25.5 m. The red line of Lingbi Road is 24 m wide and is a side road of the city. The surrounding plan of the foundation pit is shown in Figure 1.

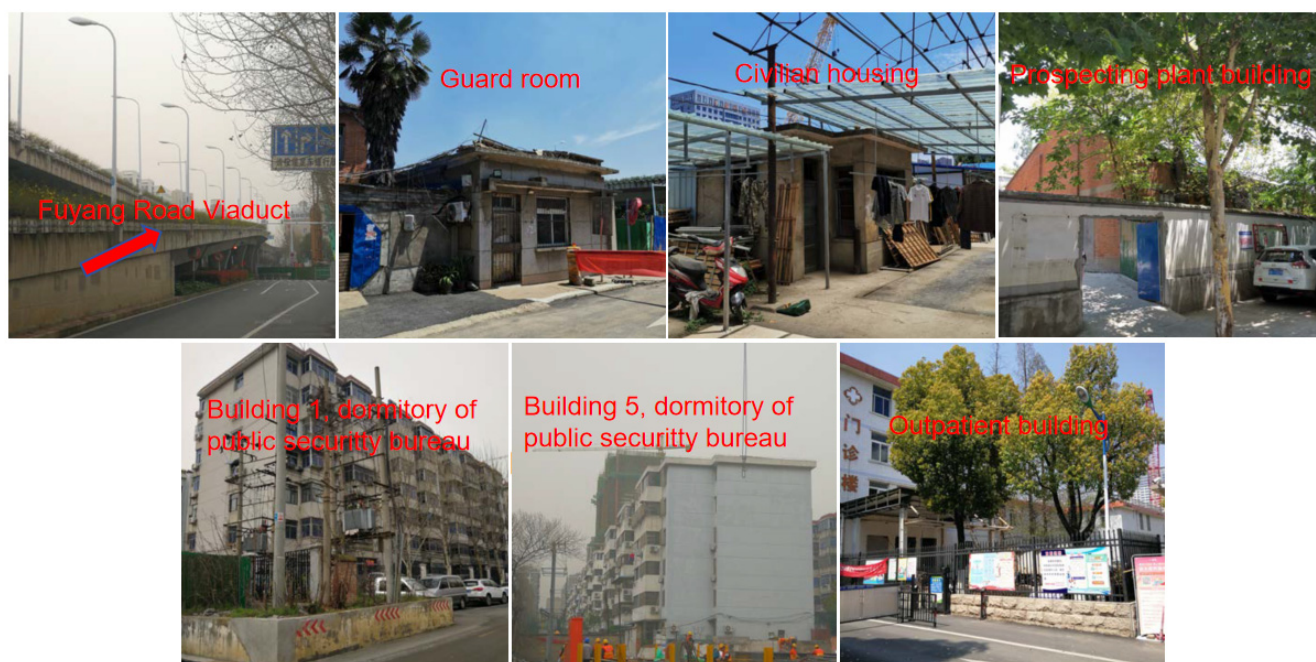
Figure 2. Fuyang Road viaduct and buildings around the foundation pit.

Fuyang Road viaduct (see Figure 2), the main bridge of Fuyang Road viaduct, is laid along the north-south direction of Fuyang North Road, and is located on the east side of the main body of the station. The bridge adopts pile foundation + cap foundation, the pile diameter is 1.5 m, the pile length is 39~41 m, and the bridge deck width is 25.5 m. The bridge piles of the main bridge are about 20.66 m closest to the main foundation pit of the station. The on-ramp bridge is laid along the north-south direction of Fuyang North Road and is located on the east side of the main body of the station. The ramp bridge adopts pile foundation + cap foundation, the pile diameter is 1.2 m, the pile length is 32~35 m, and the bridge deck width is 8.5 m. The nearest distance between the ramp bridge pile and the main foundation pit of the station is about 4.31 m. There is an abandoned civil air defense passage at the north end of the station and near the entrance and exit on the east side of the station, running east-west and north-south. The connecting channel is a brick arch structure with a buried depth of about 10 m, a width of about 2 m, and a height of about 2.5 m. The risk level of the foundation pit caused by the Fuyang North Road viaduct is level one.

The buildings around the foundation pit are shown in Figure 2. (1) The guard room of the factory building of Hefei Prospecting Machinery Factory is a brick structure on the first floor, about 25 m away from the main foundation pit of the station. (2) The private house is a one-story brick structure, about 43 m away from the main foundation pit of the station. (3) The factory building of Hefei Prospecting Plant is a one-story brick structure, about 39 m away from the main foundation pit of the station. (4) The No. 1 residential building in the second living area of Hefei Public Security Bureau is a seven-story concrete structure, and the closest distance to the main foundation pit of the station is about 32 m. (5) The No. 5 residential building in the second living area of the Hefei Public Security Bureau is a six-story concrete structure, and the closest distance to the main foundation pit of the station is about 29 m. (6) The outpatient building is a four-story concrete structure, about 14 m away from the main foundation pit of the station. The risk level of the foundation pit caused by the surrounding buildings is level two.

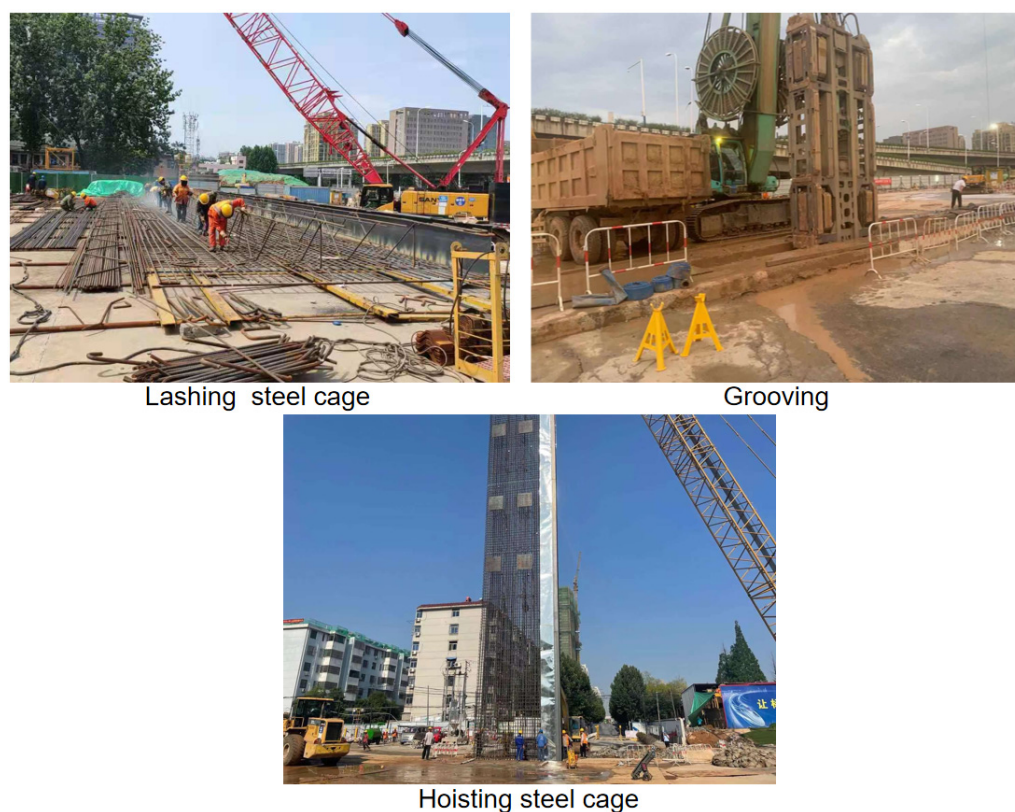
**Figure 5.** Construction picture of underground diaphragm wall.

The construction process of the underground diaphragm wall is shown in Figure 5. The horizontal displacement monitoring points at the top of the retaining wall are arranged in an array-like pattern along the perimeter of the foundation pit, with one measurement point every 20 to 40 m. It is advisable to place the monitors in the middle of each side of the trench, at the sun angles and near the shelter, and to place two monitors at each end-well on either side of the station. A total of 18 monitoring points are in place, with numbers from S1 to S18. The instrument used to monitor the horizontal displacement at the top of the wall is a Leica TS09 total station, and the monitoring map of the field is shown in Figure 6. Figure 7 shows the results of monitoring the horizontal displacement at the top of the wall.

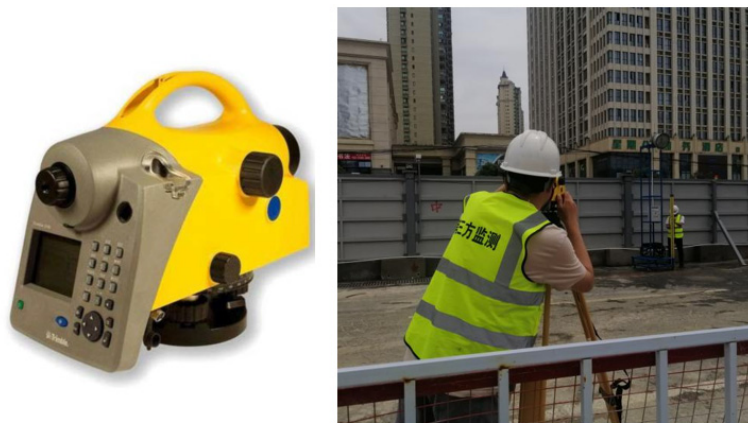
Trimble DINI03 electronic level Field picture of displacement monitoring

Figure 8. Field monitoring map of vertical displacement at the top of wall.

The vertical displacement monitoring point at the top of the enclosure wall and the horizontal displacement monitoring point at the top of enclosure wall are common points. The vertical displacement monitoring instrument at the top of wall is Trimble DINI03 electronic level, and the field monitoring map is shown in Figure 8. The horizontal displacement monitoring results at the top of wall are shown in Figure 9.

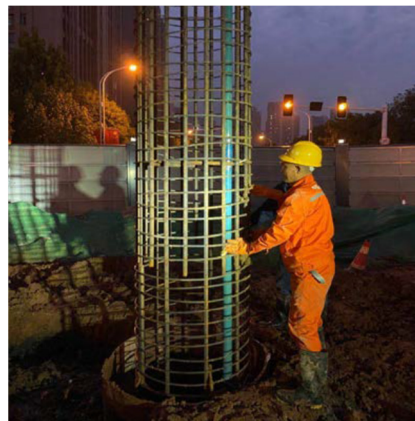
Figure 10. The actual picture of the laying of the inclinometer pipe.

The layout of the monitoring points for the deep horizontal displacement of the enclosure wall is the same as that of the horizontal displacement monitoring points for the top of the enclosure wall. The inclinometer pipe is fixed on the steel cage of the wall by direct binding, and after the steel cage is put into the groove, concrete is poured, as shown in Figure 10. A total of 18 monitoring points are in place, with numbers from T1 to T18. The deep horizontal displacement monitoring instrument of the wall is the CX-3C foundation pit inclinometer, and the field monitoring map of horizontal displacement in the deep layer of wall (see Figure 11). According to the importance of the location of the monitoring layer points, the monitoring results of the deep horizontal displacement of the four monitoring points T2, T4, T6, and T12 with the largest displacement are shown in Figure 12.

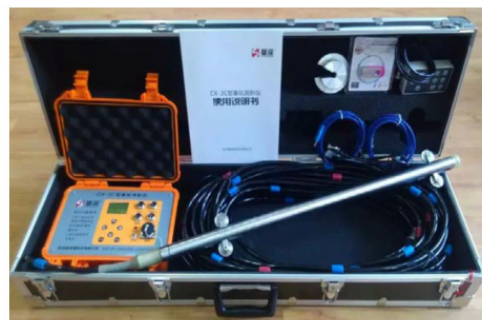
CX-3C inclinometer for foundation pit

Field picture of displacement monitoring

Figure 11. Field monitoring map of horizontal displacement in the deep layer of wall.

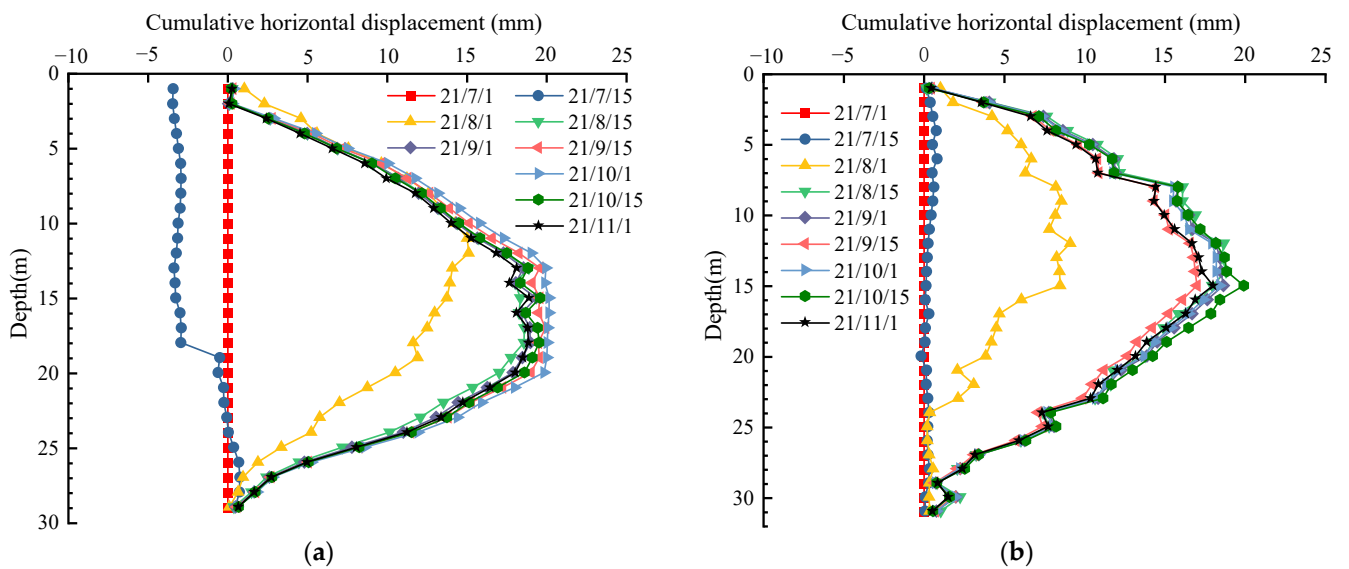
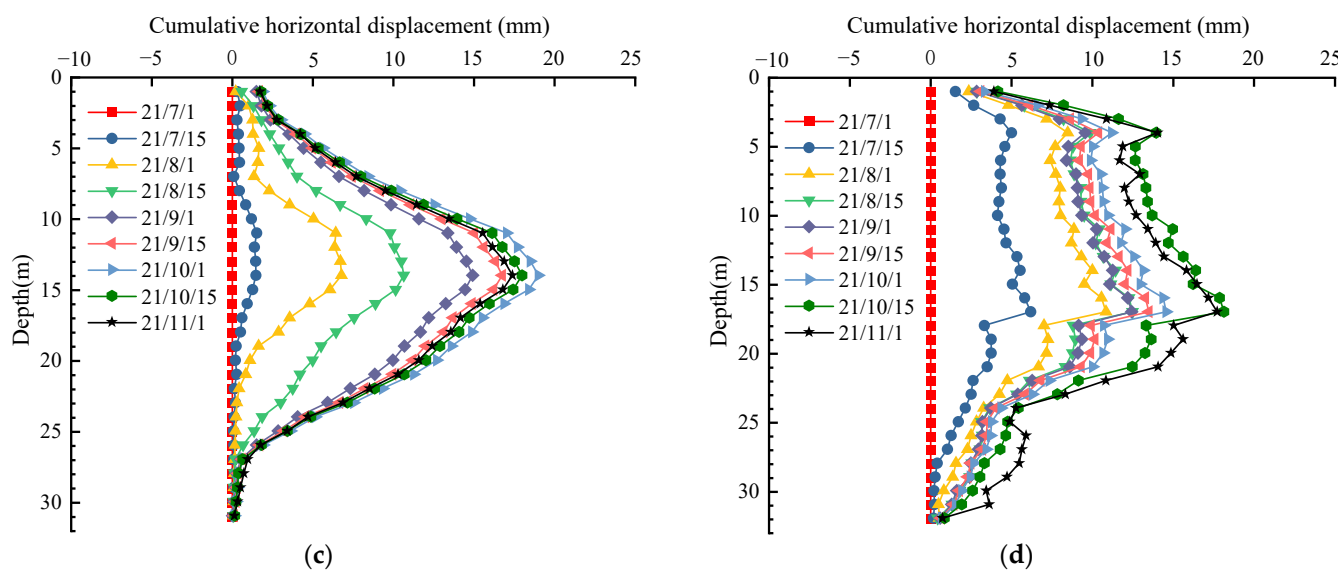
**Figure 12.** Time history curve of horizontal displacement in the deep layer of wall. (a) Time history curve of horizontal displacement in the deep layer of T2. (b) Time history curve of horizontal displacement in the deep layer of T4. (c) Time history curve of horizontal displacement in the deep layer of T6. (d) Time history curve of horizontal displacement in the deep layer of T12.

As shown in Figure 12, except for 1 July and 15 July 2021, the deep horizontal displacements of T2, T4, T6, and T12 monitoring points all showed a trend that is large in the middle and small at the ends for the rest of the time. The above rules also fully demonstrate that in the design of foundation pit support, the middle and lower parts of the foundation pit are the focus of the design. From Figure 12a, it can be seen that the maximum displacement of T2 monitoring point occurred at the buried depths of 15 m and 16 m on 1 October 2021, and the maximum displacement was 20.20 mm. From Figure 12b, it can be seen that the maximum displacement of T4 monitoring point occurred at a buried depth of 15 m on 15 October 2021, and the maximum displacement was 19.98 mm. From Figure 12c, it can be seen that the maximum displacement of T6 monitoring point occurred at the buried depth of 14 m on 1 October 2021, and the maximum displacement was 19.06 mm. From Figure 12d, it can be seen that the maximum displacement of T12 monitoring point occurred at a buried depth of 17 m on 15 October 2021, and the maximum displacement was 18.2 mm. Throughout the excavation of the foundation pit, the monitoring values of the deep horizontal displacement monitoring points of each wall did not exceed the control value (30 mm) specified in the code [22], which meets the design requirements.

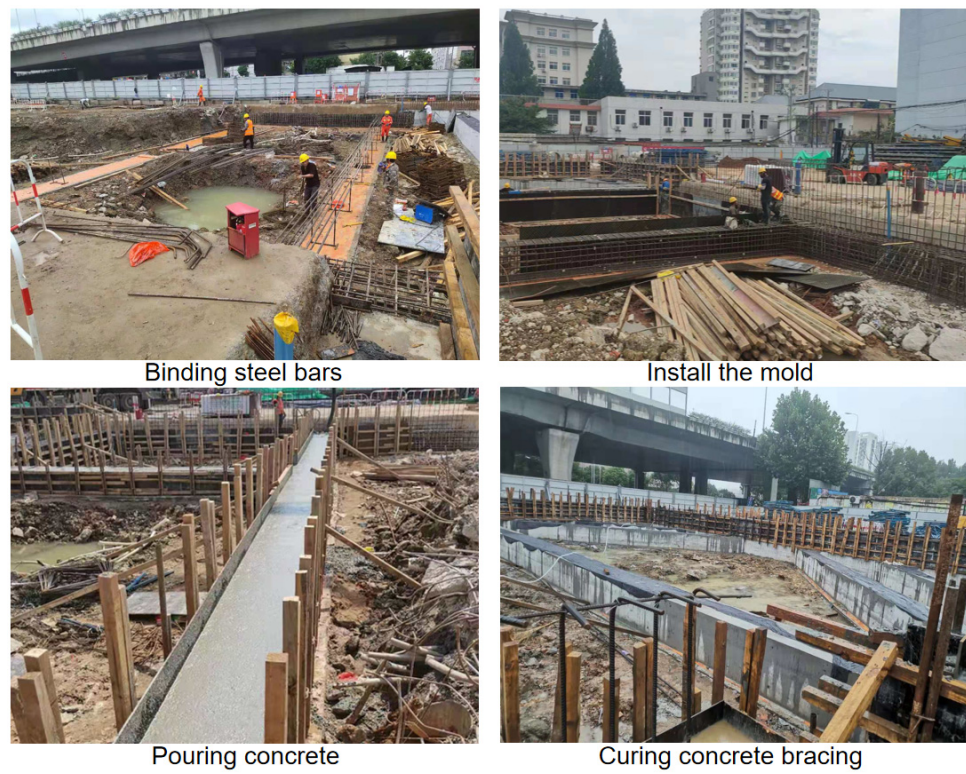
Figure 13. Construction process of the first reinforced concrete internal bracing.

The construction process of the first reinforced concrete internal bracing is shown in Figure 13. The number of monitoring points for each layer of bracing is not less than 10% of the number of each layer of bracing, and not less than three. Eight monitoring points are arranged for the first reinforced concrete bracing, numbered from ZC1 to ZC8. Eight monitoring points are arranged for the second steel bracing, numbered from ZC2-1 to ZC2-8, and the axial force meter of bracing is shown in Figure 14. The bracing axial force monitoring instrument is CTY-202 vibrating wire frequency reading instrument, and the field picture of bracing axial force (see Figure 15). Considering the importance of the bracing position, only the monitoring data of the first bracing and the second bracing are analyzed. Due to the damage of the second bracing monitoring point during the construction process, there are only four monitoring points that can obtain monitoring data. The monitoring results of the bracing axial force are shown in Figure 16.

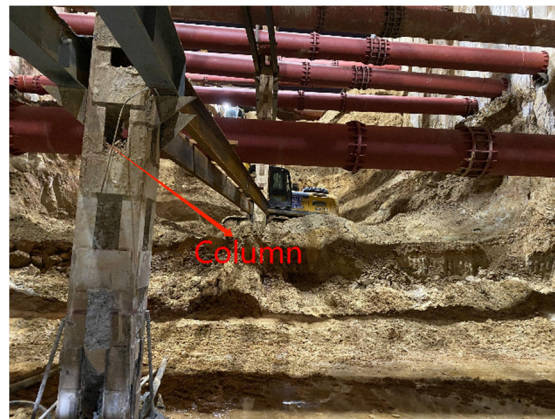
**Figure 17.** The construction picture of the column.

The construction picture of the column is shown in Figure 17. The monitoring number of column settlement shall not be less than 5% of the total number of columns, and not less than three. The column settlement monitoring point is arranged in the middle of the foundation pit and at the intersection of multiple bracings. The layout method is to paste the reflector to the top side of the column exposed by excavation. A total of nine monitoring points are in place, with numbers from L1 to L9, and the column settlement monitoring instrument is TS09 total station. Due to the destruction of some monitoring points in the process of construction, there are only four monitoring points that can read the data. The monitoring results of column settlement are shown in Figure 18.

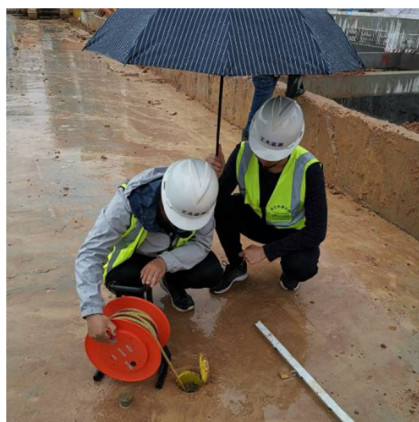
**Figure 21.** Field picture of groundwater level.

The groundwater level monitoring points are arranged around the foundation pit, and at least one groundwater level observation hole is arranged on each side of the foundation pit. A total of seven monitoring points are in place, with numbers from W1 to W7. The SWJ-90 steel ruler water level meter is used to monitor the groundwater level, and the field picture of groundwater level is shown in Figure 21. Due to the destruction of two monitoring points during construction, there are only five monitoring points that can read the data. The monitoring results of building settlement are shown in Figure 22.
