Article

Hydrological Vulnerability Assessment of Riverine Bridges: The Bajo Grau Bridge Case Study

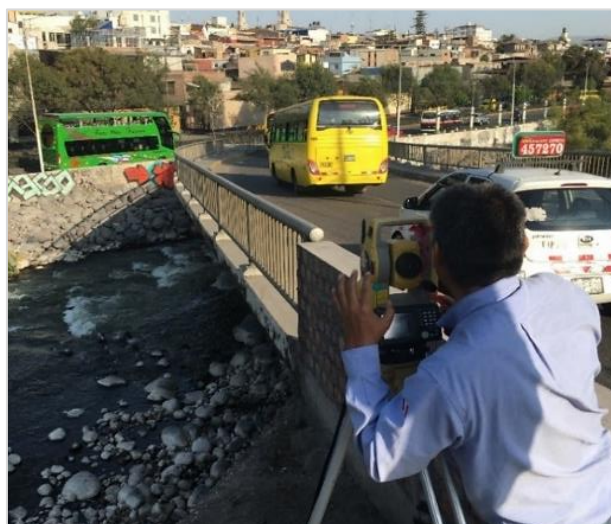
The information about the bridge was requested by the local city council. This included the design technical file, the location, architecture, and the structural plans of the bridge. However, not all of the information was available, as the design technical file and other documents had been lost. Thus, it became necessary to carry out a survey of the bridge and the riverbed to complement the insufficient information. Figure 1 shows a photograph of the survey carried out as seen from the highest part of the bridge, in the flow direction, from upstream to downstream. Additionally, a visual inspection was undertaken which revealed the erosion at the bottom of the bridge deck due to past flow impacts (Figure 2), and enabled information to be collected about the land use to get Manning's roughness coefficient along the channel [21]; a key data set for the vulnerability analysis.

Figure 1. Surveying of the bridge.

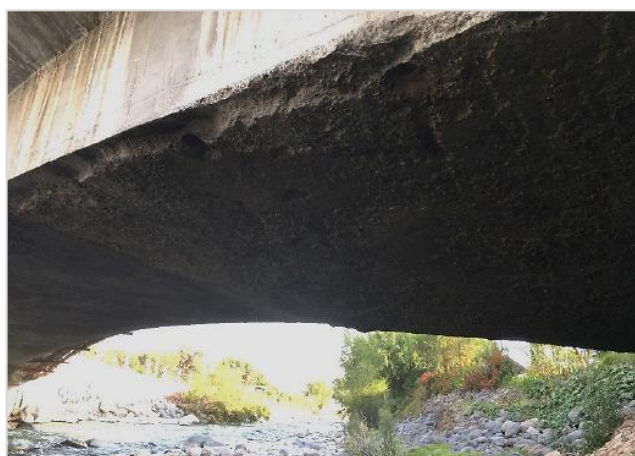
Figure 2. Erosion on the deck of the bridge.

The bridge is made of reinforced concrete, a resistant material. However, as evidenced in the visits to the bridge, it shows erosion due to the impact of the flow. That is why its vulnerability was determined as medium (rating of 2).

Through the inspection carried out on the bridge, it was observed that there is erosion in the lower part of the deck derived from the impact of the river flow. Similarly, the results for all critical scenarios translates into an impact on the deck; this supposes an incremental erosive process in such a way that it increases the fragility of the bridge. Thus, the vulnerability is high (a rating of 3).

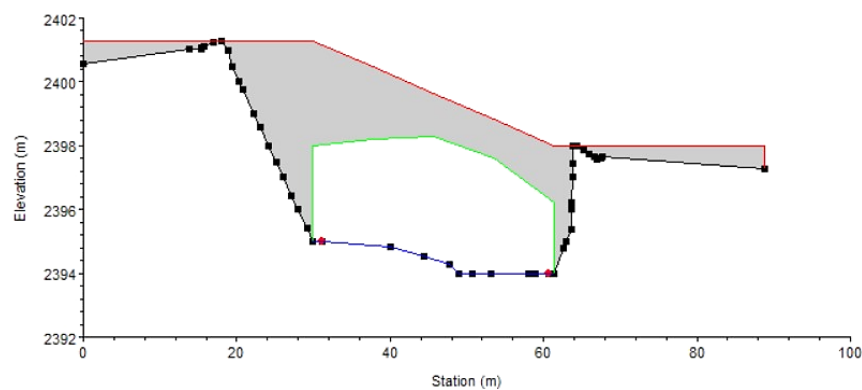
Figure 4. Cross section of the bridge.

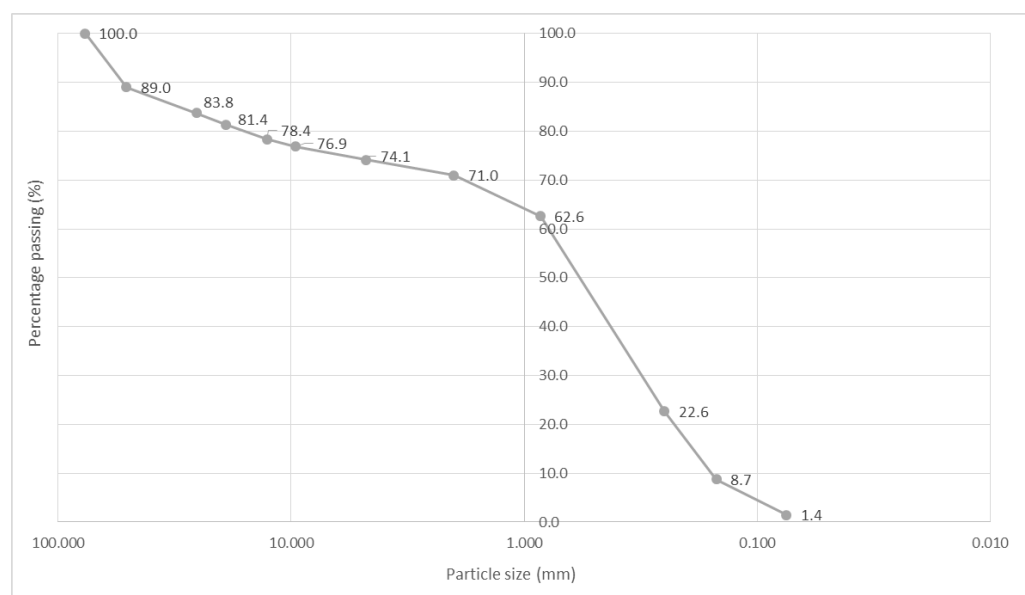
The particle size analysis resulted in obtaining the deciles of the soil based on the distribution curve. Sieves of 2", 1 1/2", 1", 3/4", 1/2", 3/8" (inches, Imperial units used), and mesh no. 4, 10, 20, 60, 100, 200 were used (Figure 5). Similarly, after a laboratory analysis, the other two soil properties were obtained. The moisture content was 27.5% and the specific weight was 2.65 g/cm³. These two properties, along with the parameters obtained from the particle size distribution curve, concluded the direct collection of data from the soil and the bridge, and were ready to be used as inputs in the next stages of the vulnerability analysis.

Figure 5. Particle size distribution curve.

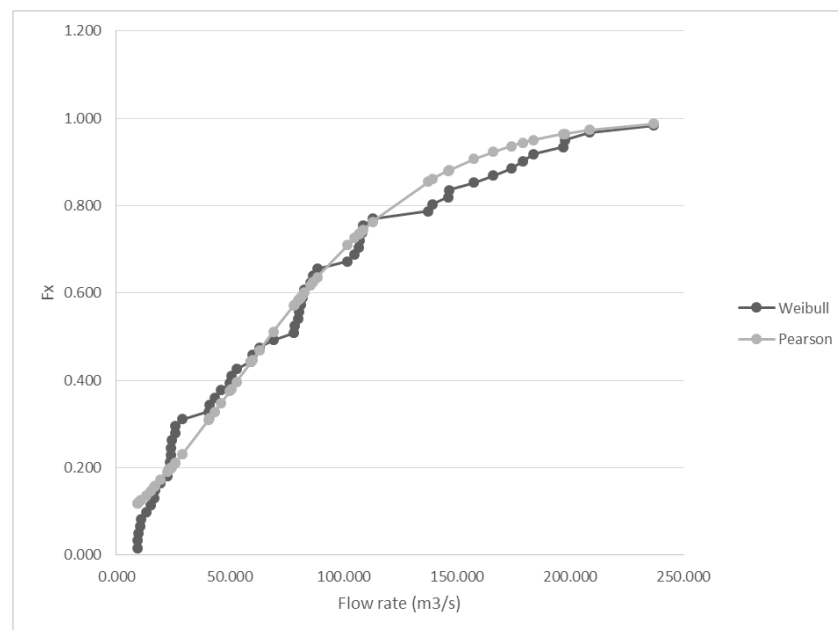
According to the analysis, the Pearson III distribution was the one that best fitted the hydrological data, as its *D* was lower than *d* and it was the lowest of all the other results. Figure 6 shows the Kolmogorov–Smirnov goodness of fit test with the empirical and the theoretical models.

Figure 6. Kolmogorov–Smirnov goodness of fit test.

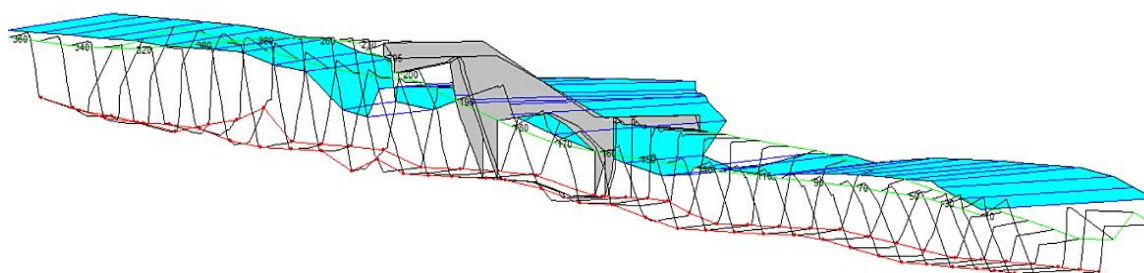
Accordingly, the model shown in Figure 7 represents the simulation of the most critical scenario, which has a flow rate of $Q = 500 \text{ m}^3/\text{s}$ and a flow area of 263.19 m^2 in the bridge section. As it can be seen, the water impacts the deck of the bridge, generating major flooding; the consequences are analysed in the vulnerability analysis.

Figure 7. HEC-RAS hydraulic simulation for scenario 6, with a flow rate of $Q = 500 \text{ m}^3/\text{s}$.

As presented in the models, the flow reaches the superstructure for every scenario. The deck should increase its height with respect to the Extraordinary Maximum Water Level. This variation in height also implies an increase in the length of the deck, as well as a change in its slope and possibly new features in the substructure, such as the placement of pillars. Hence, it is given a rating of 3.

It was observed that for a return period of 500 years, the water flow exceeds the cross section of the bridge, as well as the sections upstream, due to the fact that, among other factors, there is a contraction in that area. The result of the poor location of the bridge, as well as its geometry, is that it produces a flood on La Marina Avenue. Hence, this criterion was estimated as high (a rating of 4).

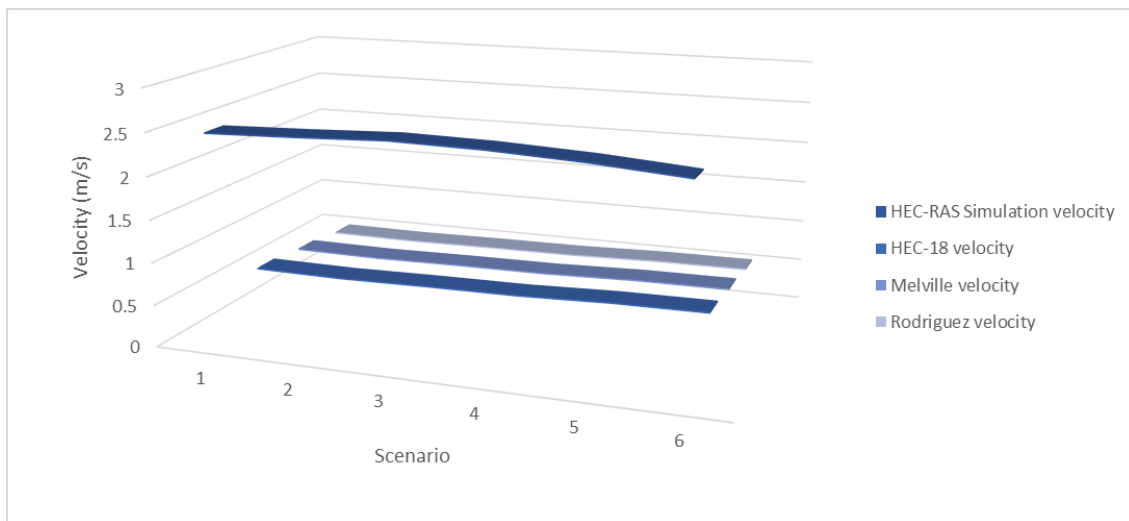
The erosive velocity is the parameter used to determine if the scour occurs in a live bed or clear water. A large number of the equations are based on this scour classification; therefore, it is necessary to determine it. It should be noted that scour depths in a live riverbed may be limited if there is an appreciable number of large particles at the bottom of the channel, in which case it is advisable to also use scour equations in clear water and choose a representative depth. As mentioned: (a) Clear water scour occurs when the erosive velocity is greater than the average velocity, $V < V_e$; and (b) Live bed scour occurs when the erosive velocity is less than the average velocity, $V > V_e$. Three methods were used to characterize the erosive velocity (Equations (2)–(4)); the comparison for the three calculation methods for D50 is presented in Figure 8. The scouring type is live bed.

Figure 8. Erosive velocity methods comparison.
