Article

A Low-Cost, UAV-Based, Methodological Approach for Morphometric Analysis of Belci Lake Dam Breach, Romania

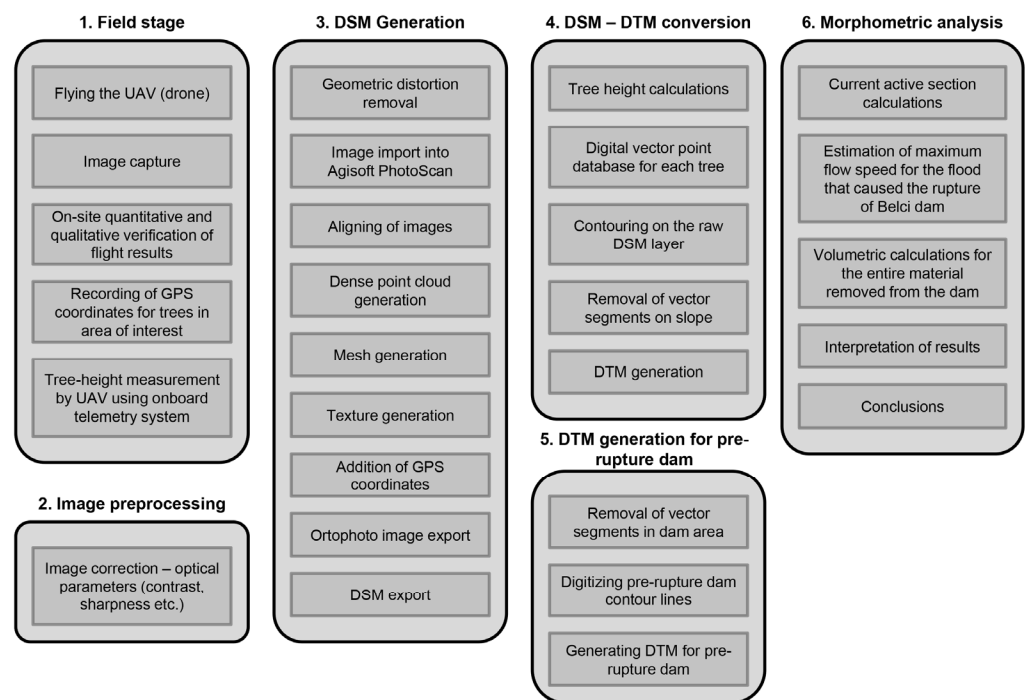
The present study involved several steps, from the field stage to the interpretation of the final cartographic materials generated. It started from the acquisition of aerial imagery, by means of a Phantom 2 drone, to examine the dam itself and to determine the height of certain trees from the left-side hilltop in the study area, which were then removed from the DSM. What followed was the pre-processing stage of these images, which involved making geometric corrections in order to facilitate their interpretation by the Agisoft software (version 1.4.0); to aid in generating a DSM layer, useful in the identification of the geometric elements present in each image; and to ensure a better connection between images and common items. The third stage involved semi-automatic processing by means of Agisoft PhotoScan Professional, during which the images were converted into a DSM and digital orthophoto layer with geographic coordinates. In recent literature, the DSM generated for a predominantly woody area is frequently described as a canopy height model (CHM), with the latter being of interest mainly in ecological and biometric studies [60–64]. Given that the methodology employed in converting the raw data into cartographic materials is based on regular, visible-spectrum images (and not LIDAR-type points, which would have generated pre-classified layers, eliminating the need for further corrections), a correction stage was applied to the DSM, in order to remove the arborescent vegetation located on the slope located to the left of the dam breach, which would have generated errors in calculating the area of the breach section and the volume of material removed, as a result of the 1991 flood. Following this, the DTM of the entire dam was also generated in order to highlight the difference between its current state and the dam state prior to the rupture (and to identify the values mentioned above). Once the cartographic materials were complete, the calculations were made, and the results were interpreted. Although these steps are, indeed, time-consuming and the methodology may seem fairly complicated, each stage contributes to the minimization of the number of potential errors (Figure 2).

Figure 2. Methodological approach of the morphometric analysis.

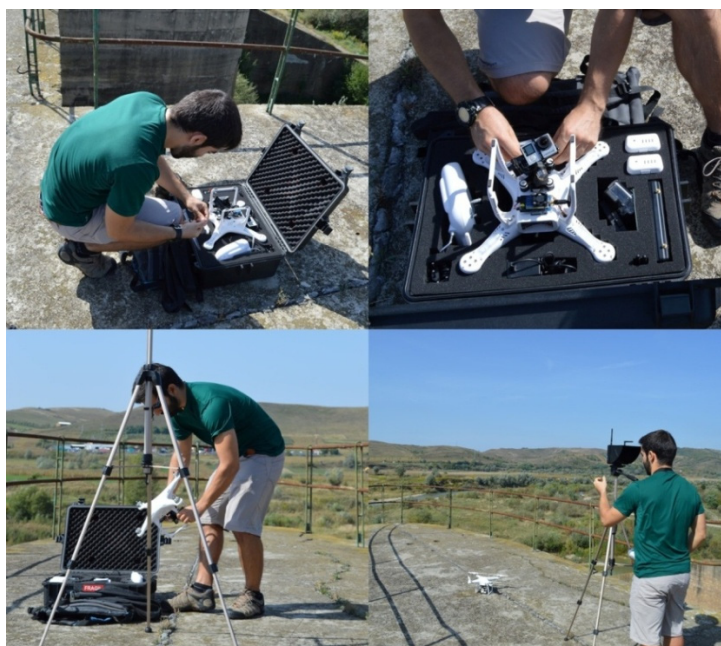
A series of procedures, carried out in a pre-established order, were necessary for the preparation of the flight so as to ensure the proper collection of aerial images. Weather conditions (visibility, wind, humidity, temperature) had to be adequate. The perimeter required for launch must be open, obstacle-free and high enough to guarantee a permanent signal to maintain remote control over the drone. After the necessary equipment is mounted, the camera is attached to the gimbal and adjusted, this is followed by the antenna of the FPV system, the propellers and then the drone battery. The ground station is composed of a double-channel FPV station and a remote control (Figure 3).

Figure 3. Preparation of the flight equipment.

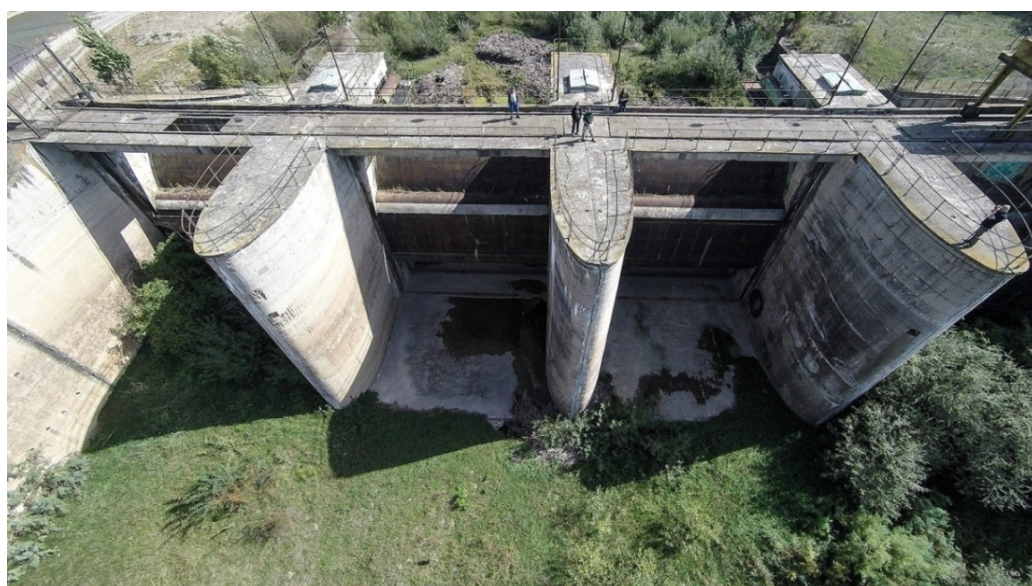
side walls required numerous aerial images, out of which 152 files were selected for final analysis (Figure 4).

Figure 4. Aerial imagery of Belci dam.

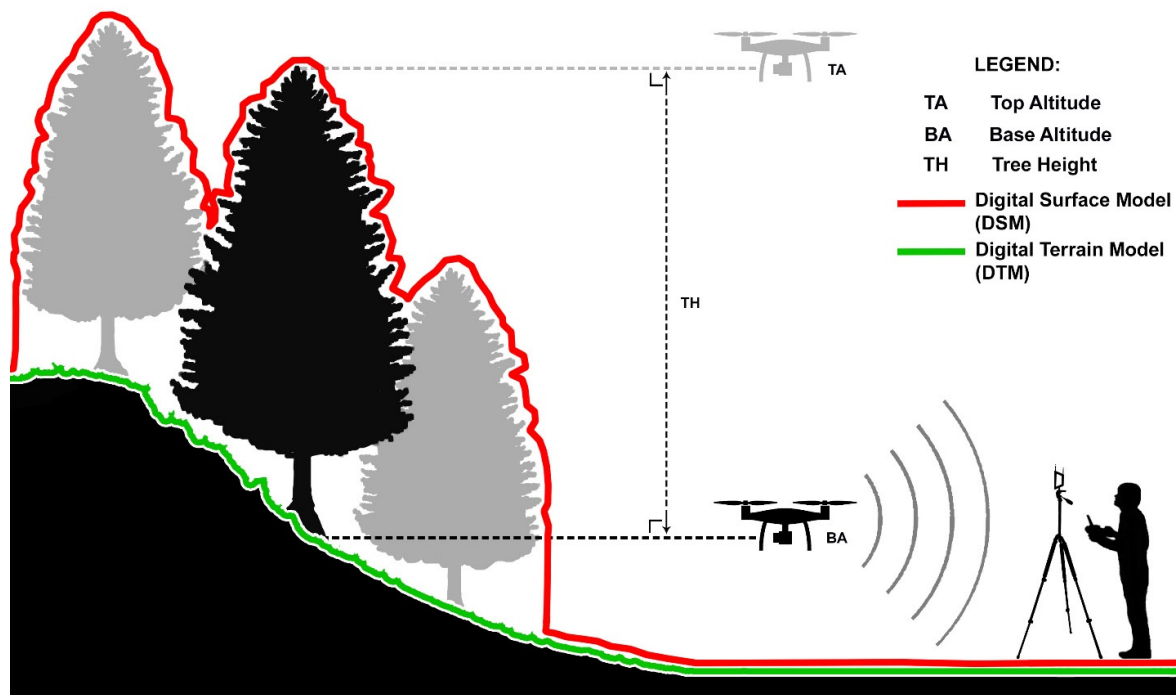
Figure 5. Tree height measurement based on relative drone altitude difference, using telemetry data.

The principles according to which this type of measurements functions are as follows: the drone operator initiates the flight at the base of the tree, in order to record the relative

altitude of its base at topographic level, which is then transmitted via the drone's telemetry system to the operator. Then, the device is flown to the altitude of the top of the tree, recording the new value. By calculating the difference between these two values, the height of the tree is established. These steps were repeated for each tree (the numbers shown in red, in Figure 6). One drawback to be noted is the fact that, where the drone could not fly as a result of dense vegetation, it was carried by hand to the roots, with its engines turned off (to avoid potential accidents), the relative altimetry value was recorded, after which the drone was launched, in order to record the altitude at the top of that particular tree. This was possible due to the precise gimbal functionality, low build/tolerance errors, and close proximity to the trees.

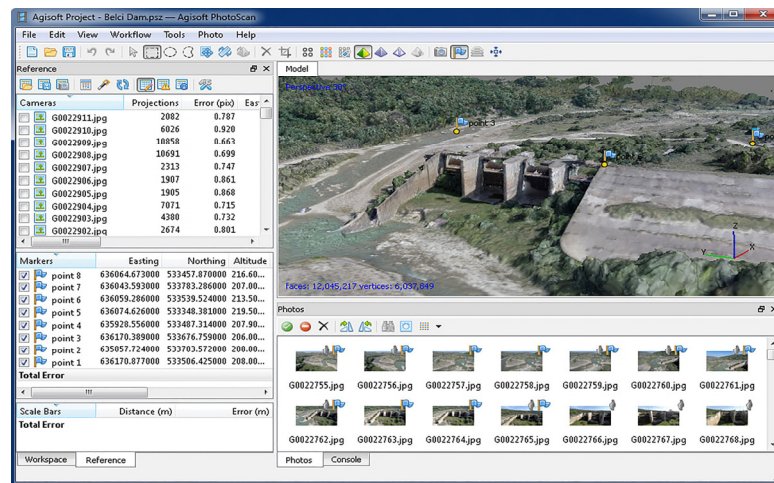
Figure 7. High-definition 3D-textured model of the Belci dam.

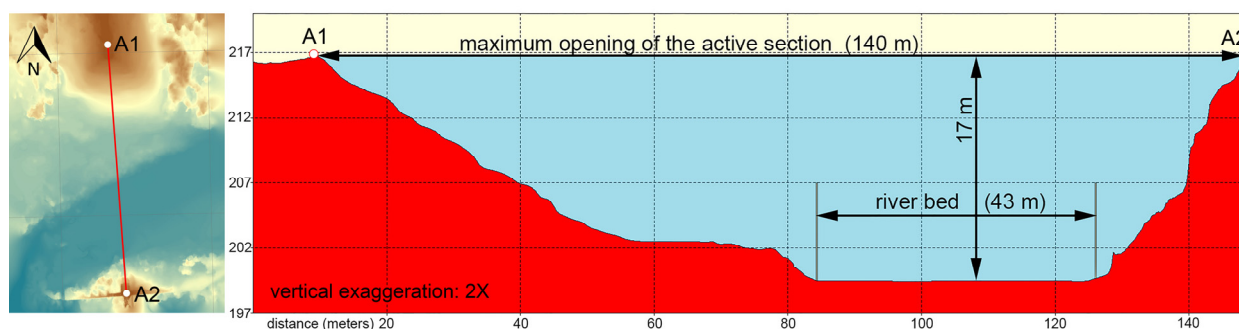
The dam breach active section area was calculated along the dam rupture up to the maximum height of the earthfill dike, more precisely between the 217 m altitude points (which were named in Figure 9: A1 and A2), located at the top of the northern edge of the concrete dam, and the highest current altitude of the left dike, which was overflowed in 1991, causing the rupture of the dam. From a vertical perspective, the active section is regarded as stretching between the base of the current minor riverbed and the highest point of the former dike (217 m altitude).

Figure 9. Current active section of the dam breach.

After the cross-section profile was generated, the surface of the active section was calculated by means of image-editing software. The simplified steps involved were the following: the number of pixels located inside the active section was identified, the surface of each one was calculated, and the two values were then multiplied in order to precisely obtain the surface of the active section, expressed in m^2 .

For expressivity reasons, the active section is represented with a twofold vertical exaggeration. Obtaining the surface of a single pixel required the calculation of both length and width of a particular pixel, because, though the pixel is square, the metric values represented are different for each side. The horizontal side was calculated based on 241 pixels, corresponding to a real distance of 20 m. A simple division led to the determination of the length of the horizontal side of a pixel as 8.29875518 cm (0.0829875518 m). The same steps were taken for the vertical side, and a length of 5 m was calculated, corresponding to 118 pixels. Therefore, the vertical side of a pixel is 4.2372881355 cm (0.042372881355 m).

The real surface of a pixel, calculated by multiplying the values above, is $0.00351642168 m^2$. Through automatic selection, a total number of 121,698 pixels could be identified within the active section. Once the overall surface, expressed in number of pixels, and the surface of a single pixel were known, the real surface of the active section, $427.94 m^2$, was calculated. Other morphometric properties of the section were also calculated, such as its current maximum opening (140 m) and height, or the width of the current riverbed (Figure 9).

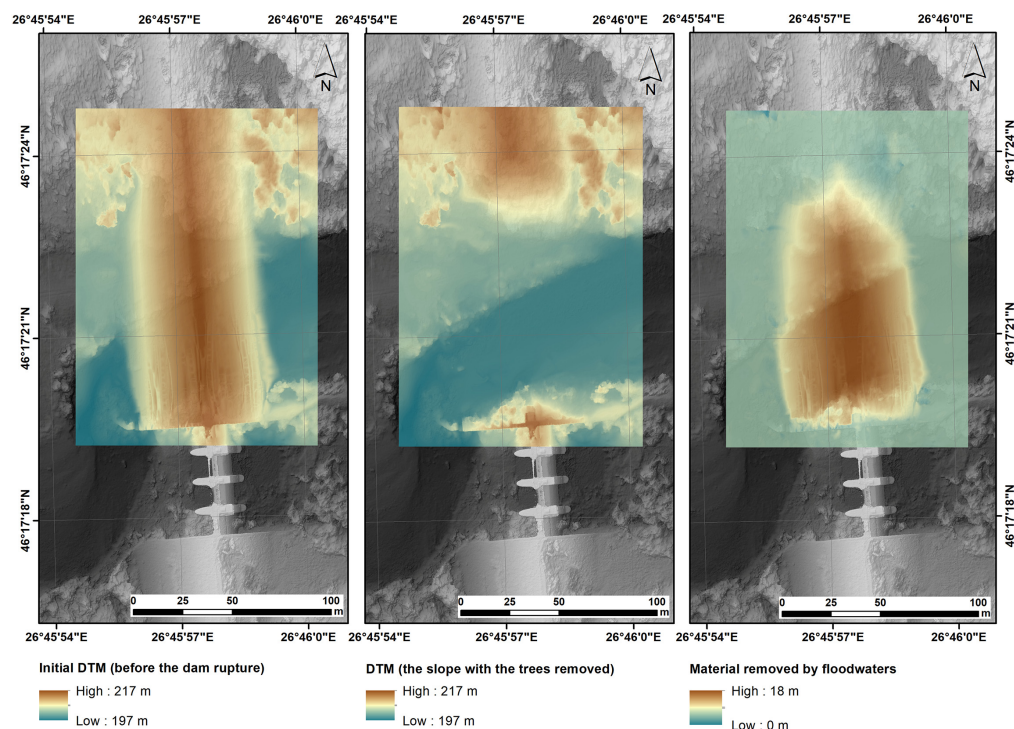
Starting from this spatial layer, two methods were employed in order to accurately calculate the volume of material removed by the flood. The first method (the manual method) started from the premise that the difference between the two raster layers generated a layer containing nothing more and nothing less than the material eroded as a result of the flood. The surface of a single pixel could easily be calculated. A multiplication between the surface provided by the number of pixels (and their corresponding surface) and the mean value of the former, from the surface of the entire raster file, led to the desired volume value. The numerical model corresponding to the volume of eroded material includes 4,253,568 pixels. The surface of a pixel is 0.0049656 m², hence the total surface is 21,122 m² (this is not the surface from which material was removed from the dike, but the entire surface, which includes the difference up to the rectangular spatial extension of this numerical model). The mean pixel value is 3.46575080633 m (in height). The process of multiplying the surface and the mean pixel value reveals a volume of 73,203.3 m³ (the approximate equivalent of 20 Olympic-sized swimming pools).

For validation purposes, a second, automatic method was used, namely the surface volume function of ArcGIS. Starting from a numerical terrain model, this function allows the calculation of a volume with certain parameters (higher or lower than a certain altitude or using another thematic layer as reference plane). Running this function led to the identification of a total area of 1.4 ha, over which the entire material was removed from the dike. The volume calculated automatically by this function was 74,281 m³, a very similar value to that calculated manually. The 1.45% error is within negligible limits. Therefore, starting from the two main layers (the elevation model prior to the dam rupture, and the one after the event), a third layer could be generated (Figure 10), and the volume of material removed from the dike was calculated with high accuracy.

Figure 10. DTM of the original dam, before the rupture in 1991 (left); corrected DTM with the vegetation removed (middle); the volume of earth displaced from the dam by the flood, depicted as a DEM (right).

The current results reveal a total earth volume, removed from Belci dam, of approximately 73,000–74,000 m³. However, this value is subjected to a few processes and the lack of previous temporal measurements, which could possibly induce errors. Fluvial geomorphology implies that the variance in flow rates and water levels will induce lateral erosion, attrition, etc. over time. Rivers are subjected to permanent hydraulic dynamic processes, which can take place over the span of decades, or just minutes. Unfortunately, since the Belci dam break accident, thorough measurements of the breach have not been performed, and its state has been kept the same, without any intervention, so there are no quantitative numbers that could be used to extract the riverbank erosion, or talweg migration etc. However, through empirical methods, and by asking local people, it can be stated that the volume of earth eroded after the dam break is negligible, considering that there were no similarly significant floods following this dam break event, and that the river has not been seen/measured to exit its current banks. Furthermore, the core of the dam is made of clay, and is therefore impermeable, so that no more water has managed to infiltrate in such high volumes as to make the remaining ruins of the dam collapse even more. However, this uncertainty in the volumetric/morphological measurements, over the span of over 30 years, makes it impossible to completely and accurately evaluate the exact volume of earth eroded by the event itself. This is a limitation of the model, but it is considered to be negligible, considering that it is extremely difficult to accurately measure the exact amount of earth displaced by a dam break accident, even when measuring the site a few days after the event. This is due to the fact that most dams that fail have existed for multiple years, that the silting process has been active (considering that large lakes generally have large hydrographic basins), and also that the water infiltration into the ground is very high. For this reason, the earth erosion process itself does not stop at the exact ending time of the flood hydrograph, but rather takes weeks/months to stabilize. This due to the soft nature of sediments, which cannot be thoroughly distinguished from clay or other similar types of dam building material through topographic measurements. This implies there will always be an error in measuring displaced volumes of earth from dam breaks, even under optimal conditions for such measurements, immediately after such events. This limitation of the study (of possibly overestimating the total removed earth volume) is accepted due to the physical constraints of measuring the break by any other means, and also due to the lack of other previous measurements.
