# Spatio-Temporal Morphodynamics of a Nourished Sandy Shore Based on LiDAR Measurements

Marek Harenda, Aleksandra Dudkowska \*

**Citation:** Harenda, M.; Dudkowska, A.; Szmytkiewicz, P. Spatio-Temporal Morphodynamics of a Nourished Sandy Shore Based on LiDAR Measurements. *Water* **2024**, *16*, 1055. <https://doi.org/10.3390/w16071055>

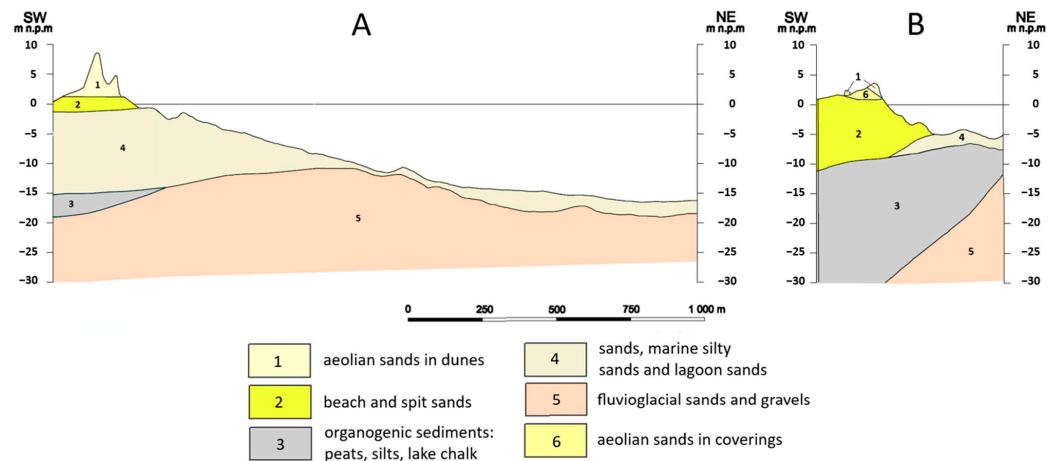
**Figure 2.** Geological cross-sections through the Hel Peninsula coastal dune system at (A) 11.7 km H and (B) 13.5 km H (modified PGI materials) [34]. The spatial locations of the geological profiles are shown in Figure 1b.

The terrain relief of the western open-sea side of the Hel Peninsula is dominated by the presence of a beach as a morphological element directly adjacent to the marine environment, with frontal dune ridges on its back, having one or multiple crests, and numerous irregularly shaped hillocks behind them, relics of former dunes and aeolian activity [32]. The differences in the subsurface distribution of successive sediment layers of the western (west to Kuźnica, Figure 2A) and eastern (east to Kuźnica, Figure 2B) part of

the study area can be seen in the geological cross-sections through the coastal zone of the initial part of the Hel Peninsula obtained from the Polish Geological Institute (PGI).

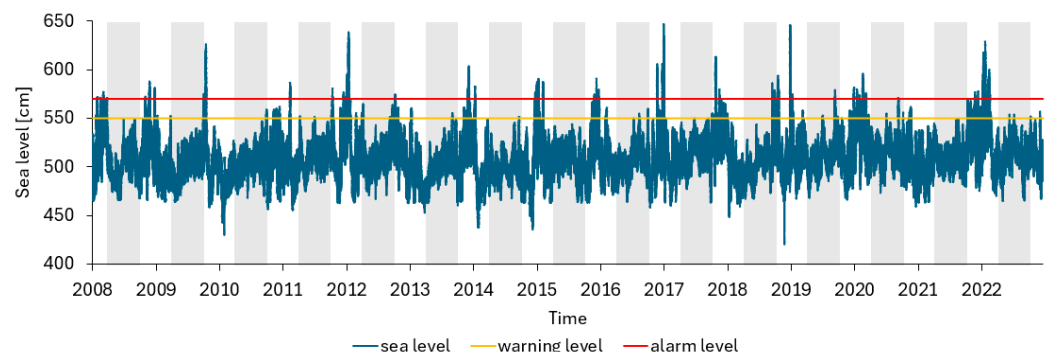
**Figure 3.** Sea level variations measured in Port of Władysławowo during the last 15 years. The gray stripes mark the spring-summer seasons, and the white stripes mark the autumn-winter seasons.

The intensity of erosion phenomena along the coast of the Hel Peninsula is significantly influenced by the occurrence of storm surges throughout the year. To assess the occurrence of surges during the study period, sea level data from the Władysławowo tidal gauge have been gathered from the Polish Institute of Meteorology and Water Management (PIMWM) resources. A storm surge for the Polish coast is defined as a sea level exceeding the alarm level, which is set at 570 cm (500 cm is the mean sea level and it is equal to 0.0 m in Amsterdam 55 vertical datum) [36]. Such situations occur almost exclusively during the autumn–winter season. During the period 2008–2022, exceeding the alarm state according to the tide gauge in the port of Władysławowo has occurred several times (Figure 3). The most significant exceedances of the alarm state occurred during the following months: October 2009, January 2017, January 2019, and January 2022. Elevated sea levels, higher than the warning level, were most frequently observed in January, February, and December (Table 1). Additionally, the years 2015, 2020, and 2022 were exceptionally intense compared to other years.

A qualitative comparison of the storm surge data (Figure 3, Table 1) and the results of the present erosion study does not allow for a possible correlation between erosion and the number of days with high sea levels. This is primarily due to the limited availability of data. During the course of this study, LiDAR data collected annually were only available for a period of 7 years (2016–2022), during which years with a higher number of days of elevated sea levels occurred in 2020 and 2022. However, investigating this relationship is not the subject of this study. Further research should explore the multifactorial dependence of erosion on wind speed and direction, the number of stormy days, elevated sea levels, shore nourishment, ice cover, and seabed morphology. Systematic, continued LIDAR measurements in the next years would provide a comprehensive database, enabling such multidimensional studies and in-depth examination of the complex interactions in the coastal zone that lead to morphodynamic changes. At this stage of the research, the gathered data on beach erosion and artificial nourishment enable a qualitative evaluation of the morphodynamic processes ongoing in the study area and their interplay with human activities. To delve deeper into the specifics of each area, we proceed to discuss individual sections in detail.

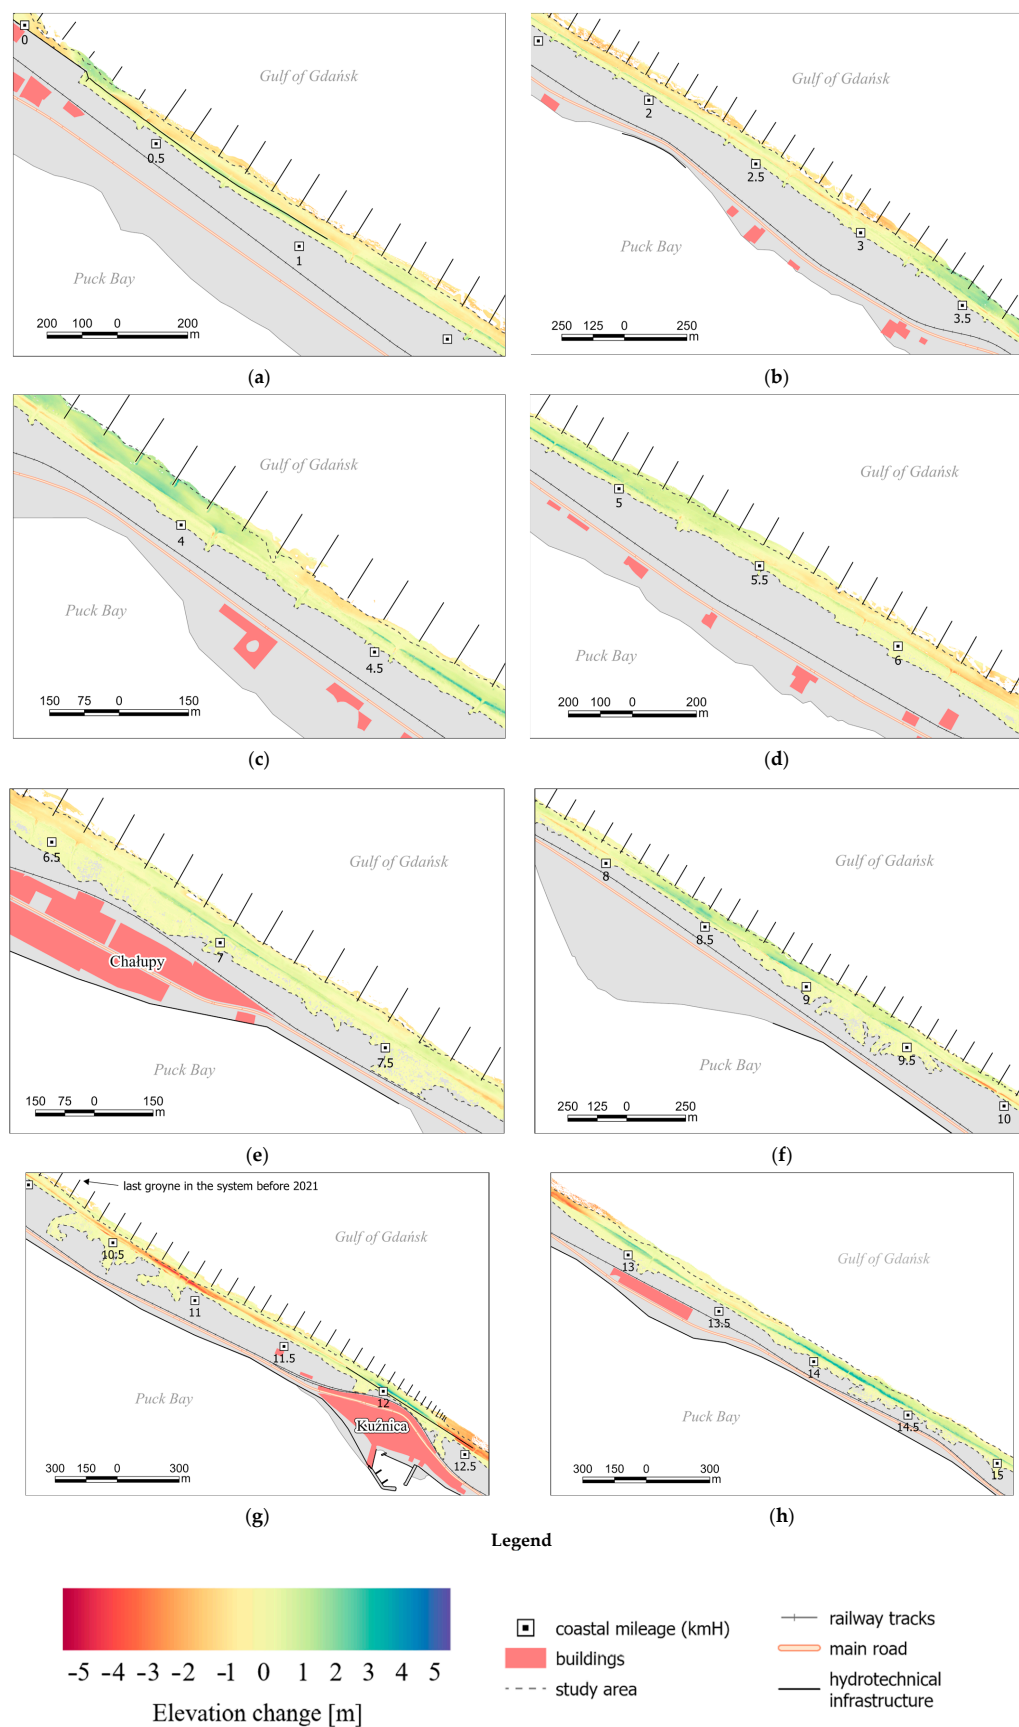
**Figure 8.** Difference maps of DTMs (2022–2009) in eight subzones (subfigures (a–h)) indicated in Figure 7.

The DTM difference map shows no major changes between 2009 and 2022 year within the beach and dune volume (Figure 8a). Moderate erosion is visible directly at point 0.0 km H and in the 0.3–0.5 km H segment, which is protected by the seawall. However, a comparison of DTMs year by year (results for the whole subsection not presented graphically) revealed that a significant decrease in elevation occurred during the period 2021–2022. This is evident in the example of a selected cross-shore profile of 0.4 km H (Figure 9). There is a seawall in the distance about 20 m from the baseline. The profile remained stable and underwent minimal change over time up to that point. Beyond the structure (distance from baseline above 20 m) the profile underwent changes over time, which were associated among other factors with conducted nourishment activities. A significant increase in elevation was observed in the 2014 year to the year 2009. The profile was kept stable in the period 2014–2021 with sediment refills of more than 200,000 m<sup>3</sup>/100 m. This is the capacity of one medium-sized tanker. In the 2022 year, the profile was largely eroded down to the seawall (Figure 9).

A comparison of DTMs from 2009 and 2022 (Figure 8c) shows predominantly accumulative trends in the area. This primarily relates to the beach in the 3.6–4.2 km H section, as well as the dunes in the 4.5–4.8 km H section. Between 4.2 and 4.5 km H, a small erosive area on the beach was observed. Erosion in this short section recurred in the periods: 2021–2022, 2014–2015, and 2009–2014 (here 4.1–4.2 km H). In the periods 2015–2016, 2016–2017, and 2017–2019 large patches marked by accumulation after nourishment in the years 2015–2019 were observed there. The overall situation at 4.1–4.4 km H is well illustrated by the cross-shore profile in Figure 11.

Through comparisons of DTMs from 2009 and 2022 (Figure 8d), the area reveals its dual nature. The western part (4.8–5.4 km H) had an accumulative character during this time, while the eastern part (5.4–6.5 km H) experienced erosion along almost the entire length of the cross-sectional profile (Figure 12). The western part is a part of the accumulation coast, which was also marked in the previous section (4.5–5.5 km H). In the years 2021–2022, slight dune erosion was observed in the 6.1–6.3 km H section, in the years 2017–2019 in the 5.5–5.7 km H section, and in the period 2016–2017, erosion occurred in the 5.7–6.4 km H section. During the period 2009–2014, accumulation was evident in the 4.8–5.1 km H stretch and to a lesser degree at the 5.5–6.3 km H. The remaining intervals between consecutive LiDAR measurements showed no significant changes in beach and dune volume along this stretch.

The section was partially nourished in 2008, 2016, 2017, and 2020. A comparison of the two most temporally distant DTMs from 2009 and 2022 (Figure 8e) indicates accumulation in the frontal part of the dune at the 6.6–7.6 km H section and erosion in both outermost parts (6.4–6.5 km H and 7.7–7.8 km H). The erosion is directly related to the dune, and near 6.5 km H, it affects the entire beach profile. Accumulation reached +2 m, while erosion reached −1.5 m. The difference map from 2008 to 2009 indicates the removal of sediment nourished in 2008 at the 6.9–7.4 km H section on the beach face. The situation stabilized on this stretch in the period 2009–2014. Nevertheless, further erosion occurred on a segment of the dune in the 6.9–7.05 km H section (Figure 13). This is an example of an erosive profile nourished in 2016 and 2017 and systematically eroded in the past few years. A slight accumulation in the dune foot was observed in the 6.6–6.9 km H and 7.4–7.7 km H sections, despite the lack of nourishment. In subsequent years, there were no significant changes until the period 2016–2017, when the difference map reflected the effect of nourishment. It illustrates significant accumulation in the 6.5–7.1 km H section, sometimes covering the entire beach. During the same period, considerable erosion occurred on the dune front in the 7.3–7.8 km H section. Partial erosion of the nourishment occurred in the following period (2017–2019). In recent years, there have been no major changes in this stretch except for the period 2021–2022, when the entire subzone experienced minor to moderate erosion, mainly affecting the beach, slightly extending to the dune foot (7.0–7.1 km H).

Considering the differences between DTMs from 2009 to 2022 (Figure 8g), the studied section had an erosional character along its entire length, except for the foredune in the most critical section of 11.9–12.3 km H, where accumulation was observed due to cyclic nourishment practices (Figure 16). In the past, this section alternated between erosion and accretion, thanks to almost annual nourishment treatments. On the southeast side of this area, there is a segment marked by the second-highest erosion values among the entire coastline. Beach and dune losses reached up to  $-3.4$  m here from 2009 to 2022 in the 12.3–12.6 km H section (Figure 17). The entire shore profile, along with the dune foot, was affected by erosion.

A comparison of the DTMs from 2009 to 2022 (Figure 8h) provides information about the predominance of accumulation in this section, even before the extensive nourishment carried out in 2022. The only erosive area (12.6–12.8 km H) is an extension of the previously discussed section (10.0–12.6 km H), where the groynes system ends and its side effect occurs. The other parts of this section exhibit signs of accumulative or at least morphodynamically neutral behavior over a longer time scale. Accumulation at the dune foot is most marked in the sections 12.8–13.4 km H and 13.6–15 km H (Figure 18). The greatest intensification in each of these subsections occurs in the central part. Terrain height increases in these areas are uniform and range from +2 m to as much as +3.5 m. In these areas, it was already noticeable in older periods (2009–2014—up to +2 m). In the time interval 2016–2017, erosion occurred in the 13.1–13.9 km H section (up to −1.5 m, but in a narrow strip). In the subsequent comparative period (2017–2019) erosion continued but with a slightly smaller extent: 13.3–13.8 km H. In the following years, the balance stabilized except for the period 2021–2022, where erosion from the end of the groynes system extended to 13.1 km H. Minor losses on the dune foot are also noticeable in the 13.5–13.6 km H section. In several other sections, there was erosion of the foreshore, but without affecting the higher parts of the shore profile.

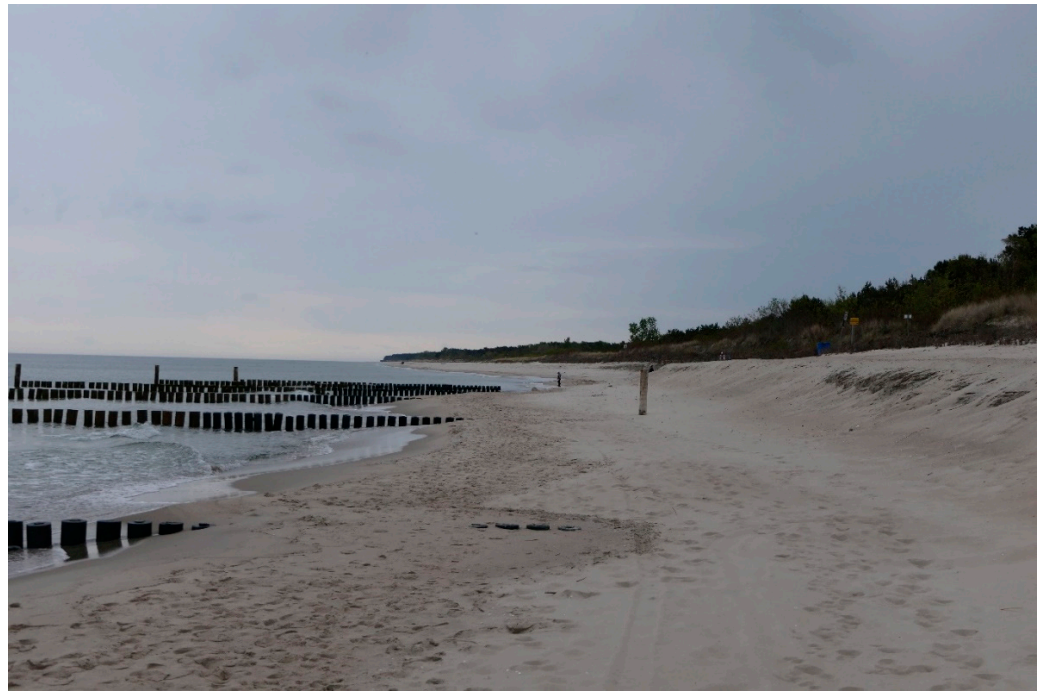
**Figure 20.** View of the endpoint of the newly constructed groyne group on the Hel Peninsula. In the distance, erosion of the coast and dune can be seen, located at km H 10.9. (Photograph taken on 21 May 2021, credited to P. Szmytkiewicz).

Notably, the considerable and persistent erosion of dunes at the 10.9 km H mark is indicative of the combined impacts of these factors. The primary contributing factor involves the installation of novel groynes, coinciding with a particularly severe storm event shortly after their construction. Erosion that occurs at the end of the groyne group is well known in the literature [42,43]. Figure 20, a photograph taken on 21 May 2021, during the LiDAR measurement, clearly shows the sea side effect associated with the intensification of erosion processes at the end of the newly constructed groynes.

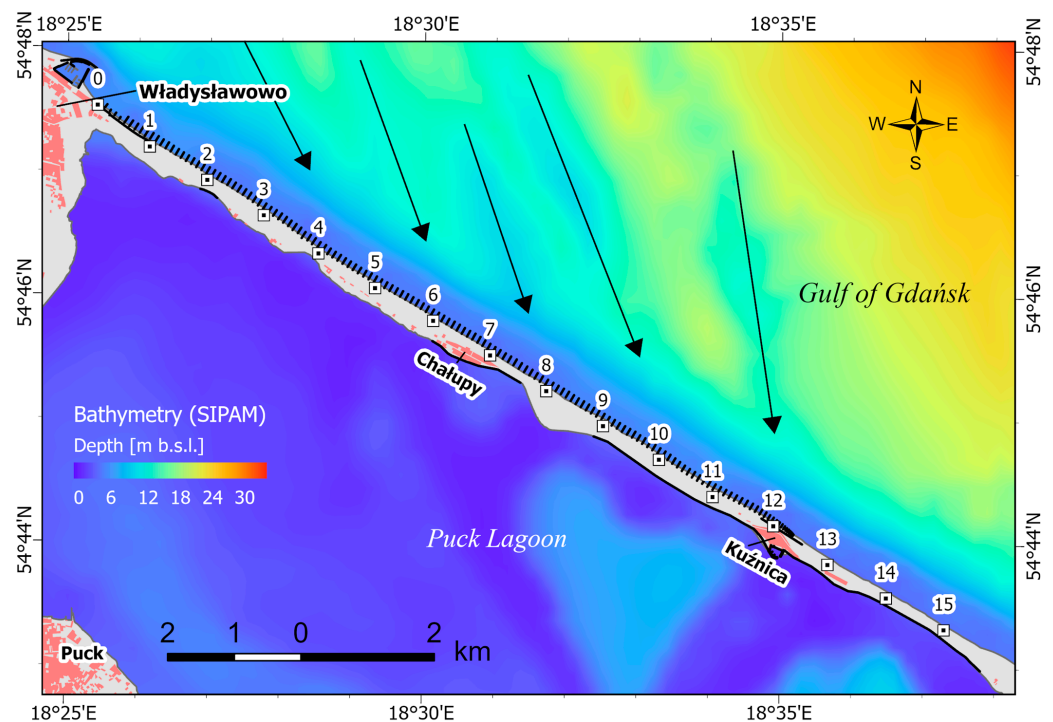
**Figure 21.** Bathymetric map of Baltic Sea seabed around Hel Peninsula's northwestern part with marked hypothetical locations of so-called energy windows—long troughs oblique to the shore.

The heightened dune erosion in the area may also be attributed to the long, oblique to the shore depressions present in the bottom topography. The issue has been under investigation since the 1990s. Among other research, in 1999 Gajewski et al. [27] identified such seabed forms during extensive bathymetric surveys. Their research revealed non-uniform bottom topography at greater depths characterized by significant depressions called “runnels” resulting in wave energy concentration [41]. These underwater features allow greater wave energy to reach the coast in favorable meteorological conditions. Notably, one such “energy window”, aligned with the area around km H 10.9, likely contributed to increased dune erosion along this stretch. Bathymetric maps suggest that in the nearshore zone of the northwestern part of the Hel Peninsula, there are at least five such energy windows at: 4.3, 6.4, 7.8, 10.9, and 12 km H (Figure 21). All these “runnels” are oriented obliquely to the coast, and their axis is directed approximately from northwest to southeast, which, given the relatively frequent occurrence of northwesterly winds in the study area, increases the likelihood of intensified coastal erosion along these specific sections of the coast. The influence of bottom relief and similar seabed forms on erosion has already been confirmed on another section of the Polish coast in the vicinity of the Widowo Nature Reserve located approximately 20 km west of Władysławowo [44].
