Article

Impact of Mining Area Steep Slope Conditions on the Soil and Water Conservation Benefits of Ecological Restoration

Keywords: soil and water conservation; excavated slopes; filled slopes; mining area

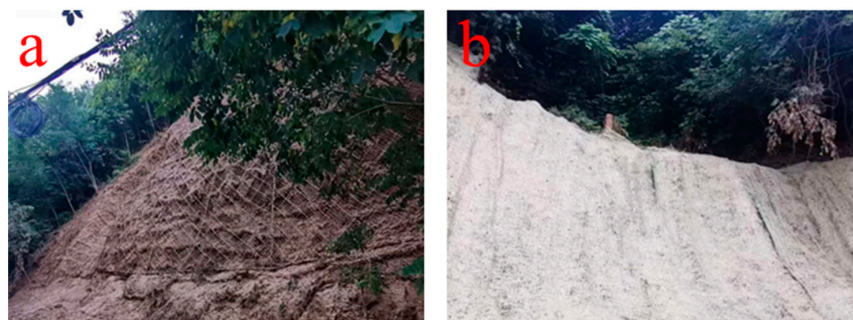
Figure 1. Schematic diagram of lead wire mesh and plant blanket. (a) Lead wire mesh, (b) plant blanket.

The Nannihu molybdenum mine, a large-scale open-pit operation in use since 2008, has generated extensive excavation and filling slopes. In May 2024, ecological restoration works has commenced on some slopes. In the process of ecological restoration, the slope was firstly levelled, then a lead wire mesh was laid to ensure the stability of the slope (Figure 1a). The aggregate soil containing water-retaining agents, adhesives, fertilizers, and plant seeds was sprayed on the slope approximately 10 cm thick. Then, a plant blanket was laid on the upper layer (Figure 1b) to prevent the slope from being washed by water.

Compared to the unrepaired slope, the ecologically restored slopes exhibited significantly lower runoff and sediment yields, consistent with findings from previous studies [29,30]. Li et al. [7] further reported that spraying techniques can reduce sediment yields of rocky slopes by over 90%. In this study, in addition to netting and soil spraying, a plant blanket was applied to the surface of the slope (Figure 1b).

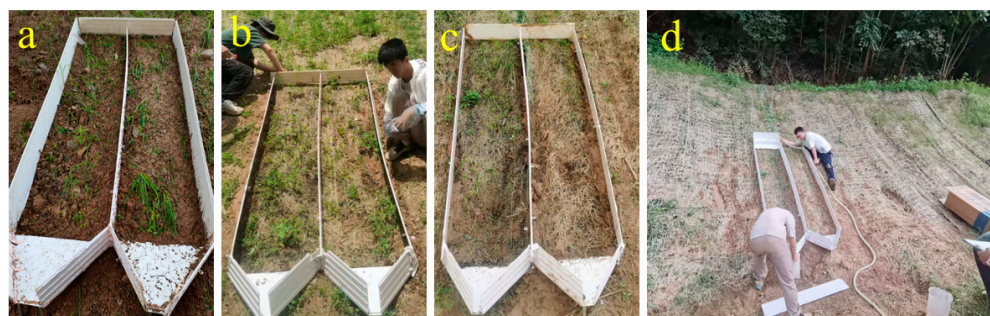
Figure 2. Schematic diagram of runoff plot. (a) Unrepaired slope plot, (b) repaired filled slope plot, (c) repaired excavated slope plot, (d) erosion process.

Two slopes, located on either side of an excavation road within the mining area, were selected for analysis: one excavated rock slope (R1, Figure 2c) and one filled slope (R2, Figure 2b), both of which had undergone ecological restoration in 2024. By the time the experiment commenced in August 2024, the average restoration period for these slopes was 45 days. Additionally, an unrestored fill slope (W, Figure 2a) was chosen as a control. Two runoff plots (length and width of 200 cm and 50 cm) were established on each slope, for a total of 6 plots across the three slopes. To simulate the early-stage conditions of ecological restoration, plots were located in sparsely vegetated areas with sparse vegetation cover (less than 10% canopy cover) on the restored slopes. Basic information for each slope is provided in Table 1.

Based on local rainfall data and the drainage area of the mining site, the simulated erosion flow rate was set at 208 mL·s⁻¹, with an erosion duration of 9 min. During the experiment, the runoff–sediment mixture samples were collected manually, every minute for 20 s, using plastic buckets placed at the lower end of the plots. The collected samples were weighed using an electronic balance to determine their mass, and sediment mass was subsequently calculated by drying the samples at 105 °C for 24 h. Runoff volumes were then estimated by utilizing both the mass measurements of the runoff–sediment mixture and the sediment samples.

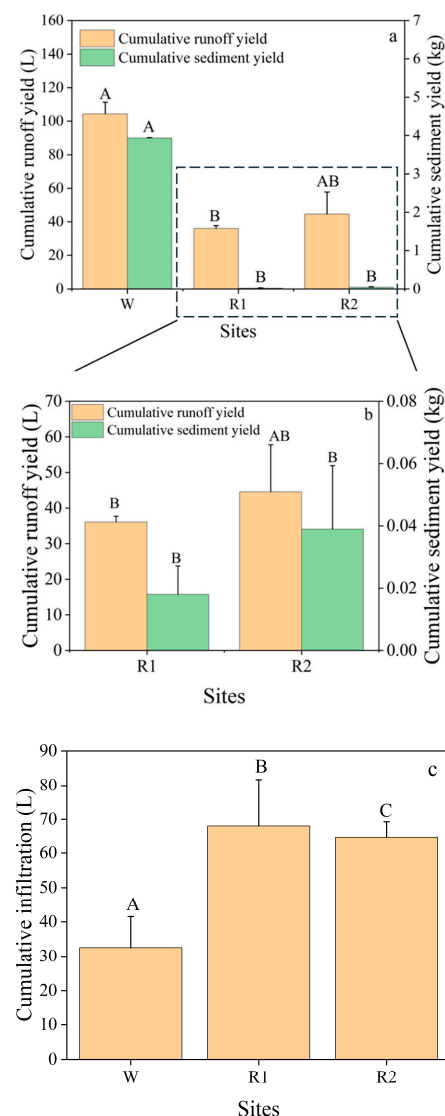
Figure 3. Cumulative runoff, sediment, and infiltration of different slopes. W: unrepaired slope, R1: repaired excavated slope, R2: repaired filled slope. (a) Cumulative runoff and sediment production of different slopes, (b) cumulative runoff and sediment production of R1 and R2 slope, (c) cumulative infiltration of different slopes. Different capital letters indicate significant differences between different slopes ($p < 0.05$).

The cumulative runoff for the unrepaired slope (W), repaired filled slope (R1), and repaired excavated slope (R2) were 104.37 L, 36.06 L, and 44.56 L, respectively. Compared to the W slope, the runoff for the repaired slopes R1 and R2 decreased by 65.45% and 57.31%, respectively, with an average reduction of 61.38%.

The cumulative sediment yield for the W, R1, and R2 were 3.93 kg, 0.02 kg, and 0.04 kg, respectively. Compared to the W slope, the sediment yields for the R1 and R2 slopes were lower by 99.54% and 99.01%, respectively, with a mean reduction of 99.28% (Figure 3a).

The cumulative infiltration for the W, R1, and R2 were 32.51 L, 68.07 L, and 64.75 L, respectively. Compared to the W slope, the infiltration for the R1 and R2 slopes increased by 109.36% and 99.15%, respectively, with a mean increase of 104.26% (Figure 3c).

Compared to R2, R1 exhibited 19.06% less cumulative runoff and 53.77% lower cumulative sediment yield, with a 5.13% increase in cumulative infiltration (Figure 3b). These results demonstrate that the ecological restoration measure of hanging net soil spraying on excavated rock slopes offers superior soil and water conservation benefits in the early stage.

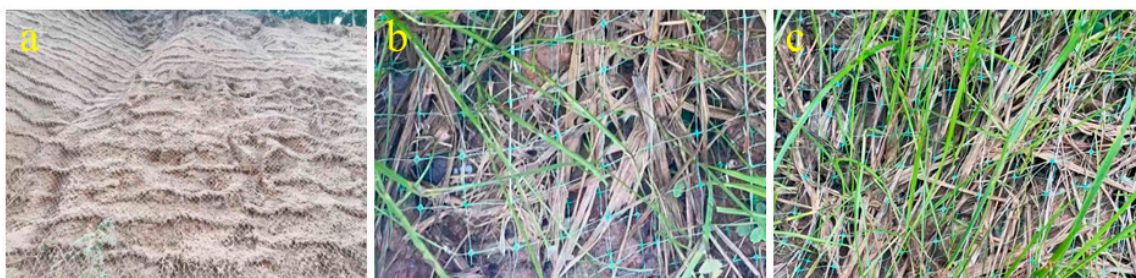
Figure 7. Composition of ecological restoration measures. (a) Hanging nets, (b) planting blankets, (c) vegetation recovery.

The use of hanging nets enhances shear resistance on steep and high slopes, significantly improving slope stability and creating favorable conditions for plant growth [31]. Soil spraying materials typically contain water-retaining agents and adhesives. The adhesives bond soil particles to each other and to the slope surface, enhancing the erosion resistance of the slope soil. Meanwhile, water-retaining agents significantly increase the soil's water retention capacity and reduce runoff [32]. Planting blankets adhere to the soil surface, forming numerous micro-depressions that trap runoff and sediment. Additionally, they increase surface roughness, reduce runoff velocity and erosion energy, enhance infiltration [28], and decrease soil detachment [33]. Furthermore, planting blankets help maintain soil temperature and moisture, improve soil fertility and erosion resistance (Figure 5), and prevent seed washout, thereby facilitating vegetation recovery [34].

After vegetation recovery on the slope, plant roots provide significant reinforcement. Compared to bare soil, roots increase soil shear strength by 2.5% to 139.4% [35], leading to a 41.69% to 99.00% reduction in soil detachment [36]. Additionally, plant roots enhance infiltration and water retention capacity [21], thereby reducing runoff and helping to retain moisture. The ecological restoration in this study involved a combination of hanging nets, soil spraying, planting blankets, and vegetation recovery (Figure 7), providing effective slope protection. As a result, runoff was reduced by 61.38%, and sediment yield decreased by 99.28%.

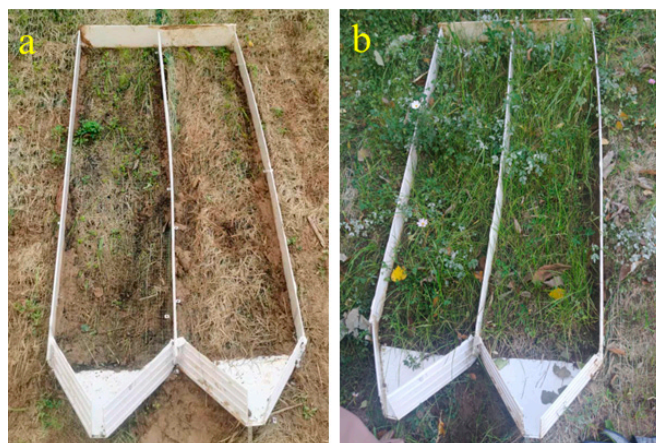
Figure 8. Plots of different ecological restoration periods. (a) Restored 45 d, (b) restored 76 d.

Continuous monitoring has demonstrated that the ecological restoration measures have yielded positive results. Compared to the 45-day restoration plot, the 76-day restoration plot exhibited superior vegetation growth (Figure 8). Further monitoring will continue to assess the vegetation growth and soil and water conservation effectiveness, with the aim of evaluating the long-term sustainability and stability of these restoration measures. In the plot restored for 76 days, the main species were *Cosmos bipinnatus*, *Medicago sativa*, and *Lolium perenne*. Therefore, these three plants can serve as long-term monitoring candidates, to evaluate the effects of vegetation and the sustainability of restoration.

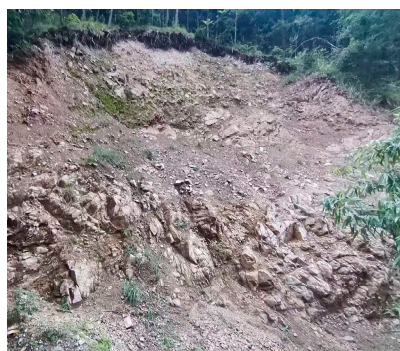
Figure 9. Fissures in rock slopes.

Compared to filled slopes, excavated rocky slopes exhibit lower runoff and sediment yields during the early stages of ecological restoration. This can be attributed to the presence of numerous fissures in the rock slopes (Figure 9), which facilitate water loss through the matrix soil layer during ecological restoration. Consequently, runoff volumes are lower on rocky slopes, which in turn reduces the erosion energy and leads to decreased sediment production.
