Article

Appraisal of Strategies for Dealing with the Physical Hazards of Abandoned Surface Mine Excavations: A Case Study of Frankie and Nyala Mines in South Africa

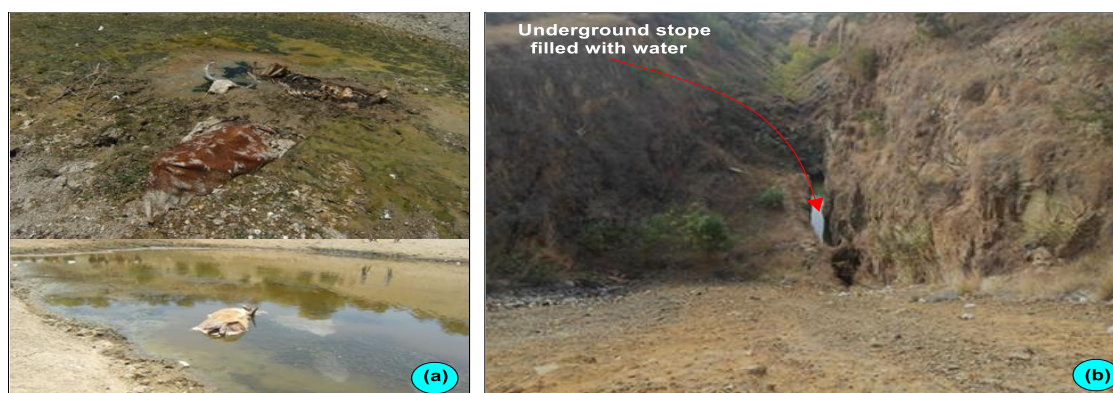
Figure 5. (a) The evidence of the animals killed by being trapped in mud at the pit floor [10], and (b) is an illustration of the connection of the surface excavation with the underground open stope filled with water.

For example, the water in Pit-I of Nyala Mine was reported by Mhlongo and Amponsah-Dacosta [21] to be used by domestic animals as drinking water and the public as water for washing clothes, swimming and domestic fishing activities [22]. On the other hand, the water in Pit-A of Frankie Mine is currently not used by the community. However, there are high chances that domestic animals that graze around the mine site may be tempted to drink the water in the Pit-A. In addition, the domestic animals that go to the abandoned excavations at Nyala Mine for drinking water in these excavations do get killed by being trapped in sticky mud found at the floor of the excavations (see Figure 5a). In view of this, the mud formed by fine sediments deposited at the pit floor at the abandoned magnesite Nyala Mine was identified as a serious safety risk to the animals that drink the water in these excavations. Although in the case of Frankie Mine there is no death of animals reported at Frankie Mine, falling into the water that is at the bottom of Pit-A can result to death with no possibilities of successful recovery of the body. This is because the bottom part of this excavation is connected to the underground open stope, which is filled up with groundwater (see Figure 5b).

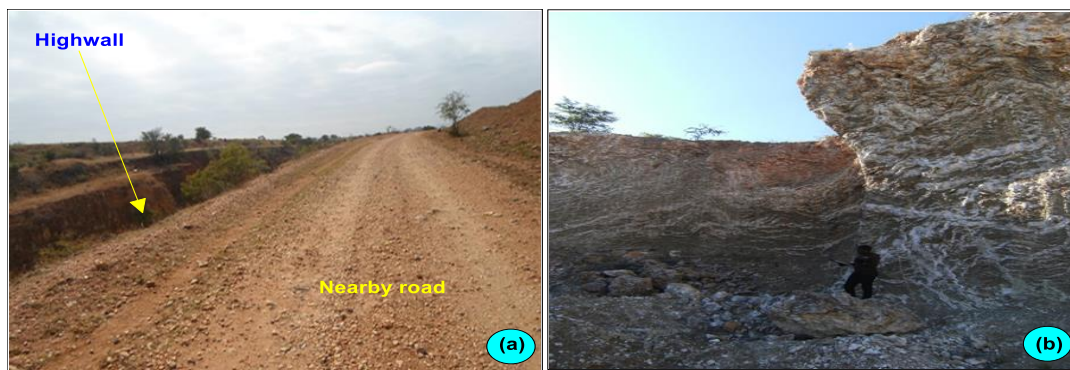
Figure 6. (a) An illustration of the close location of the excavation to the access route and Frankie Mine, and (b) the unstable highwalls of the excavations at Nyala Mine.

In addition, the risks of falling from the highwalls or being injured, due to the falling of the rocks from the highwalls were identified to be the common problems associated with the abandoned surface excavations in both mines in the study area. This is because all the excavations were found with sections of the highwalls that are about 5 m high and even more. This alone contributes to such highwalls being unstable. The other factor contributing to the highwalls of the excavations in the study area is prone to collapse the fact that they are mostly characterized by deteriorating rock-mass which generally make it easy for rock falls to occur [23]. Some of these highwalls were found with slopes that were greater than 90° (see Figure 6b), while others had fissures developed, which are evidence ground movement towards the excavations [13]. The major concerns of this situation are that both people and animals may be tempted to work above these highwalls or take refuge in the shadows provided by the highwalls, thus, exposing themselves to the safety risks of such excavations. It is important to note that, generally in operational mines; it is recommended that no persons can be at a distance of less than 25% of the highwall height [24]. However, with the situation of unrestricted public access to abandoned surface mine excavations, it is impossible to control the public exposure to the physical hazards of the highwalls of the abandoned surface mine excavations.

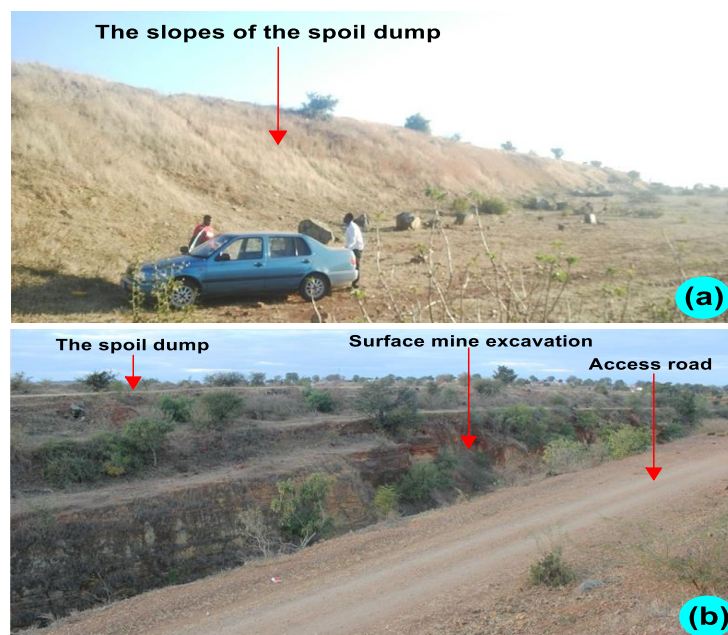
Figure 8. (a) The community facing slopes of the spoil dumps and (b) the access route and pit facing slopes of the spoil dumps at Frankie Mine.

On the other hand, the Frankie Mine was found characterized relatively small spoils dump; thus, there is very little backfilling of the excavations that can be conducted in this abandoned mine site. The dump of spoil material found at Frankie Mine is generally of stable slopes which are completely covered with native grasses. These have resulted in the spoil dumps at Frankie Mine having a relatively low impact on the aesthetic appearance of the mine landscape. Figure 8 shows the appearance of the spoil dumps of Frankie Mine from the nearby community and access route.

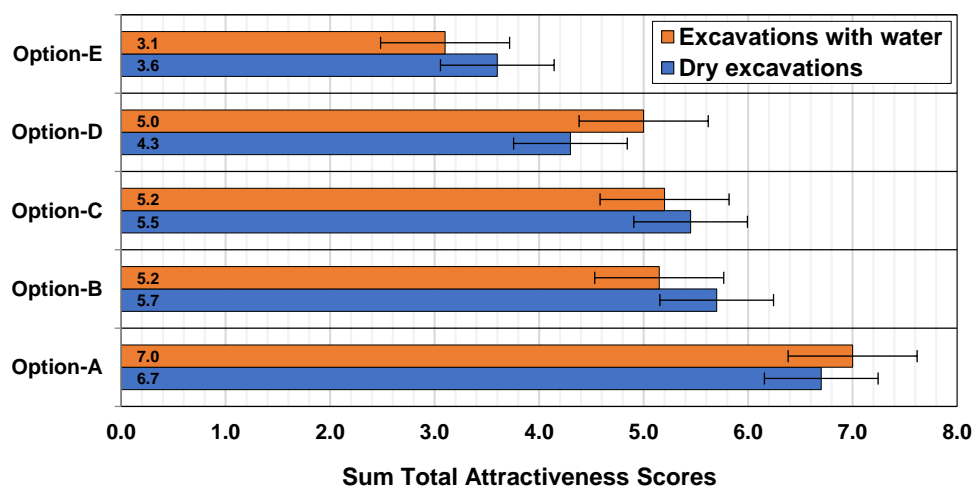
Figure 9. Comparison of the attractiveness of the rehabilitation options in addressing the issues of abandoned surface excavations. **A** is the combination of strategies, **B** is the reduction of highwalls and reuse of the excavations, **C** is the fencing of the excavations, **D** is the backfilling of the excavations, and **E** is a no-action option.

The results of the analysis of the attractiveness of the strategies for addressing the physical hazards of the excavations (both, those that contained water and those that were without water) demonstrated that using a combination of approaches in dealing with the physical hazards of these excavations was the most attractive approach. This is because the use of this approach had the potential of addressing the physical hazards of the abandoned excavations in the manner that promote the reuse of the excavations, while improving the aesthetic appearance of the landscape. Moreover, the reuse of the excavations promises to reduce the high costs that are associated with the extensive earthworks of backfilling the disused surface mine excavations. However, the second most attractive strategy for water containing excavations was the reshaping of the highwalls and stabilization of the slopes of the excavations to promote the safety uses of the water in the abandoned surface mine excavations. In the case of dry excavations, the restriction of access of the abandoned surface excavations through the erection of a fence around the excavations was found to be the second most attractive rehabilitation approach (see Figure 9).

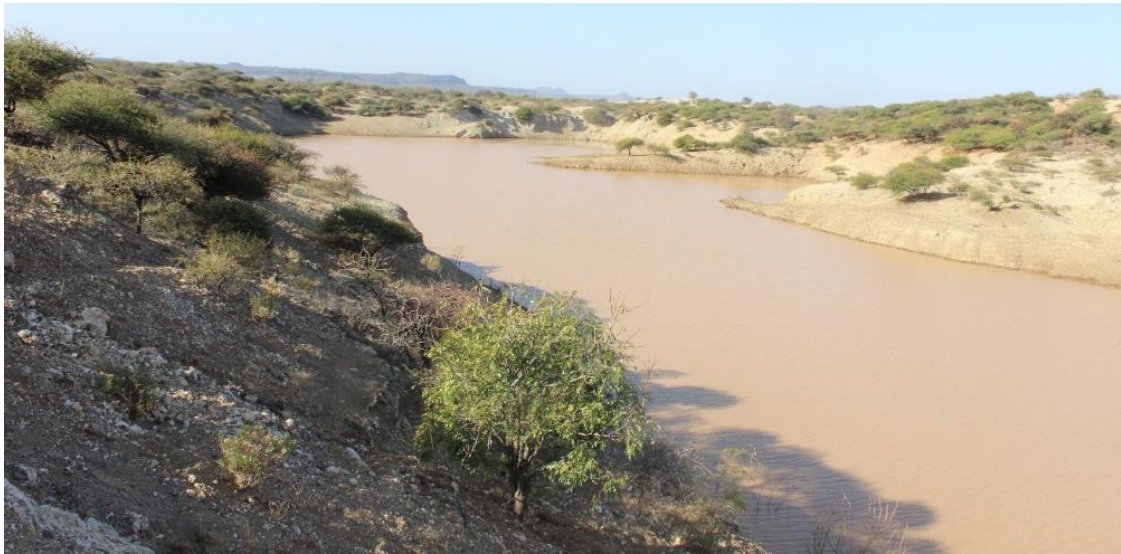
Figure 10. The water-filled excavation (Pit-I) of the abandoned Nyala Mine.

Although the backfilling of excavations for morphological restoration have several advantages, the attractiveness of this method in dealing with the physical hazards and some of the environmental problems of the sites that are affected by surface mining is mainly affected by the potentially high costs of the backfilling operations and the lack of locally available material for backfilling the abandoned excavations. As a result, the less costly strategies that are implemented to protect the public from the physical hazards of the excavations, while promoting the safe and easy reuses of the excavations for other purposes was found to be more attractive than the option of backfilling the excavations. For example, in different countries (e.g., Germany, Poland, Czech Republic), old surface mine excavations have been developed to pit-lakes (or lake districts) that supports a variety of activities, which includes, but not limited to, aquaculture, aquatic sports, shipping and recreational activities [29,31]. The development of Pit-I of Nyala Mine to a pit-lake through the reduction of the slope angle of its walls (including highwalls), controlling of the level of sediment deposition at the pit floor, and the improvement of the quality of the water in the pit was proposed and argued by Mhlongo and Amponsah-Dacosta [14]. The abandoned surface mine excavation can also be developed for use as a waste disposal facility or landfill sites [25,33]. In general, all these reuses of abandoned surface mine excavations require that the slopes of the excavations are graded to maintain a safer and stable angle. The restriction of access through the fencing of the excavations may also be necessary. An illustration of Pit-I filled with water after the rainy days at Nyala Mine is shown in Figure 10.

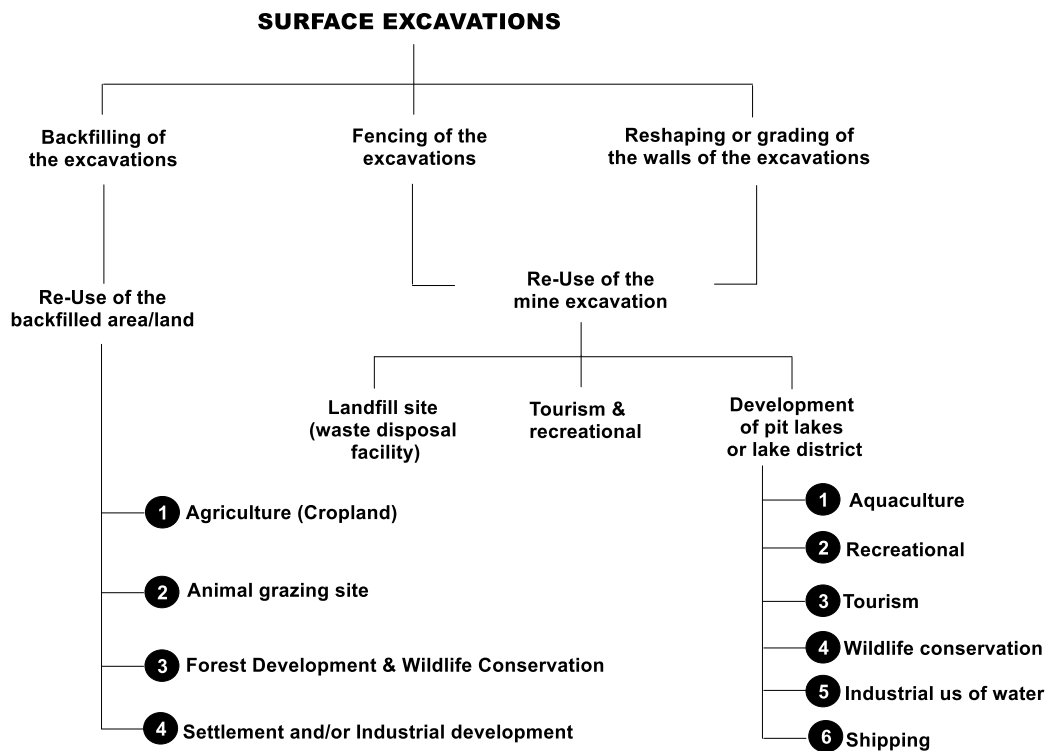
Figure 11. The summary of the practical approaches for addressing the problems of abandoned surface mine excavations.

Three approaches for addressing the physical hazards of abandoned surface mine excavations are listed in Figure 11. The first approach was backfilling of the excavations to make the land occupied by the excavations available for other uses. The area of backfilled excavations can be used for crop farming, site for animal grazing, forest and wildlife conservation development, and development of settlement and/or industrial site. The other approaches of addressing the physical hazards of the surface mine excavations can be erecting a fence around the excavations and reshaping of the walls of the excavations to make them safe and stable. This can ensure that the beneficial reuses of the abandoned mine excavations are safety implemented. Some of the possible reuses of the old surface mine excavations are included in Figure 11.
