Article

Mortars from the Palace of Knossos in Crete, Greece: A Multi-Analytical Approach

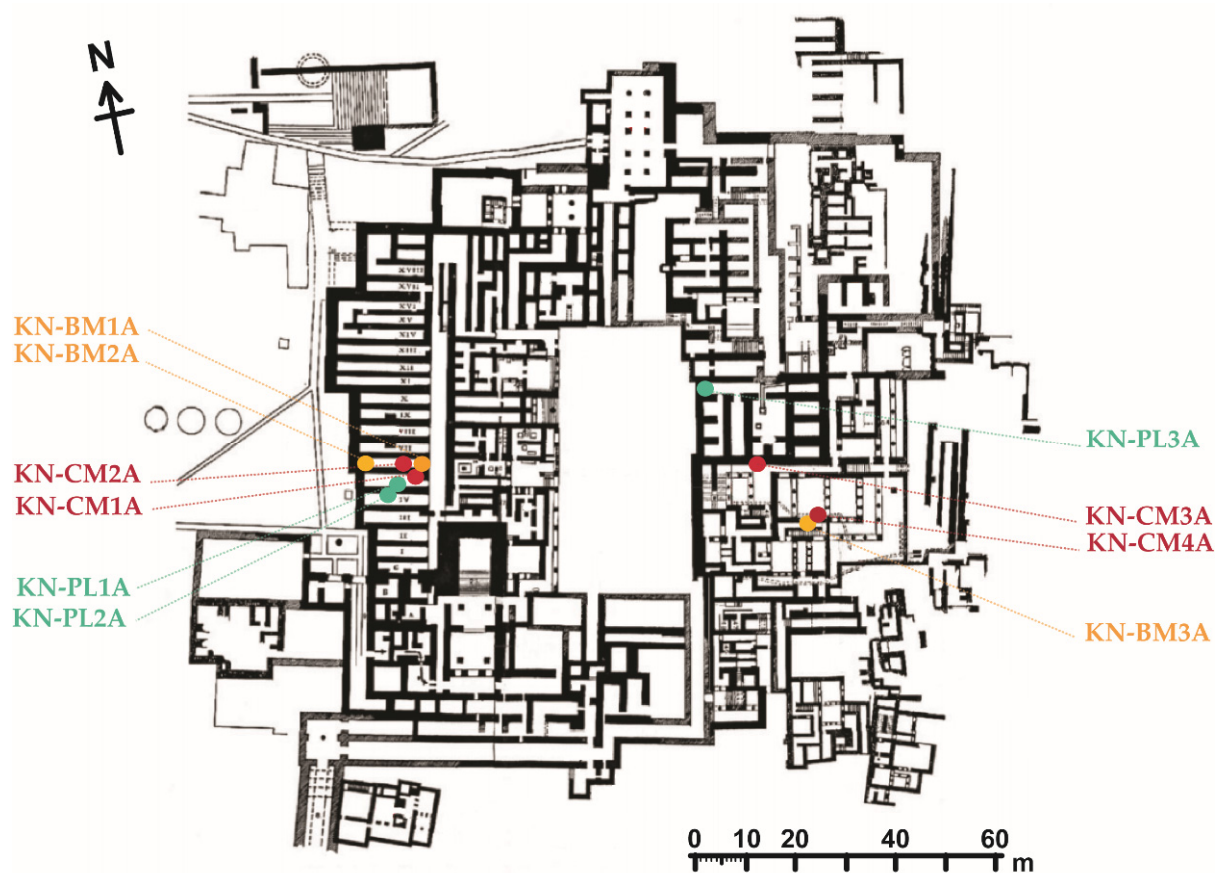
Figure 3. Sampling locations on the Palace of Knossos, West Magazines, and East Wing. (Image adapted from HERACLES Project [3,36]).

For the study and characterization of mortars from this archaeological site, samples were collected from visually distinct typologies, with bedding and render functions applied in different locations (Figure 3 and Table 1). Following a minimally invasive approach, the quantity of sample collected in each case was the smallest possible amount necessary for laboratory chemical and morphological analyses, inhibiting the use of some destructive testing techniques such as the acid separation of the binder and the definition of the granulometry of the aggregates via mechanical and/or manual processes.

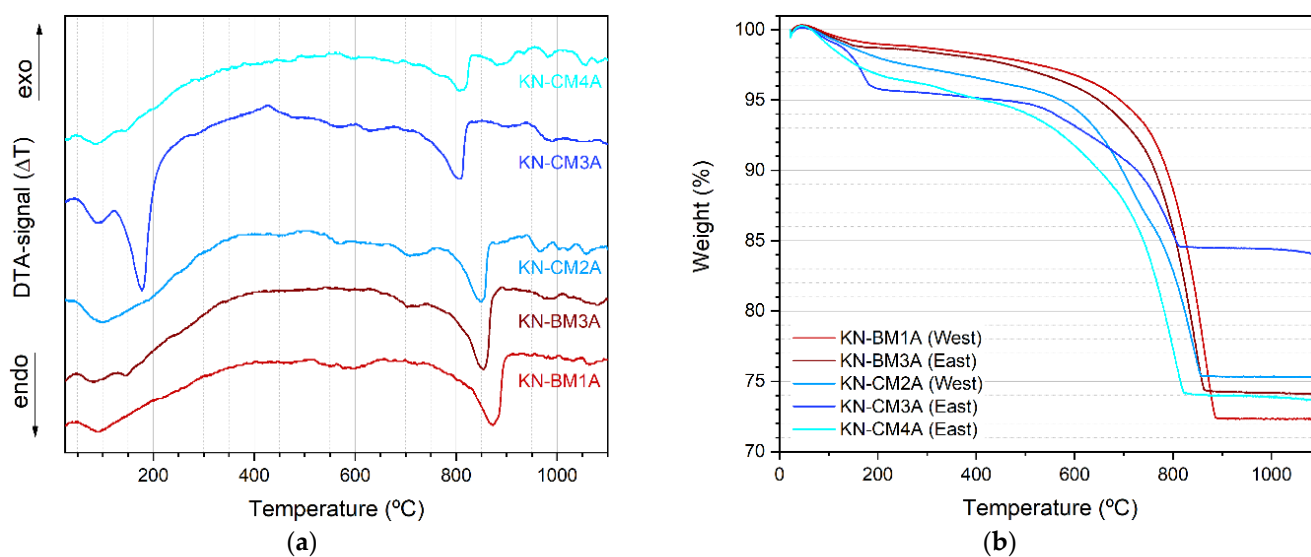
Figure 6. TG-DTA curves of mortar samples from the Palace of Knossos: (a) comparison of the curves obtained by differential thermal analysis, in which the curve referring to the KN-CM3A sample stands out, with the endothermic peak characteristic of dihydrate calcium sulfate; (b) comparison of the curves resulting from the thermogravimetric analysis, in which the similar trend for percentage of weight loss to all samples stands out, except for the KN-CM3A sample.

Simultaneous thermogravimetry and differential thermal analysis was performed only in mortars from bedding stonework, respecting the amount of sample available as it is a destructive technique. The mass losses were calculated from the data obtained from the thermogravimetric curves (TG) (Figure 6b) and are presented in Table 5. The curves obtained by differential thermal analysis (DTA) (Figure 6a) show endothermic peaks up to 200 °C for all samples, attributed to the loss of adsorbed water compatible

with nonhydrated compounds, except in the KN-CM3A sample where the DTA curve is characteristic of dihydrated calcium sulfate, with two endothermic peaks with maximums at 87 °C and 175 °C, corresponding to the loss of hydration water [43,44]. In addition, the curve also presents an exothermic peak with a maximum of 422 °C attributed to the change of the crystalline structure from anhydrite I to anhydrite II [43,44]. All samples show the same tendency of mass loss, from 600 °C, with the maximum ranging between 800 and 900 °C, attributed to the transformation of calcium carbonate. In this case, the calculated mass loss (Table 5) varies between 9.29% and 24.44%, the lowest loss corresponding to sample KN-CM3A, indicating that this mortar has gypsum as the main binder. Sample KN-CM4A shows the highest percentage of mass loss calculated between 200 and 600 °C, attributed to the structural water losses of the compounds [45].

When considering the CO₂/H₂O loss ratio in Table 5, calculated from TG values, the degree of hydraulicity of the mortar can be inferred, because the lower the value of this ratio, the greater the degree of hydraulicity of the mortar. The literature considers that ratios above 10 correspond to aerial lime mortars, while the values between 3.5 and 10 are considered hydraulic mortars, and below 3.5 are considered pozzolans [10,46–48]. Based on the values obtained, it is possible to observe that KN-BM1A presents a value compatible with that of an aerial mortar, and the other mortars present values corresponding to hydraulic mortars. In the case of sample KN-CM3A, it is important to note that all the results indicate and confirm that it is gypsum-based (non-lime-based), and this sample
