# Instability Mechanism, Pressure Relief, and Long Anchorage Control Countermeasures for Surrounding Rock of Strong Mining Roadway at Large Mining Height Working Face

**Abstract:** Double-roadway tunneling could mitigate the contradiction between mining production needs and tunneling speed, which is pivotal to the sustainable development of underground mines. However, it is very difficult to control the stability of a mining roadway on an adjacent working face suffering from strong mining disturbance due to double-roadway tunneling, especially at a large mining height working face. In order to control the stability of the return air roadway (RAR) 23205 of a strong mining roadway at working face 23205 in the Zhuanlongwan Coal Mine in Inner Mongolia, we carried out field monitoring, theoretical analysis, numerical simulations, and engineering practice to identify the main factors influencing the deformations and the stress distribution law of the surrounding rock in order to propose countermeasures for strong mining roadways. The results show the factors influencing the large deformation of strong mining roadways include large mining height, repeated mining, stress concentration due

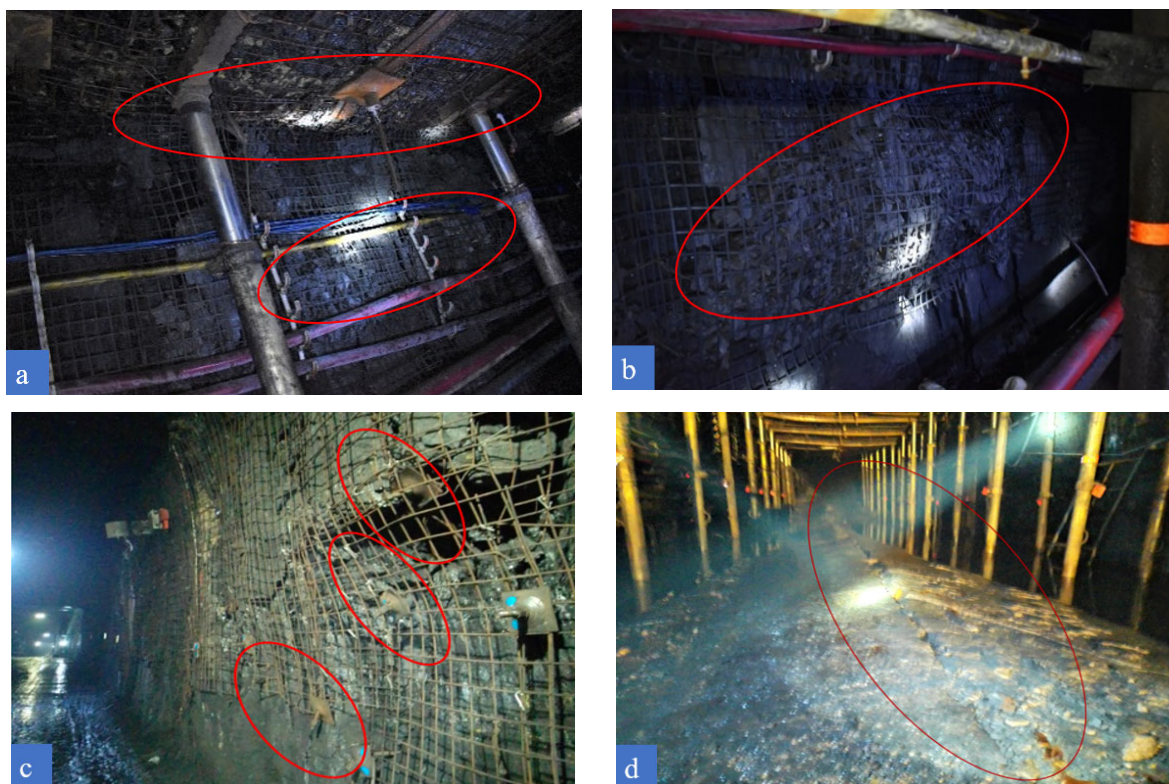
**Figure 5.** Failure characteristics of a strong mining roadway in RAR 23204: (a) stepped roof subsidence and mining sidewall failure; (b) failure instability of mining sidewall; (c) pillar sidewall failure instability and bolt failure; (d) severe floor heaving and floor cracking.

As shown in Figure 5a, stepped roof subsidence and mining sidewall failure occurred. A bedding fracture of the coal body developed, which often causes delamination damage

and collapse. The tensile stress concentrated in the middle of the roof due to the large section span, as was the delamination damage range. The roof subsidence in the local area was up to 700 mm, and the roof separation was up to 80 mm.

As shown in Figure 5a–c, the mining sidewall of RAR 23204 under the influence of severe mining showed a large area of failure and instability and the failure of a large number of bolts. Under the action of strong disturbance and mining stress, the stress concentration of the roadway shoulder angle was high. The local roof was completely cut at the shoulder angle, the coal–rock mass was broken and collapsed, and the roof was netted.

As shown in Figure 5d, the coal roadway with a large mining height and large section was affected by strong mining: the abutment pressure of the coal rib increased sharply, and the stress was transmitted to the no-support floor through the coal rib. The mining stress caused floor cracking and severe floor heaving, which affect traffic and safety.

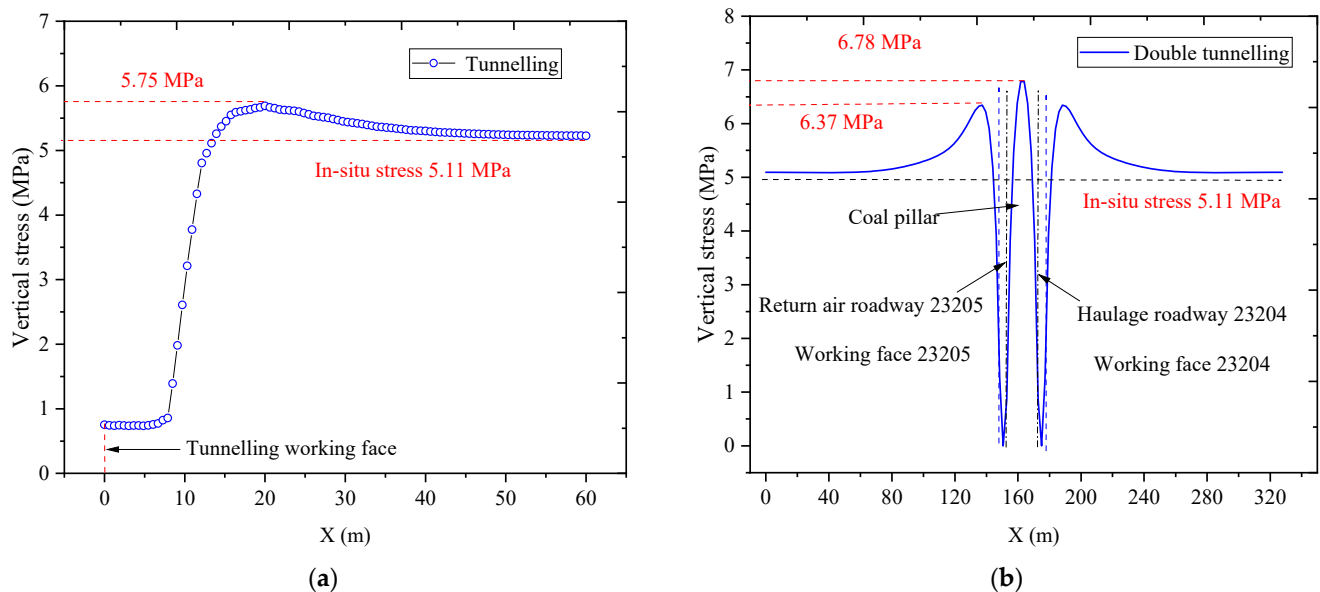
**Figure 9.** The stress evolution law of the surrounding rock during the tunneling: (a) stress distribution in the front of the tunneling; (b) stress distribution in the middle of the roadway after the tunneling.

It can be seen from Figure 9a that, due to the influence of the tunneling disturbance, the stress in the front of the tunnel was in a dynamic adjustment process. The coal body in the front of the tunnel was broken to form a plastic zone, and the range of the plastic zone was about 5 m. Subsequently, stress increased rapidly. The maximum stress was 15 m in the front of the tunneling working face, the peak stress was 5.75 MPa, and the stress concentration coefficient was 1.125. Subsequently, the stress decreased slowly, and the 40 m in the front of the tunneling working face was reduced to the in situ stress.

The stress distribution in the front of the tunneling working face of RAR 23205 is shown in Figure 9a; after the completion of the double tunneling, the stress distribution in the middle of RAR 23205 is shown in Figure 9b.

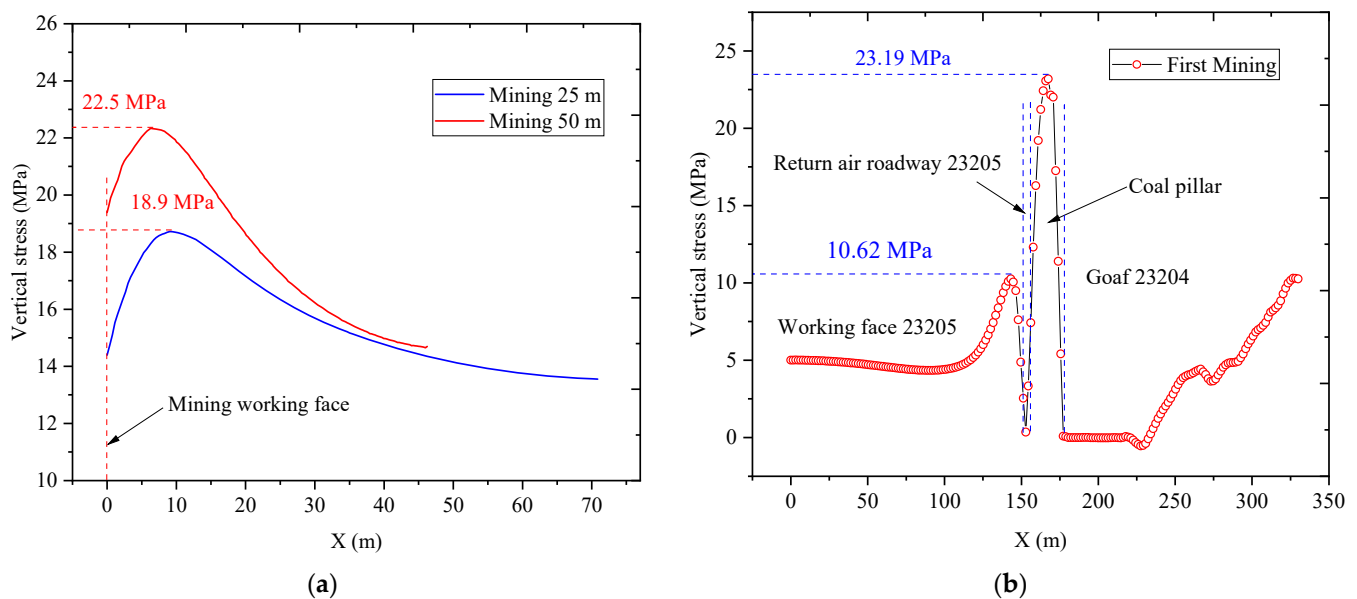
It can be seen from Figure 10a that the influence of mining not only formed a stress concentration in the coal pillar but also caused an increase in stress near the goaf in the front of the mining face. The stress concentration area moved forward with the mining of the working face. Due to the influence of mining disturbance, the coal mass in the mining face was loose and broke to form a plastic zone; the stress increased rapidly in the front of the working face, reached a peak at 8–9 m in the front of the working face, and then decreased gradually. The peak stress was 18.8 MPa and 22.3 MPa at 25 m and 50 m of the working face, respectively. The roof did not collapse at 25 m of the working face mining. Therefore, the stress disturbance was significantly less than that at 50 m of working face mining. Although the stress peak was different due to different engineering disturbance intensities, the stress evolution laws were the same.

According to Figure 10b, the movement space caused by roof breaking due to the mining effect was sufficient, and the stress in the coal pillar increased sharply due to the strong disturbance. The peak stress was 23.19 MPa, and the stress concentration coefficient reached 4.538. The peak stress was 6 m away from the pillar sidewall of goaf 23204 and 13 m away from the pillar sidewall of RAR 23205, and the peak position range was 9–13 m. The peak stress of the mining sidewall was 10.62 MPa, the stress concentration coefficient was 2.078, and the stress was only 45.8% of the pillar sidewall. The peak stress was 6.2 m from the roadway. The influence of the main roof fracture on the mining sidewall was significantly less than that of the pillar sidewall when working face 23204 was mined, but the peak stress of the roadway was significantly greater than that of the tunneling period.

During the first mining, the vertical stress distribution was 2 m along the roof of RAR 23205 in the front of the working face 23204 with different mining distances, as shown in Figure 10a, and the vertical stress distribution in the middle of RAR 23205 is shown in Figure 10b.

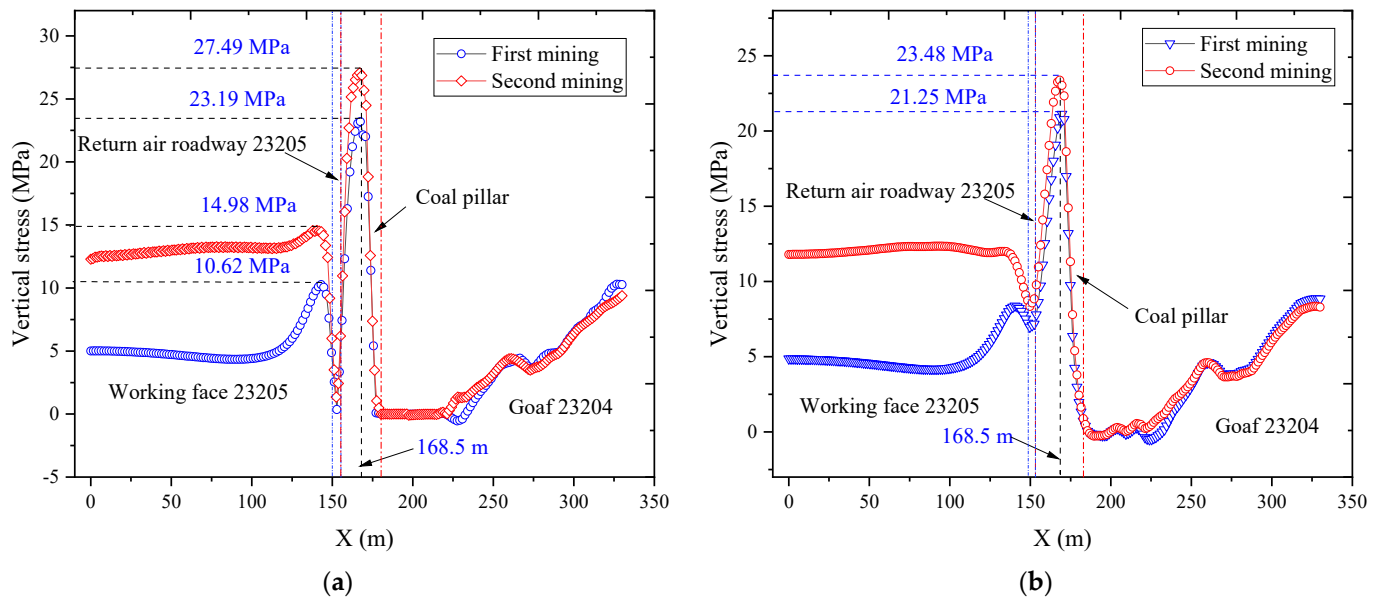
**Figure 11.** Stress evolution law of surrounding rock during the second mining of working face 23205: (a) the vertical stress distribution in the middle sidewalls of RAR 23205; (b) the vertical stress distribution 2 m along the roof of RAR 23205.

When RAR 23205 was disturbed by mining, the peak stress in the middle of the roadway was significantly higher than that on the roof. It can be seen from Figure 11a that, after the mining of the working face 23204, with the initial breaking and the periodic weighting of the roof, the cantilever beam structure of the goaf caused the stress to increase sharply in the front of the working face. The peak stress of the coal pillar under the first mining was 23.19 MPa, and the stress concentration coefficient was 4.538. In the mining process of working face 23205, the peak stress in the coal pillar increased again; the peak value reached 27.49 MPa, and the stress concentration coefficient increased to 5.379. Compared with the first mining period, the stress increased by 18.54% during the second mining period; the peak stress in the coal pillar was 10.5 m away from the pillar sidewall and 8.5 m away from the goaf. The peak stress range of the coal pillar during the first mining and the second mining was 8–13 m and 7–13 m, respectively. The stress peak values of the solid coal side during the first mining and the second stress were 10.62 MPa and 14.98 MPa, respectively. Compared with the first mining period, the peak stress during the second mining period increased by 41.05%. The peak stress point moved from 9 m to 11 m away from RAR 23205, i.e., it moved 2 m deeper into the coal body.

During the second mining of working face 23205, the vertical stress distribution in the middle of the roadway and 2 m along the roof of RAR 23205 is shown in Figure 11a,b respectively.

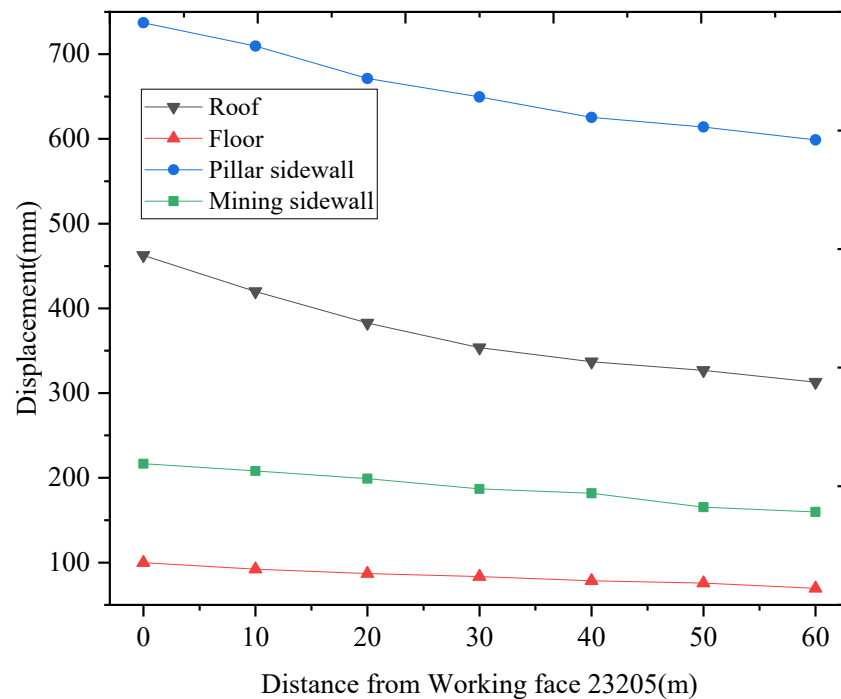
**Figure 14.** Displacement of the roadway-surrounding rock at different distances from the front of working face 23205 during the second mining.

According to Figure 14, the displacement of RAR 23205 in the front of the working face decreased gradually with the increase in the distance from the working face. The deformation and failure of the roadway-surrounding rock were mainly caused by horizontal deformation of the pillar sidewall. The displacement of the pillar sidewall reached 737.07 mm, and the roof subsidence was serious. There was no timely support for RAR 23205 in the front of the working face, or the support strength was too low, so the roof was prone to overall subsidence or stepped subsidence at the roadway shoulder corner before the mining of working face 23205.

The deformation and displacement of roadway-surrounding rock at different distances from the front of working face 23205 during the second mining are shown in Figure 14.

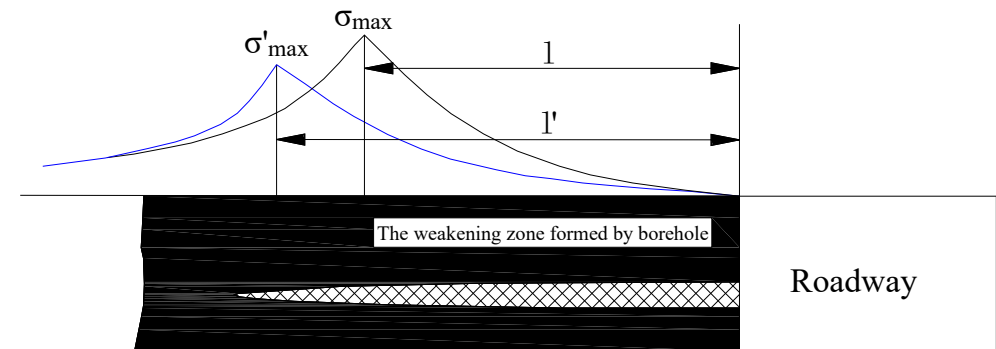
pressure relief zones of each borehole are connected and penetrated to form a weakening zone, as shown in Figure 17. The pressure relief borehole destroys the bearing structure of the coal body, and the range of the stress equilibrium zone in the coal body increases significantly. The peak stress shifts to the deep part of the coal body, and the peak stress value of  $\sigma_{\max}$  decreases. The coal body, after pressure relief, plays an energy absorption and protection role for the dynamic behavior in the deep coal body and the roof and floor of the roadway. The free space formed by the borehole can absorb the deformation of the roadway-surrounding rock and reduce the influence of dynamic pressure on the roadway.

**Figure 17.** Principle of borehole for pressure relief. The symbols  $\sigma_{\max}$  and  $\sigma'_{\max}$  are the peak stresses in the roadway sidewalls before and after pressure relief. The symbols  $l$  and  $l'$  are the distances from the peak stress to the edge of the roadway sidewall before and after pressure relief.

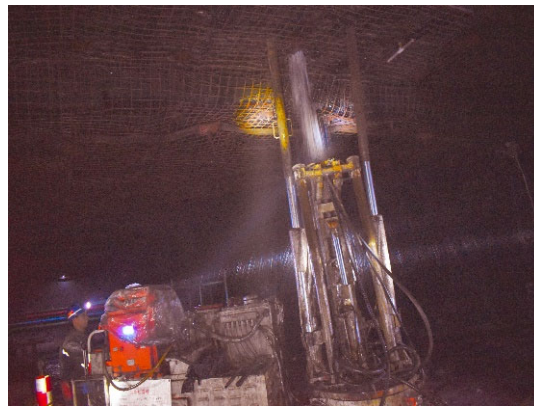
**Figure 19.** Large-diameter borehole drilling rig.

The drilling rig of ZDY1200L is used for borehole construction (Figure 19). The drilling rig is suitable for roof and roadside boreholes, and the borehole diameter is 95 mm.
