Article

Mineralogical Sequence of Self-Healing Products in Cracked Marine Concrete

Abstract: Self-healing of cracked concrete beams after 25 years of marine exposure was investigated. The extent of self-healing and the chemical and mineralogical composition of the self-healing products were characterized, and mechanisms proposed. There was no effect of varying silica fume (4%, 12%) and fly ash content (0%, 20%) on the mineralogy and chemistry of the self-healing products and the extent of self-healing. Crack widths smaller than 0.2 mm appeared closed. With increasing crack depth, a sequence of changing mineralogy of self-healing products was found. In the outer part of the crack (0–5 mm depth from the exterior surface) only calcite was precipitated followed by brucite layers from 5–30 mm depth. The brucite was occasionally intermixed with calcite. At crack depths >30 mm only ettringite was observed. It is hypothesized that the mineralogical sequence observed with increasing crack depth occurs due to an increasing pH of the solution inside the crack with increased crack depth. Self-healing of cracks in marine exposed concrete is proposed to happen through precipitation of ions fro

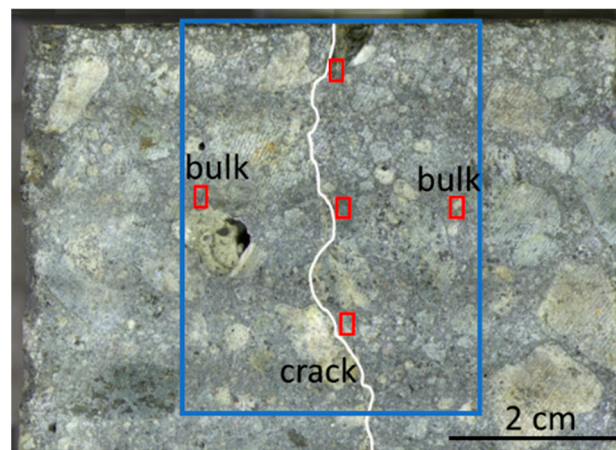
Figure 2. Illustration of positions for the SEM-EDX point analysis in the bulk and close to the crack (red rectangles). The blue rectangle illustrates the area of the thin section used for Scanning electron microscopy energy dispersive (SEM-EDX) analysis and optical polarizing microscopy.

Scanning electron microscopy energy dispersive (SEM-EDX) point analysis of the hydrated paste phases was performed (a) in the paste close to the crack (<0.1 mm from the crack) at three different depths from the exterior surface and (b) at two positions in the bulk paste, both 10–15 mm from the crack and about 20 mm from the exterior surface. Thirty points were taken at each of the paste positions close to the crack. The positions at different crack depths were selected based on differences in the phases observed in the cracks. Sixty points were taken at each of the two paste positions away from the cracks (bulk). An illustration of the positions for the SEM-EDX point analysis is given in Figure 2.

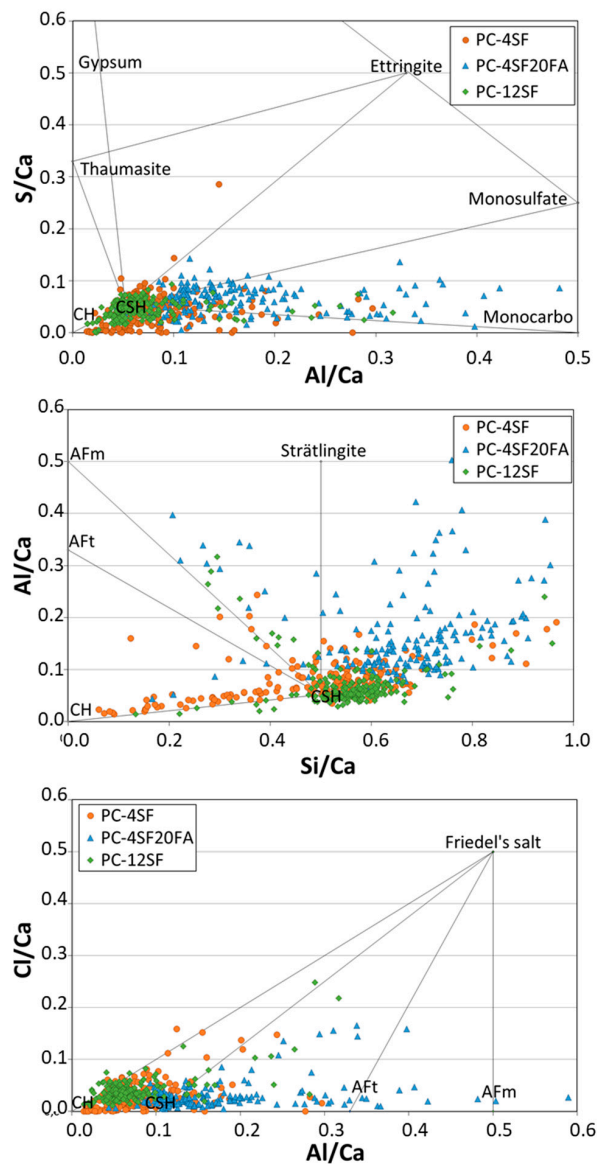
Figure 3 shows the results of the EDX point analysis of the bulk cement paste (15–20 mm from the crack face and 20 mm from the exterior surface) in the three different concretes. It can be seen

that the hydrated phases of PC-4SF and PC-12SF are rather similar. Both binders contain only silica fume, but in different amounts, and the hydration products observed after 25 years hydration and exposure to marine environment are mainly C-S-H and CH. Additionally, AFm phases (carbo-aluminate, sulpho-aluminates, Friedel's salt) and Aft phases (ettringite) were detected. It seems that PC-12SF formed more C-S-H phases and less CH compared to PC-4SF. In PC-4SF20FA little or no CH was detected but more AFm and Aft phases compared to the others. In none of the pastes gypsum or thaumasite was detected. The EDX point analysis of the cement paste close to the cracks at different crack depth did not differ significantly from the composition of the paste away from the crack and is therefore not shown here. The average composition of the paste close to the crack at different crack depth is compared to the bulk paste composition in Table 5. Minor differences in the composition were detected close to the crack with increasing crack depth from the exterior surface and between points near and away from the crack (bulk). In PC-4SF, the average magnesium (Mg) and calcium (Ca) content was increased at 5 mm depth close to the crack, while the average sulphur (S) and chloride (Cl) content was decreased compared to the paste at larger crack depth or the bulk. The Cl content reached a maximum at a depth of about 20–25 mm in the bulk, while the S content reached a maximum at a depth of about 30 mm. In PC-4SF20FA, a slightly increased Al content was measured close to the crack at a depth of 5 mm from the exterior surface. In PC-12SF, a slightly increased Cl content was measured close to the crack at a depth of 5 mm from the exterior surface.

Figure 3. EDX phase analysis of the bulk of the three different binders investigated.

The concrete columns were exposed to seawater for 25 years. Thaumasite formation is a typical indication of sulphate attack in cold climates [15]. The phase analysis did neither show the presences of gypsum nor thaumasite (Figure 3) and the microscopy showed no signs of sulphate attack to the concrete. Furthermore, only limited Friedel's salt was observed in the pastes. Friedel's salt is a product of a reaction of AFm phases like monsulpho-aluminate with chlorides from the environment [15].

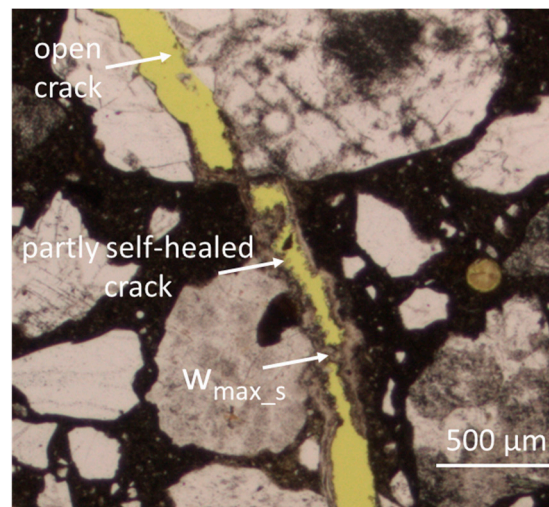
Figure 4. Explanation of the categories \blacktriangle partly self-healed, \square no self-healing (open crack) and w_{\max_s} used in Table 7.

Table 7 shows the results of the extent of self-healing at different crack depth, and the maximum crack width where complete self-healing was observed. The extent of self-healing was divided into two categories; \blacktriangle partly self-healed, \square no self-healing (open crack). Most parts were partly self-healed with smaller areas where the crack was completely closed (w_{\max_s}). Explanations of the different categories are given in Figure 4.

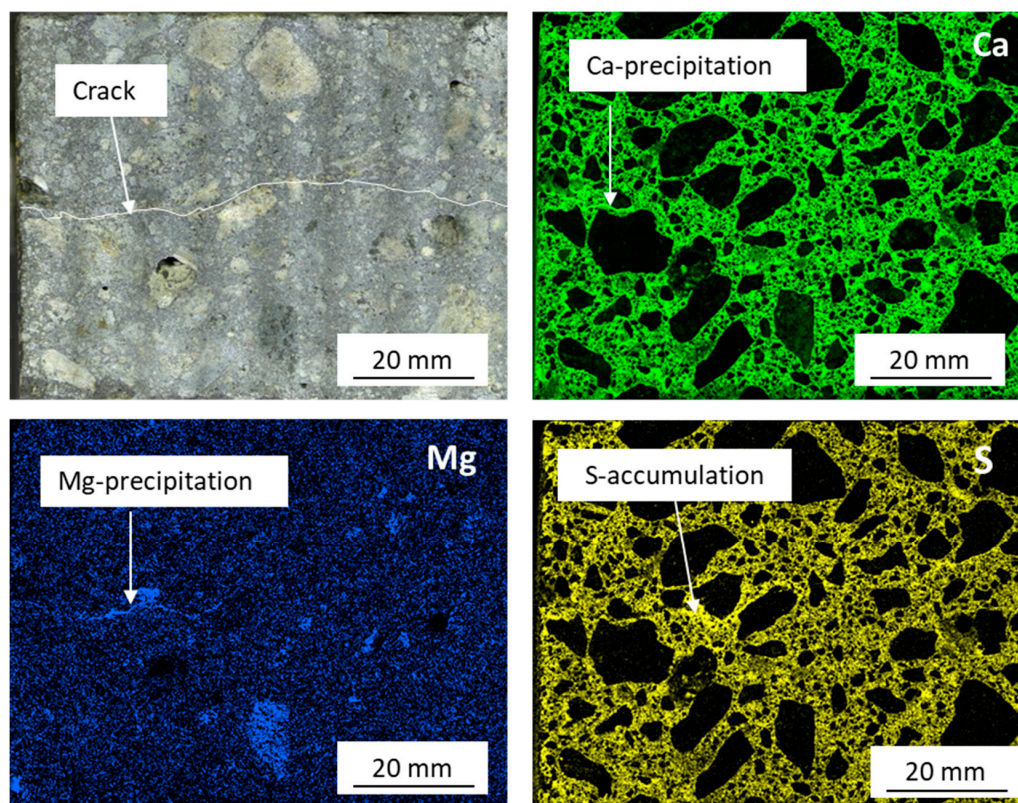
Figure 5. Overview picture (self-healed crack marked as white line) and μ -XRF elemental map of Ca (green), Mg (blue) and S (yellow) of PC-4SF20FA.

An overview of the elemental distribution in the bulk of the concrete and the cracks was obtained by the micro X-ray fluorescence (μ -XRF) mapping of the whole length of the concrete cores. Parts of the elemental map from PC-4SF20FA including Ca, Mg and S are shown in Figure 5 as a representative example for all concretes. In the Ca map, it is easy to make a distinction between paste and aggregate since the aggregate was poor in Ca (black areas). Within the first 20 mm, high intensities of Ca were observed inside the crack (white arrow). However, due to the high amount of Ca in the surrounding paste this is difficult to see. The Mg precipitation was found inside the crack until a depth of about 30 mm. The highest Mg intensities inside the crack were found at a crack depth between 10–30 mm. This is easier to spot due to the low amount of Mg in the surrounding paste. An accumulation of sulphate in the paste surrounding the crack could be observed in some areas at a depth between 25–40 mm. Figure 6 displays two close-up pictures of the crack in PC-4SF20FA showing the precipitation layer inside the crack. The EDX point analysis was performed inside the self-healing products (inside white lines indicated in Figure 6); the average composition of five points found at two crack depths is given in Table 8. The composition of the self-healing products was rich in Ca at a crack depth of 5 mm, and rich in Mg and Ca at a crack depth of 15 mm. The amount of Ca was reduced while the amount of Mg was increased with increased crack depth. The other cores showed a similar trend. The high standard deviation of the results can be explained by the rather low resolution of the μ -XRF and the relatively large spot size of the analyzing X-ray beam of 20 μ m. Due to the relatively low resolution it is not possible to spot potential different phases within the layer of self-healing products. Due to the large spot size of the X-ray beam it cannot be guaranteed that only one single phase is analyzed. The results might be the average of different phases including parts of the concrete adjacent to the crack.

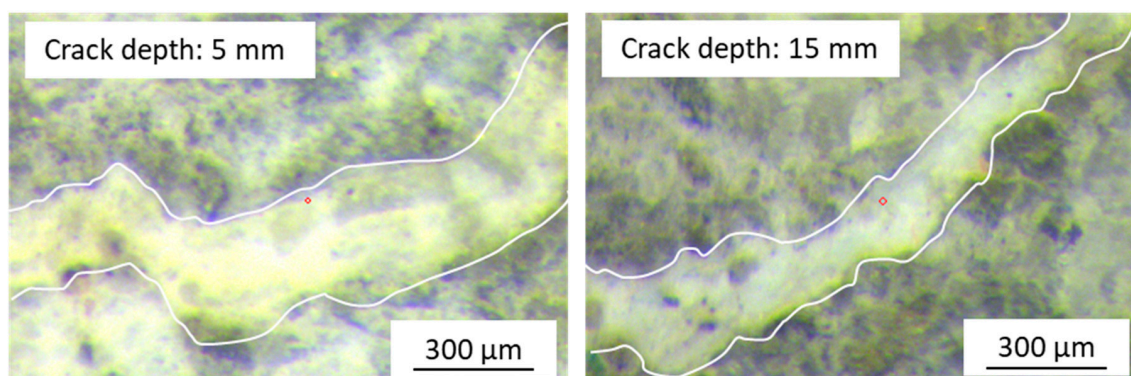
Figure 6. Close up pictures of the crack (filled with white precipitate) in PC-4SF20FA, taken with an optical camera inbuilt in the micro X-ray fluorescence (μ -XRF) instrument. Blurred due to relatively low optical resolution of the instrument. The edges (crack faces) are marked with white lines.

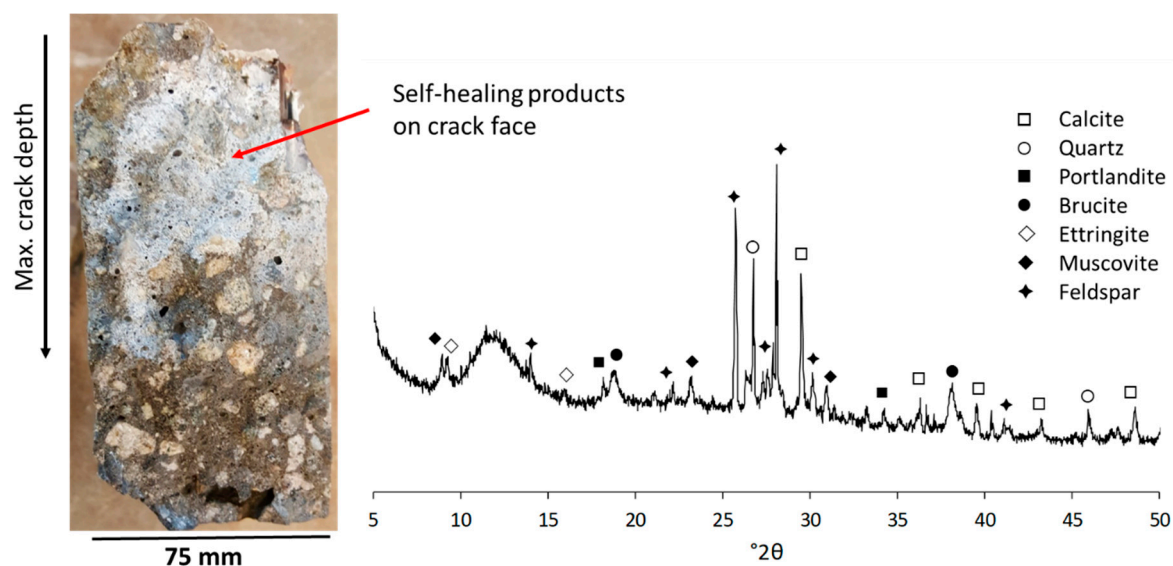
Parts of the original concrete beams were split along some cracks. Figure 7 (left) shows the crack face of a crack in the tidal zone of PC-4SF20FA. White colored self-healing products were observed on the crack face. The self-healing products were carefully removed with a spatula to collect enough powder for X-ray diffraction (XRD). The diffractogram of the powder collected from the self-healing products of concrete PC-4SF20FA is shown in Figure 7 (right). The diffractogram shows the average composition of the self-healing products at a crack depth between 0–50 mm as otherwise not enough powder would have been available. Brucite, portlandite, calcite and ettringite were detected in the collected powder. Due to the removal of the self-healing product by scratching with a spatula on the crack face, phases from the adjacent concrete might be intermixed with the self-healing products. This is indicated by the detection of quartz, feldspar and muscovite, which are typical, aggregate phases e.g., deriving from granite stone.

Figure 7. Left: Self-healing products on crack face in the tidal zone of PC-4SF20FA, Right: XRD diffractogram of the self-healing product. The wide hump between 10–15 °2θ indicates the desiccator wax used for the sample preparation.

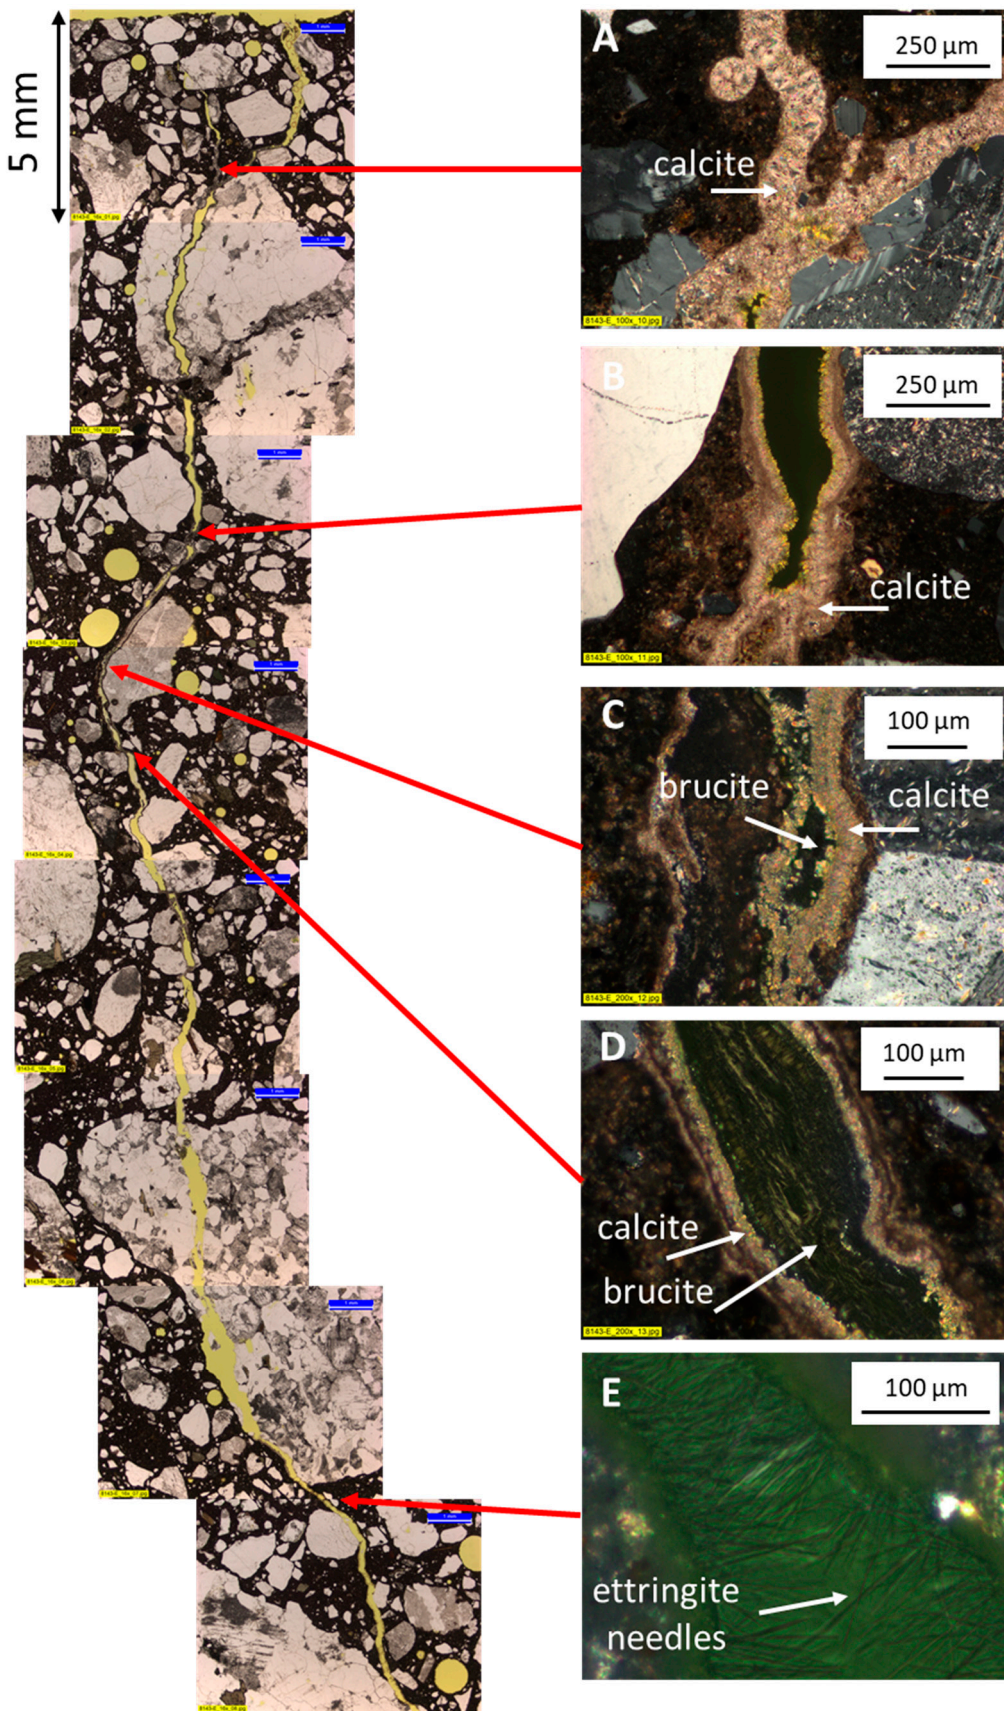
Figure 8 shows pictures from the optical polarizing microscopy of the crack in PC-4SF20FA. On the left side of Figure 8 an overview of the epoxy-impregnated crack is given while close-up pictures of the self-healing products in dependence of crack depth are given to the right of Figure 8. Figure 8 (right) shows close-up pictures at a crack depth of about 4 mm (A), 12 mm (B), 16 mm (C), 18 mm (D) and 40 mm (E). Figure 8A,B show calcium carbonate as dense product closing the crack completely (A) and partly (B). In Figure 8B, a dense lining of calcium carbonate was observed on the crack faces as a dark brown layer. On top of that layer, a lighter layer of needle like calcium carbonate crystals were growing, stretching towards the center of the crack. In some cases, it was observed that bridging by calcium carbonate occurred occasionally where small paste fragments from the cracking of the concrete were present inside the crack.

Figure 8C,D show a calcium carbonate layer intermixed with brucite. In Figure 8D, a clear thin lining of calcium carbonate is observed followed by a thicker lining of brucite in parts completely closing the crack. Ettringite appeared as fine needles, occasionally growing across the cracks but not massively filling the cracks. Ettringite needles growing across the crack at crack depths larger than 32 mm are shown in Figure 8E.

Figure 8. Left: Overview image of the epoxy impregnated crack of PC-4SF20FA until a crack depth of 40 mm, Right: Zoomed in pictures of parts of the cracks showing the variation in self-healing products with crack depth.

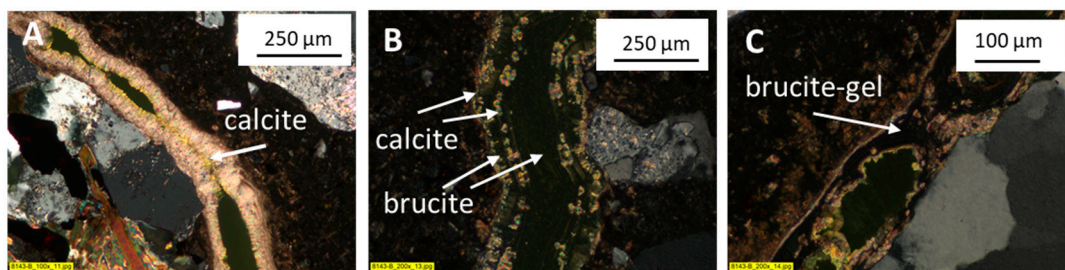
Figure 9 shows a selection of self-healing products found at different crack depths in PC-4SF. As mentioned, calcite was observed to occasionally densely closing the cracks, typically as small bridging calcite crystals. An example is given in Figure 9A. In some places, precipitation of calcite and brucite appeared as a layered texture where each new layer seemed to precipitate on the former layer (Figure 9B). The colorful and more light interference colors are typical for calcium carbonate and there seems to be a layer of calcium carbonate at the crack face, followed by a layer of brucite (dark areas), and again a layer of calcium carbonate on top of the brucite layer. At crack depths larger than 12–16 mm, an isotropic phase forming bridges to close the crack was observed (Figure 9C). The texture of the phase was similar to brucite and SEM-EDX analysis confirmed the brucite composition. However, the phase had no crystallinity and was therefore assigned to be a brucite-gel. The brucite-gel phase was again intermixed with calcium carbonate. There was a clear mixing of calcite and brucite as an interface zone between more massive appearances of the two. While calcite was densely filling the cracks, brucite fillings appeared rather porous (Figure 10). Epoxy could easily penetrate areas of brucite during vacuum preparation of the specimens (Figure 10 right).

Figure 9. Examples of (A) Calcite bridging; (B) brucite and calcite, layered and intermixed; (C) brucite-gel observed inside the crack of PC-4SF at different crack depth; crack depth from the exterior, (A): 4 mm, (B): 17 mm, (C): 23 mm.

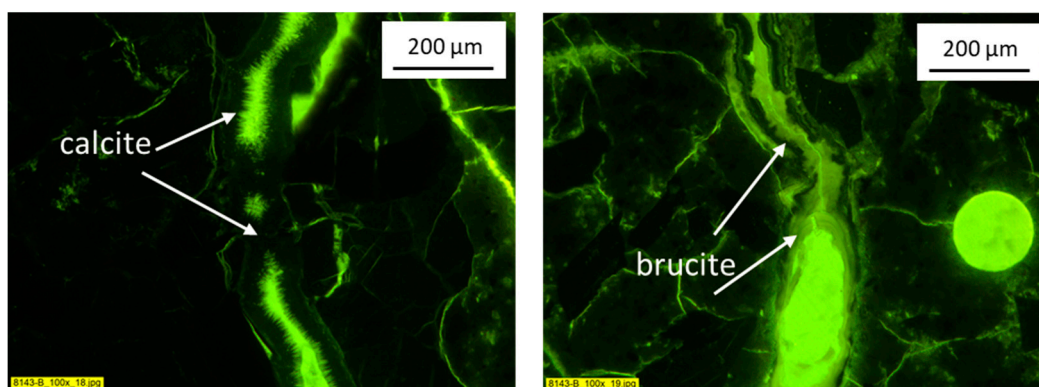
Figure 10. Crack in core PC-4SF, Left: Massive precipitation of calcite along the crack face with small bridges closing the crack, Right: Brucite interlayered with dense calcite. The porous brucite is fully impregnated with epoxy. Fluorescent light mode.

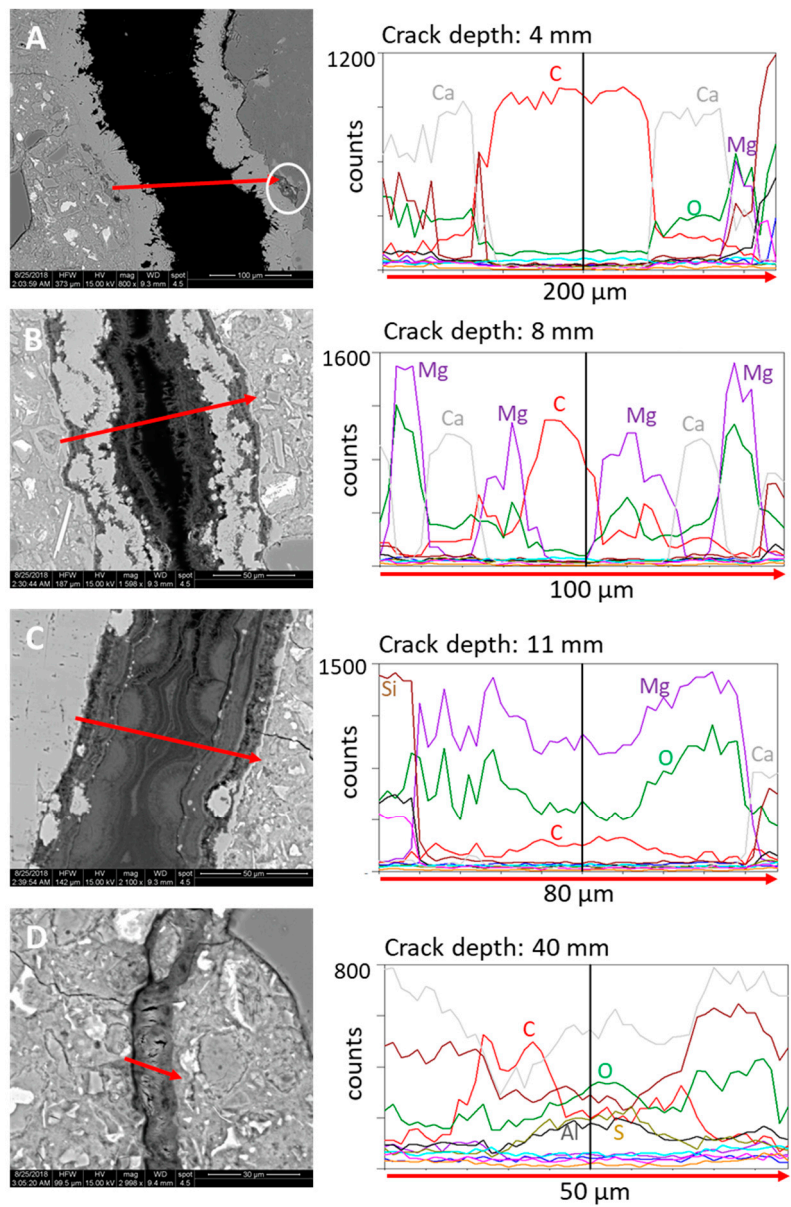
Figure 11. Left: BSE images of self-healing products of PC-4SF at different crack depth, Right: SEM-EDX line scan elemental analysis through the self-healing product. Line colors representing different elements according to Table 10.

Figure 11A shows that the dense lining on the crack faces at a crack depth of 4 mm is high in Ca, confirming it is calcium carbonate. At the right end of the line scan, intensities of magnesium (Mg) and silicon (Si) are increased, indicating the presence of magnesium silicate hydrate (M-S-H) in between the calcium carbonate lining and an aggregate particle. At a depth of 8 mm, (Figure 11B) the intermixing of calcium carbonate and brucite layers were verified by the chemical profile. At this position brucite appeared as the first formed phase followed by alternating formation of calcium carbonate and brucite. The crack was at this position not completely closed. At a depth of 11 mm (Figure 11C) Mg intensities indicate the presence of a massive appearance of layered brucite closing the whole crack. In Figure 11B,C at the right side of the crack the Mg intensities decreased while Ca increased. This may be due to the presence of a very thin calcite or portlandite layer just between the brucite and the cement paste; this thin layer was just seen in the backscatter images. At a depth of 40 mm, (Figure 11D) where the crack was no more than about 0.03 mm wide, increased intensities of aluminium (Al) and S and relative high intensities of Ca verified the presence of ettringite. EDX point analysis verified the composition of the named phases found in the cracks (Table 11).

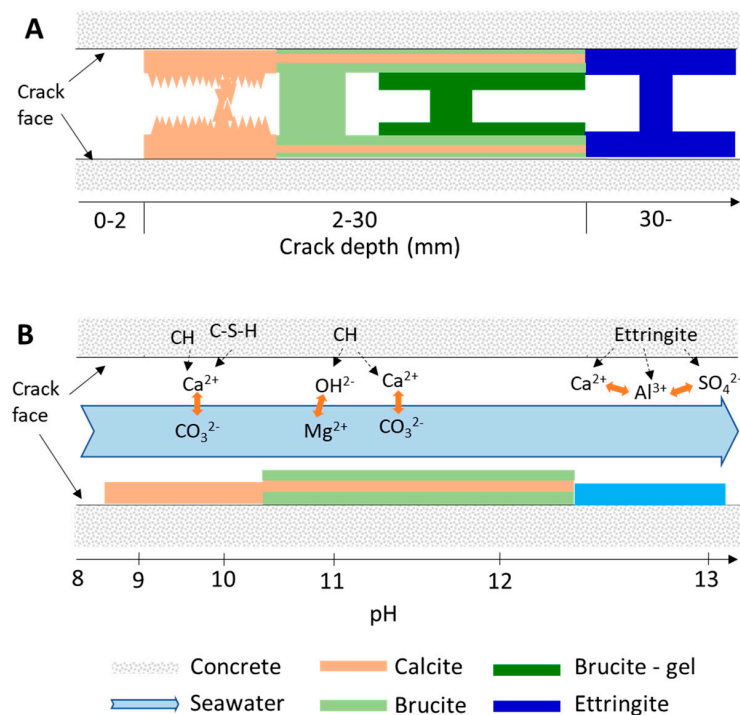
There was no difference in the self-healing in respect to mineralogy and chemistry between the three different binder combinations investigated. In all three concretes, calcite precipitation appeared along the crack faces in the outer part of the cracks. Further inwards brucite was dominant and even further inwards ettringite dominated (Figure 12A).

Figure 12. Illustration of (A) Observed mineralogical sequence of self-healing products with increased crack depth; (B) proposed self-healing mechanism. Only main components contributing to self-healing are indicated.

An illustration of the potential self-healing mechanism found in the different binders is given in Figure 12B.

The cracks investigated in this study were exposed to the tidal zone, meaning that they were subjected to wetting and drying cycles. The first millimeters of a crack will dry out most rapidly causing calcite to precipitate directly from the seawater in form of dense layers. In contact with concrete, the seawater gets oversaturated with Ca ions from CH and C-S-H leaching. In that environment, carbonate ions from seawater can rapidly react with Ca^{2+} from the cement paste to form calcite.

In the normal pH range of seawater (pH about 8), seawater is undersaturated with respect to brucite. However, when seawater gets in contact with the high pH environment in a concrete pore solution, brucite will precipitate [15]. Mg^{2+} will react with hydroxyl ions (OH^-) from the cement paste to form brucite. In several places it was observed that brucite was intermixed with calcite. Optical polarizing microscopy showed that the brucite layer is not dense (Figure 10). Hence, Ca^{2+} and CO_3^{2-} ions can potentially be transported through the brucite layer and co-precipitate as calcite. It was also observed that calcite layers form on top of brucite layers. Mg^{2+} potentially reacts with CH to form

brucite. In this process Ca^{2+} ions from CH are made available for reaction with CO_3^{2-} ions from the seawater. This would lead to precipitation of calcite on top of brucite. The formation of a calcite layer on top of a brucite layer was also observed in other investigations on concrete surfaces submerged in seawater [31].
