Article

Effect of Cutting Parameters on Tool Chipping Mechanism and Tool Wear Multi-Patterns in Face Milling Inconel 718

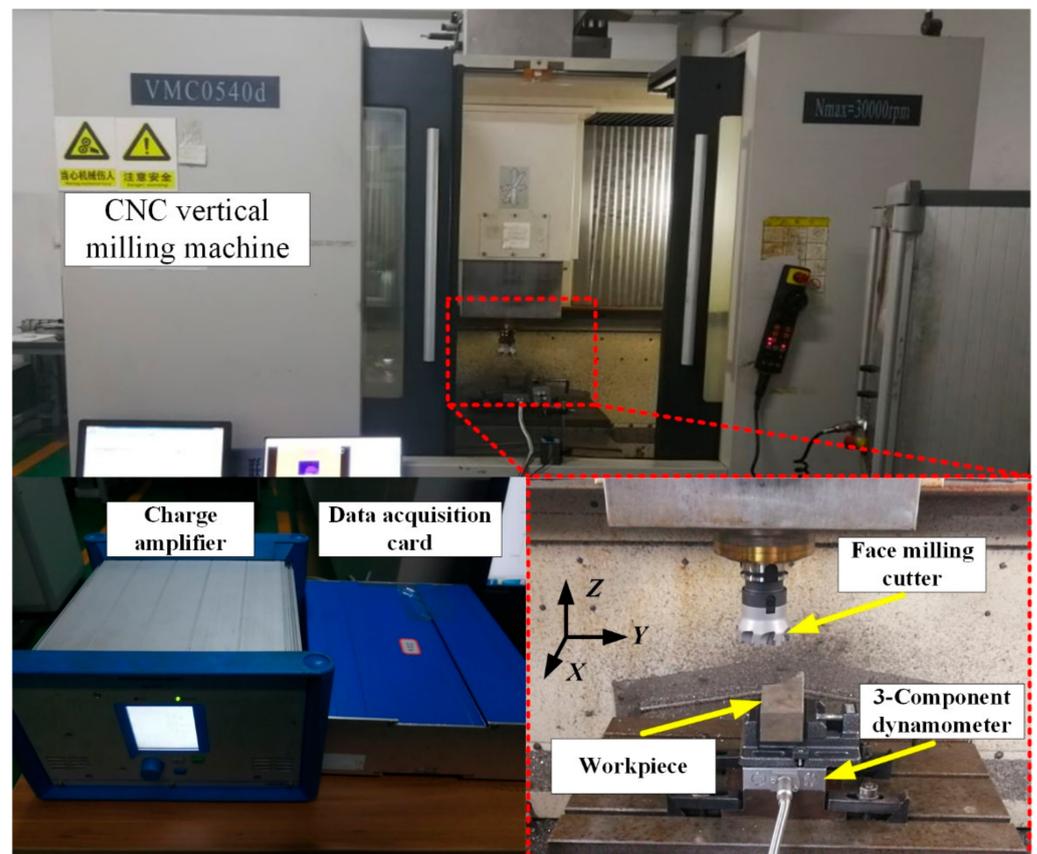
The experimental setup is shown in Figure 1. Face milling of Inconel 718 was conducted on a VMC0540d CNC vertical milling machine with cemented carbide inserts under a dry machining environment. The indexable face milling cutter (diameter $D = 80$ mm,

Figure 1. Face milling experiments.

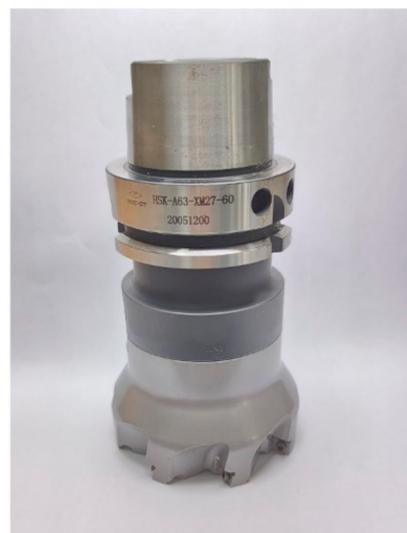
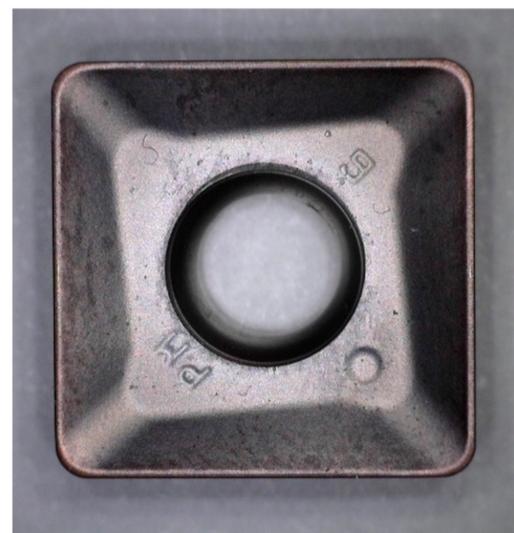
Figure 2. Overall view of face milling cutter and insert.

maximum number of teeth $z = 8$) provided by cutting tool supplier ZCC-CT was used in the experiments, as shown in Figure 2. The milling experiment was conducted by applying one tooth to the cutter. A TiAlN-coated WC-Co cemented carbide insert with 0.8 mm tool nose radius was selected for experiments. The effective rake, clearance, and inclination angle were -15° , 5° , and 0° , respectively.

(a) Indexable milling cutter

(b) Overall view of insert

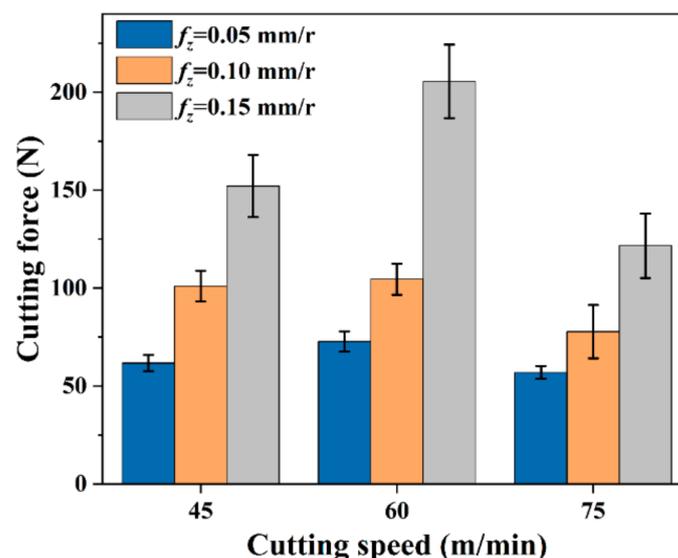
The resultant cutting forces of the new inserts at different cutting parameters are shown in Figure 3. The resultant cutting force of 152.1 N is observed at the cutting speed of 45 m/min and the feed rate of 0.15 mm/r, whereas the resultant cutting force is 61.7 N at the feed of 0.05 mm/r. It can be seen that the resultant cutting force increases with the increase in the feed rate. The same trend can be found at cutting speeds of 60 m/min and 75 m/min. This is because the variation in undeformed chip thickness at different feed rates has an effect on cutting force [24].

Figure 3. Cutting force at different cutting parameters with new inserts.

However, the effect of cutting speed on resultant cutting force is found to be different from that of feed rate. The maximum value of resultant cutting forces of new inserts in every feed rate is achieved at the cutting speed of 60 m/min. The variation of cutting force is generated due to the change in the build-up edge and adhesion layer observed on the flank face in the milling process. The effective rake angle is added due to the generation of the build-up edge as the cutting speed increases. It results in an increase in the cutting force on the one hand. On the other hand, the temperature generation rate becomes higher at a higher cutting speed, which makes workpiece material soft [25]. It leads to a reduction in cutting force at a higher cutting speed. The variation of cutting force with cutting speed is attributed to these two factors.

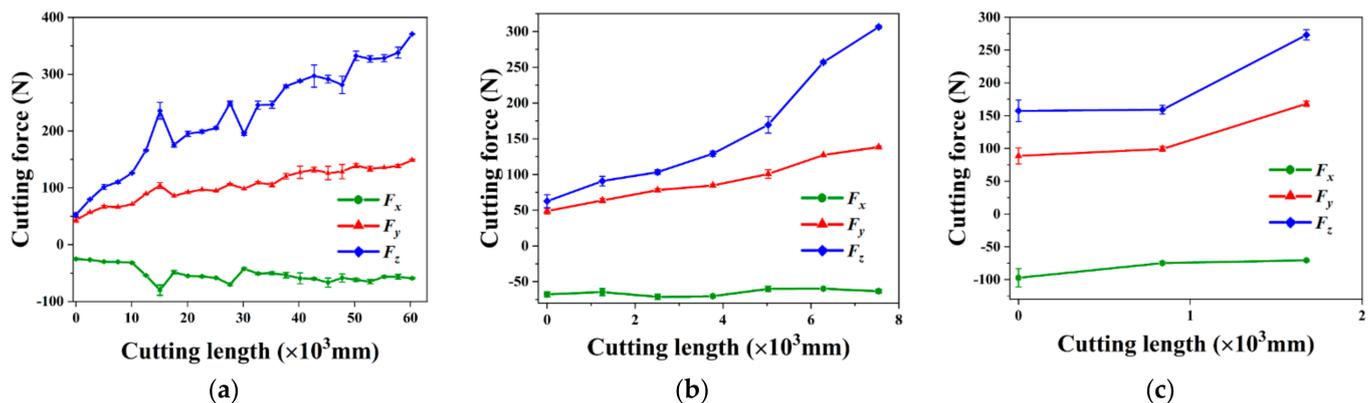
The evolution of cutting force over cutting length at the cutting speed of 60 m/min with different feed rates in milling Inconel 718 is shown in Figure 4. The force components, including feed force (F_x), tangential force (F_y), and axial force (F_z), force were measured with a dynamometer during each test until the critical flank wear width of 300 μm was reached. It can be seen that all three cutting force components increase with the cutting length. The F_x is observed to be almost constant over cutting length under the feed rates of 0.10 mm/r and 0.15 mm/r. The average growth rate of F_z 5.27 N/m is obtained at the feed rate of 0.05 mm/r. Such an evolution trend is observed in the cutting force component F_y . However, the average growth rate of F_y is 1.745 N/m, which is much smaller than F_z at the feed of 0.05 mm/r.

Figure 4. Cutting forces vs. cutting length at $v_c = 60$ m/min and (a) $f_z = 0.05$ mm/r, (b) $f_z = 0.10$ mm/r, and (c) $f_z = 0.15$ mm/r.

The axial force F_z is observed as the largest of the three force components, while the feed force F_x is minimum. The pressure and friction between the workpiece and the negative chamfer render the F_z larger than the other components. The maximum F_z value of 370 N is measured at the feed rate of 0.05 mm/r and cutting speed of 60 m/min, while the maximum value of F_z at the feed rate of 0.15 mm/r and the cutting speed of 75 m/min is less than 250 N. The worn-out inserts are subjected to higher temperatures at larger cutting parameters, which is similar to the new inserts. Small cutting forces are obtained under the cutting speed of 75 m/min from both the new insert and worn-out insert.

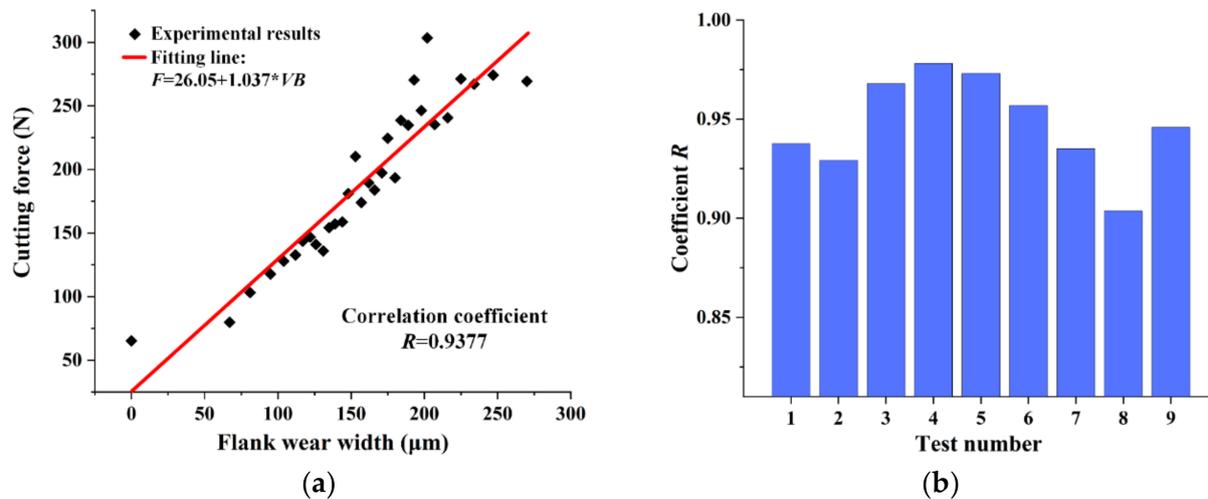
The interaction between tool wear and cutting forces is shown in Figure 5. The friction behavior and the tool–workpiece contact condition are affected by the evolution of tool wear [26]. The evolution of cutting force is affected by the increase in contact area on the tool–workpiece interface induced by tool wear. Then the increase in cutting force results in an increase in the normal stress on the flank face, which further aggravates tool wear. The relationship between cutting force and tool wear width on the flank face at the cutting speed of 45 m/min and the feed rate of 0.5 mm/r is shown in Figure 5a, with the correlation coefficient of 0.9377. The correlation coefficient R values for the rest of the test are shown in Figure 5b. The values of the correlation coefficient R between tool wear and cutting force in

each test group are all over 0.9. This indicates that the tool wear and cutting force are linear in the milling process.

Figure 5. (a) Cutting force vs. tool flank wear width at $v_c = 45$ m/min and $f_z = 0.05$ mm/r; (b) correlation coefficients at other cutting parameters as shown in Table 3.

1. Cutting force and tool wear show a strong linear relationship. The values of the correlation coefficient R between cutting force and tool wear are all above 0.9 under different cutting parameters. The relationship between cutting force and tool wear propagation can be used for milling process planning and for the development of effective tool condition monitoring strategies.

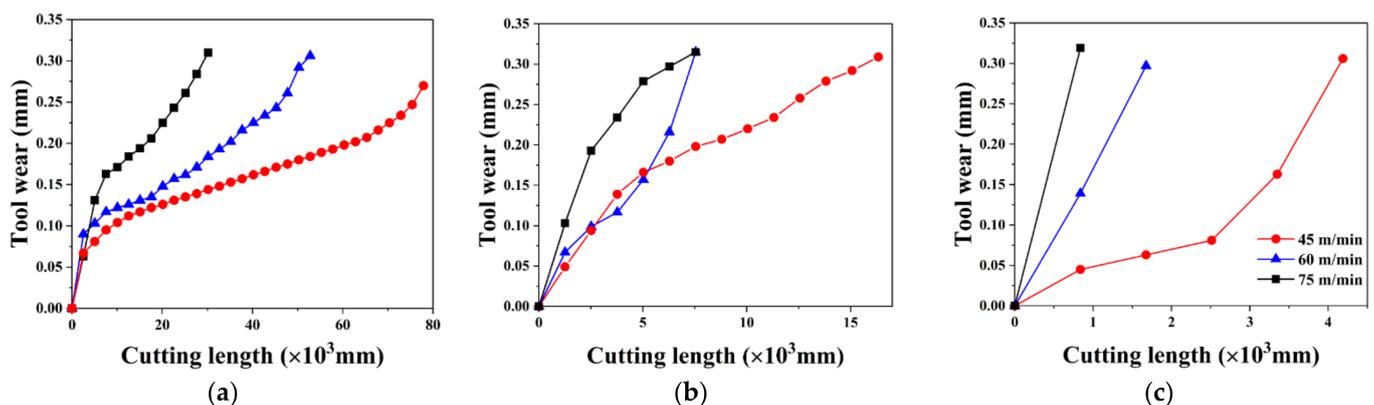
The flank wear curves of the coated carbide insert in face milling Inconel 718 under different cutting parameters are shown in Figure 6. The evolution of tool wear can be observed with an initial wear stage followed by a steady wear stage. A significant increase in the tool wear rate after the tool wear reaches a certain level is called the failure region. However, the failure region is less obvious at the larger cutting parameters. This is because the tool insert is worn out before the rapid wear occurs.

Figure 6. Tool wear progress curves at (a) $f_z = 0.05$ mm/r, (b) $f_z = 0.10$ mm/r, and (c) $f_z = 0.15$ mm/r.

The effect of cutting parameters on the tool wear evolution can be characterized by tool life. The carbide inserts wear faster when cutting parameters become larger. The tool life is reduced by 63% as cutting speed increases from 45 m/min to 75 m/min, whereas the tool life is reduced by 84% as feed increases from 0.05 mm/r to 0.15 mm/r. The effect of feed on tool life appears more significant under experimental conditions.

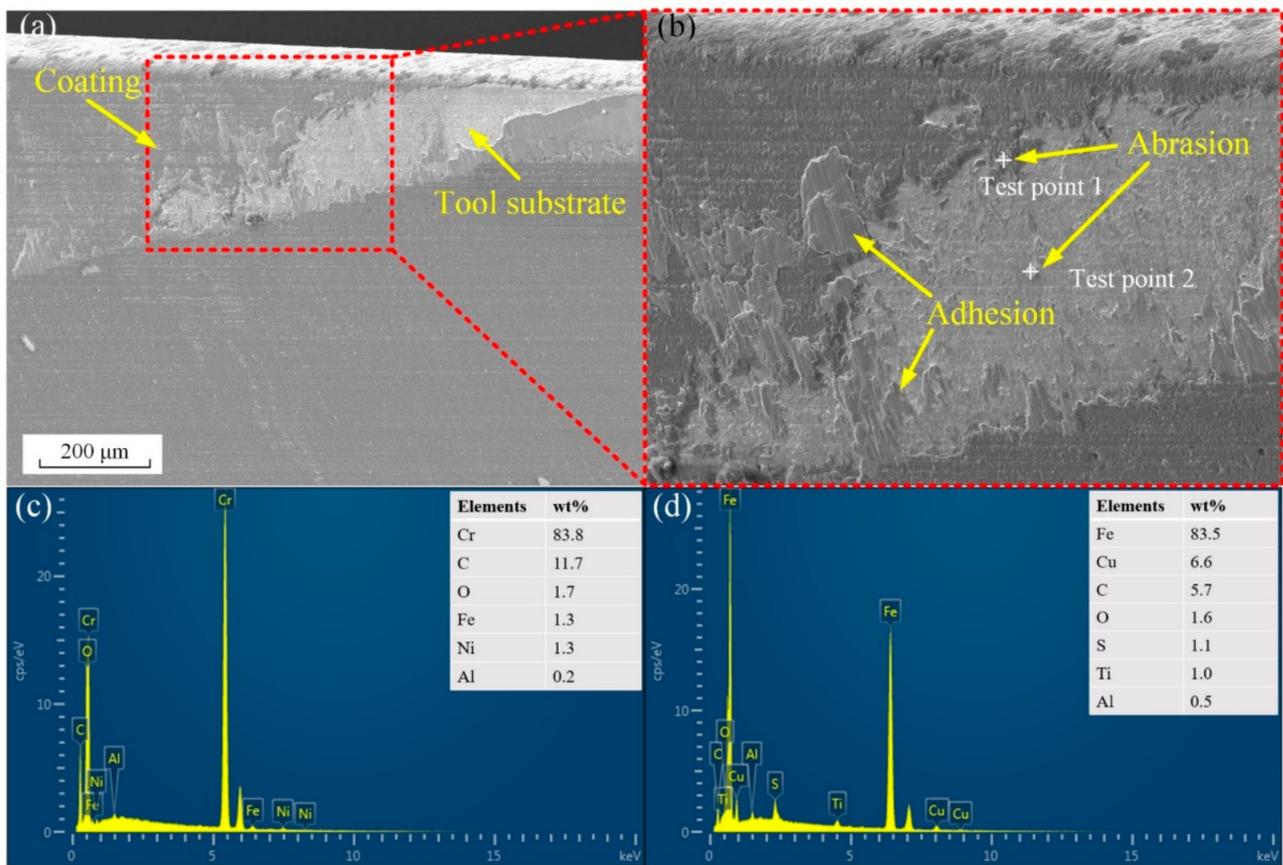
Figure 8. (a,b) Tool flank wear morphology at $f_z = 0.05$ mm/r and $v_c = 75$ m/min and (c,d) chemical compositions at Test point 1 and Test point 2, respectively.

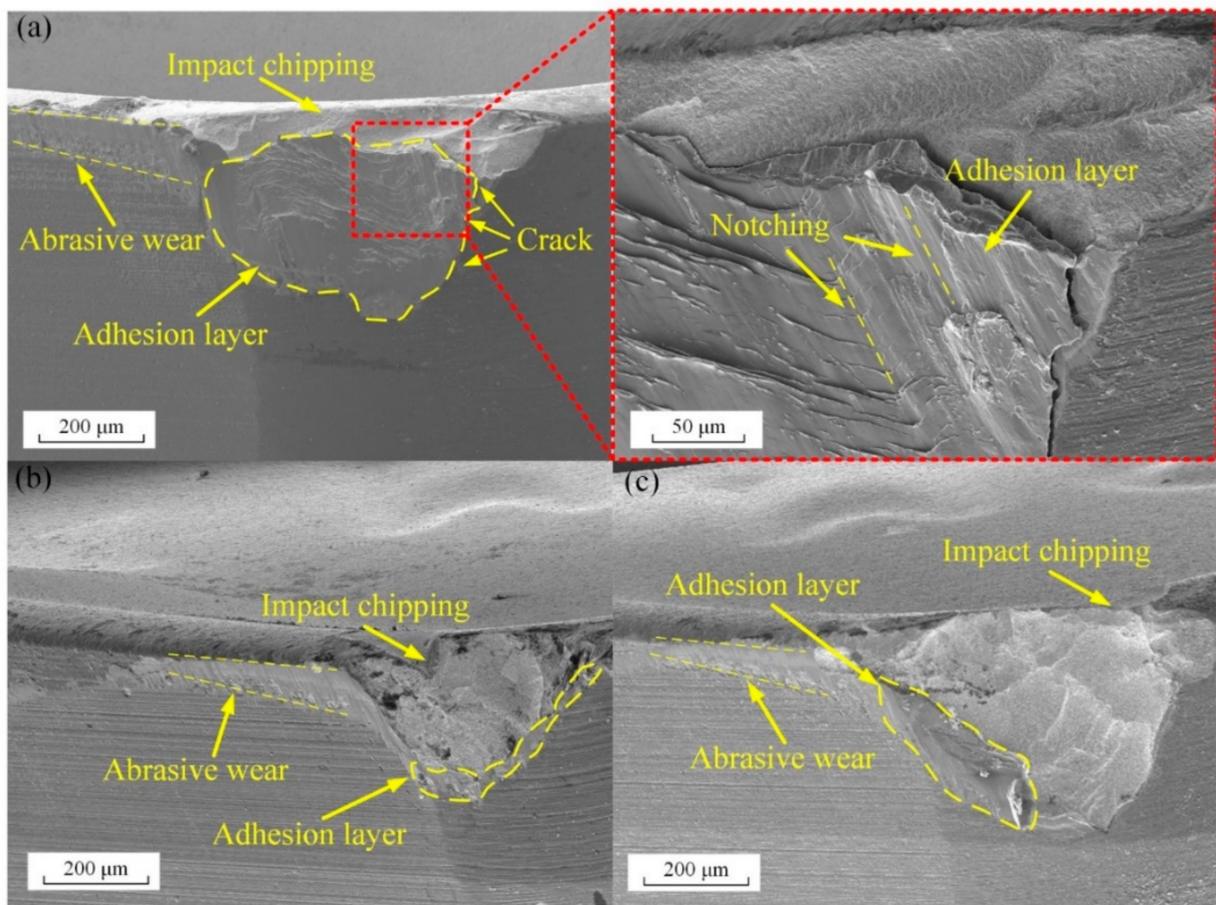
The SEM images on the flank face at the cutting speed of 45 m/min and various feed rates are shown in Figure 9. The width of abrasive marks on the flank face reduces as the feed rate increases from 0.05 mm/r to 0.15 mm/r as shown in Figure 9. The area of the adhesion layer reduces as the feed rate increases from 0.05 mm/r to 0.15 mm/r. The minimum proportion of adhesion layer in the flank wear region is observed in Figure 9c at the feed rate of 0.15 mm/r. The maximum cutting force is measured at the feed rate of 0.15 mm/r according to Figure 3. The larger alternating force at the feed rate of 0.15 mm/r in the milling process results in a reduction in the adhesive layer.

Figure 9. SEM images of Inconel 718 adhesion layer on tool surface at feed rate of (a) 0.05 mm/r, (b) 0.10 mm/r, and (c) 0.15 mm/r.

Traces of abrasive are also found on the adhesion layer in Figures 9a and 10a. This indicates that intense friction occurs on the interface of the adhesive layer and workpiece. The adhesion layer replaces the tool substrate to interact with the workpiece material. The tool substrate is protected by the stable adhesion layer, which extends the tool life [29]. However, the tool wear is accelerated by the peeling of the unstable adhesion layer in the milling process.

The tool edge chipping at various cutting parameters is shown in Figures 9 and 10. The width of the tool edge chipping on flank face is used to evaluate the tool edge chipping. The average width of each chipping is measured from three equidistant positions, as shown in Figure 15. The width of tool edge chipping increases as the feed increases from 0.05 mm/r to 0.15 mm/r at every cutting speed. However, the maximum width of tool edge chipping is achieved at the cutting speed of 60 m/min and the feed rate of 0.10 mm/r. A similar phenomenon is also reported by Peng et al. [31] in their simulation and experiment results. The possible reason is the weakening of workpiece strength and hardness due to high cutting temperature as the cutting speed increases [32]. The reduction in crack propagation is faced as a result of the reduction in the strength and hardness of the workpiece.

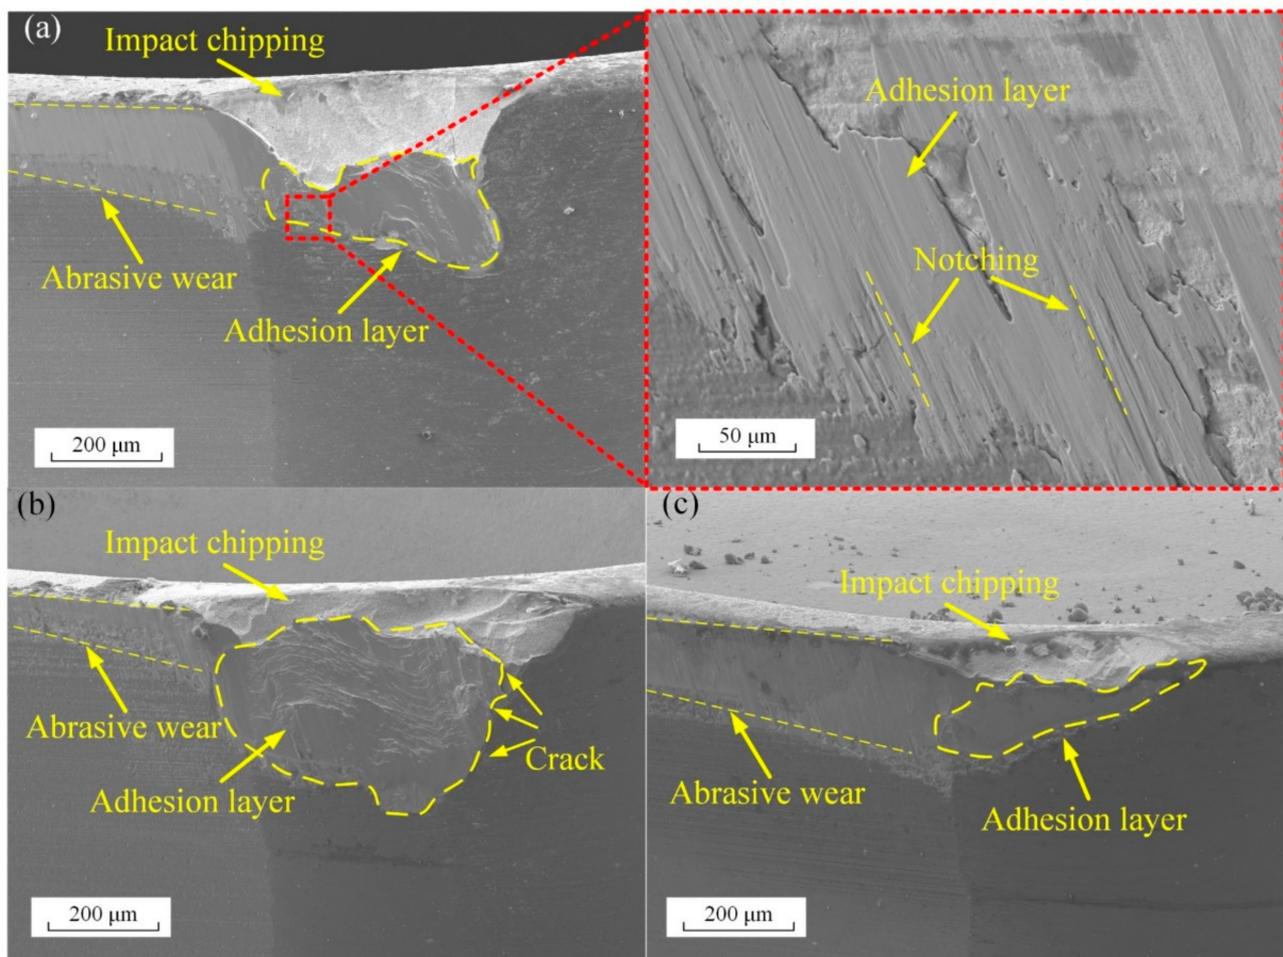
The effects of the cutting speeds on abrasive wear and adhesive wear are shown in Figure 10. The minimum width of abrasive marks is generated at the cutting speed of 60 m/min as shown in Figure 10b. However, the maximum adhesion layer can be found on the flank face at the cutting speed of 60 m/min. Cracks are observed at the edge of the adhesion layer in Figures 9a and 10b. This indicates that the adhered material is unstable at these cutting parameters.

Figure 10. SEM images of Inconel 718 adhesion layer on tool surface at the cutting speed of (a) 45 m/min, (b) 60 m/min, and (c) 75 m/min.

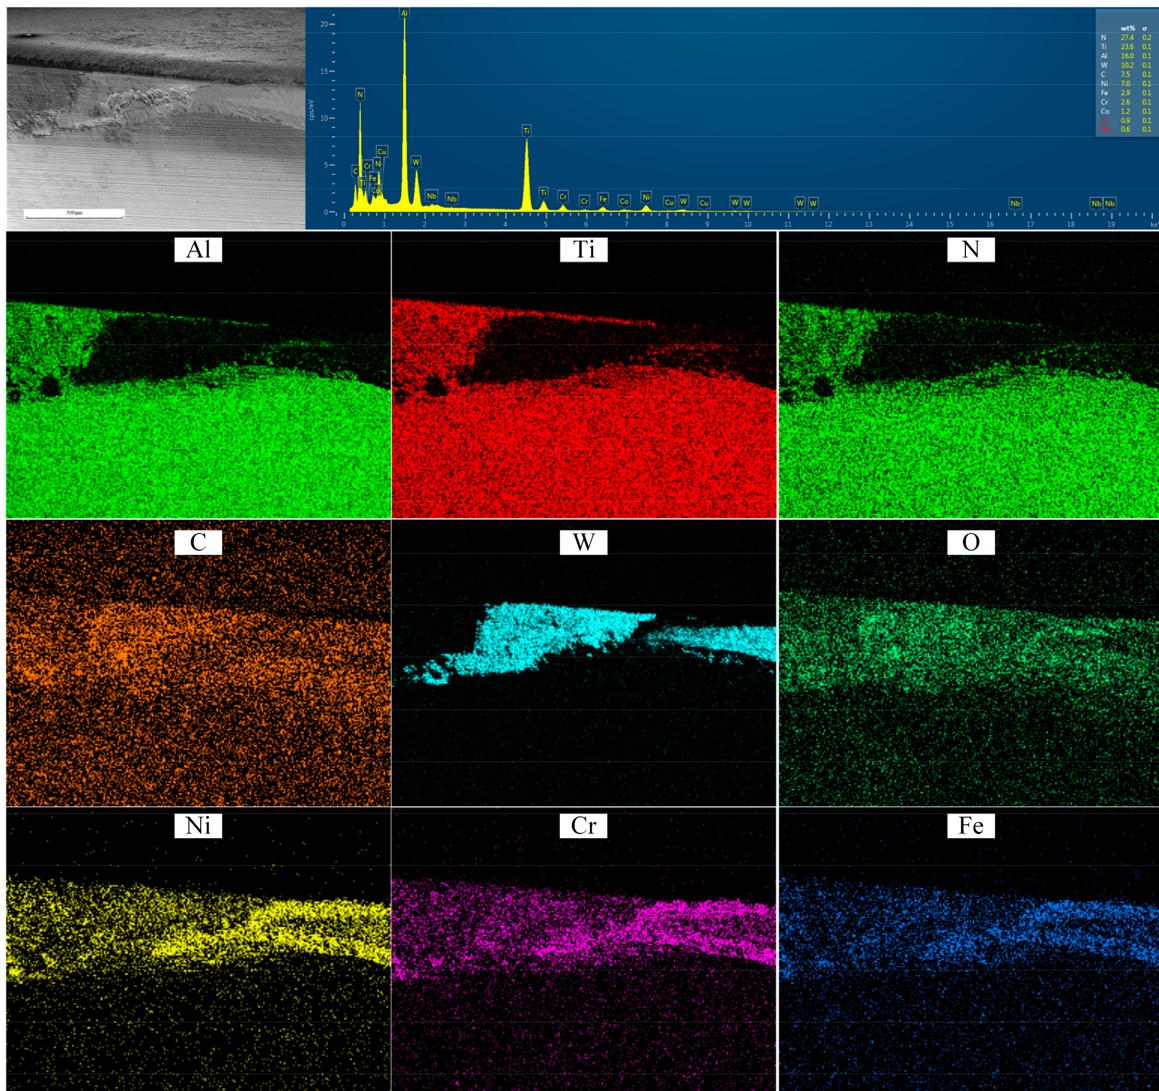
The element distribution on the worn surface was obtained by EDS mapping, as shown in Figure 11. The distribution of C and W is detected on the wear area, which indicates that the tool substrate is exposed on the worn flank face. The distribution Ni, Cr, and Fe is detected on the wear area on the flank face. In addition, the distribution of oxygen also appears on the flank face. It can be inferred that intense oxidation reactions occur on the worn surface.

Figure 11. EDS mapping on tool worn flank face.

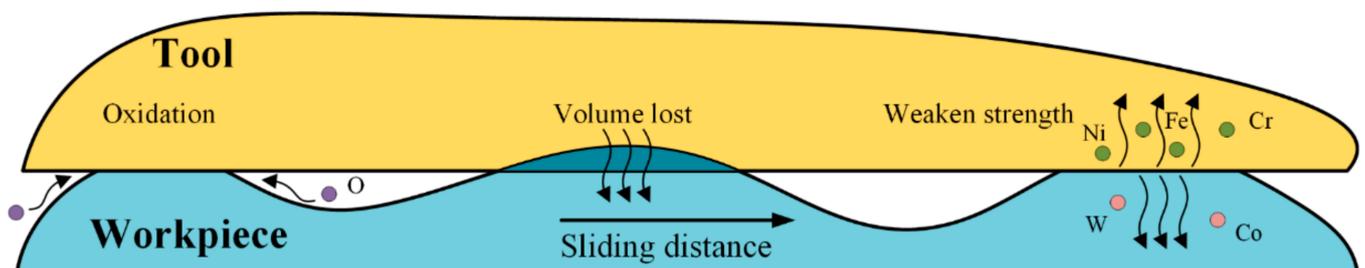
The process of diffusion wear is presented in the schematic in Figure 12 drawn by the authors. The contact interface between tool and workpiece material consists of mechanical and chemical bonding. The diffusion of elements through the contact interface is caused by the element concentration gradient and the high temperature. Intense oxidation reactions occur on the tool–workpiece interface. Therefore, the effect of diffusion and oxidation on tool wear can be classified into strength weakening, volume loss, and oxidation.

Figure 12. Tool wear progress with diffusion and oxidation.

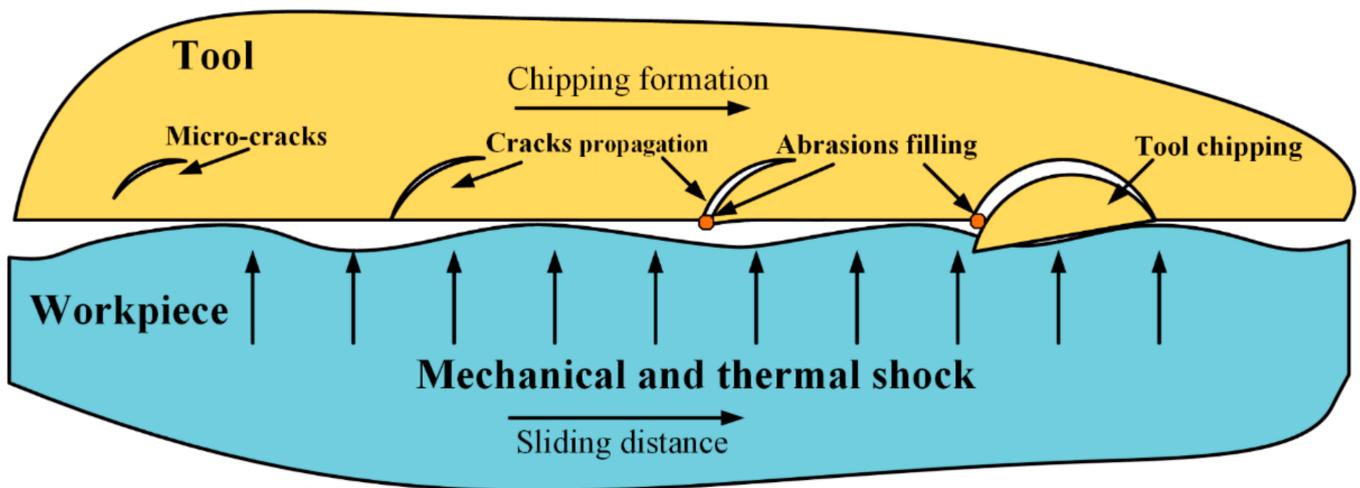
The failure of a cutting tool in machining Inconel 718 is caused by tool edge chipping together with flank wear [30]. The tool edge chipping plays a considerable role in tool failure due to the large area of this wear morphology on the flank face. The formation process of this wear pattern is shown in Figure 13 drawn by the authors. The micro-cracks and dislocation on the tool sub-surface layer are joined together under mechanical and thermal shock in milling. Cracks can be observed on the tool surface when the cracks propagate to the tool surface. The abrasions fill the cracks, leading to the further propagation of the cracks. The tool substrate is damaged by the generating and peeling of the lamellar chipping as the cutting process continues.

Figure 13. Tool chipping formation due to mechanical and thermal shock.

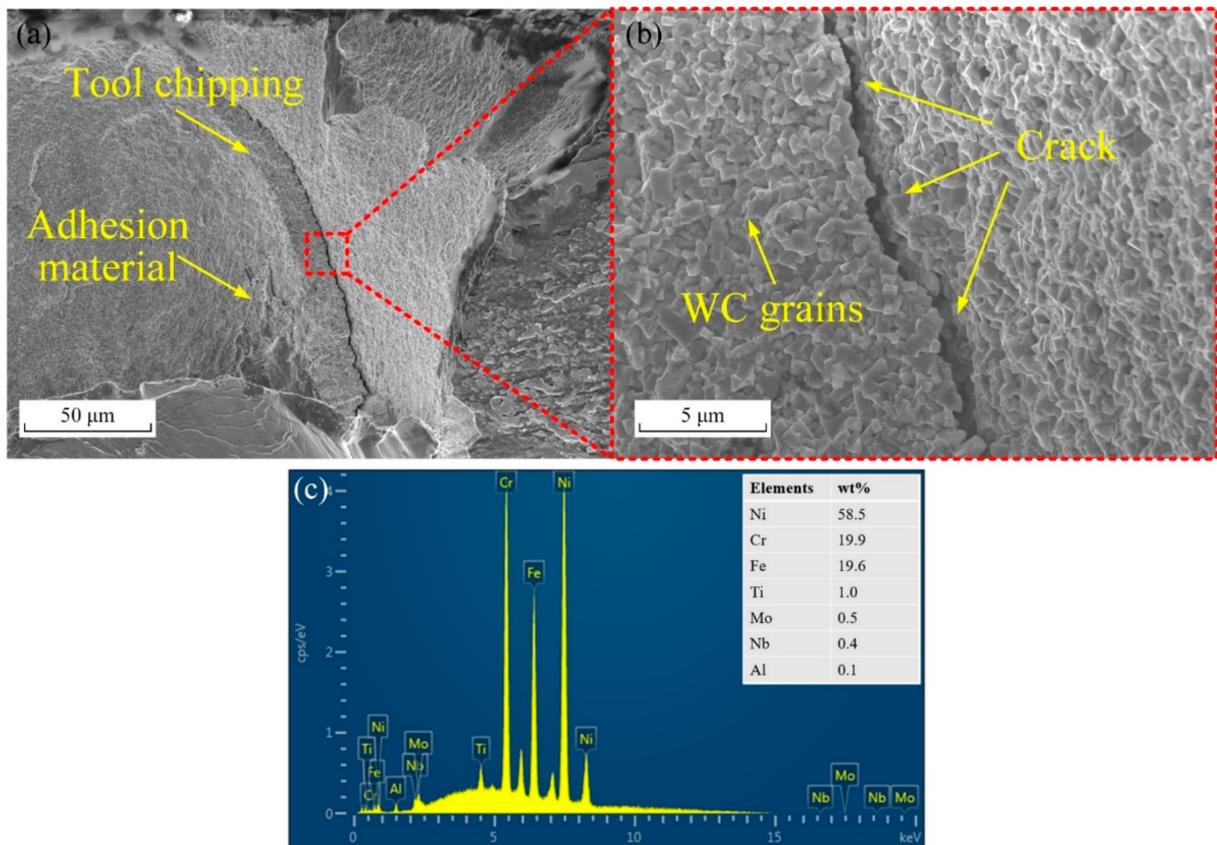
Evidence of crack propagation and peeling can be found on the worn surface at all cutting parameters in experimental conditions according to the tool wear morphology in Figure 14. The fracture-like appearance with the grain exposure is observed at the tool edge chipping surface. Some of the grains are covered with adhesion material as shown in Figure 14a,c. This indicates that the worn surface is under intense friction against the workpiece material. Additionally, it can be seen that micro-cracks propagate to the surface of tool edge chipping.

Figure 14. SEM image of micro-crack propagations under tool surface with (a) low and (b) high magnifications, and (c) EDS results of adhesion material.

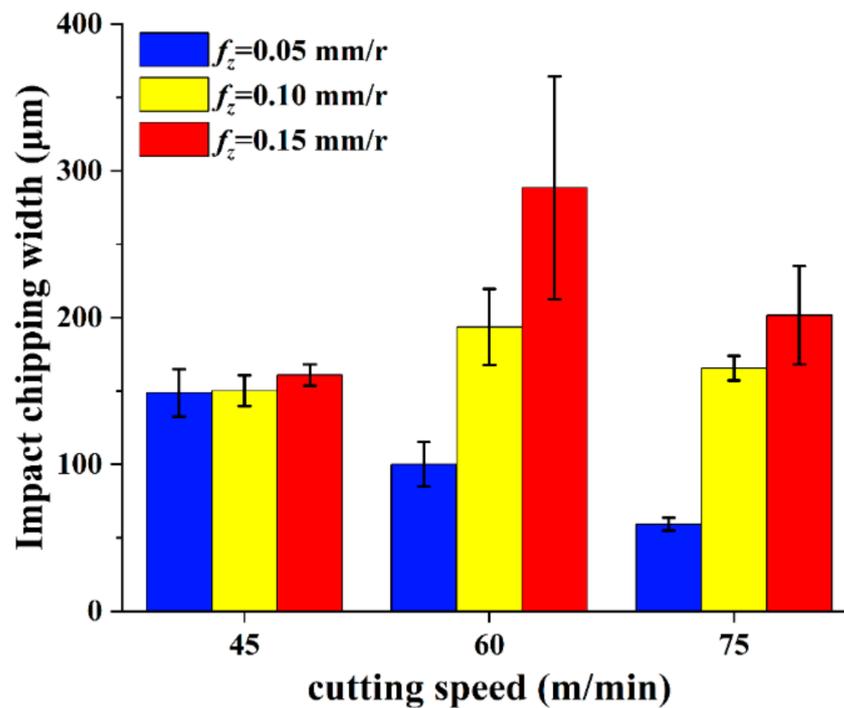
Figure 15. Tool chipping width at various cutting parameters.
