Friction Behavior of Pre-Damaged Wet-Running Multi-Plate Clutches in an Endurance Test

Thomas Schneider *, Katharina Voelkel , Hermann Pflaum and Karsten Stahl

Gear Research Centre (FZG), Technical University of Munich, 85748 Garching, Germany; voelkel@fzg.mw.tum.de (K.V.); pflaum@fzg.mw.tum.de (H.P.); stahl@fzg.mw.tum.de (K.S.)

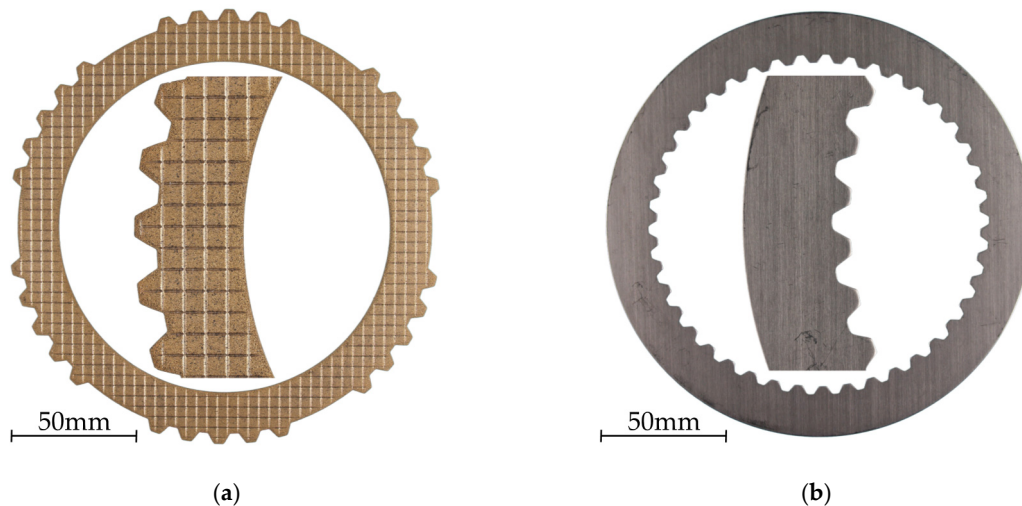
Photographs of the investigated friction plates with sintered metal friction lining, as well as the corresponding steel plates, are shown in Figure 1. The technical data is listed in Table 1. The steel plates are used as inner plates and the friction plates are used as outer ones.

Figure 1. (a) Friction plate; (b) steel plate.

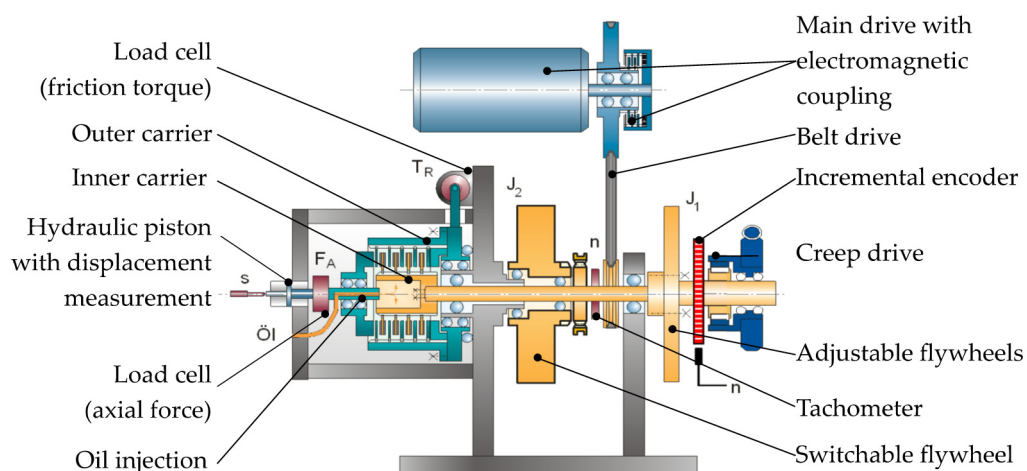
To examine the load limits concerning spontaneous damage to multi-plate clutches, step tests were carried out on the ZF/FZG KLP-260 component test bench. A sketch of the test bench is shown in Figure 2. Sketch of the test bench ZF/FZG KLP-260 according to Meingaßner et al. [22].

Figure 2. Sketch of the test bench ZF/FZG KLP-260 according to Meingaßner [23].

The tests were carried out on the ZF/FZG KLP-260 clutch test bench. The test bench is a brake test bench with an outer carrier fixed to the housing, as well as a rotating inner carrier [23]. In the ZF/KLP-260 test bench, a complete clutch of the transmission is installed via corresponding drivers. The inner plates are arranged on the central shaft and connected to the flywheels (J1, J2). The contact pressure is applied to the outer plates, at which the friction torque of the clutch is also measured. The clutch is supplied centrally with cooling oil from the inside (defined cooling oil flow; oil temperature ϑ_{oil} thermostat-controlled heating and cooling). External lubrication from above is also possible.

For each shifting test, the main shaft with internal driver and flywheel masses is accelerated by the speed-controlled main drive to the differential speed Δn . During the clutch test, the motor is separated from the test bench by an electromagnetic clutch. The shifting force is applied to the clutch by the hydraulic cylinder in a defined manner via the clutch-specific pressure ring. Force increase and force maximum are adjustable.

In the slip operation, a defined axial force is applied to the clutch. The specified differential speed is set in the clutch via the creep drive. The slip speed is measured via a high-resolution incremental encoder.

The mass moment of inertia J loading the clutch can be changed by flange-mounting discs of different mass moments of inertia J_1 and connecting the basic mass J_2 . The technical data of the test bench are listed in Table 2.

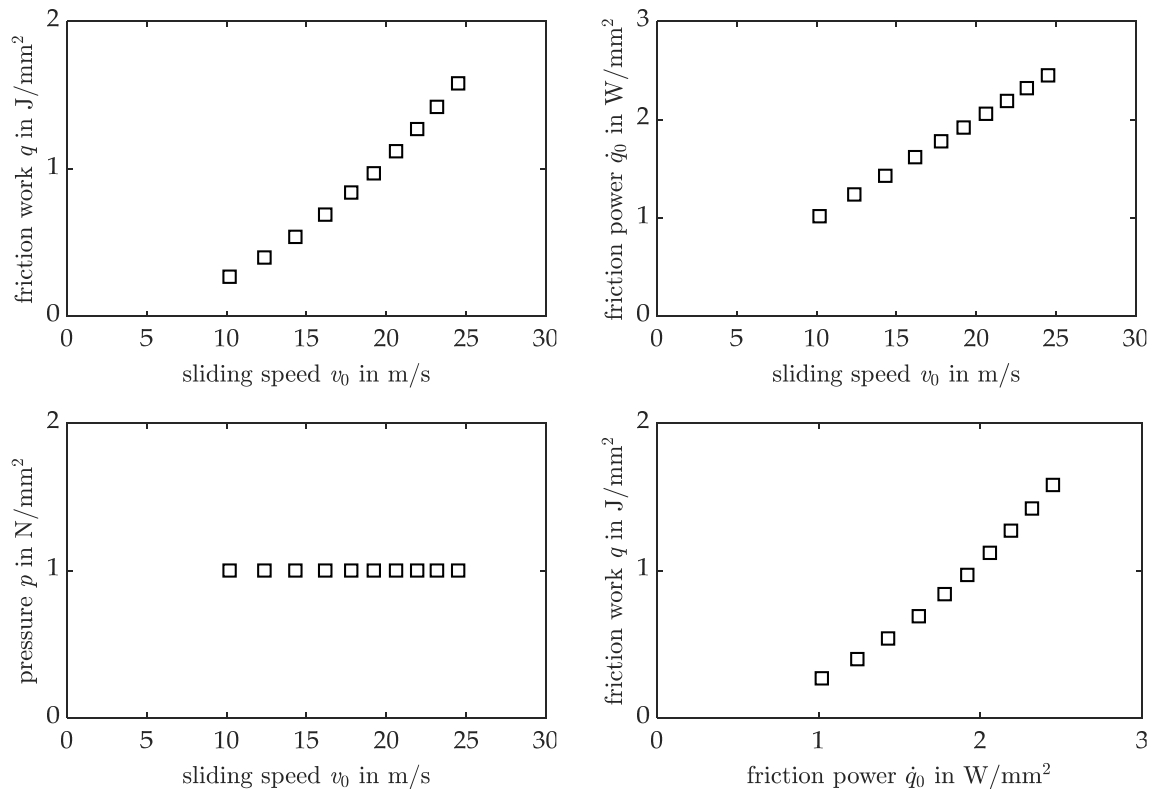
For a better overview, the loads are also shown graphically in the step-by-step test. Figure 3 illustrates the specific load levels of a step test with ten load levels. Each point represents a load level of the step test. The variation of the sliding speed v_0 in the individual load levels affects the friction work q and peak friction power \dot{q}_0 .

**Figure 3.** Load levels of the step test.

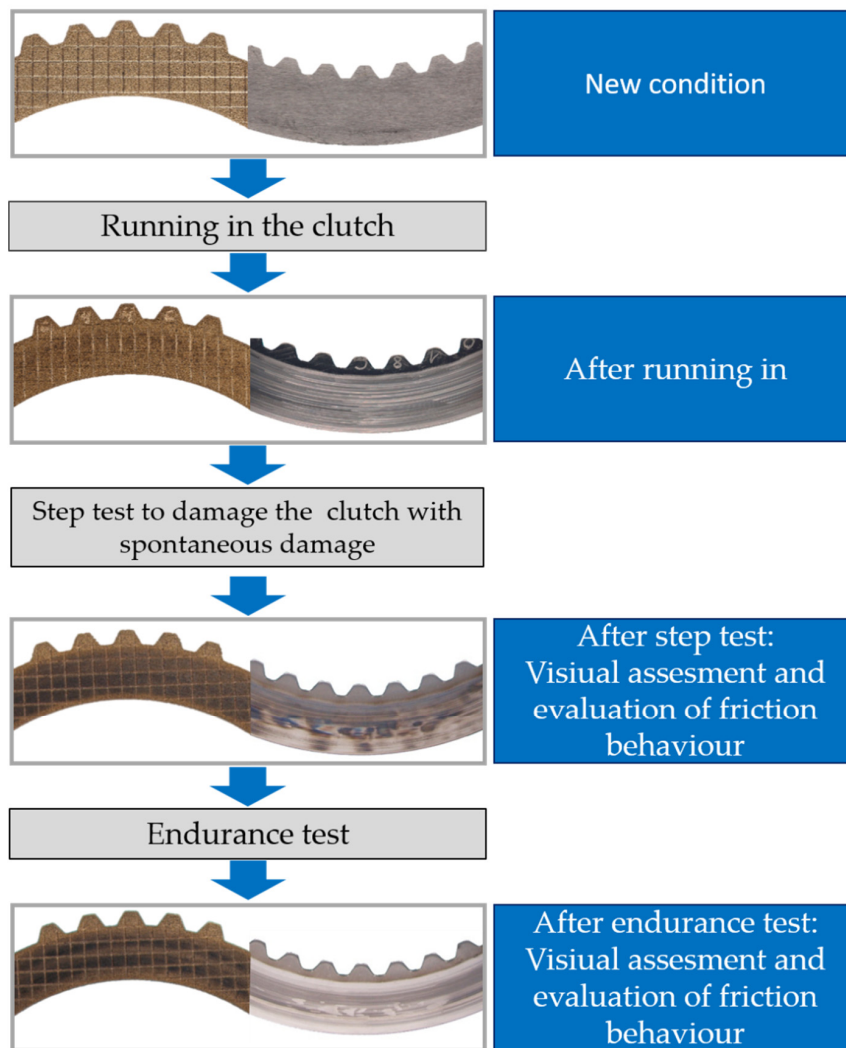
To aid understanding, the experimental method is shown in a schematic diagram in Figure 4.

Figure 4. Experimental method.

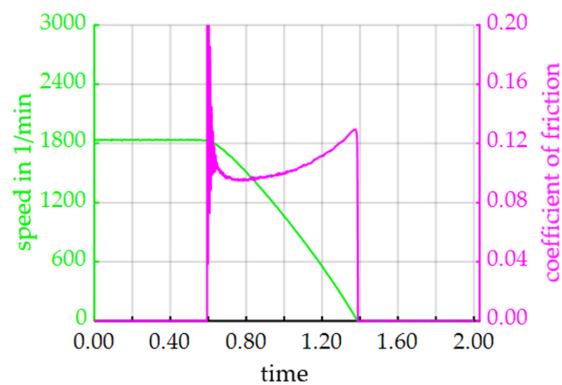
For the test LL-03, the step test was run up to load level 3 (cf. Table 4). These loads caused the first local discolorations on the steel plate. No fluctuations in the friction coefficient of a cycle were observed at load level 3. Figure 5 shows the friction coefficient curve for a shift at load level 3. The step test was followed by the endurance test.

Figure 5. Friction coefficient curve for a shift at load level 3.

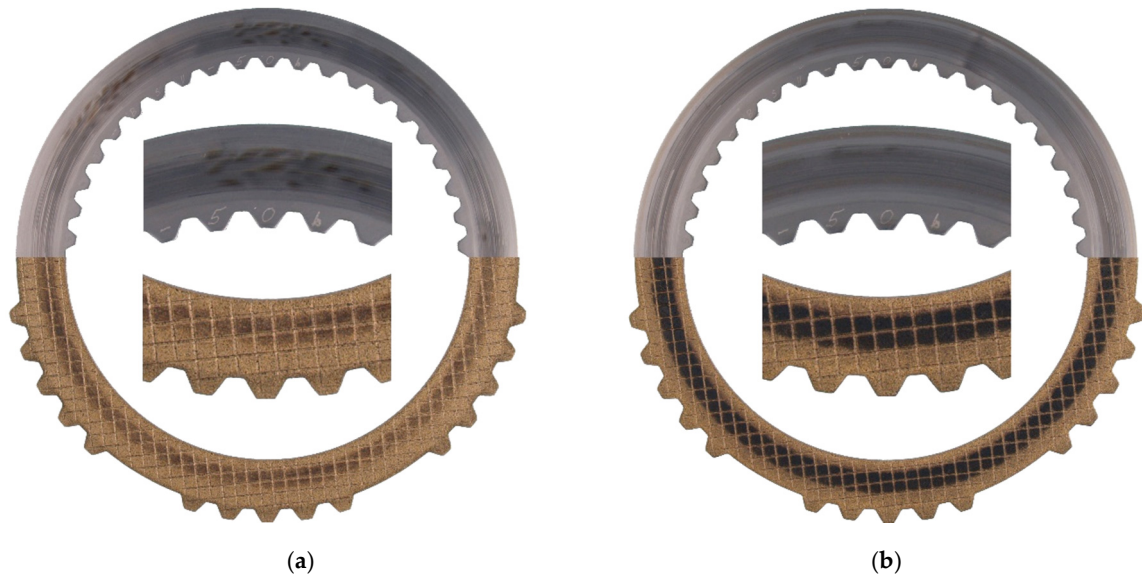
Figure 6a shows the steel and lining plate directly after the step test by pre-damaging the package. First discolorations on the steel plates can be observed. On the right-hand side (Figure 6b), the condition of the plates after the endurance test is documented. The photographs show that local discoloration on the steel plate is no longer visible after the endurance test. The friction plate shows a stronger discoloration after the 10,000 shifts of the endurance test.

Figure 6. (a) Photos of the pre-damaged plates after load level 3; (b) photos of the pre-damaged plates after the endurance test.

In the step test, the different load levels cause varying forms of damage. Local discoloration, sinter transfer and friction coefficient fluctuations can be observed. After the endurance test, local discoloration and sinter transfer are no longer visible on the steel plate. This shows that this local discoloration, which is also described in the literature as oil-cracking products [13], is removed again due to wear mechanisms during the endurance test. It is also assumed that the sinter transferred is also removed due to wear during the endurance test. In the areas with very strong discoloration before the endurance test, speckled brightening is visible after the endurance test. This brightening indicates structural changes as described by Kasem, Fairbank and Strebel [8,11,25]. These structural changes in the material cannot be visibly altered by wear mechanisms. A visible darkening of the lining plates in the continuous shifting test is caused by oil deposits and oil-cracking products in the pores. This was also observed by Acuner [26].

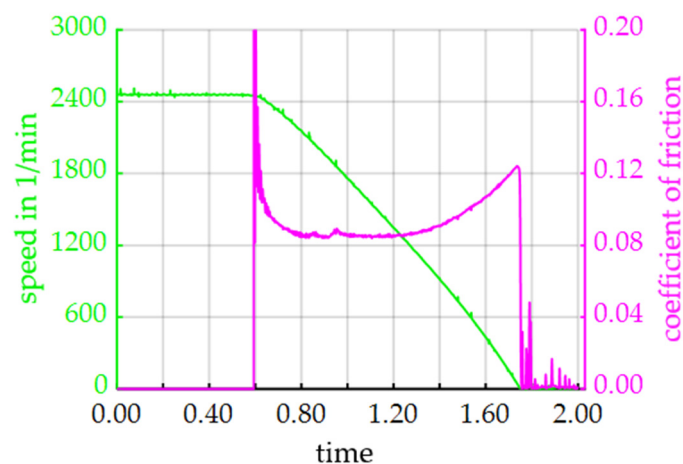
For the test LL-06, the step test was run up to load level 6 (cf. Table 4). The step test is carried out until local discoloration and a recognizable amount of sinter is transferred to the steel plate. At the same time, friction coefficient fluctuations as a result of seizing occur during the shifting process (Figure 7).

Figure 7. Friction coefficient curve for a shift at load level 6.

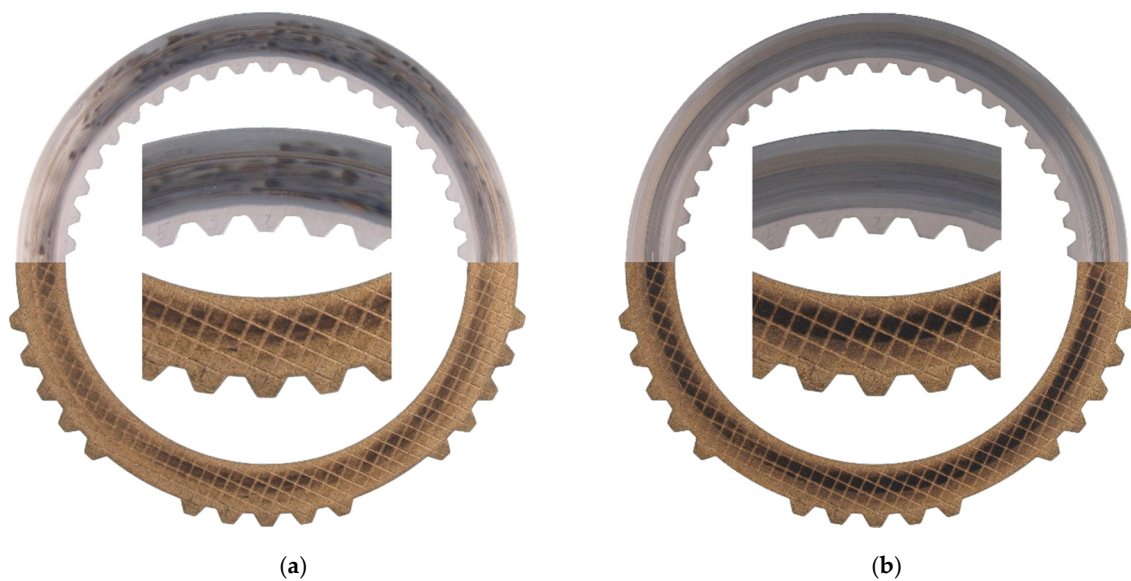
Figure 8a shows the steel and lining plates directly after the step test by pre-damaging the package. On the right side (Figure 8b), the condition of the plates after the continuous shifting test was documented. The photographs show that local discoloration and sinter transfer are no longer visible on the steel plates after the endurance test. The friction plate shows a stronger discoloration after the 10,000 shifts of the endurance test.

Figure 8. (a) Photo of the pre-damaged plates after load level 6; (b) photo of the pre-damaged plates after the endurance test.

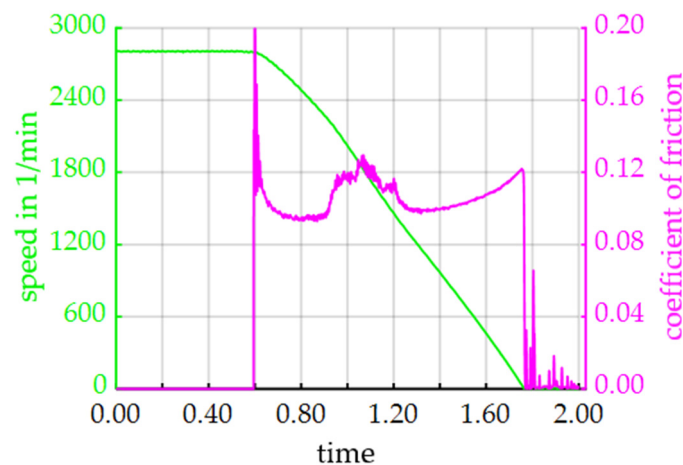
For test LL-08, the step test was run up to load level 8 (cf. Table 4). These loads resulted in local discoloration and a recognizable transfer of the sinter on the steel plate. In the friction coefficient curve of exemplary engagements at load level 8, a strong increase in the friction coefficient as a consequence of seizing can be seen (Figure 9). The step test was followed by the endurance test.

Figure 9. Friction coefficient curve for a shift at load level 8.

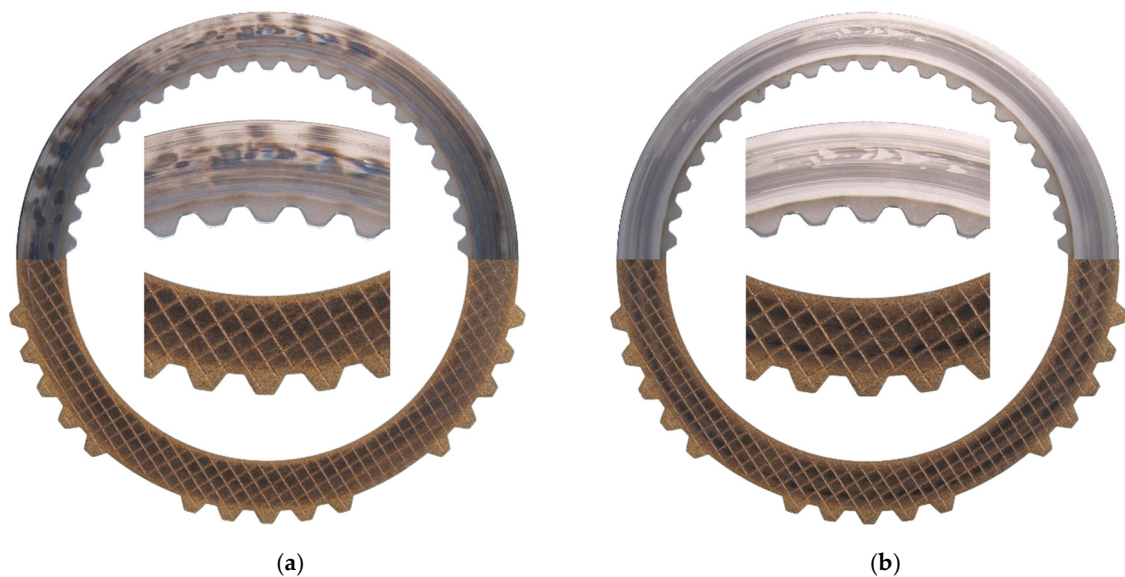
Figure 10a shows the steel and lining plates directly after the step test by pre-damaging the package. On the right side (Figure 10b), the condition of the plates after the continuous shifting test is documented. The photos show that local discoloration and sinter transfer are no longer visible on the steel plate after the endurance tests. In the areas of very significant discoloration on the steel plate prior to the endurance test, selective brightening can be seen after the endurance tests. The friction plate shows a stronger discoloration after the 10,000 shifts of the endurance test.

Figure 10. (a) Photo of the pre-damaged plates after load level 8; (b) photo of the pre-damaged plates after the endurance test.

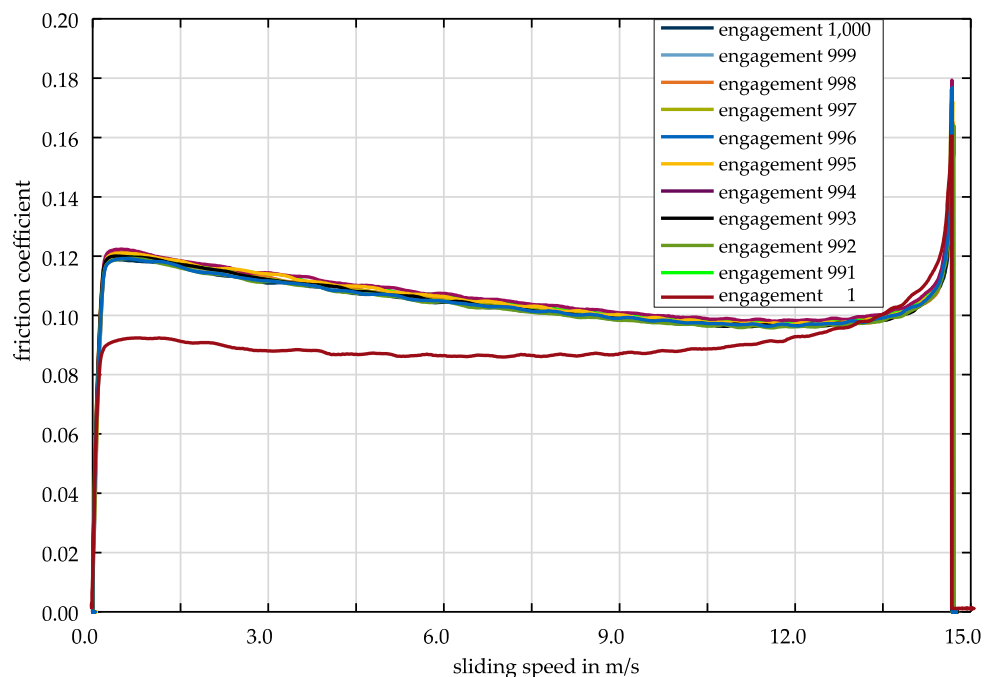
Figure 11 shows the friction coefficient curves of the last 10 engagements and the first engagement during the running in for test LL-03. It can be seen that the friction coefficient curves of the last 10 engagements differ slightly compared to the first engagement. This knowledge is relevant for evaluating the following measurement records.

Figure 11. Friction coefficient curves of the last ten engagements in the run-in for test LL-03.

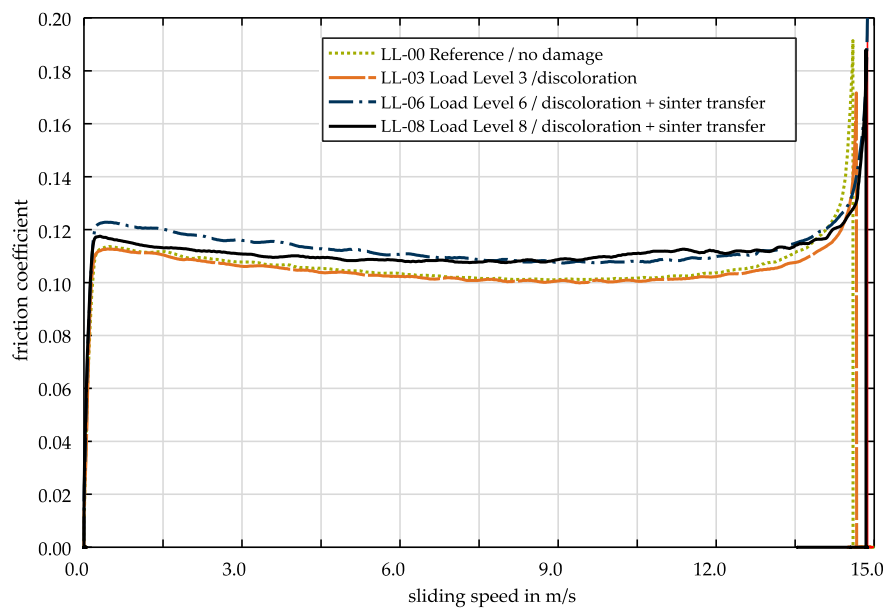
Figures 12–14 show the friction coefficient curves of three pre-damaged clutches (LL-03 to LL-08) and one reference clutch that was not pre-damaged (LL-00) for selected shifts in the endurance test. For shift 1 in the endurance test, the coefficients of friction over the entire speed range of the heavily pre-damaged clutches (pre-damaged at load levels 5 and 8) are slightly higher than with a slightly pre-damaged clutch (pre-damaged at load level 3) and a clutch that was not pre-damaged (cf. Figure 12).

Figure 12. Single engagement comparison of previously damaged and non-damaged clutches (engagement 1 in the endurance test).

At the start of the endurance test, the values of coefficients of friction over the entire speed range of the heavily pre-damaged clutches are higher than with the slightly pre-damaged clutch and the clutch that had not been pre-damaged. Thus, the sinter transfer on the surface of the heavily damaged steel plate has an influence on the friction coefficient.

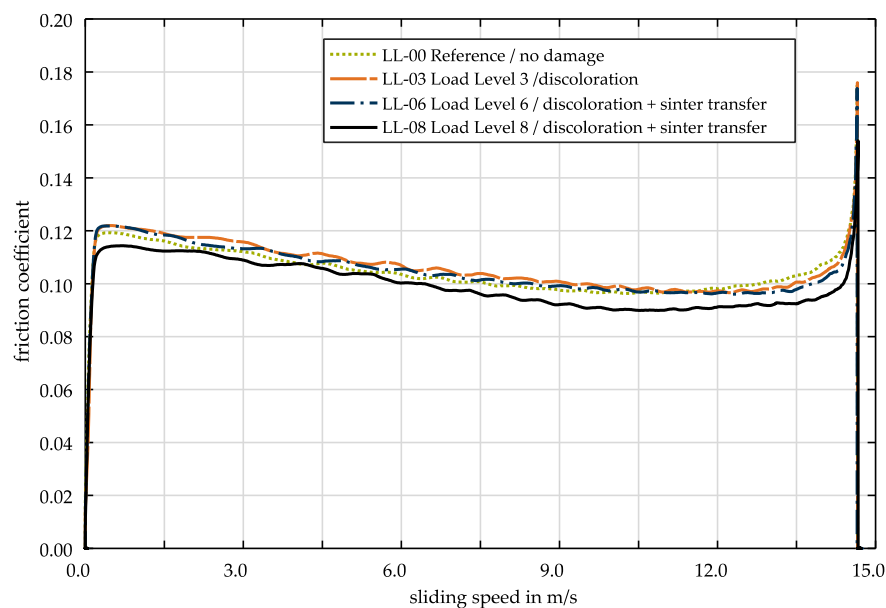
Figure 13. Single engagement comparison of previously damaged and non-damaged clutches (engagement 5000 in the endurance test).

Figure 13 shows values of the friction coefficients over the sliding speed for shift 5000 of the endurance tests. Clutch LL-08 shows a lower coefficient of friction level in comparison to the other clutches. In addition, the gradient of coefficient of friction over sliding speed with decreasing sliding speed is greater in the pre-damaged systems than in the reference clutch. This means that with decreasing sliding speed the coefficient of friction increases more strongly in the pre-damaged clutch than in the reference clutch. The speed-dependent fluctuations in the coefficient of friction of the pre-damaged clutches have increased in the endurance test compared with shift 1 (Figure 12).

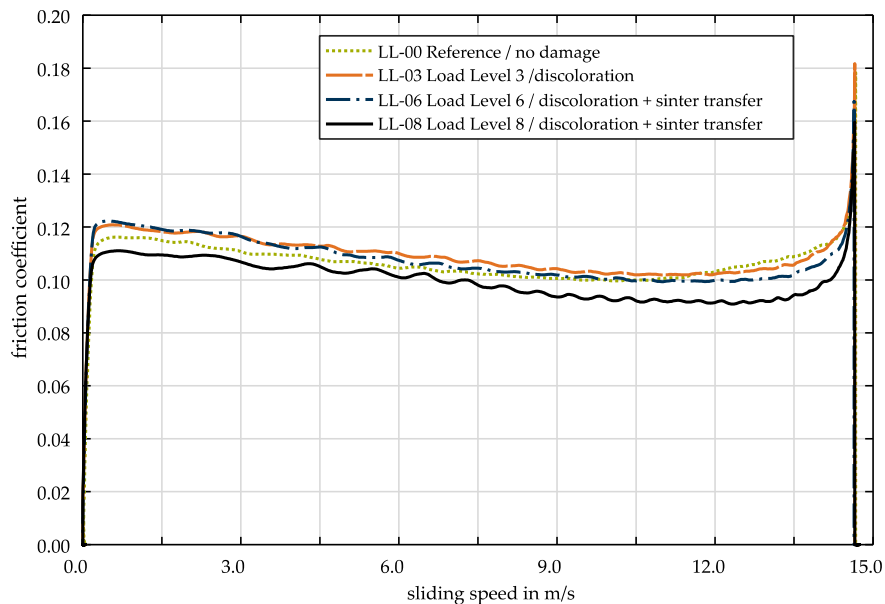
For cycle 10,000 in the endurance test a similar picture as for shift 5000 appears (Figure 14). The increase in the coefficient of friction with a decrease of the sliding speed can be observed in the pre-damaged clutches. In addition, a stronger speed-dependent fluctuation of the coefficient of friction can be observed in the pre-damaged systems. The coefficient of friction level for clutch LL-08 is below

the level of the other clutches. This is strongly related to the fact that the friction coefficient level is very low in relative terms at the beginning of the shifting process. The coefficient of friction over sliding speed gradient behaves similarly to clutches LL-03 and LL-06.

Figure 14. Single engagement comparison of previously damaged and non-damaged clutches (engagement 10,000 in the endurance test).

At the end of the endurance test it can be observed that with increasing pre-damage, the values of coefficients of friction at the beginning of the shift are lower. In the case of carbon synchronizer, this behavior was justified by the friction lining becoming smoother due to oil deposits [26]. It is assumed that this phenomenon also occurs here and that the pores are partially clogged up and smeared due to the damaging engagements.

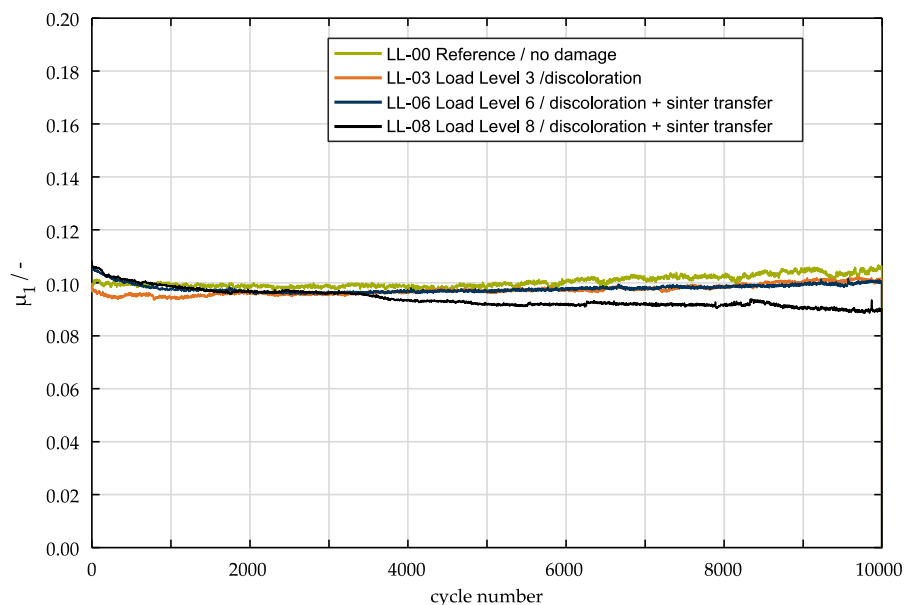
In addition to the individual shifts, Figure 15 shows the trend curves for μ_1 of the four clutches investigated in the endurance test. The friction coefficient μ_1 corresponds to the friction coefficient at 85% of the maximum sliding speed [26]. The trend curves show that μ_1 in the reference clutch rises minimally during the endurance test. For clutches LL-03 and LL-06, μ_1 decreases at the beginning and then rises slightly. LL-08 shows a continuous drop in the value μ_1 over the duration of the endurance test and shows a clear difference to the other tests at the end.

Figure 15. Trend comparison of μ_1 over 10,000 shifts in the endurance test.
