Article

Investigation on Ultrasonic Cavitation Erosion Behaviors of Al and Al-5Ti Alloys in the Distilled Water

Keywords: Al alloys; cavitation erosion; cavitation pit; micromorphology

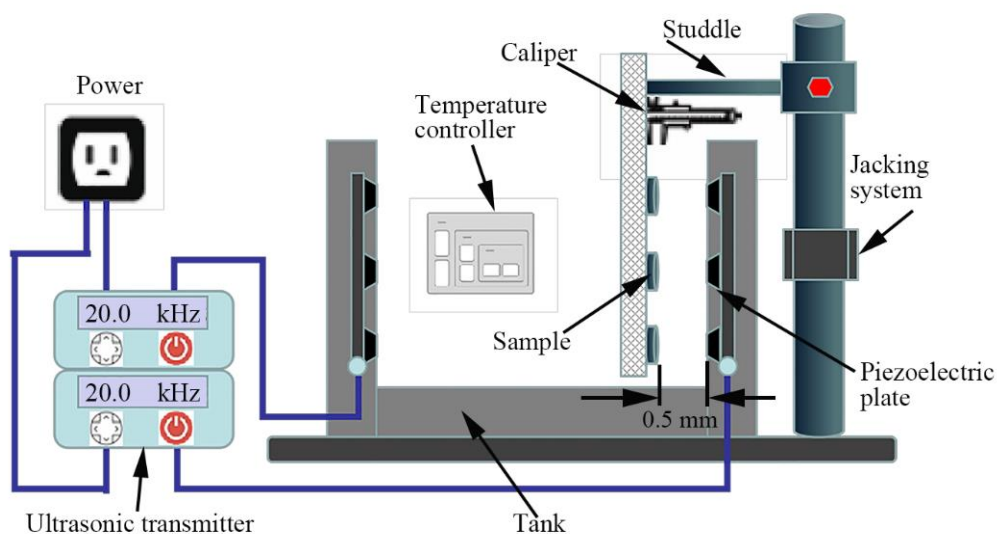
Figure 1. Schematic of the ultrasonic cavitation erosion device.

According to the original vibration stand, the cavitation erosion experiments were performed in ultrasonic vibratory equipment, as shown in Figure 1 [39,48]. The ultrasonic vibratory frequency was 20 kHz, the peak amplitude was 60 μm , and the distance between the samples surface and ultrasonic probe was 0.5 mm. The air compressor was used to cool the ultrasonic transducer, while the temperature of water was controlled at 25 $^{\circ}\text{C}$ by a temperature control system. The mass loss of specimens with cavitation erosion time increasing from 5 min to 200 min was measured, and the mass loss rate M_{LR} was calculated in the following equation [2,49]:

The advantages of the cavitation device shown in Figure 1 are that the number of test samples are increased and the complex test cycles are shortened. However, there is also an unfavorable factor, which is the layout of the station used carries the risk of deviations from the values of cavitation loads specific to ASTM G32 standard, with the risk of variation of this load during the experiment. The sources of this variability are the migration of bubbles to the liquid surface and the vibration of the sample carrier plate. Fixing a long arm of the carrier on a bracket with a relatively long arm can cause a vibration of the order amplitude, which slightly changes the distance between the sample and the ultrasonic probe.

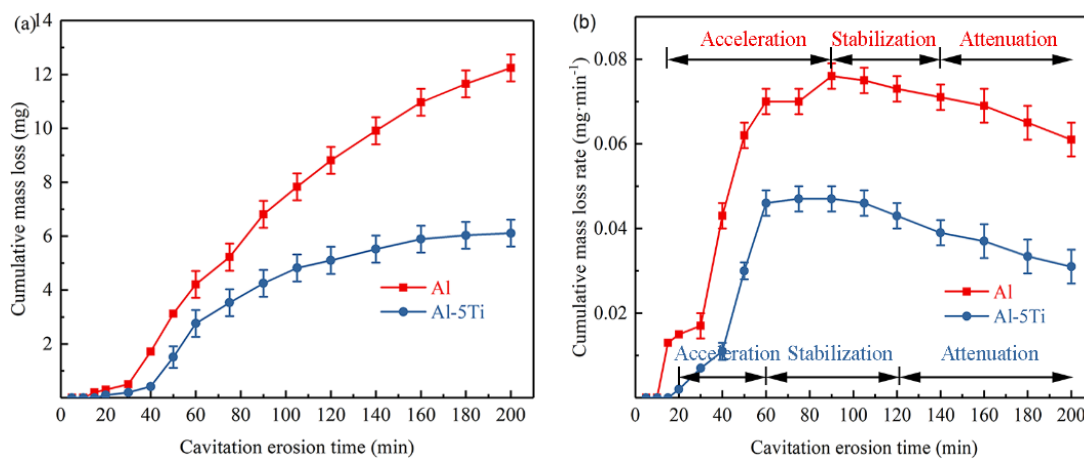
Figure 2. The cumulative mass loss graphs (a) and the cumulative mass loss rate graphs (b) in distilled water.

The mass loss of the Al and Al-5Ti samples in the cavitation erosion process is shown in Figure 2a, as well as the mass loss rate. It is obvious that the cumulative mass loss of Al and Al-5Ti is increased with cavitation erosion time (Figure 2a). The cumulative mass loss of Al is consistently higher than that of Al-5Ti, and it reaches 12.24 mg for Al and 6.11 mg for Al-5Ti after cavitation erosion for 200 min. Similar to cumulative mass loss, the cumulative mass loss rate of Al is also greater than that of Al-5Ti, as shown in Figure 2b. The cavitation erosion process can be divided into four stages; namely, the incubation period, acceleration period, stabilization period and attenuation period. The incubation period of Al is quite short, and cavitation erosion accelerated after 10 min. In contrast, the cumulative mass loss rate of Al-5Ti increased slowly within 20 min, and then sharply with the extension of cavitation erosion time. The stabilization period of Al and Al-5Ti occurred at 90 min and 60 min, respectively, and the stabilization period of Al was shorter. After cavitation erosion for 200 min, the cumulative mass loss rate of Al and Al-5Ti are 0.061 mg/min and 0.031 mg/min, respectively. Apparently, ultrasonic cavitation erosion damage of Al in distilled water is more serious.

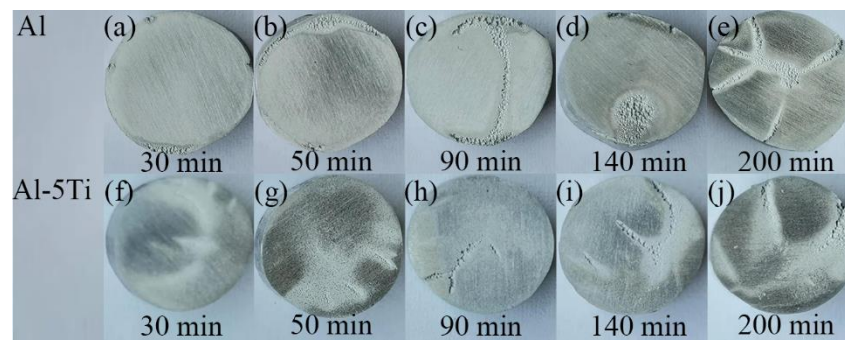
Figure 3. The macroscopic morphology of Al and Al-5Ti alloys after different cavitation erosion time (a–e) Al, (f–j) Al-5Ti.

Figure 3 shows the macroscopic morphologies of Al and Al-5Ti samples after different cavitation erosion times. When cavitation erosion time was 30 min, slight cavitation pits appeared on the edge of the Al sample (Figure 3a), and they became more serious, advancing to the center with the cavitation erosion time increasing (Figure 3b). The Al-5Ti sample presents a better corrosion resistance, and few pits can be observed after 30 min of cavitation erosion (Figure 3f), while the cracks began to appear after cavitation erosion for 50 min (Figure 3g). When the cavitation erosion time reached 90 min, the Al-5Ti sample had severe cross cracks appearing on its surface, but its surface damage was still less than in the Al sample, as shown in Figure 3c,h. Additionally, the cavitation erosion area of each sample occurred first at the edges. Compared with the center of the sample, there are two reasons for cavitation erosion at the edge of the sample. One is that the cavitation erosion of the edges of the samples is likely to be caused by the implosion of the bubbles migrating towards the liquid surface. The other is that the bubbles generated at the edges are more likely to burst than that at the center of the samples.

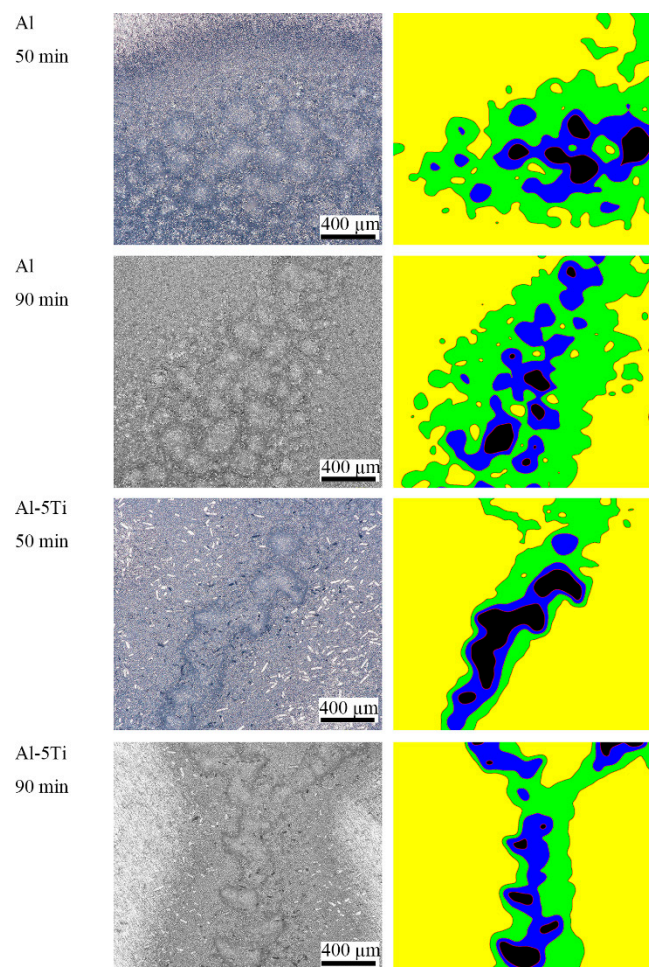
Figure 4. The OM photos of Al and Al-5Ti alloys after cavitation erosion for 50 min and 90 min, and its corresponding surface profile on the right.

The OM photos of Al and Al-5Ti samples after cavitation erosion for 50 min and 90 min are presented in Figure 4, and its corresponding surface profile is on the right. It can be seen that the surface of Al is more serious after the same cavitation erosion time, and the surface damage area is more than that of Al-5Ti. The ratio of the cavitation area of Al and Al-5Ti in the same area after 90 min of cavitation erosion measured by the metallographic method are 55.54% and 26.41%, respectively. However, this is only a part of the cracks on the sample, which cannot completely prove that the cavitation erosion resistance of Al-5Ti is better than that of Al.

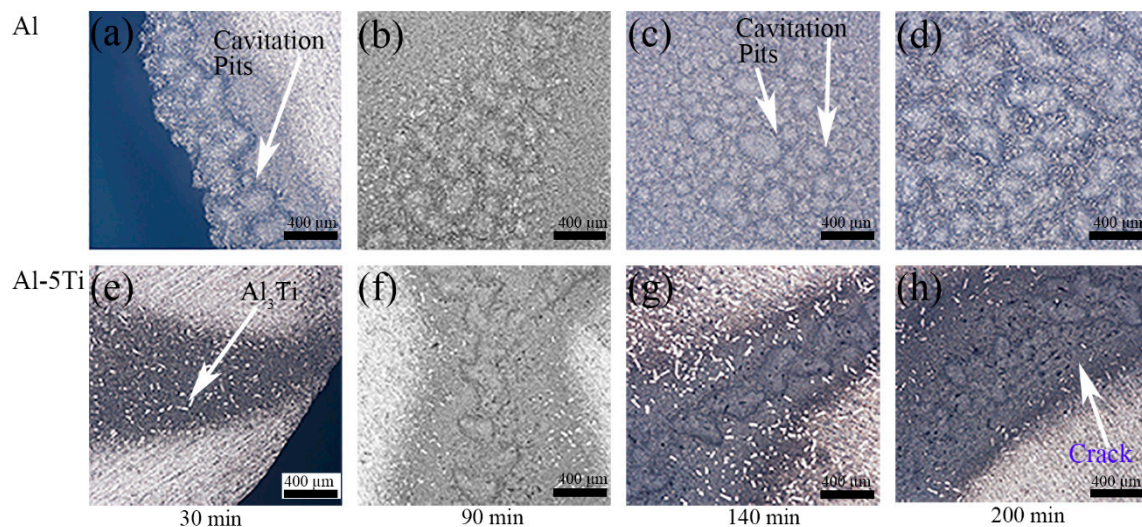
Figure 5. Damaged surface of Al and Al-5Ti alloys after different cavitation erosion time.

Figure 5 shows the damaged surface of Al and Al-5Ti samples. After cavitation erosion for 30 min, the edge of the Al sample began to appear cavitation erosion, but the area of cavitation erosion is small. In contrast, darker colored areas appeared in the edges of the Al-5Ti sample, and there are no obvious cavitation pits, but the white granular material Al_3Ti phase could be clearly seen. Serious cavitation pit groups appeared in both Al and Al-5Ti samples after cavitation erosion for 90 min, and the difference is that the surface damage of Al-5Ti is relatively slight. Figure 5c shows the surface damage in the form of the round cavitation pits group in Figure 3d after cavitation erosion for 140 min, and it can be seen that the cavitation pits group was formed by connecting multiple cavitation pits. After cavitation erosion for 140 min, cavitation pit cracks on the surface of the Al-5Ti sample were more serious than those after cavitation erosion for 90 min. The surface of the Al and Al-5Ti samples was seriously damaged after cavitation erosion for 200 min.

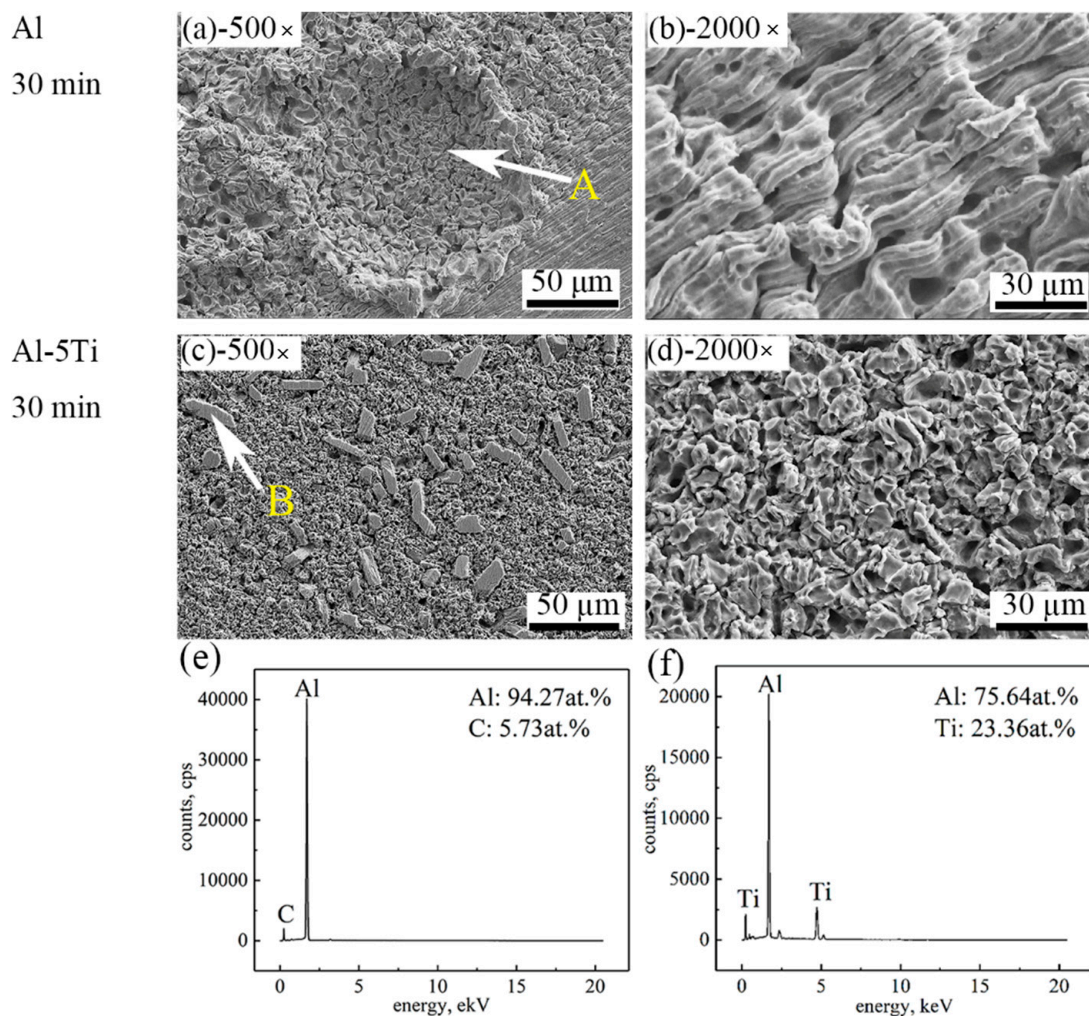
Figure 6. SEM images of different magnification of Al and Al-5Ti alloys after cavitation erosion for 30 min (a) 500× of Al, (b) 2000× of Al, (c) 500× of Al-5Ti, (d) 2000× of Al-5Ti, (e) the EDS of point A, (f) the EDS of point B.

In order to study the cavitation erosion resistance of Al and Al-5Ti alloys, the erosion micromorphology after different cavitation erosion times is shown in Figure 6. The cavitation pits can be observed on the surface of Al sample after cavitation erosion for 30 min, and the sample surface became very coarse, implying heavy damage of the Al sample (Figure 6a). However, there are no obvious cavitation pits on the sample surface of Al-5Ti, and Al_3Ti phases are of dispersed distribution (Figure 6c). It is a remarkable fact that the cavitation pit on the Al surface is larger than that of the Al-5Ti surface, which indicates a much more serious corrosion, as shown in Figure 6b,d. Figure 5e shows the EDS analysis results of point A in the Figure 6a, f shows the EDS analysis results of point B in Figure 6c. The results show that point A is the Al matrix and point B is the Al_3Ti phases.

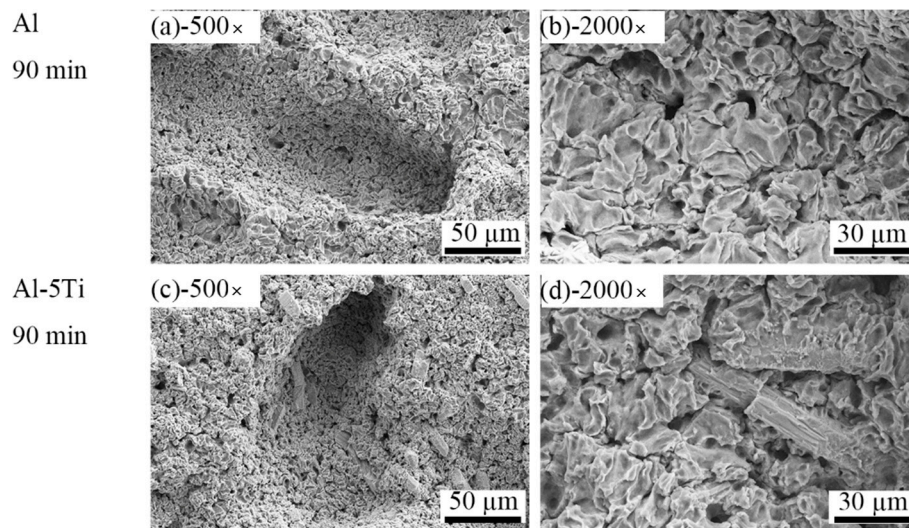
Figure 7. SEM images of different magnification of Al and Al-5Ti alloys after cavitation erosion for 90 min (a) 500× of Al, (b) 2000× of Al, (c) 500× of Al-5Ti, (d) 2000× of Al-5Ti.

Under the continuous impacts resulting from cavitation bubbles, the surface of Al and Al-5Ti samples were seriously damaged after cavitation erosion for 90 min. Figure 7a,c are SEM images of cracks in Figure 3c,h, respectively. It can be easily observed that cracks in the Al sample are longer than those in Al-5Ti. The single cavitation pit on the sample surface gradually developed into cavitation pits group after a long cavitation erosion time. The cavitation pit group then turned into a crack along the sliding direction under the impact force, which crossed longitudinally to the center of the sample. Figure 7b,d clearly show that the surface of Al and Al-5Ti samples were honeycombed with no obvious difference. Figure 8 shows the surface morphology of Al and Al-5Ti samples after cavitation erosion for 180 min. It can be obviously seen that the depth of the cavitation pit is deeper than before (Figure 8a), but the surface morphology of Al-5Ti (Figure 8c) has no significant change compared with Figure 7c. Compared with Figure 7b, it can be clearly seen that the Al grains are exposed in the cavitation pits (Figure 8b), and the Al matrix around Al_3Ti is completely shed (Figure 8d) and embedded in the cavitation pit. This is a confirmation that the Al matrix in the primary site for erosion and the intermetallic particles improve the cavitation resistance of materials, as reported in previous studies by the authors [40].

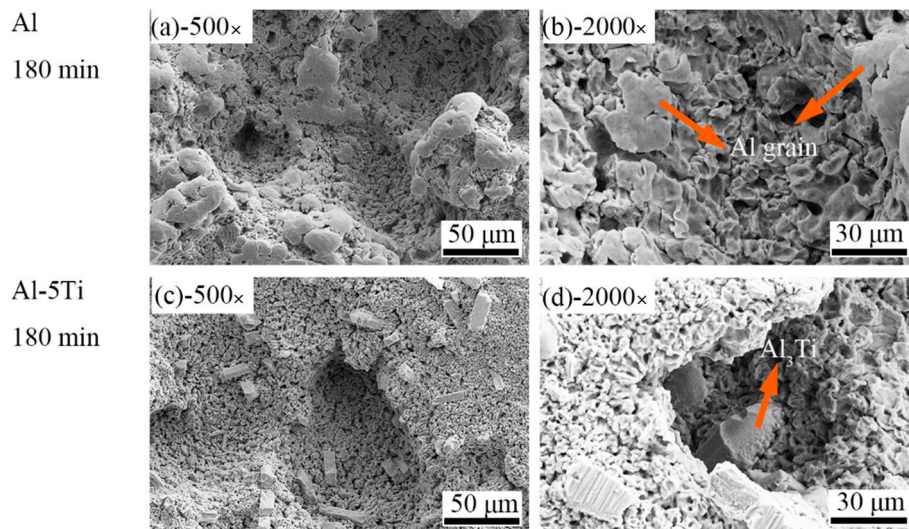
Figure 8. SEM images of different magnification of Al and Al-5Ti alloys after cavitation erosion for 180 min (a) 500× of Al, (b) 2000× of Al, (c) 500× of Al-5Ti, (d) 2000× of Al-5Ti.

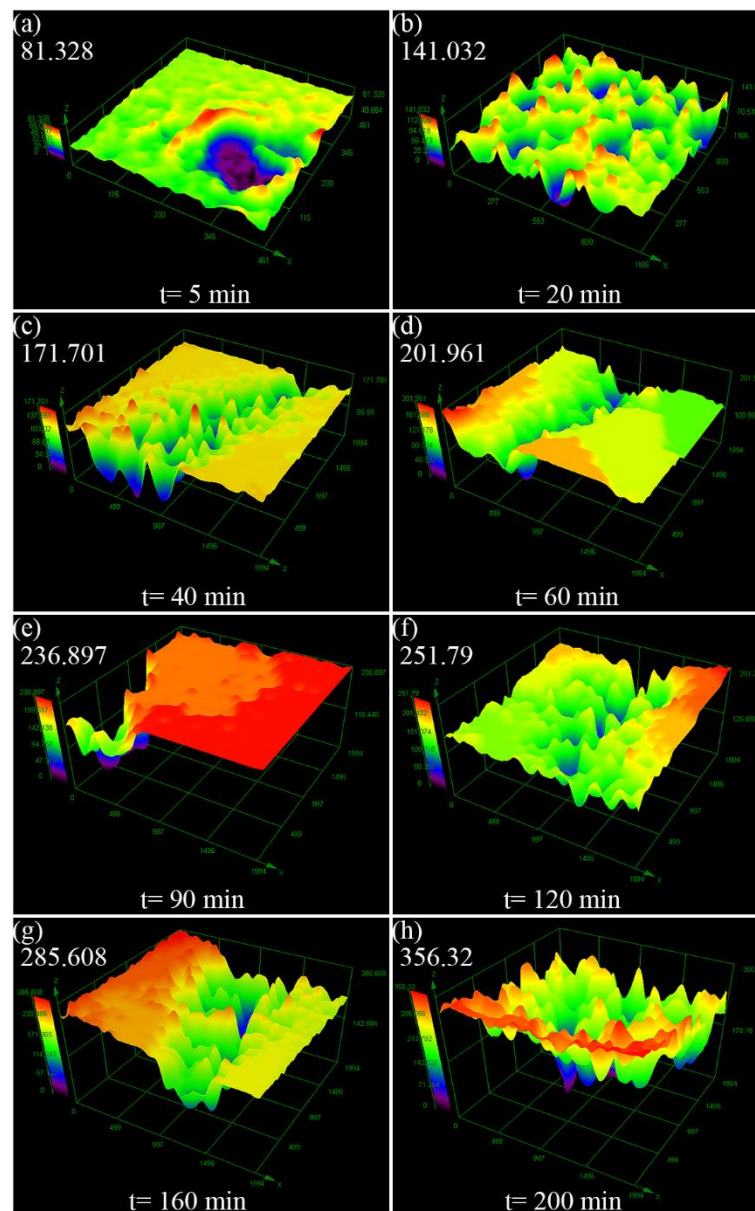
Figure 9. Three-dimensional morphology of Al surface after different cavitation erosion time in the distilled water (a) 5 min, (b) 20 min, (c) 40 min, (d) 60 min, (e) 90 min, (f) 120 min, (g) 160 min, (h) 200 min.

To further analyze the surface damage, the three-dimensional topographies of the Al sample after different cavitation erosion time in distilled water are shown in Figure 9. It is obvious that the cavitation pits form firstly on the edge of the sample after cavitation erosion for 5 min with a depth of 81.328 μm (Figure 9a), and then become dense after cavitation erosion 20 min (Figure 9b). When the cavitation erosion time is 40 min to 160 min (Figure 9c–g), the cavitation pits formed similar cracks in a certain direction at the center of the sample, and the area of cavitation pits region become larger. Figure 9c is the three-dimensional topography of the deepest crack on the sample, which is located in the edge area. It could indirectly prove that the crack mentioned in Figure 3 first occurs on the edge and then develops toward the center. Figure 9h shows that the sample surface exists in obvious peaks and pits after cavitation erosion for 200 min, and the final depth of the cavitation pit is 356.32 μm . In addition, the area occupied by the convex peak is very small, indicating that the material surface has severe cavitation.

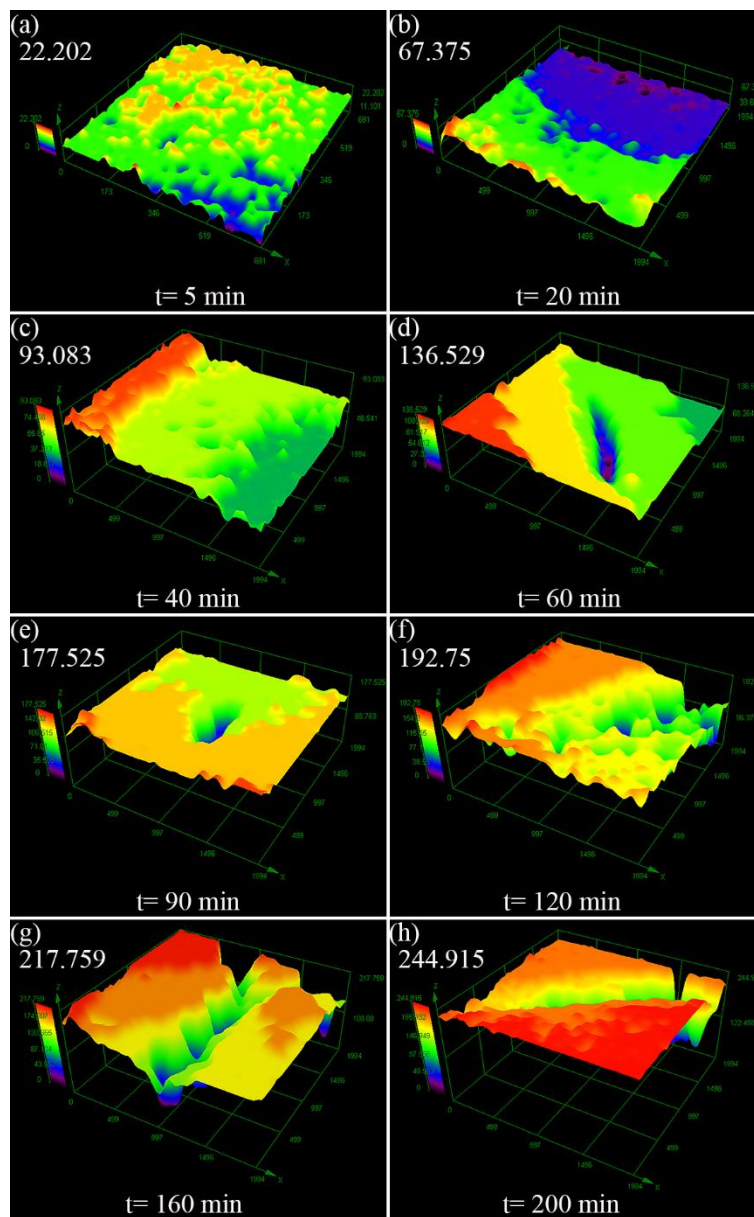
Figure 10. Three-dimensional morphology of Al-5Ti surface after different cavitation erosion time in the distilled water (a) 5 min, (b) 20 min, (c) 40 min, (d) 60 min, (e) 90 min, (f) 120 min, (g) 160 min, (h) 200 min.

Figure 10 shows the three-dimensional morphology of the Al-5Ti surface after different cavitation erosion time in distilled water. Apparently, the sample surface remained flat with a small number of cavitation pits, as showed in (Figure 10a,b), and the depth of cavitation pits were $22.202 \mu\text{m}$ and $67.375 \mu\text{m}$, respectively. After cavitation erosion for 40 min, no cracks appeared, but the depth of cavitation pits became significantly larger, and the sample surface began to deform. The sample surface of Al-5Ti after cavitation erosion 60 to 200 min is depicted in Figure 10d–h, and the crack is shallower than that of Al, which is similar to Figure 9. However, the cavitation pits of the Al-5Ti sample developed more slowly and appear less at the edges. In addition, the cavitation pits on the Al surface were densely distributed on the wider cracks, while the Al-5Ti surface cracks were relatively narrow with no pits. Figure 10h shows the three-dimensional morphology of Al-5Ti after cavitation erosion for 200 min, and the depth of the cavitation pit is $244.915 \mu\text{m}$, which is 31.3% lower than Al. Figure 11 is a histogram of the maximum depth of Al and Al-5Ti cavitation pits after different cavitation erosion

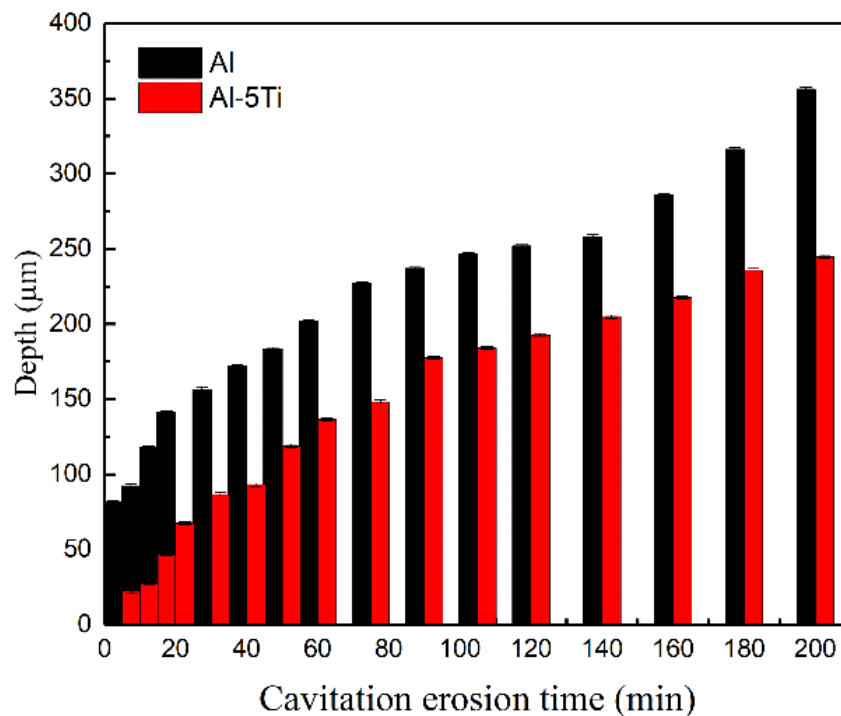
Figure 11. The histogram of the maximum depth of Al and Al-5Ti cavitation pits at different cavitation erosion times.

times. It precisely indicates that depth of the cavitation pit is increased with the increasing cavitation erosion time, and the depth of Al-5Ti is smaller than Al.
