Article

The Impact of Process Factors on Creating Defects, Mainly Lustrous Carbon, during the Production of Ductile Iron Using the Lost-Foam Casting (LFC) Method

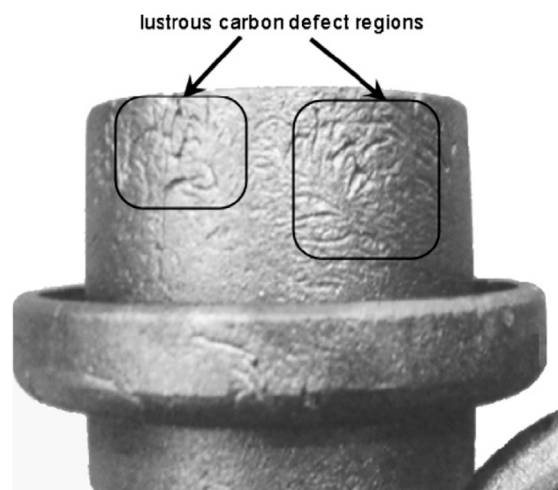
Figure 1. The defect of the casting surface generated in the lost-foam casting (LFC) process caused by lustrous carbon inclusions [9].

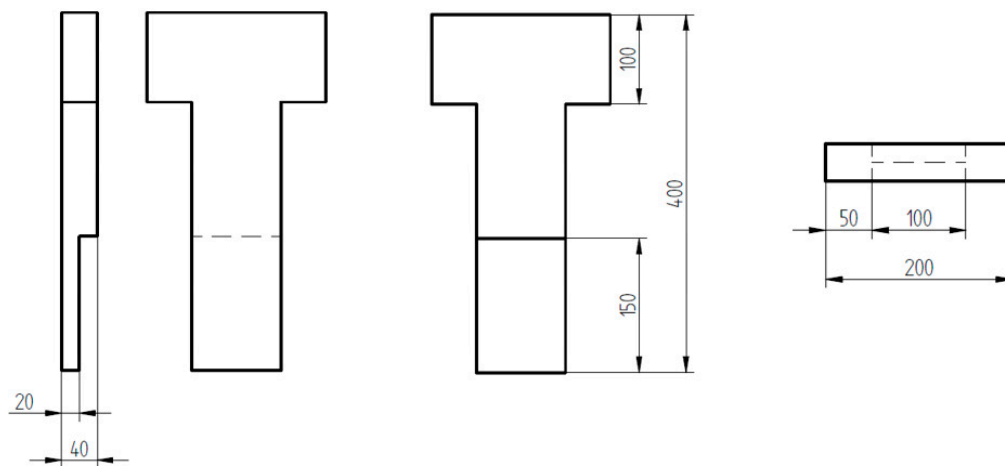
Figure 2. Molding pattern used in the tests (unit: mm).

The motivation behind the studies was quality issues detected in a foundry that manufactured heavy castings and used the lost-foam casting (LFC) process with some in-house modifications. As a result, the first stage of the conducted studies was to design a pattern to meet the requirements and limitations resulting from the manufacturing process used by the Rafamet foundry. Figure 2 presents the shape and dimensions of a foamed polystyrene pattern used in the experiments.

The casting pattern used during the studies was intentionally provided with building imperfections to stimulate the generation of defects. Among other things, all the walls were designed without any curvature radii. Besides, some pattern areas were seriously affected by the generation of thermal nodes. Those places allowed us to further analyze contraction cavities for variable process parameters. Studies were performed under the industrial conditions of the Rafamet foundry during normal production. As a result, the experiments were partially passive, i.e., some parameters, e.g., temperature, were not preset without any restraints. They were measured only for the assumed fluctuation levels.

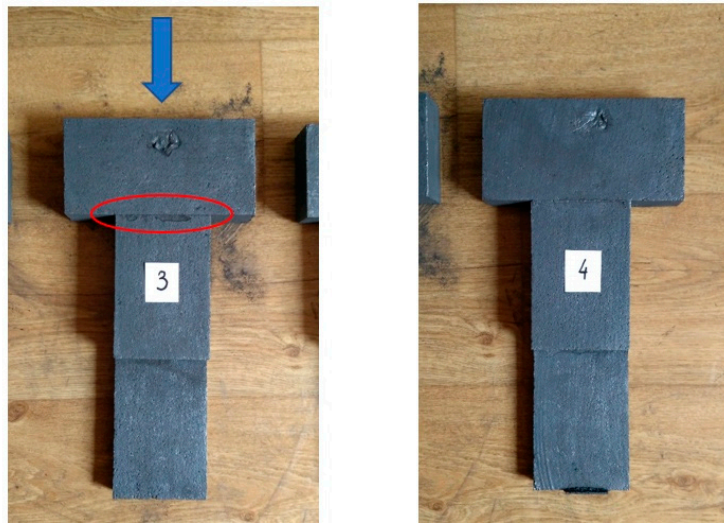
Figure 3. Sample castings. The defects related to pattern craftsmanship are marked red, while the inlet system entrance and pouring direction are marked blue; Melt 1.

The defects generated on all four samples were caused by the improper selection of the casting number attachment place. This step was carried out by a blue-collar worker who was not aware that the defect could have occurred. In this case, that was a contraction defect showing different features, depending on the grain sand used. Castings 1 and 2, molded with quartz sand, show slightly different defects from Castings 3 and 4. It is mainly about the size and depth of the contraction cavities generated. The samples molded with quartz sand show slightly larger defects than the remaining two samples. By contrast, Castings 3 and 4 show less extended but slightly deeper defects. Those discontinuities may have been affected by the pouring temperature. The temperature of 1305 °C is lower than the optimum temperature for pouring ductile cast iron. This parameter may have affected the flowing power and the capacity to fill the mold.

The defects marked red are related to the direction of pattern pouring. This defect appeared when the metal was fed as shown by the arrows on the photos above. The two remaining samples did not show the defect because they were poured from the other side. This relates to the method of pattern creation. This is because it is manufactured with three parts bonded with a polymer adhesive. In places of defect occurrence, the pattern is glued; therefore, it can lead to the dislocation or tearing of some parts of the pattern. This tear-off may have also occurred during pattern shaping. The weight of the molding compound may have broken off a piece of the pattern from the complete body. The problem is hard to assess because the foundry is not provided with instruments to analyze the reason behind the quality issue.

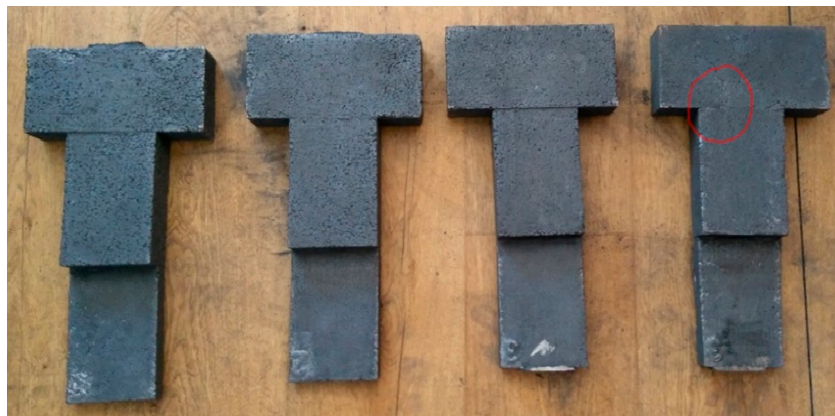
Figure 4. View of castings after removing the inlet system with a marked defect in the form of a lustrous carbon inclusion; Melt 2.

The quality of the casting surfaces in places where the casting numbers were glued on significantly deviates from the quality of the remaining castings. Those markings had an extremely negative impact on the quality of the surface obtained. The quality of the sidewalls for all the castings differs significantly from the desired casting quality level.

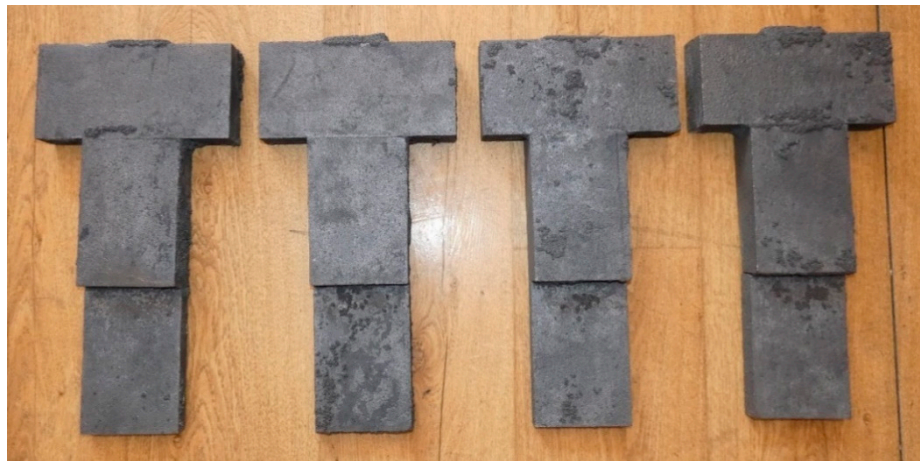
Figure 6. View of castings after removing the inlet system, Melt 3.

The defect of the lustrous carbon inclusion presented in Figure 6 may result from a pouring temperature that, in this particular case, was 1236 °C. Reducing this value by about 100 °C from the recommended temperature significantly reduces the efficiency of the mold cavity filling process. This is because it has a considerable impact on the alloy flowing power. All those dependencies translate into the quality of the castings. The side edges do not accurately reflect the polystyrene pattern, which considerably reduces the quality of the castings obtained. Besides, the potential of lustrous carbon inclusion generation increases significantly.

The castings during the third melt series did not show any contraction-related defects. Adopting a fundamentally bad pattern, with a large module in the central part, did not stimulate any occurrence of lustrous carbon inclusions. The numerous burns of the molding compound found on the surface of each casting can be related to two parameters. The first one is the pouring temperature, which was selected above the recommended level, which resulted in the appearance of thermal-origin defects. The second parameter is the concentration of the reclaimed part in the molding compound. The combination of the two unfavorable parameters causes many problems. The use of a compound with a reclaim level of 100% showed that such a step provides benefits, as there was no need to use any fresh sand. However, it induces some unfavorable effects. The use of such compounds results in many defects to be removed. Their removal requires a lot of time and money. The cost of repairing castings that were molded with such a compound is frequently higher than the profits resulting from the use of a fully reclaimed molding compound. The temperature of 1360 °C was the highest pouring temperature used during the performed studies. It can be noticed that values higher than those recommended for pouring have a very low impact on the occurrence of lustrous carbon inclusions. After three melt series, it was found that the reduced temperature was the factor that mainly stimulated the occurrence of that defect. During the final melt series, the pouring temperature was approximately 1250 °C.

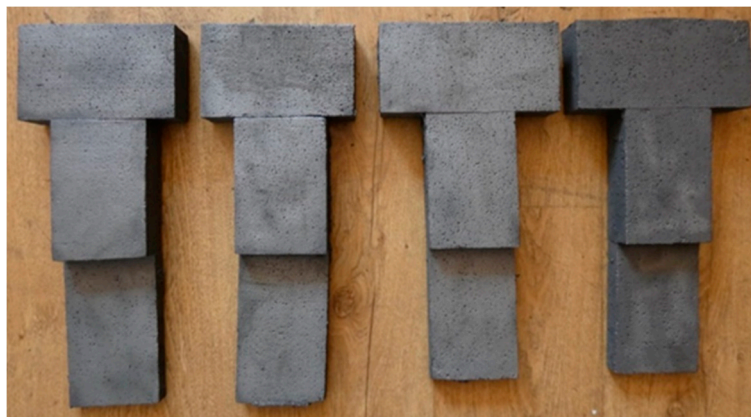
Figure 7. View of castings after removing the inlet system; Melt 4.

The use of coating did not considerably affect the surface quality. All samples look almost the same, but in the corner of one of them, there is a defect in the form of lustrous carbon as presented in Figure 8. The surfaces of the castings accurately reflected the molding pattern. A low pouring temperature had a lower effect on the quality of the samples obtained, as compared to the that of the melts of batch No. 2.

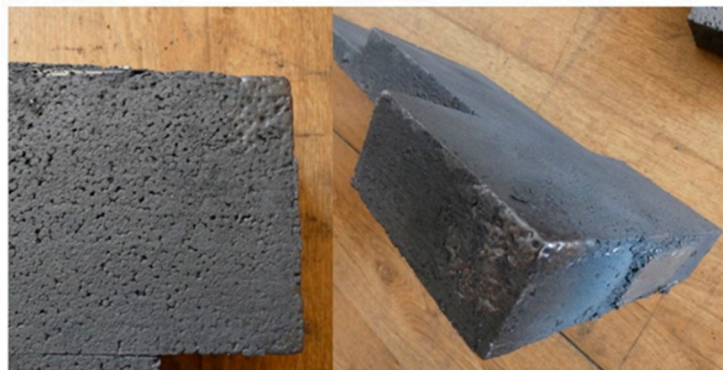
Figure 8. View of the surface where the lustrous carbon defect occurred; Melt 4.

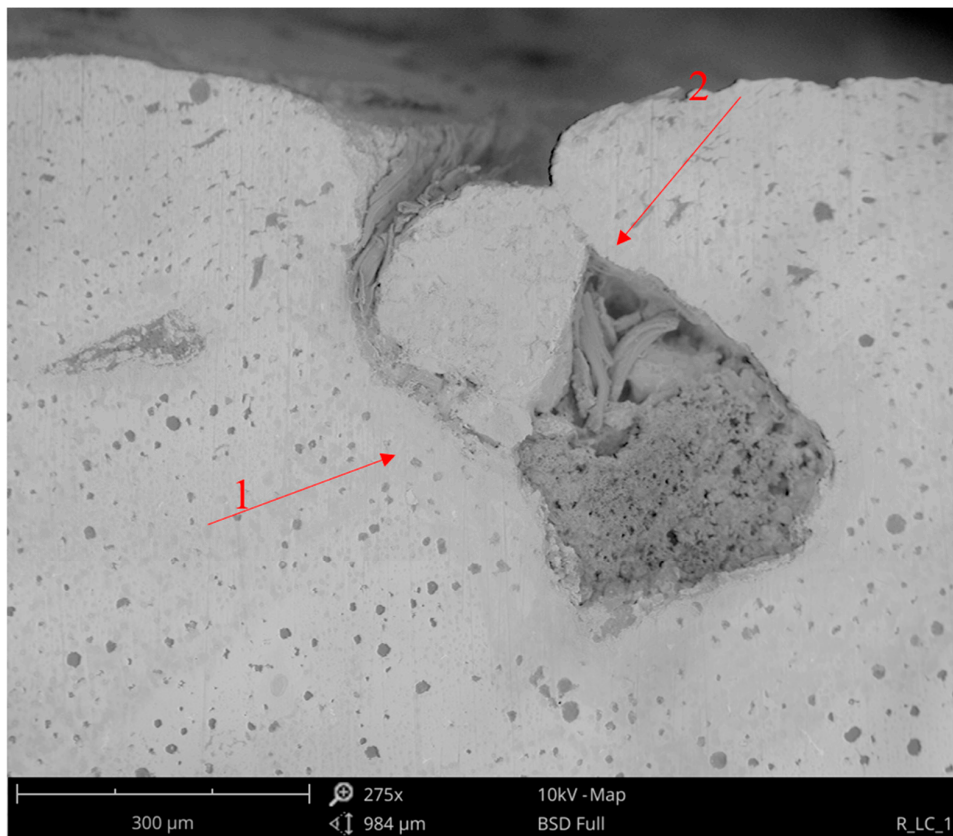
Figure 9 presents an SEM photo of the lustrous carbon defects located near the top rough surface of the casting. It is apparent that the defect marked with 1 seems to open itself to the surface of the casting; it may seem like a crack; nevertheless, it was formed during the turbulent filling, when the carburized casting skin wrinkled. On the right-hand side of this defect, there is another that, at first glance, seems to be separated from the surface; nevertheless, a closer examination allows us to find that its edges connect at its top and adopt the form of a double film opening up at the surface. The degenerated morphology of the graphite precipitations near the defects, similar to the degeneration near the rough surface, supports this hypothesis as the defects entrained previously constituted a part of the casting surface being formed.

Figure 9. Carbon bifilms near the surface of the casting, SEM; Melt 2.

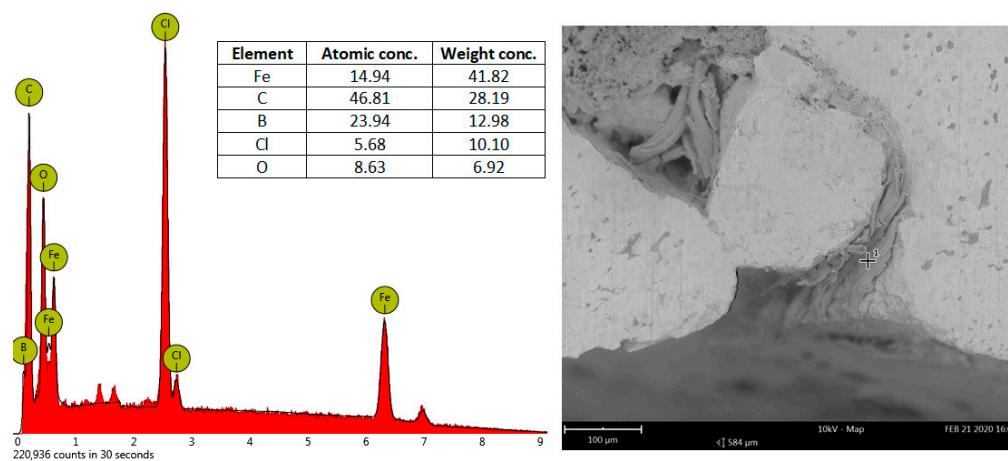
The results of EDS analysis performed on the surface of inclusion presented in Figure 9 are shown in Figure 10. It can be seen that a high concentration of carbon allows us to find that the inclusion consists mainly of carbon. The presence of Fe can result from the fact that EDS also scanned the volume located below the carbon layer. The presence of oxygen can be explained with Campbell’s theory [5], indicating that between the layer of carbon and the alloy, a thin oxide layer can be formed. A high concentration of Cl is connected with the fact that the sample was etched using iron chloride still present despite the thorough rinsing of the sample. This unfortunate issue allowed for the formulation of a vital conclusion that the presence of such defects may cause the retention of liquids in their center, which may act as a dangerous corrosion starting point. It is also possible that the undesirable capillary intake of liquids into the inclusion may occur.

Figure 10. EDS analysis of the defect surface, SEM EDS; Melt 2.

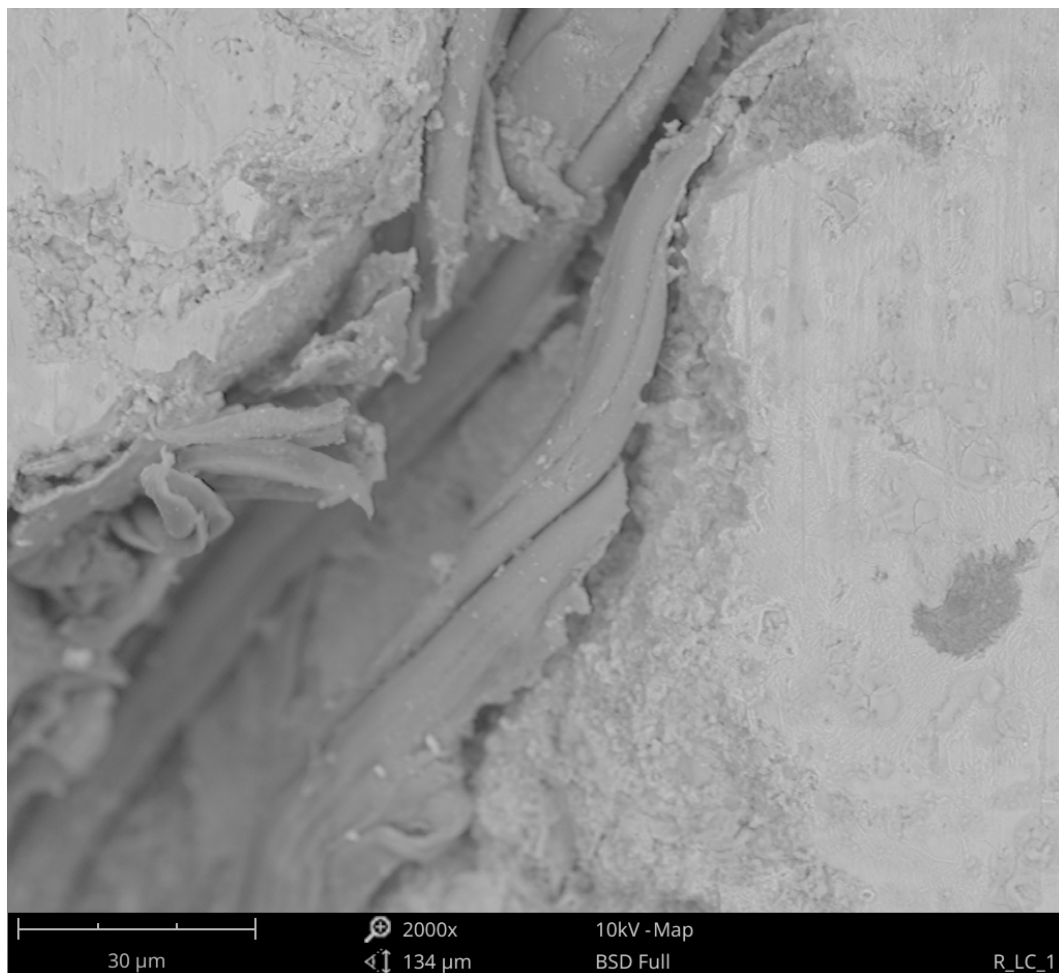
A magnified image of the defect surface marked with 1 presented in Figure 9 is shown in Figure 11. It can be seen that the carbon film constituting the defect surface is slightly separated from the metal surface. According to Campbell [9], due to the differences in the thermal expansion of the carbon film and iron during the crystallization of casting, the carbon film may detach from the casting. In the upper left corner of the figure, a large number of cracks resembling inclusion are present. They are also believed to be associated with the turbulence, as they are connected to the larger defect and can simply be its folded extension.

Figure 11. Magnification of a carbon bifilm, SEM; Melt 2.

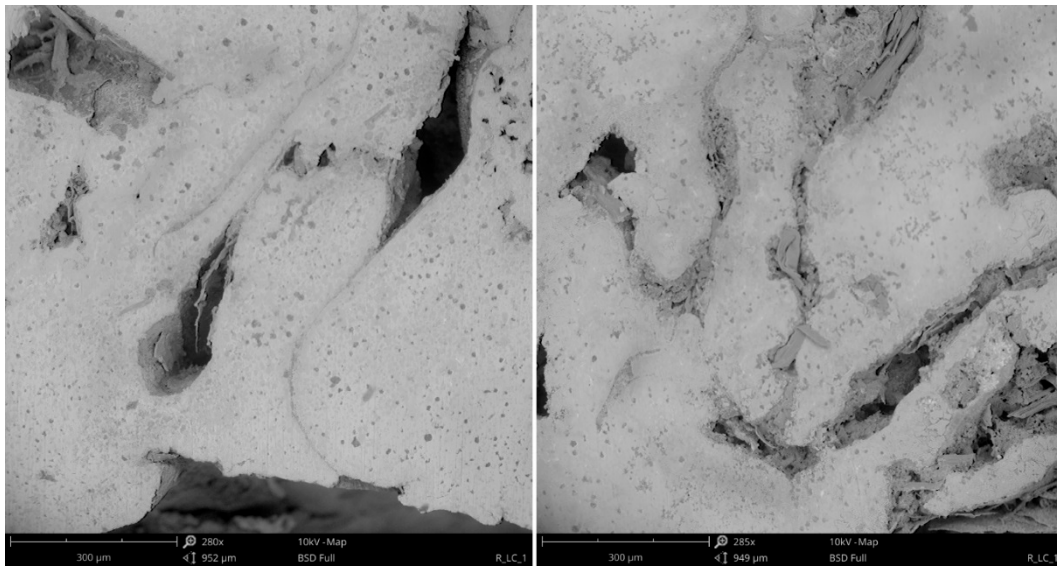
Typical castings manufactured with an unoptimized gating system that allows for breaking wave formation contain a significant amount of such carbon bifilm inclusions. The majority of them are connected with the casting rough surface. Interestingly, the length of such bifilms can reach up to centimeters! Figure 12, on the left-hand side, presents the surface outlet of the bifilm or rather its inlet; on the right-hand side, the end of the bifilm is shown; the authors would like to draw the readers' attention to the complexity of the inclusion with numerous folds. It should be kept in mind that the presence of such inclusions severely impairs the mechanical properties of manufactured castings, as they act as large internal cracks. Additionally, because there is a space between the two films composing the bifilm, such a defect can form a potential leak path [21,22], resulting in a lack of casting tightness.

Figure 12. Carbon bifilm inclusions, SEM; Melt 2.

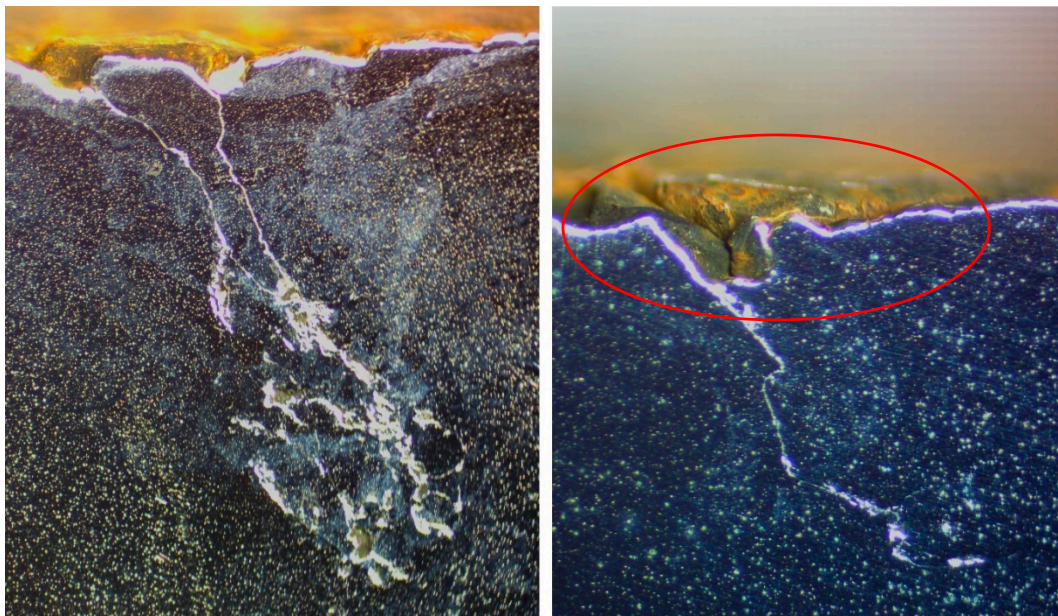
Particularly interesting images of entrained carbon bifilms can be obtained by using a stereomicroscope (SM), allowing us to present the character and morphology of the defect at the casting's rough surface. It can also be used to highlight the defects. Figure 13 presents two entrained films from the manufactured test castings; a corroded rough surface is visible at the top of each image. On the left-hand side, Figure 13 presents two entrained bifilms with a tangled end, potentially creating a large defect. If the surface of the casting was subjected to machining, the furled part could be uncovered. On the right-hand side, Figure 13 presents a visible triple fold in the rough surface with a section showing the entrained part of the film.

Figure 13. Entrained carbon bifilms near the casting's rough surface, stereomicroscopy; Melt 2.

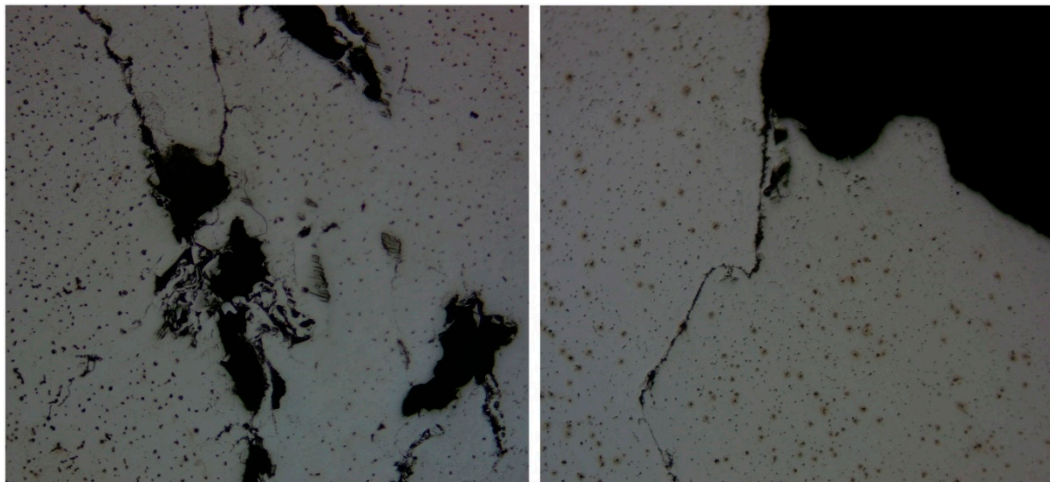
The analysis of entrained films presented in Figure 14 using light microscopy (LM) at a magnification of x50 on unetched samples allowed us to confirm their double nature and show that there is a possibility that, in other sections, such defects could be misinterpreted as porosity.

Figure 14. Magnification of entrained bifilms, light microscopy (LM) (x50); Melt 2.

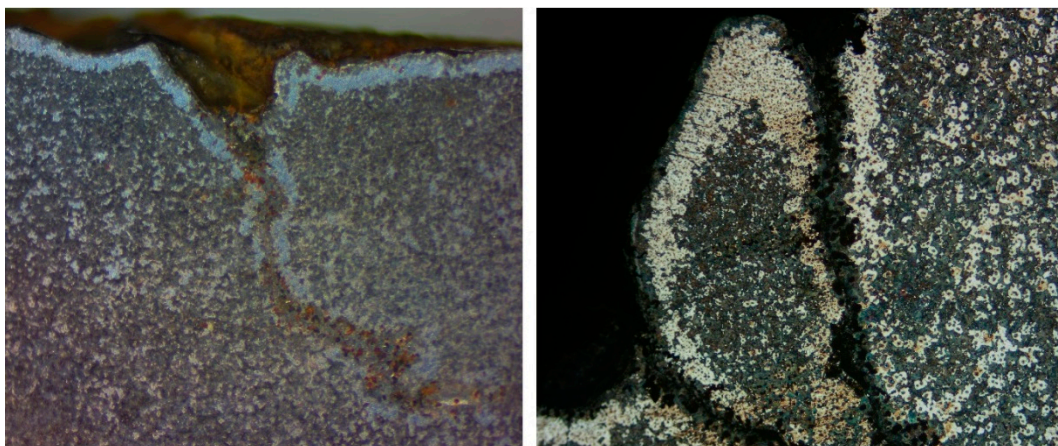
The analysis of the sample etched with iron chloride allowed us to find that, in the vicinity of the carbon film, the matrix exhibits decarburization features, as shown in Figure 15. Figure 15, on the left-hand side, presents the stereomicroscope image of the inclusion featuring a visible light-colored zone near the film, as well as the surface. It can be seen that the matrix changes from pearlite to ferrite in the zone adjacent to the film. On the right-hand side, the LM image at a magnification of x50 is presented to show that for other entrained films, the trend is the same. Similar phenomena found near the presented films and the surface allow us to emphasize the fact that entrained defects previously constituted a part of casting surface being formed.

Figure 15. Stereomicroscope (SM) image of a carbon bifilm on the left; LM image of a carbon bifilm on the right (x50); Melt 2.

The carbon bifilm entrainment shown can be eliminated by observing a strict process regime in the foundry. Special attention should be paid to the pouring temperature and gating system design to help prevent turbulence.
