# Residual Flexural Capacity of Corroded Prestressed Reinforced Concrete Beams

**Keywords:** corrosion degradation; prestressed reinforced concrete beam; corroded strands; residual flexural capacity

**Citation:** Kioumarsi, M.; Benenato, A.; Ferracuti, B.; Imperatore, S. Residual Flexural Capacity of Corroded Prestressed Reinforced Concrete Beams. *Metals* **2021**, *11*, 442. <https://doi.org/10.3390/met11030442>

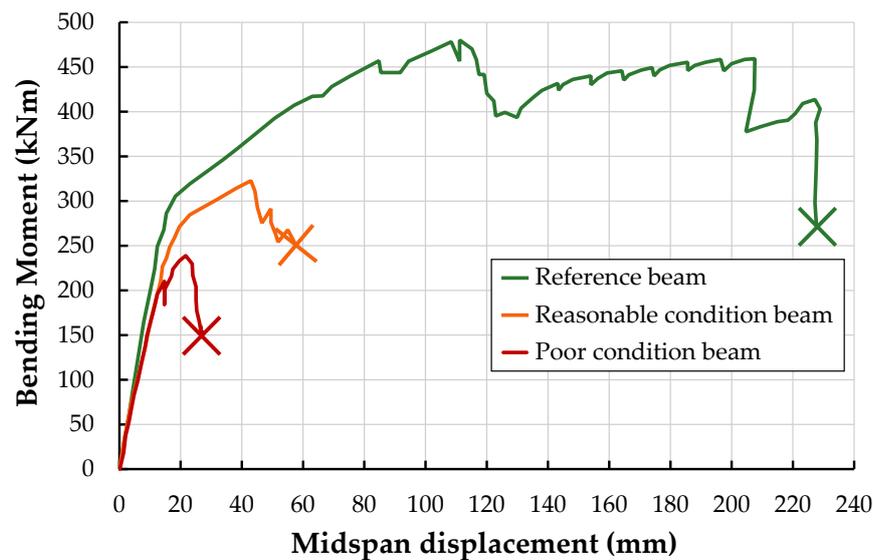
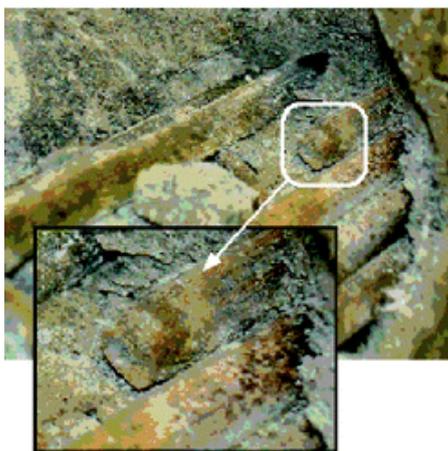
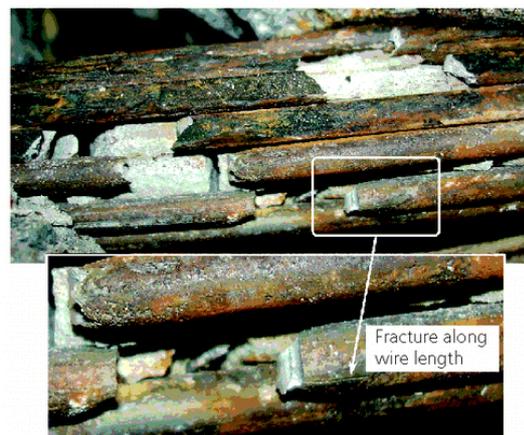
**Figure 1.** Experimental test by Pape and Melchers: (a) bending moment vs. midspan displacement curves, adapted from [29,30], (b) ductile fracture of prestressing wires in the reference beam [30], and (c) brittle fracture of prestressing wires in the most corroded beam [30].

From the beam tests, the authors observed that the corrosion of strands progressively reduced the flexural response of the PRC beam in terms of strength and ductility (Figure 1a). The observed reduction in the ultimate bending moment was 31% for the beam in reasonable condition and 49% for the beam in poor condition. Moreover, the number of wires broken during the flexural test seems strictly related to the increase in the load-bearing capacity reduction: 10 out of a total of 36 wires were fractured during the test in the case of the reference beam, 17 wires were fractured for the beam in reasonable condition, and 33 wires were fractured for the one in poor condition. The authors also showed the crack pattern of the beams after the flexural test. In the case of the reference beam, equally spaced cracks in the midspan can be observed, consistent with a flexural failure. In the corroded beams, however, large diagonal cracks that connected with the original longitudinal web cracking were formed. Therefore, variation in the collapse mode from flexural (ductile) failure to shear (brittle) failure was observed because of the corrosion degradation. The different failure modes of the reference and the corroded beams also emerged following the accurate analysis of the strands after the flexural testing: the failure surfaces of the prestressing wires were cup and cone—typical of ductile failure—in the reference beam (Figure 1b); in the corroded beams, the strands presented fracture surfaces in arrow-point form, typical of brittle failure (Figure 1c).

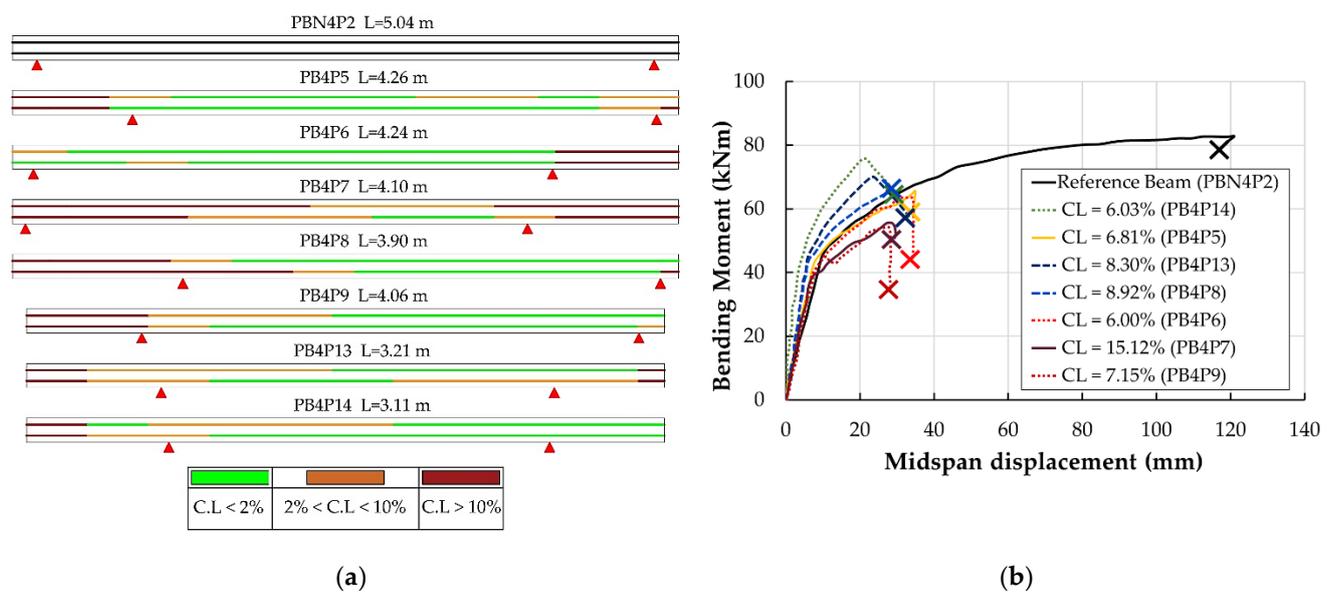
**Figure 2.** Experimental test by Belletti et al. [34]: (a) corrosion level (CL) distribution along the tested beams, and (b) bending moment vs. midspan displacement curves adapted from [34].

Since the existing beams were damaged in the inferior part, the authors decided to perform experimental four-point tests adopting different span lengths for each beam depending on the extension of concrete cover spalling caused by the corrosion at the beam-ends [34]. The positions of the supports are depicted in Figure 2a with the span lengths  $L$  used for each beam. In detail, the span length varied from 5.04 m (in the case of the reference beam) to 3.11 m (for the PB4P14 specimen characterized by an average corrosion level of approximately 6.03%). In order to make the results comparable for the different beams, at least in terms of loading, in the present paper, the load–displacement curves provided by the authors were transformed in the bending moment–displacement curves (see Figure 2b) to provide a clearer overall view of the experimental findings. It is worth noting that the midspan deflections are not comparable, since they are influenced by the different span lengths.

The analysis of the experimental results clearly shows that the corrosion deterioration progressively reduces the beams' ductility and strength. After ruling out some exceptions, a trend in the reduction of the flexural strength depending on the corrosion level can be observed. Concerning the beam referred to as PB4P9 in [34] and characterized by an average corrosion level of 7.15%, a lower structural response can be observed. However, such a result can be completely disregarded since the beam is characterized by a premature pure shear collapse, as highlighted by the authors, analyzing the crack pattern in the deformation maps captured by digital image correlation (DIC) during both the test and the collapse. The structural performance of the beams referred to as PB4P5 and PB4P6 in [34] does not appear to be consistent with the rest of the experimental campaign. In this case, however, the reason does not lie in the variation in the failure mode but rather in the value attributed to the assigned corrosion level. In fact, even if low to mid-corrosion can be observed between the supports, the structural response could be governed by the presence of deeper pits along the strands. In fact, the pitting corrosion provides stress localization, causing the wires to rupture and, therefore, resulting in the brittle failure of the beam. It is worth noting that the presence of localized pits along the strands is a significant uncertainty parameter that could not substantially modify the mass loss of a certain section. Therefore, the average mass loss should be regarded only as an index of the possible structural behavior, which must be ever associated with the dimension and the location of the deeper pits. Unfortunately, the maximum pit depth and location have not been indicated in either case in [34].

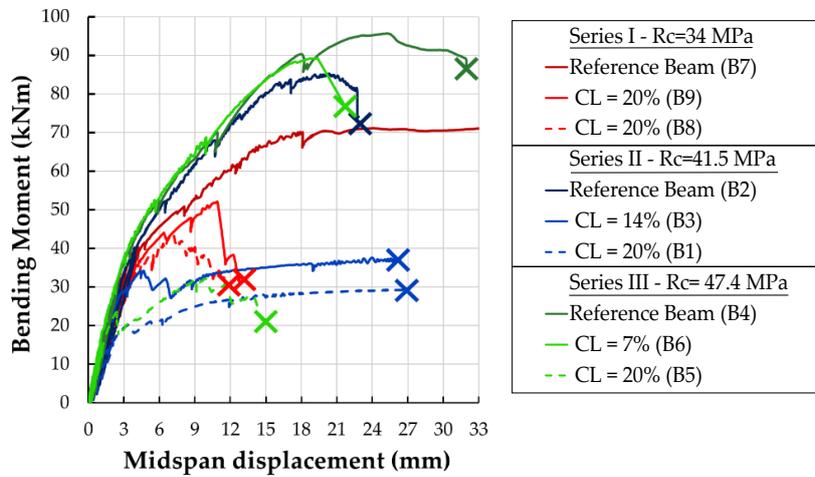
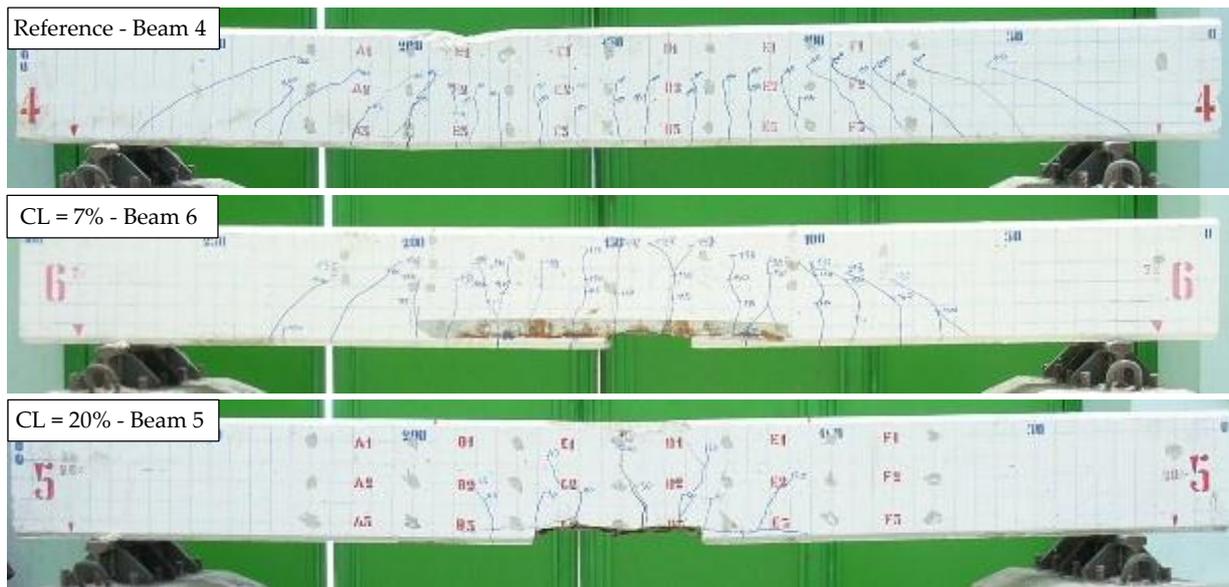
**Figure 3.** Experimental tests by Rinaldi et al. [37]: (a) bending moment vs. midspan displacement curves at different corrosion levels (CL), adapted from [37], and (b) crack pattern during the collapse of the corroded and uncorroded beams [37].

Rinaldi et al. [36,37] conducted experimental testing on corroded and uncorroded PRC beams with four-point bending. The strands were prestressed to 1300 MPa, which was approximately 0.70 times of their nominal ultimate strength. In total, nine PRC beams—characterized by different concrete compressive strengths (34.0, 41.5 and 47.4 MPa)—were artificially corroded, with various percentages of mass loss (7%, 14% and 20% by loss of steel mass of each strand); in all cases, the corrosion was restricted to the bending zone of the beams. The obtained results are represented in Figure 3a in the form of bending moment–displacement curves. In the concrete with 34.0 MPa compressive strength, the bearing-capacity loss was between 28% and 41% under severe corrosion (20% by mass loss). However, in the good-quality concrete, corrosion of medium and severe corrosion levels (14% and 20%) led to a sharp reduction in the capacity (up to 66%). Moreover, ductility degradation, due to the increase in the corrosion level, can be observed in the results. The analysis of the crack pattern resulting from the collapse suffered by the beams (Figure 3b) indicates that corrosion changes the failure mechanism of PRC beams. With the exception of the beam characterized by higher concrete strength—for which pure bending failure was observed—in the absence of corrosion, collapses occurred for concrete crushing accompanied by bending and shear interaction. The crack pattern at failure becomes more localized with an increased corrosion level. In detail, for the beam with 7% mass loss, vertical cracks between the two-point loads and inclined cracks in the shear spans can be observed, whereas for the higher corrosion levels, the crack pattern is characterized only by sub-vertical cracks with branches. With the exception of the lower corrosion level—for which the simultaneous crisis in concrete and strands occurred—the strand failure governed the collapse of the corroded beams. Since, during the test, the sudden rupture of the prestressing wires weakened by the corrosion deterioration was observed, the structural performance of the corroded beams is associated with the average level of corrosion achieved. Nevertheless, it can be assumed that the stress and strain localization provided by the pitting corrosion is the cause of the wire rupture. Therefore, it is concluded that the mass loss can be considered only as an index of the severity of degradation, since the beams' ultimate capacity is governed by the stress localization in the corrosion pit. For a better explanation, a picture of the strand is presented in Figure 4 for the case of specimen B8 (characterized by a 20% mass loss and a concrete strength of 34.0 MPa). Specimen B8 collapsed due to the wire strands' local rupture in the section affected by the deeper corrosion pit; see Figure 4b.

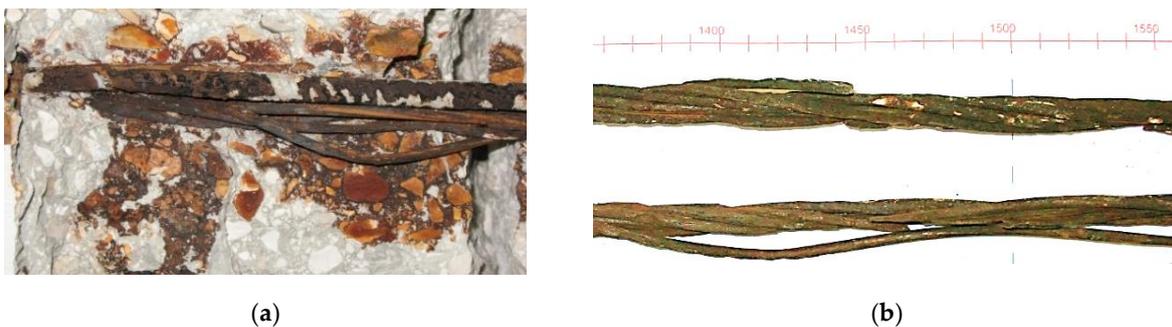
**Figure 4.** Experimental tests by Rinaldi et al. [36]: (a) prestressing strand failure in corroded beam 8 (20% mass loss), and (b) examples of strand corrosion in specimen B8.

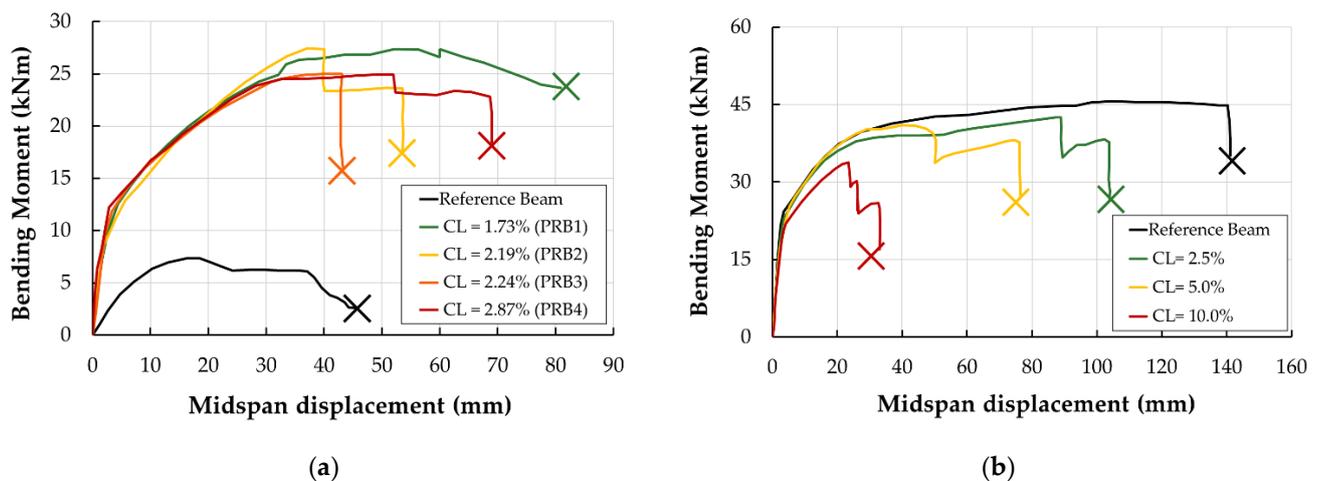
**Figure 5.** Bending moment vs. midspan displacement curves at different corrosion levels (CL), adapted from: (a) experimental test results by Li and Yuan [38], and (b) experimental test results by Menoufy and Soudki [39].

Li and Yuan [38] experimentally investigated the performance of ten PRC beams, of which five were pretensioned RC beams and five were post-tensioned ones. The beams were characterized by the same materials and reinforcement arrangements. An initial prestressing action of 1395 MPa, which is approximately 0.75 times the strands' characteristic ultimate strength ( $f_{ptk} = 1860$  MPa), was applied to the beams. The corrosion was induced by means of an electrolytic procedure, where the degradation process was catalyzed by introducing 3% sodium chloride into the mass fraction of cement. With reference to the PRC beams, the obtained corrosion degree was extremely low, up to 2.87% in mass loss. To evaluate the flexural capacity of the corroded beams, four-point bending tests were performed. In any case, it is important to note that the result regarding the reference uncorroded beam cannot be employed since this member prematurely collapsed in pure shear coupled with the slippage of the steel strand. It seems that the pretensioned system was inefficient and, at the peak load, the prestressing action was completely lost since the maximum strength of the uncorroded specimen matched the ultimate bending moment of the beam characterized only by mild reinforcement. A synthesis of the results of the ex-

perimental campaign is presented in Figure 5a, where the bending moment–displacement curves are provided.

Due to the erroneous behavior of the reference beam, the evaluation of the reduction in bending capacity due to corrosion is not possible. However, according to the experimental results of the corroded beams, a slight reduction in the ultimate load due to the increased level of corrosion was observed, accompanied by a ductility variation trend that did not appear to be well-defined, probably since the level of corrosion was similar for the analyzed beams.

Menoufy and Soudki [39] assessed the effect of corrosion of strands on the residual capacity of PRC T-beams. To this aim, six full-scale PRC T-shaped beams were tested with four-point bending. The prestressing strands were tensioned to 70% of their ultimate stress. In this study, only the central tension region of the beams (1 m in length) was corroded. It is worth underlining that the specimens were characterized by only one strand in tension; therefore, the flexural performance of the beam was strictly related to the tensile behavior of the corroded strand. In fact, in all the corroded specimens, the failure occurred due to rupturing of the tendons. All the beam specimens were subjected to accelerated corrosion to achieve 2.5%, 5% and 10% mass loss. A synthesis of the results of the experimental campaign is reported in Figure 5b, where the bending moment–displacement curves are represented. Corrosion reduced the flexural capacity of the PRC beams: for 2.5% and 5% mass losses, the reductions in ultimate load capacity were 6.5% and 9%, respectively; for 10% mass loss, the reduced ultimate capacity was 26%, and up to 76% reduction in midspan deflection was measured.

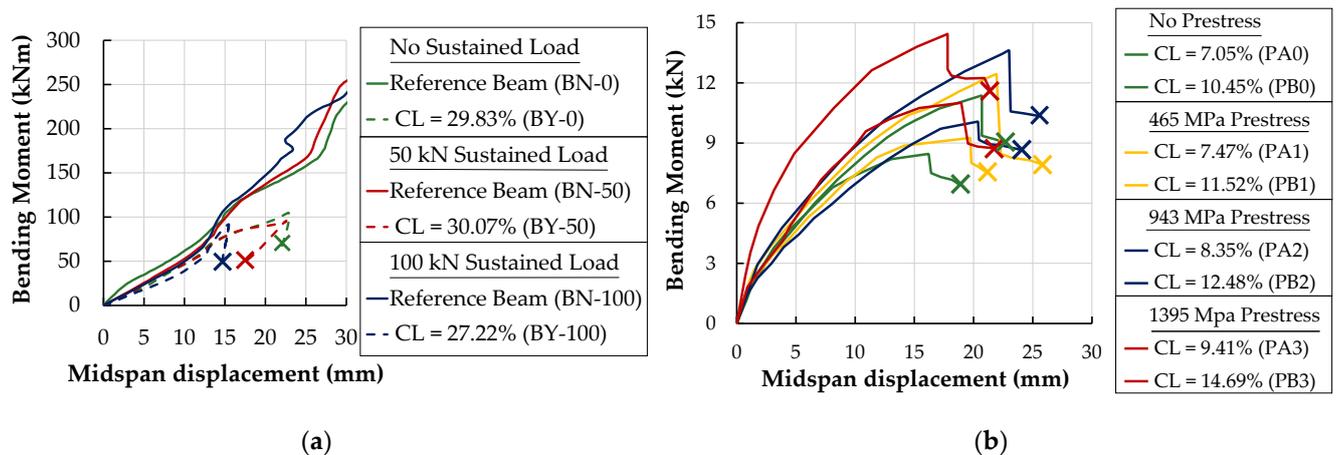
**Figure 6.** Bending moment vs. midspan displacement curves at different corrosion levels (CL), adapted from: (a) experimental test results by Yang et al. [42], and (b) experimental test results by Dai et al. [43].

Yang et al. [42], unlike other experimental groups, performed the artificial corrosion of PRC beams during the application of a high bending moment. In total, six beam specimens were fabricated and corroded using an accelerated corrosion procedure. An initial prestressing action of 1398 MPa was applied, which is 0.75 times the steel strands with a nominal ultimate strength ( $f_{ptk} = 1860$  MPa). Simultaneously, the beams were subjected to wet/dry cycles using direct current (DC) power, i.e., the specimens were kept for 3 and 4 days in dry and wet conditions, respectively. They used a sponge containing 5% sodium chloride solution to corrode the beams. The corrosion level attained was, on average, 30% in mass loss. During the artificial corrosion process, the specimens were subjected to a sustained load (0, 50 and 100 kN), in a four-point bending configuration. It should be noted that 50 and 100 kN represent around 30% and 60% of the designed ultimate bearing capacity of the beams, respectively. The entire process of loading and corrosion took 550 days. Subsequently, the specimens were monotonically loaded under a bending test machine up to 500 kN. The experimental results are synthesized in terms of bending moment–displacement curves (Figure 6a). None of the uncorroded beams experienced collapse, contrary to what was observed for the corroded specimens, which collapsed due to the rupture of the strands. The combined application of sustained load and corrosion resulted in a larger total loss of prestressing force than the case subjected to corrosion without sustained loads. In Yang et al. [42], the time-dependent tendon force was measured by means of a nondestructive technique based on sensors measuring the magnetic permeability of prestressed tendons. The largest total loss of prestressing force was around 56% for a beam subjected to 60% of its designed ultimate load during the corrosion process. Moreover, it was shown that prestressing force can restrict the development of transverse cracks during severe corrosion in the strands. Yang et al. [42] also found that a sustained load promotes corrosion localization, and beam specimens subjected to higher loads displayed more severe pitting corrosion. Other researchers report the importance of pitting corrosion in the failure of RC beams as well [50–53]. In fact, pitting corrosion dramatically reduces the mechanical properties of strands.

Dai et al. [43] investigated the effect of the level of prestress load on the corrosion level and consequently on the reduction of flexural capacity. With this aim, they performed a four-point flexural test on eight PRC corroded beams characterized by corrosion levels between 7.05% and 14.96% and different levels of prestressing action (from 0 to 1395 MPa; the yield and ultimate strengths of the strand were 1830 and 1910 MPa, respectively). The electrochemical method was employed to accelerate the strand corrosion, by applying a constant current of 0.1 A in the inferior strands for 15 (PA series) or 20 days (PB series). The beams were partially submerged in a corrosion tank. According to the authors of [43], high strand stresses can accelerate the corrosion-induced prestress loss, e.g., by varying the strand stress level from 25% to 75% of the tendon strength, the corrosion-induced prestress loss increases by 20%. In Figure 6b, the obtained bending moment–deflection curves are presented. After varying the prestressing action, beams subjected to 15 days of artificial corrosion showed mass losses between 7.47% and 9.41% coupled with prestress losses of 12.0% up to 31.3%. After increasing the corrosion duration, prestress losses from 34.4% up to 55.3% were measured, coupled with corrosion levels of 11.52% and 14.69%, respectively. Even if this study is significant because it is the only one in which the prestress losses are measured, it should be mentioned that the results of the reference uncorroded beams are omitted; thus, no consideration is given to the flexural strength and ductility reduction due to the corrosion.

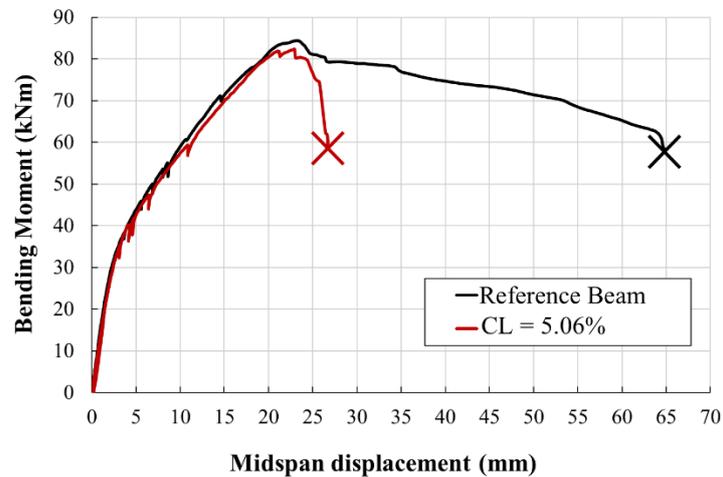
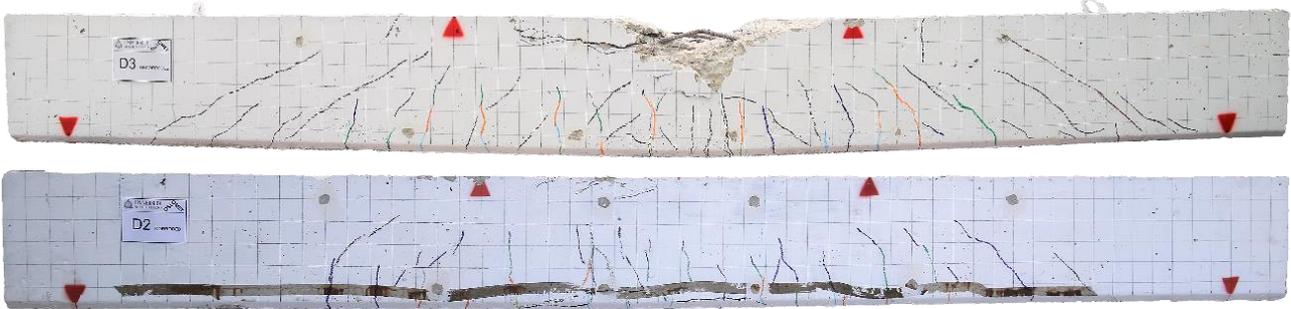
**Figure 7.** Experimental test by Benenato et al. [44]: (a) bending moment–deflection curves at different corrosion levels (CL), adapted from [44], and (b) crack pattern after the collapse of the corroded and uncorroded beams.

Benenato et al. [44] conducted experimental testing on two PRC beams using four-point bending, characterized by an initial prestressing action of 1300 MPa, approximately 0.70 times the nominal ultimate strength of the prestressing tendons. The work is part of a research project aiming to parse out the impact of a low degree of corrosion on the structural behavior of PRC beams. One beam was considered as a reference, while the other was subjected to an artificial corrosion process designed to produce realistic deterioration (the corrosion spreads along the entire structural element but is more marked on the shear spans), with an attained corrosion level at an average of 5.06% in mass loss. This corrosion level causes a loss of ductility, while the strength is practically unchanged (Figure 7a). The behavior of the corroded beam was similar to that of the reference beam up to the peak load. Concerning the brittle failure of the corroded beam, the collapse can be attributed to the concurrent concrete crushing and tendon failure, associated with a very sudden softening branch. As highlighted by the crack patterns (Figure 7b), the sound beam shows vertical cracks between the two load points and inclined cracks close to the supports. Moreover, during the collapse, concrete crushing combined with the buckling of the compressed reinforcement occurs. On the contrary, in the corroded beam, only slight concrete crushing is manifested, while inclined cracks form only near the load points.

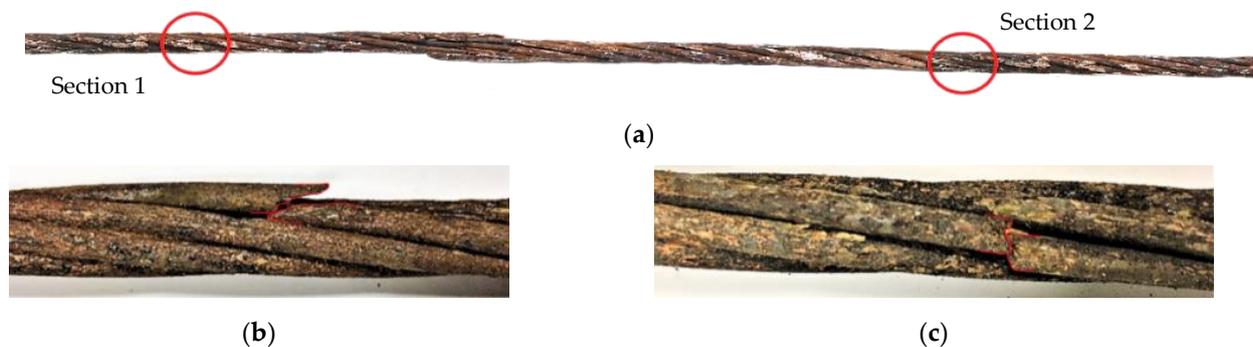
**Figure 8.** Experimental test by Benenato et al. [44]: (a) corroded strand extracted from the beam, (b) example of arrow-point type fracture (Section 1 in Figure 8a), and (c) example of inclined-shape fracture (Section 2 in Figure 8a).

In Figure 8, an example of strand corrosion and their local rupture that occurs during flexural testing is presented. Wire failure was identified along the strand where the wire's cross-section, because of the formation of localized pits, was reduced and became insufficient to sustain the superimposed stress state. Since the failure of a corroded wire is the consequence of a crack originating in a corrosion pit, it makes sense that the shape of the pitting affects the fracture surfaces of the prestressing wires. Therefore, we can find arrow-point type fracture surfaces (Figure 8b) or inclined shapes with valley breaks (Figure 8c)—in all cases, shapes which are typical of the brittle failure of steel wire.

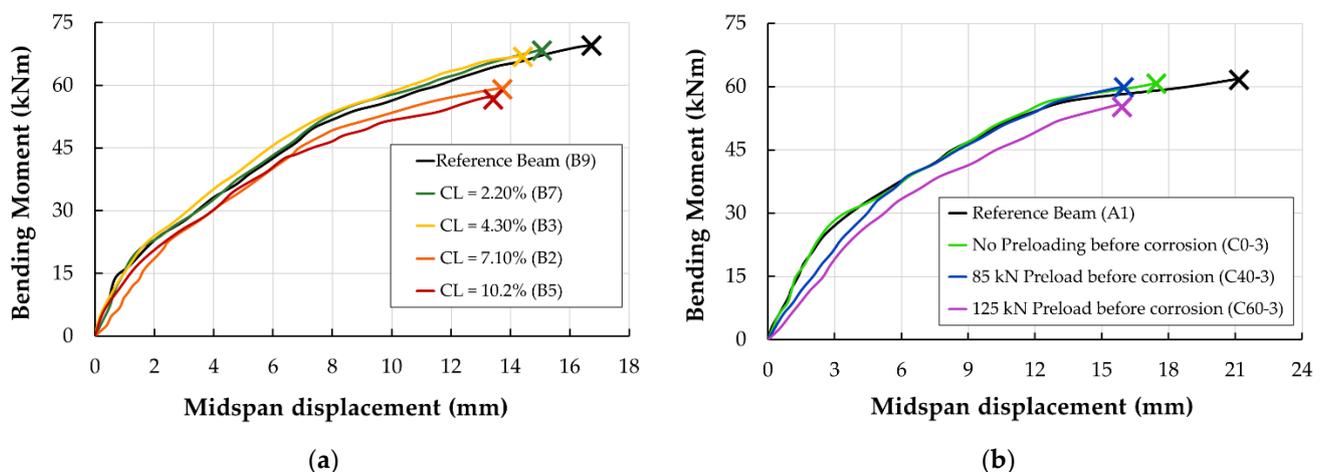
**Figure 9.** Bending moment vs. midspan displacement curves at different corrosion levels (CL), adapted from: (a) experimental test results by Liu et al. [45] and (b) experimental test results by Liu and Fan [41].

Liu et al. [45] conducted experimental testing on five PRC beams using four-point bending. A very low initial prestressing action of 558 MPa, only 0.30 times the nominal strand yield strength, was applied. The beams were subjected to accelerated corrosion for up to 42 days by means of the electrochemical method. A synthesis of the experimental results is presented in Figure 9a, where bending moment–displacement curves are provided. It is shown that slight corrosion has a weak effect on the flexural behavior of prestressed concrete beams, even if a reduction in the strand slip is observed to increase the corrosion level. Therefore, in the experimental work by Liu et al. [45], a variation in the strand-to-concrete interaction due to the corrosion was detected. The flexural capacity decreases for corrosion levels higher than 7%. For a corrosion level of 10.2%, the ultimate deflection decreases by 18.7%, the flexural capacity reduction is 17.3%, and the ductility declines by 19%. However, the slip between the corroded steel strand and concrete increases: the ultimate slip rises from 5 to 11.4  $\mu\text{m}$ .

To address the behavior of corroded beams retrofitted with composite materials, Liu and Fan [41] studied the effects of initial damages and chloride corrosion on the flexural behavior of prestressed concrete beams. In the following, the performance of the non-retrofitted beams is analyzed. Therefore, only the results obtained for four prestressed concrete beams, which were preloaded with 0%, 40% and 60% of the ultimate load, are presented. In addition, in this case, 30% of the strands' yield stress was the initial prestressing amount. The beams were immersed in chloride solution ( $\text{CaCl}_2$  and  $\text{MgCl}_2$  with 5% concentration) for 120 days. Unfortunately, the attained corrosion level is not reported in the paper. Four-point bending tests were performed. The sectional strain, deformation, flexural stiffness, flexural capacity, ductility and cracking characteristics were reported but they were not correlated with the observed corrosion level. Figure 9b presents a synthesis of the experimental results in the form of a bending moment–displacement

curve. In general, it can be observed that corrosion reduced the ductility by up to 21% and the flexural capacity by up to 10%.

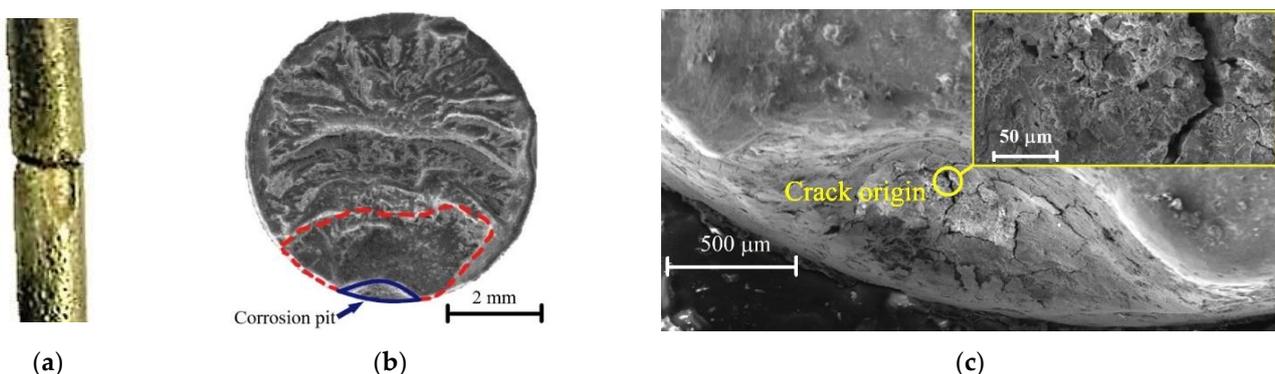
**Figure 10.** Experimental test by Zhang et al. [46]: (a) distribution of cross-sectional area of corroded prestressing wire, (b) SEM images of the fatigue fracture surface of the wire, and (c) SEM high-magnification image of the fatigue fracture surface. Adapted with permission from [46]. Copyright 2016 Construction and Building Materials.

Zhang et al. [46] tested thirteen pretensioned, partially prestressed concrete beams under cyclic loading. The prestressing reinforcements were pretensioned up to 75% of their nominal ultimate tensile strength. The beams were artificially corroded up to 5.6% average mass loss. It was reported that all the beams failed at the location of the maximum cross-section loss. The localized cross-sectional losses of the specimens were ten times greater than the average cross-section loss. The fracturing of the first wire in three corroded beams characterized by mass losses of 1.3%, 2.5% and 5.6% occurred at approximately 421,000, 219,000 and 166,000 cycles, respectively. Compared with the uncorroded beam, the fatigue life of the three corroded beams displayed a reduction of 44%, 80% and 83%, respectively. Unfortunately, no load–deflection curves are reported in the paper. However, the analysis of the fatigue fracture surface in the beam characterized by a 2.5% average cross-section loss crack pattern (Figure 10) is interesting. To do this, the authors [46] employed a scanning electron microscope (SEM) to analyze the surface of the fractured wire. In the high-magnification image, the crack origins around the pit, where many voids and interconnected cracks are present—triggered by the fatigue failure—can be observed. The propagation zone shows a flat surface with fine, randomly dispersed and isolated cracks caused by the loading cycles. More recently, the same authors (Liu et al. [54]) extracted from the failed beams a huge amount of corroded prestressing wire pieces, with the aim of probabilistical assessing the stress state developed around the corrosion pit during the fatigue test. To achieve this goal, the morphology of the corroded prestressing wires was studied by reconstructing 3D geometric models (acquired by means of a high-resolution laser scanner). Moreover, the stress state around each corrosion pit was simulated using a finite element method. It was found that the stress concentration around corrosion pits increases with the corrosion level, depending on the pit dimensions with respect to the length of the corroded reinforcement.

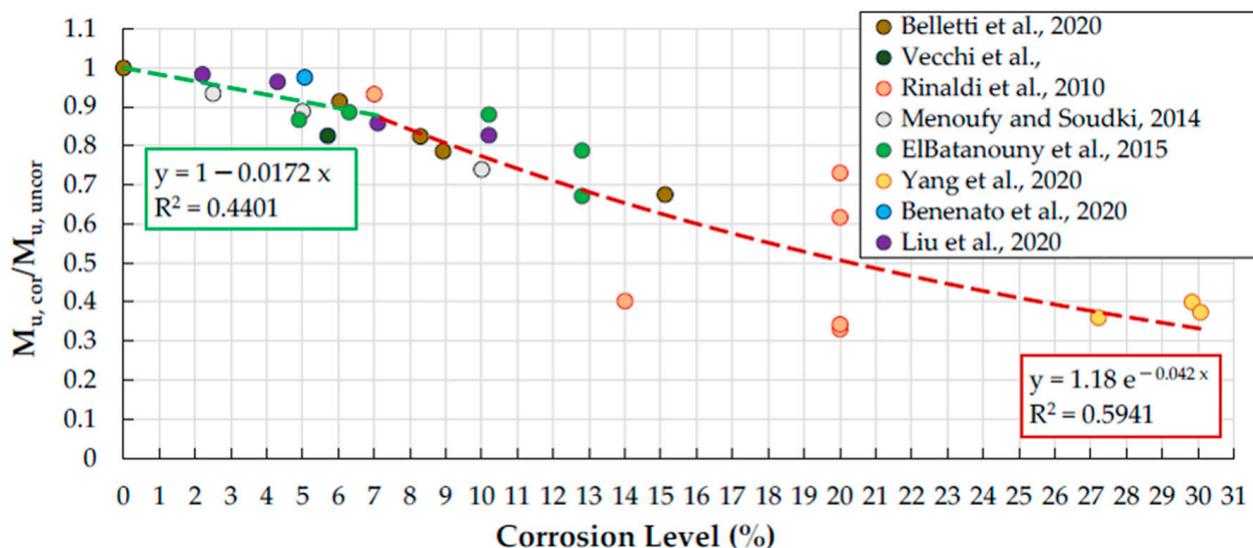
**Figure 11.** Impact of corrosion on residual moment capacity of PRC beams in flexure.

The in-depth analysis of the experimental outcomes, together with the state-of-the-art review, clearly shows that the evaluation of the structural performance of corroded PRC members is not a simple task, and the response depends on many parameters. A useful tool for an initial estimation of the corrosion impact on the residual capacity of PRC beams in flexure can be then given by a decay law able to synthesize the experimental literature results. In Figure 11, the ratio of the ultimate bending moment of corroded members ( $M_{u,corr}$ ) and uncorroded ones ( $M_{u,0}$ ) is plotted versus the corresponding percentage of mass loss of corroded strands. A clear trend in the flexural strength decay can be observed in Figure 11. The decrease in the corrosion degree up to 7% of mass loss is well represented by a linear degradation law with a slight slope. A significant deterioration of the flexural capacity in the case of higher corrosion levels can be observed, and this is well represented by an exponential branch.

Regarding the presence of the transition phase, the residual ultimate moment ratio decreases according to a two-branch relationship, written as follows:

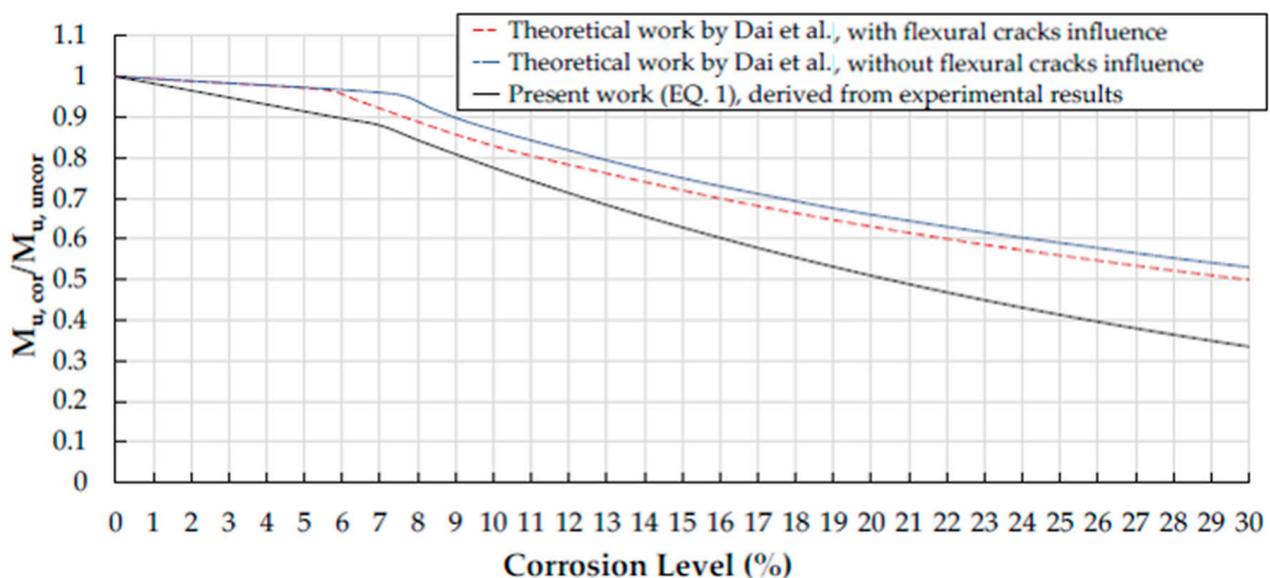
**Figure 12.** Comparison between the degradation laws derived from experimental results (Equation (1)) and the theoretical values proposed by Dai et al. [28].

As shown in Figure 12, the calibrated degradation law displays a similar trend to the ones obtained by the theoretical model presented by Dai et al. [28] for a specific beam, in which behavior is simulated considering a decay in both the strand-to-concrete interaction and the strand mechanical properties. However, the degradation law derived from the experimental results (Equation (1)) shows a higher reduction compared to that

derived by the simulation of a specific beam, probably due to the fact that the experimental data come from different beams and various parameters can affect the degradation law.
