Review

An Introduction to Wear Degradation Mechanisms of Surface-Protected Metallic Components

Pandora P. Psyllaki

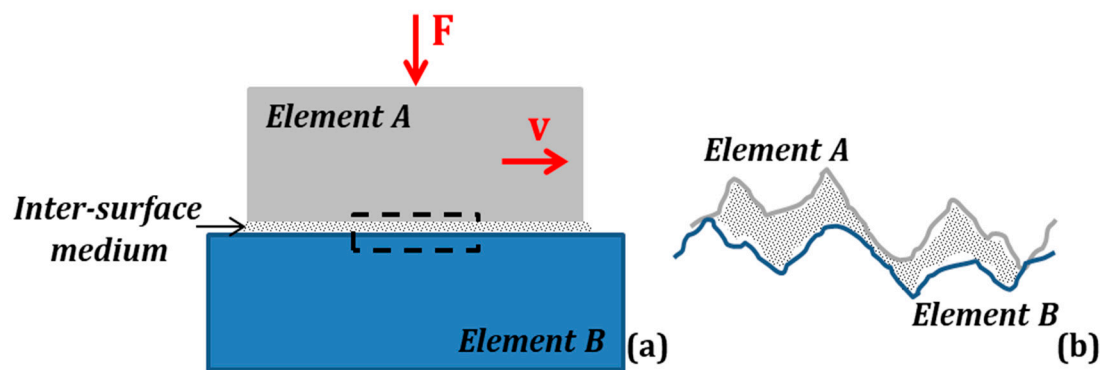
Figure 1. (a) Schematic representation of a tribosystem and (b) magnification of the inter-surface area marked in (a).

The term “tribosystem” or “tribopair” is commonly used to describe the conjugated function of two components that are moving relevant to each other [1]. Although in general, one element of the tribosystem could be in the fluid state, e.g., natural gas moving in a pipeline, in the majority of mechanical systems both elements are in the solid state and their coupled operation serves to transfer motion, power, or mechanical loading; thus, a typical tribosystem is schematically presented in Figure 1a.

A tribosystem is defined by (a) the geometry of the participating elements, (b) their relevant geometry that defines the contact as either conformal or contra-formal, (c) the microgeometry of the surfaces in contact (roughness, Figure 1b), and (d) the construction materials of the two elements and the degree of their hardening. Each such tribopair can perform under various operational parameters that combine the normal load applied (F), the relevant speed (v), and the intervention of a third medium (solid or fluid) at the area between the two in-contact surfaces [1]. Finally, the operation of the tribosystem is carried out in a particular surrounding environment that is characterized by the level of relevant humidity (% RH) and temperature, or even by the application of vacuum. Depending on the type of the relevant motion, the tribosystems in mechanical engineering can be generally divided into rolling or sliding bearings.

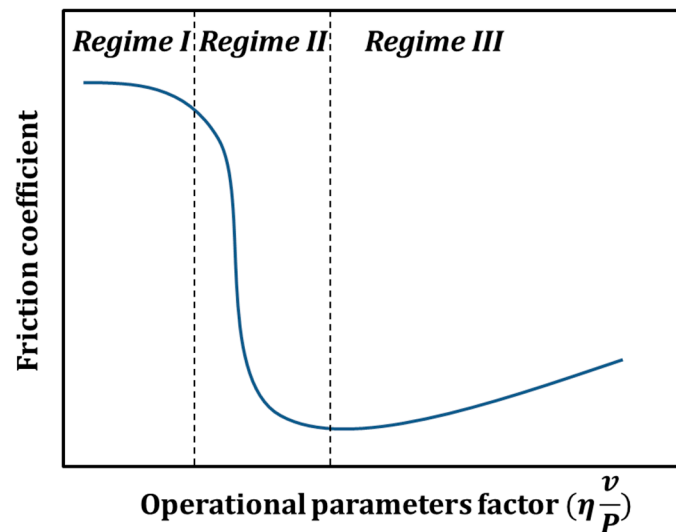
Figure 2. Typical Stribeck curve for liquid lubrication and associated regimes.

As can be observed in Figure 2, depending on the operational parameters, each particular lubricated tribosystem exhibits a wide range of friction coefficient values that correspond to three different lubrication regimes [2]:

- Within regime I, also known as boundary lubrication, the friction coefficient value tends to be similar to that under non-lubricating conditions. The thickness of the lubrication film is very thin, the load is taken on exclusively by the two solids and is transferred from the one to the other through the contact between their surface asperities; thus, the rheological characteristics of the lubricant do not intervene and the lubrication efficacy depends only on the physicochemical characteristics of the liquid. These exactly "quasi-dry" lubrication conditions result in severe wear of the two solids.

- Within regime II, also known as mixed or partial elasto-hydrodynamic lubrication, the friction coefficient drops down to very low values. The thickness of the lubrication film is moderate, and the load is borne by both the solid and the liquid film, depending on the thickness of the latter. The consecutive wear is moderate compared to that in regime I.

- Within regime III, also known as hydrodynamic lubrication, the friction coefficient values are slightly higher, the thickness of the lubrication film is significant enough to result in complete separation of the two solids and the load is transferred from the one to the other through the lubricant that should take on the entire load; thus, lubrication efficacy is dependent only on the rheological characteristics of the liquid. In this case, the wear of the two non-in-contact solids is negligible.

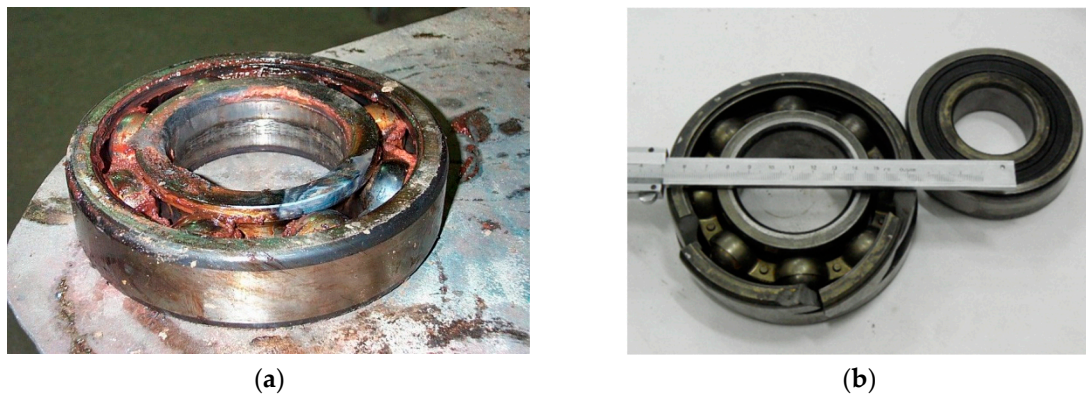
Figure 3. Rolling bearing as-received (a) and after the removal of organic residuals (b).

After the removal of all the organic residuals from the metallic surface, visual inspection revealed the catastrophic failure of the outer ring of the sub-assembly (Figure 3). In particular, 30% of its periphery was separated into three fragments that presented irregular fracture surfaces (Figure 4) and signs of oxidation on them (Figure 5).

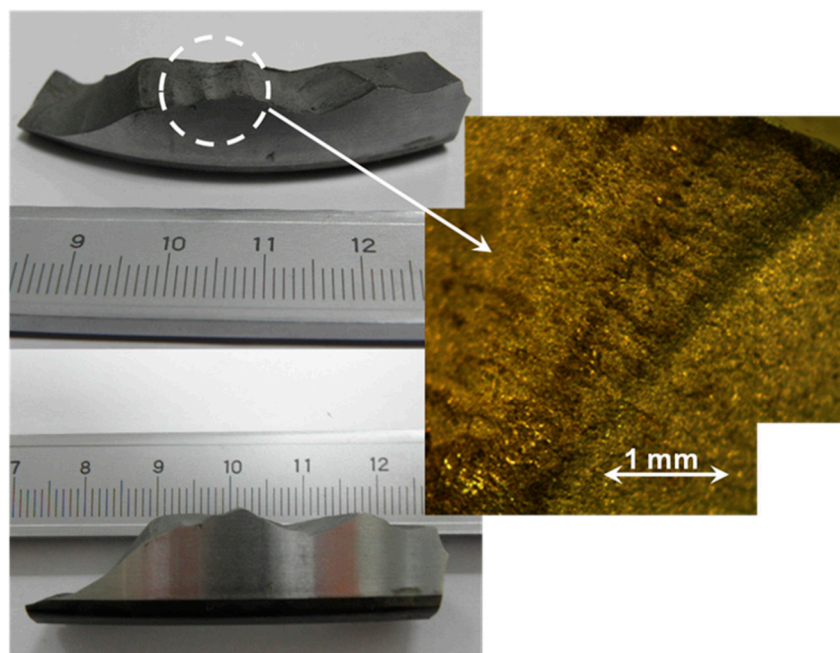
Figure 4. Stereoscopic images of a fragment of the failed outer ring, exhibiting geometric irregularities.

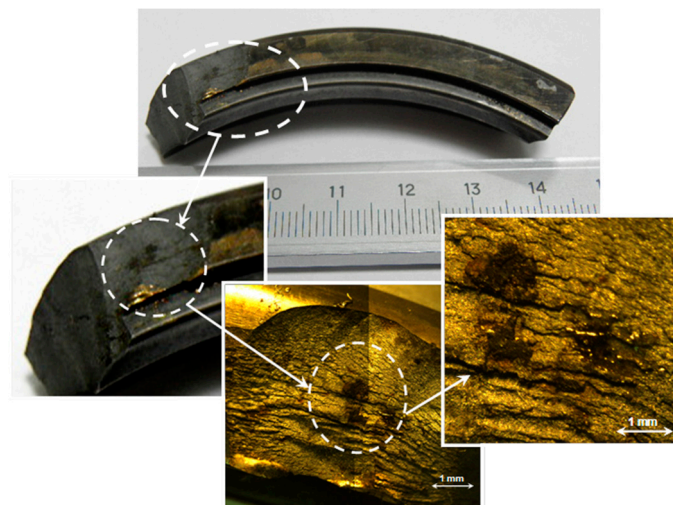
Figure 5. Stereoscopic images of a fragment of the failed outer ring, exhibiting signs of oxidation on the fracture surface.

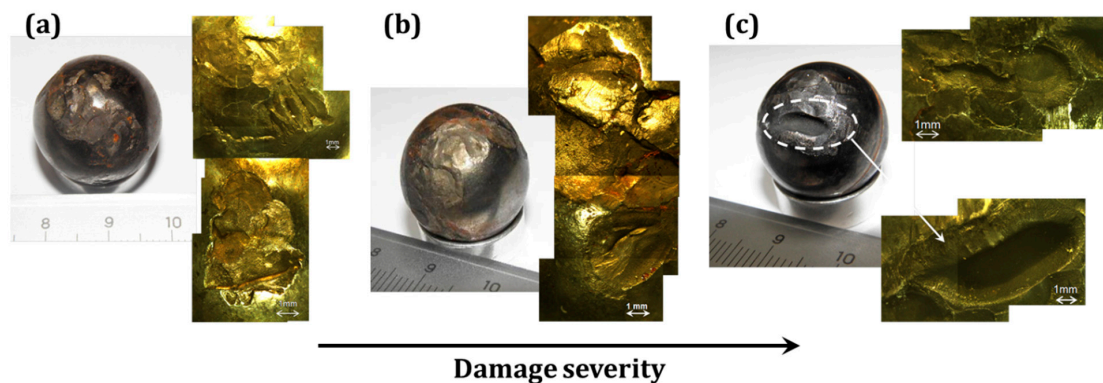
Figure 6. Representative failed rolling balls exhibiting different levels of damage severity.

Disassembling of the rolling bearing revealed that failure was not limited to the ring, but it has also affected the rolling elements (balls) that exhibited material removal in the form of craters of smaller or higher dimensions (Figure 6).

The morphology of both the fracture surfaces of the outer ring and the rolling balls advocates for insufficient lubrication during operation that resulted in impact loading that led eventually to the detrimental catastrophic failure of the sub-assembly and the operation interruption of the whole cleaning unit.

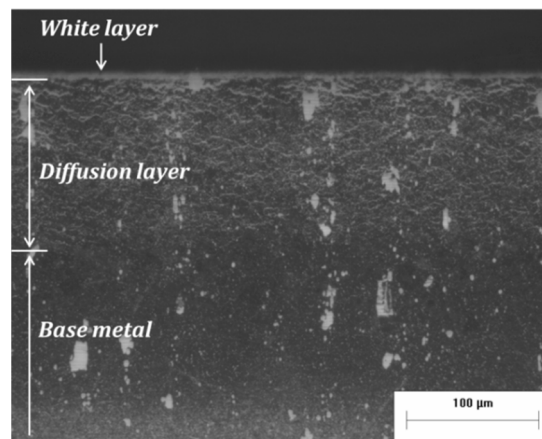
Figure 7. Representative cross-section of a tool steel subjected to Tufftriding (optical micrograph).

- (a) The outermost one is the product of the chemical reaction between the diffusing atoms and the iron of the base steel and consists mainly of ϵ -carbonitride $\text{Fe}_{2-3}(\text{C},\text{N})$. This layer, known as white or compound layer, is the feature that provides high wear resistance to the underlying material. Although its thickness does not exceed 10 μm , the compound layer contributes to the decrease of specific wear even by an order of magnitude [17].

- (b) The layer underneath is formed via the in-depth nitrogen diffusion that leads, primarily, to α -(Fe,N) solid solution with a nitrogen content decreasing with increasing depth. In previous works [18], it was found that the thickness of this diffusion layer is strongly affected by the exact chemical composition of the steel grade, its level of prior thermal hardening, or cold working percentage. Although this layer does not affect the wear resistance, it results in a field of compressive stresses that have a positive effect on the fatigue performance of the treated components.

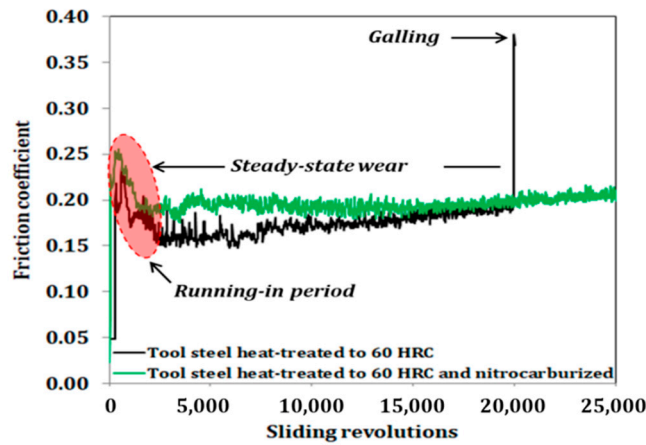
Figure 8. Evolution of the friction coefficient of a tool steel grade with and without nitrocarburizing surface treatment.

In a previous work [19] concerning the comparative study of the same steel grades with and without surface nitrocarburizing surface treatment, it was demonstrated that Tufftriding prevents galling failure (Figure 8), i.e., motion suspension of a metal–metal tribopair due to strong adhesion phenomena having occurred at the contact surface during dry sliding, typically observed in the case of sliding bearings. Moreover, nitrocarburizing protects the metallic surface from extensive oxidation (Figure 9a) that can lead to secondary tribo-corrosion mechanisms that would increase the wear rate of the metallic component.

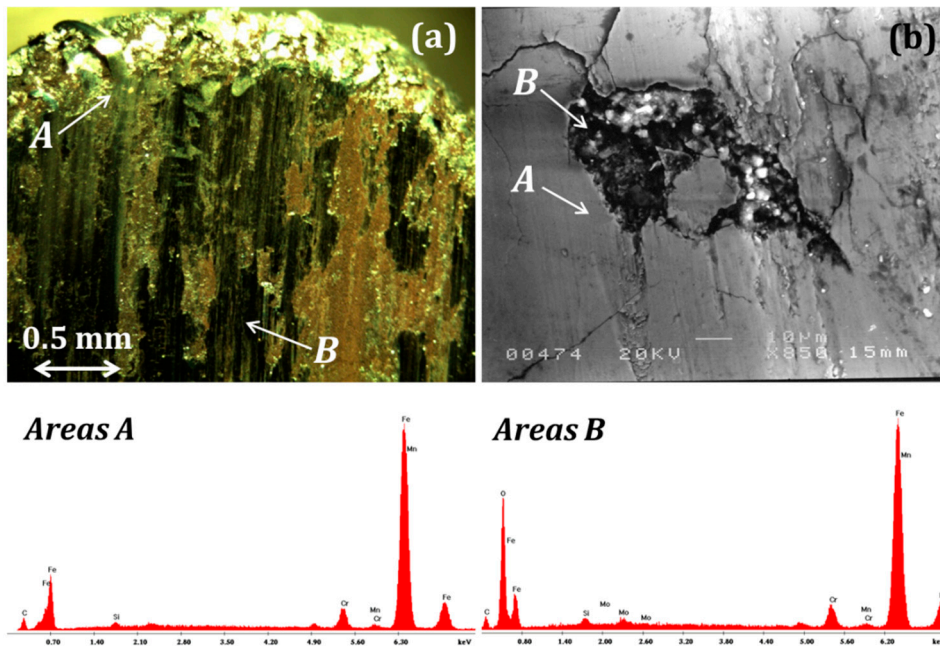
Figure 9. Scanning electron microscopy (SEM) micrographs and EDS point analysis on characteristic areas of the worn surfaces before surface treatment (a) and after liquid nitrocarburizing (b).

However, overloading can lead to cracking and exfoliation of the protective white layer (Figure 9b) creating cavities on the worn surface. In dry sliding under ambient atmosphere, these cavities act as loci of moisture accumulation that promote oxidation of the underlying diffusion zone, leading at the same time to extensive internal oxidation [16]. Even if nitrocarburizing has a positive effect on the dry sliding performance, a designer should take the operational limits (maximum applied load and sliding speed) per steel grade and hardening level into account. In cases of nitrocarburizing of a steel of low hardness, the “quasi-protective” layer would fail under milder operational parameters, accelerating the degradation of the underlying base metal. Since it is rather costly and time-consuming to test experimentally a material before proposing it as the suitable one for a specific application, the development of a well-structured artificial neural network (ANN) can provide wear maps that predict the areas of safe application [20] or areas of wear mechanism alteration [21].

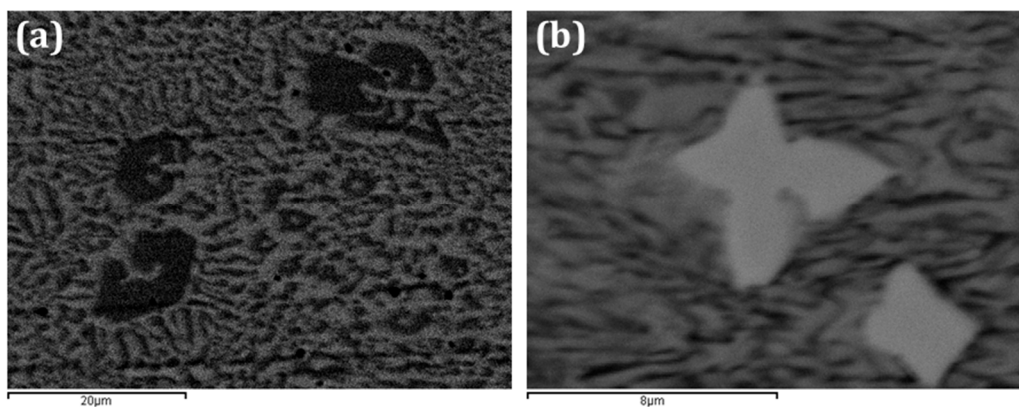
Figure 10. SEM micrographs of primary (a) chromium and (b) niobium carbides formed on an AISI 4130 steel via arc welding technique.

The common methodology for depositing composite overlays reinforced by carbide particles onto steel base metal is based on the fundamentals of arc welding and is typically applied in filling cavities on metallic surfaces that have been subjected to extreme abrasive wear. In this particular case, the overlayers are referred as “hardfacings”—not simply as “surface coatings”—a term that emphasizes their inherent properties (high hardness, low wear coefficient), beneficial for applications where wear resistance is the prime requirement. In conventional arc welding techniques, the material to be deposited is provided as a consumable bulk rod that contains iron, carbon, and strongly carbide-forming elements. During hardfacing, the feedstock material at its molten state is deposited on the surface of the ferrous base metal, part of which is also subjected to melting. The relevant weight percentage of the material provided and the base metal, when both exist in the liquid state of total miscibility, is called dilution, and its exact value is depended on the particular welding technique used and the operational parameters applied. During cooling, this melt is re-solidified leading to the desirable hard overlayer, the microstructure of which is governed by the chemical composition of the melt [22] and the cooling rate imposed. This processing results in the dispersion of carbides—primarily of the strongly carbide-forming elements contained in the feedstock rod—within a Fe-based matrix, having a modified chemical composition compared to the initial one of the base metal. Typical examples of such a structure are presented in Figure 10.

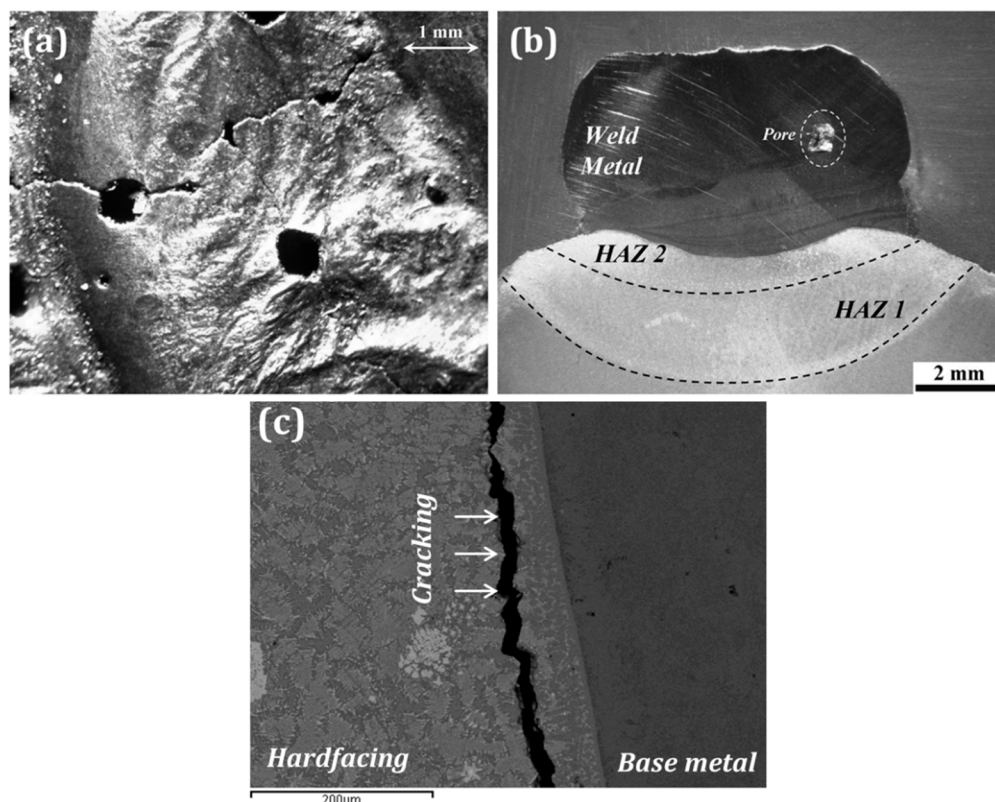
Figure 11. Microstructure flaws in hardfacing overlayers deposited manually via arc welding technique: (a) stereoscopic image of top view, revealing the development of surface pores and cracks; (b) optical image of a cross-section, revealing the existence of a sub-surface isolated macro-pore; and (c) SEM image of a cross-section at the vicinity of the base metal, indicating the development within the overlayer of a crack parallel to the interface.

however, the elaborated overlayers often exhibit microstructure flaws due to the rather empirical and random way of application. These flaws, commonly pores and cracks (Figure 11), are typical of all processes based on the gradual solidification of melts in contact with non-molten solids, deteriorating the elements' performance and reducing their service life. Especially in the case of manual deposition, the non-precise control of the treatment parameters increases the possibility of such flaws. Moreover, the occasionally prolonged exposure of the workpieces to high thermal loads results in extended heat-affected zones and could cause distortion of the entire structure and/or detrimental transformations of the base metal microstructure.

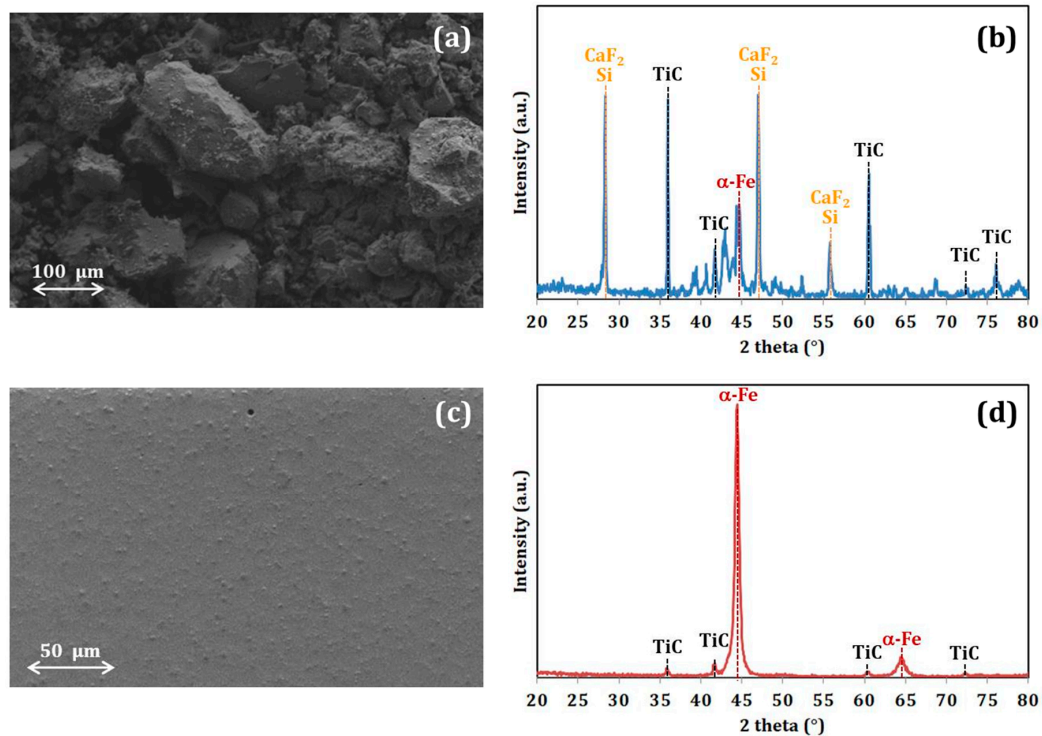
Figure 12. (a) SEM micrograph and (b) X-ray diffraction (XRD) spectrum, respectively, of the core powder of the wire used for flux core arc welding (FCAW) deposits. (c) SEM micrograph and (d) XRD spectrum, respectively, of the obtained hardfacing layers.

compared in Figure 12. The particles' agglomerates (Figure 12a) consist of TiC, which is the compound of interest in the present study, and CaF_2 and Si, which are the fluxing agents, whilst traces of ferrite were also detected originating from the wire's shell (Figure 12b). The deposit obtained (Figure 12c) is characterized by the uniform dispersion of fine TiC particulates in the metallic matrix, with rare presence of small size pores, and consists of only ferrite and TiC (Figure 12d).

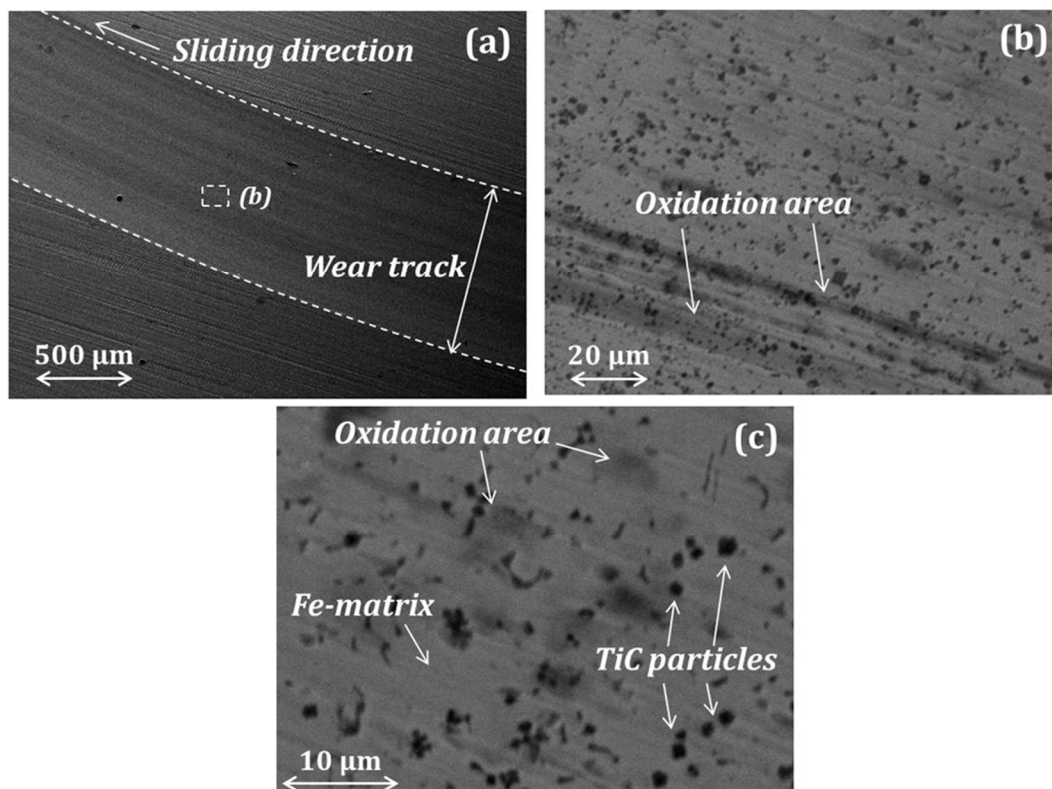
Figure 14. Top view SEM micrographs of the worn surface of the FCAW hardfacing layers, after ball-on-disk testing for 200,000 sliding revolutions, applying a normal load of 10 N: (a) entire width of the wear track, (b) and (c) successive magnifications within the wear track, demonstrating extensive oxidation and abrasion scars along the sliding direction.

SEM observations of the worn surface revealed a wear track of $\sim 840 \mu\text{m}$ width (Figure 14a), within which polishing lines and oxidation areas of the metallic matrix (Figure 14b) can be clearly observed, together with the emerged fine carbides dispersion (Figure 14c). Compared to the deposits obtained via the novel CSE technique previously mentioned [27], the friction coefficient values, as well as the wear coefficient and the associated micro-mechanisms, exhibit significant differences originating from the size of the reinforcing TiC particles and their dispersion in the matrix:

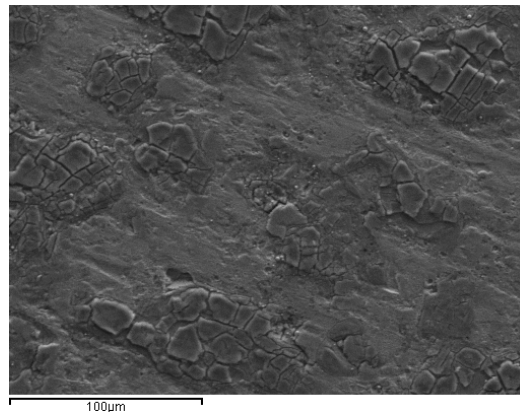
Figure 15. Top view SEM micrographs of the worn surface of the “solar” hardfacing layers, after ball-on-disk testing for 200,000 sliding revolutions, applying a normal load of 10 N.

- (a) The conventional FCAW deposits, enhanced by TiC particles of finer size, exhibit a rather metallic nature, with high friction coefficient values, tending towards those of a typical tool steel [17] and the relevant wear micro-mechanisms, involving polishing and oxidation of the metallic matrix.
- (b) The solar surface layers, enhanced by TiC particles of larger size, exhibit the typical nature of a ceramic-particle-reinforced metal (CPRM) composite, with the ceramic phase playing the predominant role in the low friction coefficient values. The wear micro-mechanism is a clear superposition of the plastic deformation of the metallic matrix and the micro-fragmentation of the carbides, leading finally to exfoliation (Figure 15).

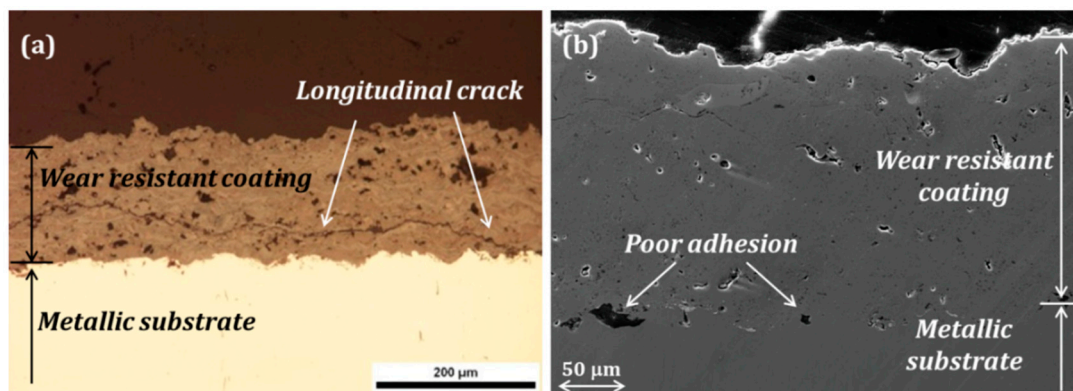
Figure 16. Microstructure flaws developed during plasma spray deposition of (a) a titania coating (optical micrograph), where a longitudinal crack propagated parallel to the coating/substrate interface and (b) a WC-Co coating (SEM micrograph) of poor adhesion to the metallic substrate, due to the presence of residues of the pre-deposition sandblasting preparation of the metallic surface.

Due to the peculiarities of the deposition technique, ceramic plasma-sprayed coatings, having a thickness of 200–400 μm , exhibit stratified structure with interfacial roughness, which promotes the formation of porosity (Figure 16a) and mechanical anchorage to the metallic surface. In order to enhance the latter prior to thermal spraying, it is necessary to prepare the metallic solid via sandblasting. This pre-processing could result in sand residues (Figure 16b) on the surface leading to poor adhesion to the metallic substrate. In particular in the case of carbide coatings, their deposition under non-recommended parameters of spraying technique causes their in-flight decomposition/decarburation [34–39].

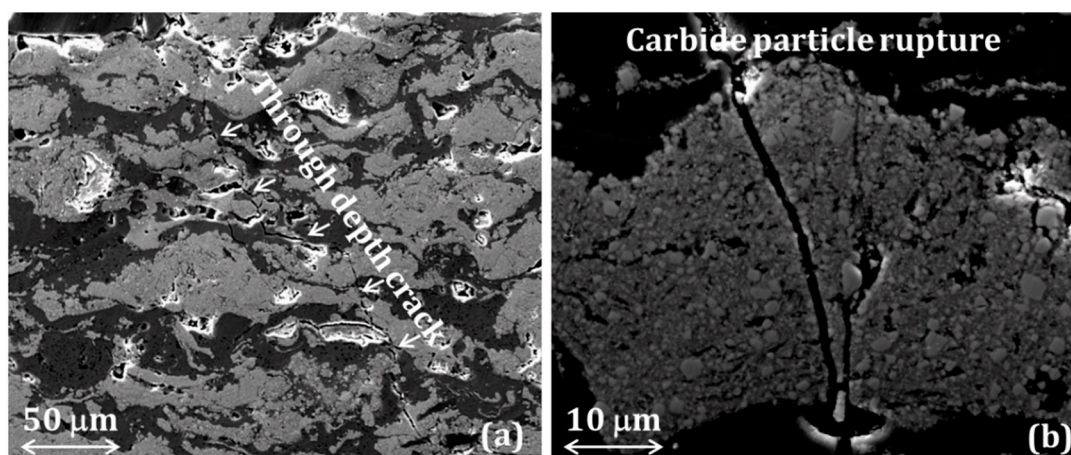
Figure 17. Degradation of a composite plasma-sprayed coating: (a) after tribological service a through-depth crack was developed below the contact area and (b) propagated through the carbide reinforcing particles resulting in their multi-rupture.

Despite all the above microstructure flaws possibly present in a thermal-sprayed coating, their tribological performance could be acceptable when operating under mild conditions [40]. Under more severe service conditions, these structure flaws accelerate their degradation (Figure 17a) via vertical cracking (Figure 17b), providing the route to the moisture or corrosive gases, to penetrate until the metallic surface that would be hence oxidized.
