Article

# Response of an Existing Two-Storey RC Frame Designed for Gravity Loads: In Situ Pushover Tests and Numerical Analyses

Simone Peloso, Chiara Casarotti \*

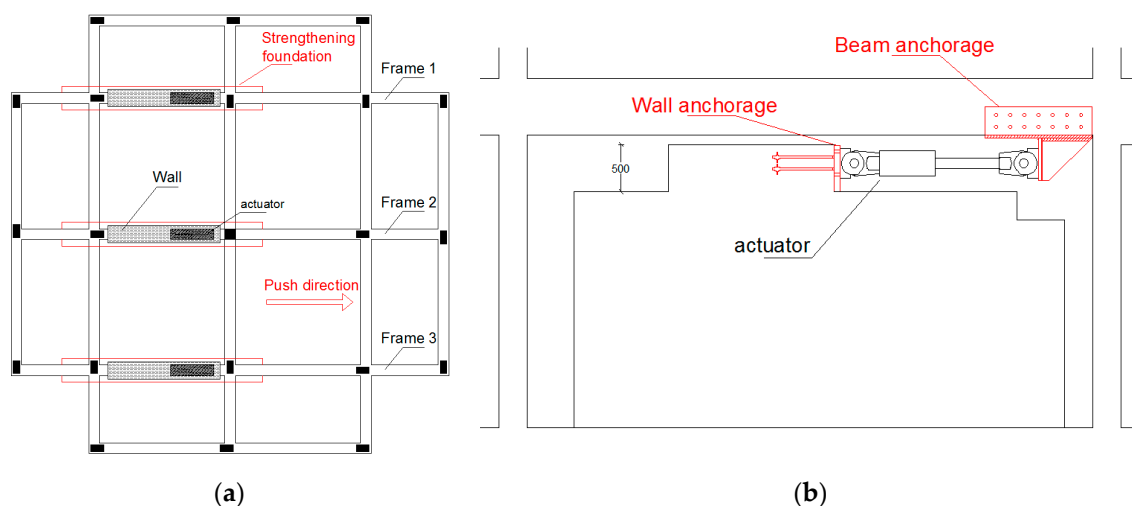
**Figure 1.** Test setup: Top view (a) and front view (b).

The pseudo-static test, described in this article, consisted of the application of push–pull cycles to a real frame building to study the response of a structure designed in the '80s for gravity loads only. The design was done according to out-of-date regulations that did not properly consider the seismic demand either at the input level or in the building detailing. Three walls were built inside the structure and connected with the existing foundation (Figure 1a) in order to counteract the forces applied to the beams of the first floor (Figure 1b). To predict the response and design the test setup, a number of numerical models and pushover analysis of the structure have been carried out, in order to account for the uncertainties related to the mechanical characteristics of the materials, to the deformable/rigid floor response, and to the contribution of the infill panels. The numerical analyses were finalized to obtain the capacity of the structure in terms of both force and displacement, the ductility reserve, and the most likely sequence of formation of plastic hinges.

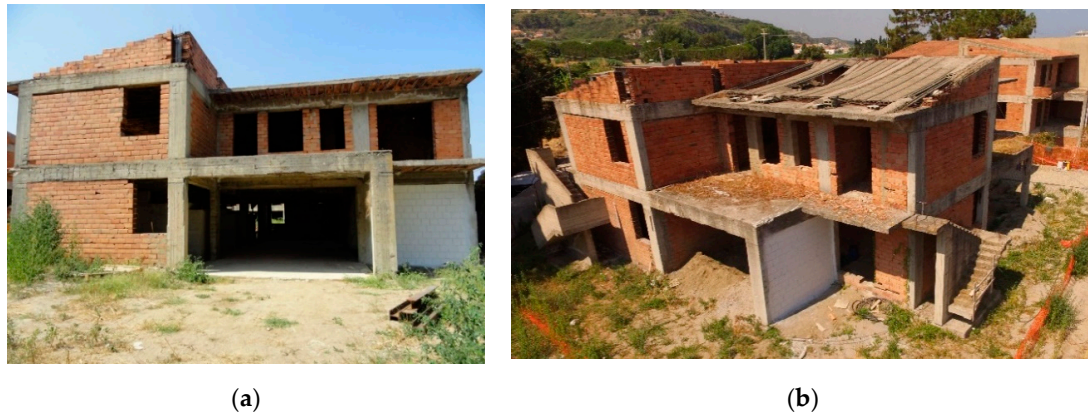
Figure 2. South (a) and north-west (b) building views.

As evident in Figure 2, the building was in a state of total abandonment. The building is a two-story RC structure, about 8 m high, with an inter-story height of 3.70 and 3.20 m at the first and second floors, respectively.

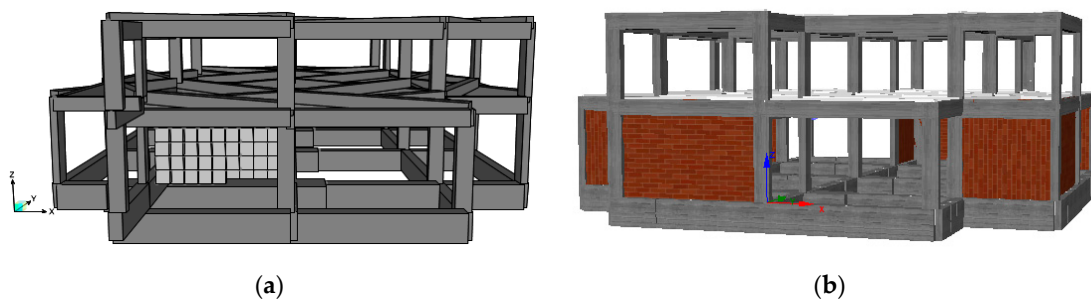
**Figure 4.** Structure modeled with SAP2000 (a) and SeismoStruct (b).

The whole structure-reaction system was modeled by means of two analysis software (Figure 4): SAP2000 v22.1.0 [22] and SeismoStruct v2020 [23]. Double modeling, elastic and non-linear, respectively, considered several hypotheses and different combinations of those variables affecting the structural behavior, in order to study various critical aspects. In this way, it was possible to optimize the design of the test, balancing costs and feasibility issues, accounting for the estimated building capacity and the interaction with the reaction system.

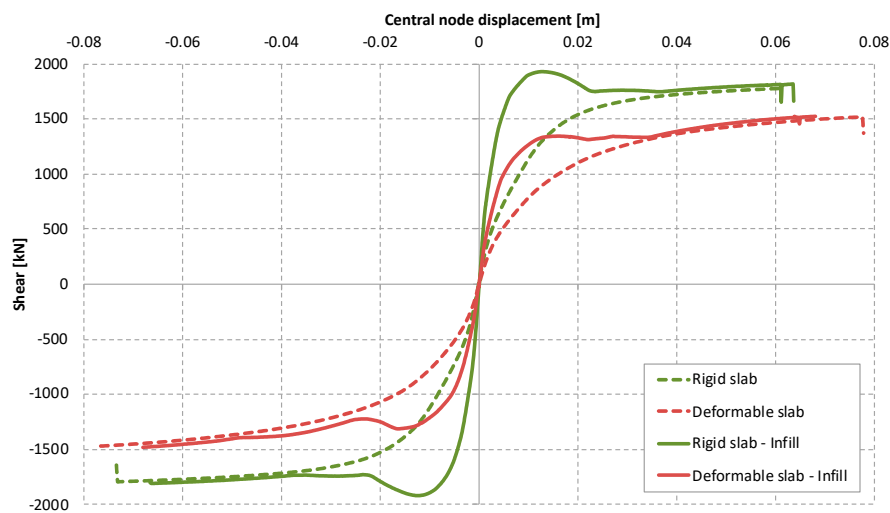
Figure 5. Pushover curves.

Figure 5 shows the pushover curves of the different models in both push and pull directions. Table 2 shows the numerical results obtained from the analyses, in terms of maximum base shear and maximum displacement measured at the central node of the first slab. In all cases, the target displacement of 0.12 m was not reached. The model with deformable slabs and infills reached the maximum displacement of about 0.08 m. As expected, the presence of infills significantly influenced the structural response, stiffening the elastic part of the capacity curve, up to the reaching of the breakout limit value of the infills themselves, beyond which the two curves obviously coincide progressively. In the model with rigid slabs, the presence of infills had a great influence on the maximum reached shear value, occurring at the infills breakdown limit value.

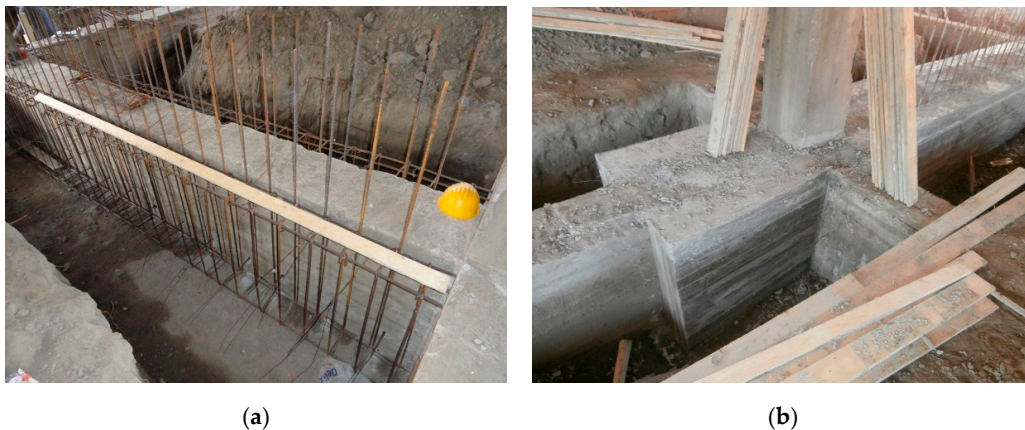
**Figure 6.** Footings retrofit: Steel reinforcement (a) and section enlargement (b).

The retaining walls were built on the existing foundation beams, which have been reinforced to withstand the expected base shear: The original section of 0.50 by 1.10 m (base and height, respectively) was extended to 1.10 by 1.10 m. Such intervention on the foundation beams was extended beyond the columns close to the walls, as shown in Figure 6, in order to reduce the stresses nearby foundation beams. The reinforcement sections were integrated with the existing section by means of connectors passing through holes created in the original foundation. Figure 7 shows the steel reinforcement of the retaining walls and a completely casted wall. It is possible to notice a squat tooth cantilever on top of the wall, where the actuator was connected through a vertical steel plate (Figure 8a). At the other end, the connection to the building was realized by means of steel plates fixed to the intrados of the first slab beam through passing connectors (Figure 8b).

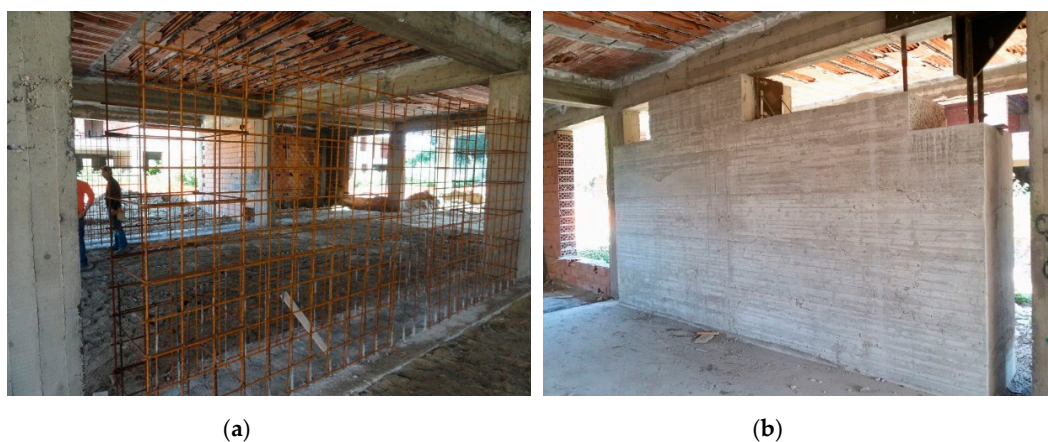
**Figure 7.** Reaction walls: Steel reinforcement (a) and fully casted wall (b).

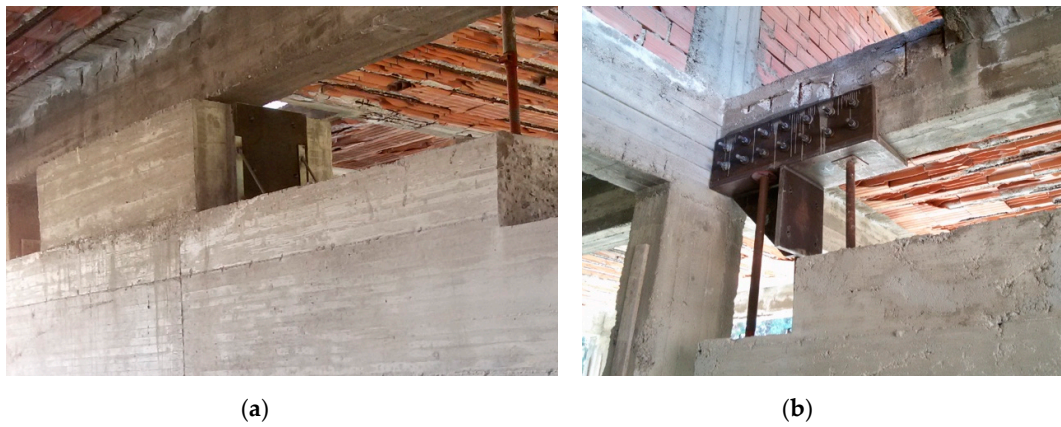
**Figure 8.** Steel element connections for the actuators: On the reaction wall (a) and on the frame first floor beam (b).

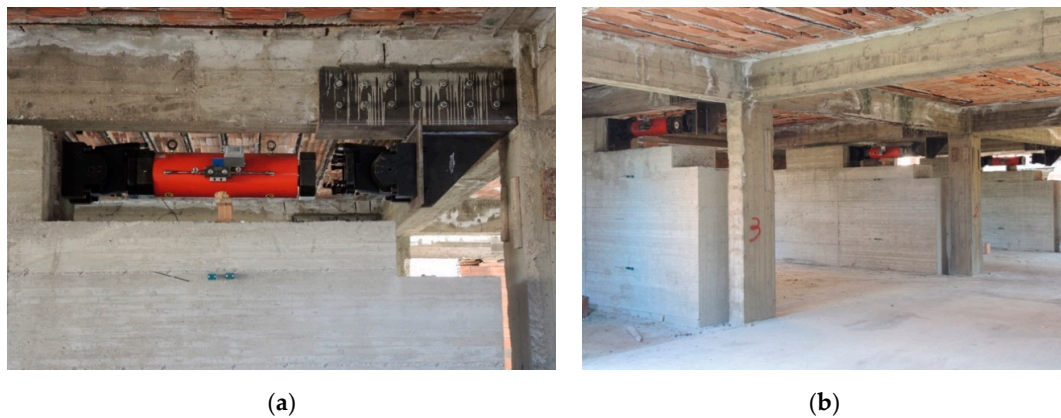
**Figure 9.** Actuation detail (a) and overview of the test setup (b).

The actuation system designed based on the test to be carried out included three double-acting hydraulic actuators, shown in Figure 9.

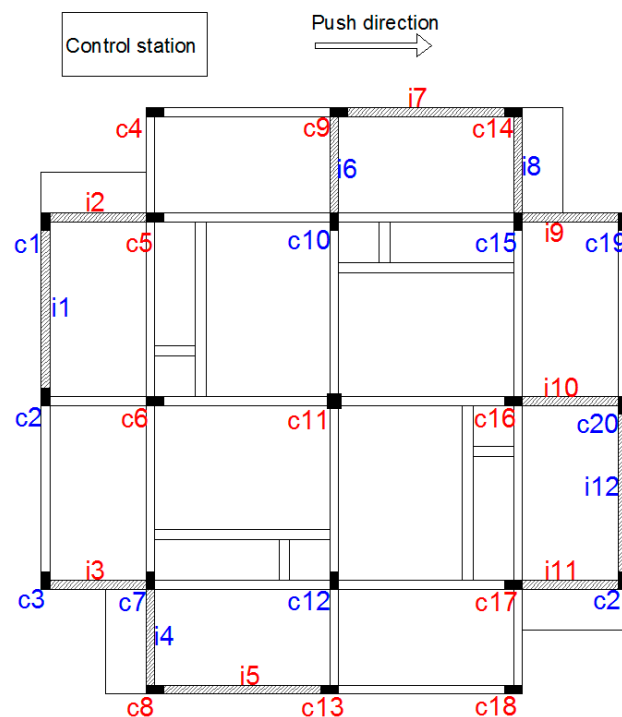
**Figure 11.** Column (“c”) and infill (“i”) labels.

Figure 11 shows the plan view with the numbering of the columns (prefix “c”) and the infills (prefix “i”), useful to locate the elements in what follows. Elements were divided into two categories, i.e., those aligned to the test direction (stronger resistance, red color) and those aligned perpendicularly (blue color). After each run, damages were checked on both structural and non-structural elements, that is, on whitened infills, where the evolution of the cracking pattern is shown as an example in Figure 12.

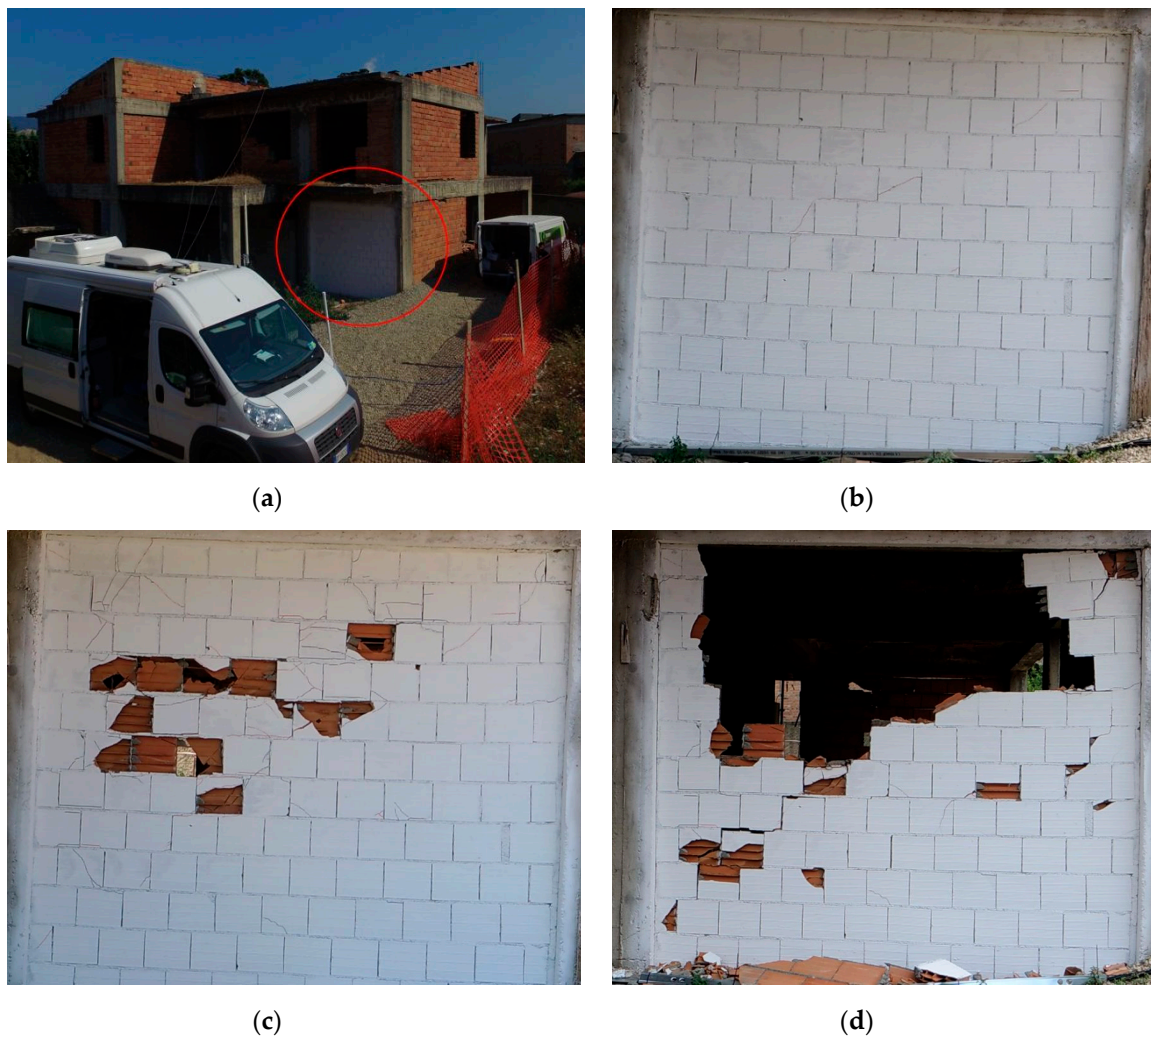
**Figure 12.** Infill panel i2 (a), cracking pattern at: run #2—4.3 mm/0.12% (b), run #5—12.9 mm/0.35% (c), run #8—52.6 mm/1.42% (d).

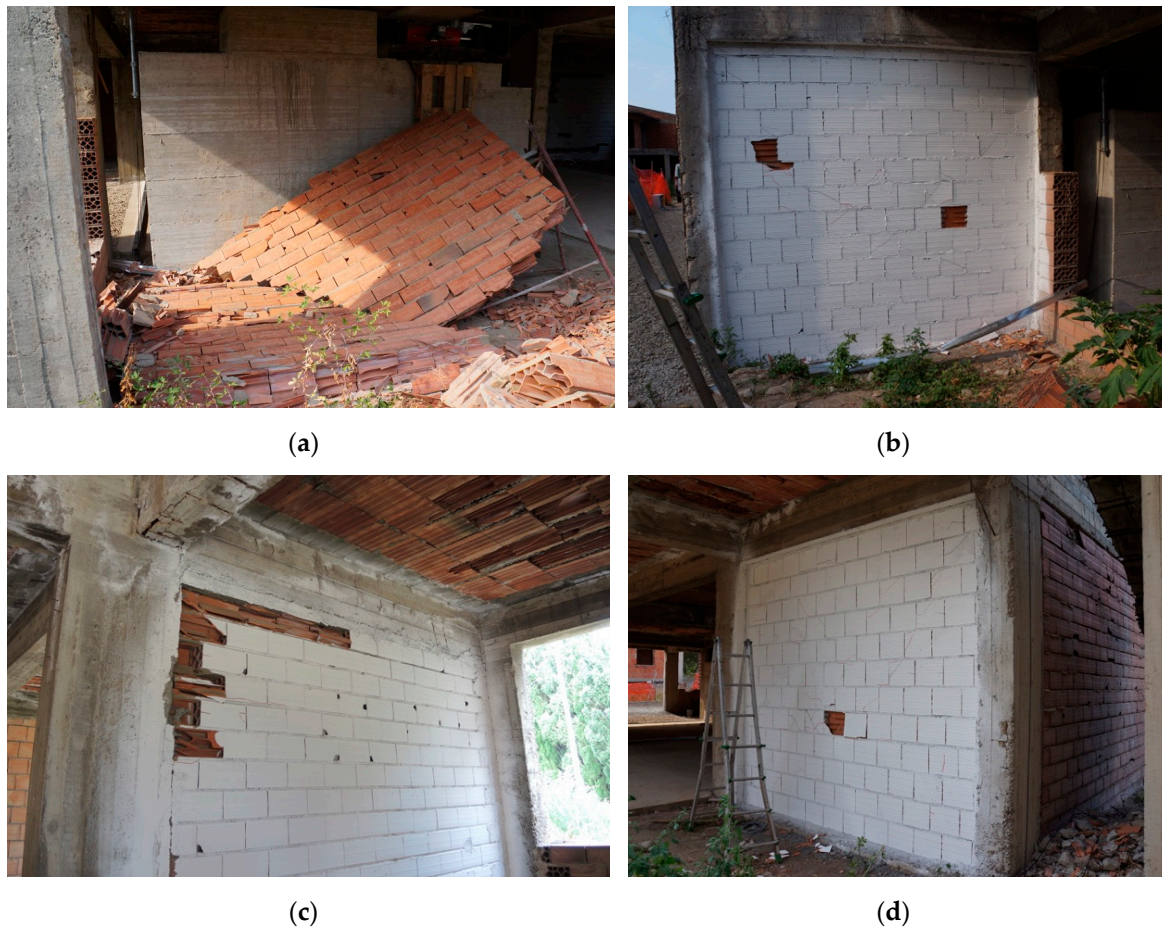
**Figure 13.** Infill damage at run #4, 9.6 mm—0.26%: Infill i5 (a); infill i3 (b); infill i10 (c); infill i11 (d).

At run test #4, the infill i5 overturned unexpectedly, probably due to bad connection with the frame, while the other infills panels reported minor damages (Figure 13), and no damage to structural elements was detected. After run #4, the infills began to be progressively damaged. It should be noticed that the current Italian code [25] sets a limit of 0.2%, 0.5%, and 0.75% for the damage limit state of ordinary bearing masonry, brittle, and ductile infills, respectively, and that recent experimental studies ([26,27]) showed that a reasonable damage limit for poor quality or weak infills (e.g., horizontal holes laying) is in the order of magnitude of 0.3%.

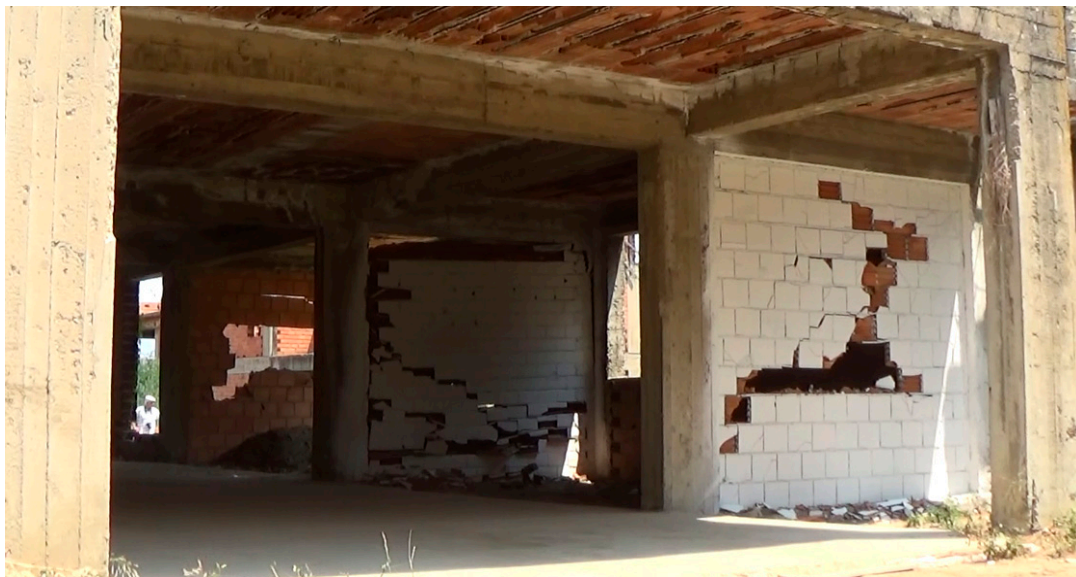
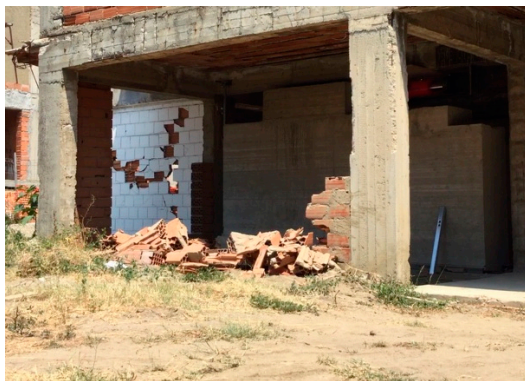
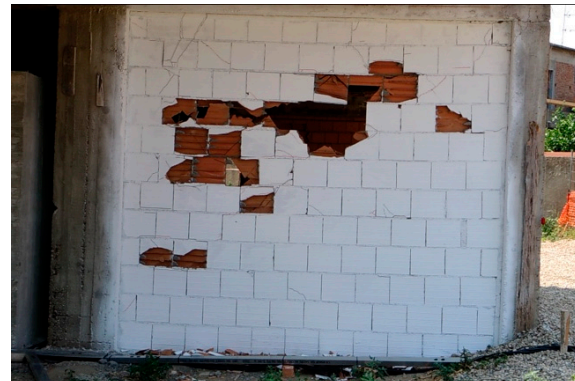
**Figure 14.** Infill damage at run #6, 21.6 mm—0.58%: From left to right, infills i9, i10, i11 (a); infill i3 (b); infill i2 (c).

Figure 14 shows the main damage that occurred at run test #6 (21.6 mm, 0.58%). No critical cracks were observed along beams and columns, but the damage at the infills increased, with some partial collapse. Obviously, as the damage increased, the strength and stiffness contribution offered by the infills decreased progressively. It is expected that at the larger drift levels, the bare frame strength reserves would be activated, i.e., damages would be extended to the structural elements.

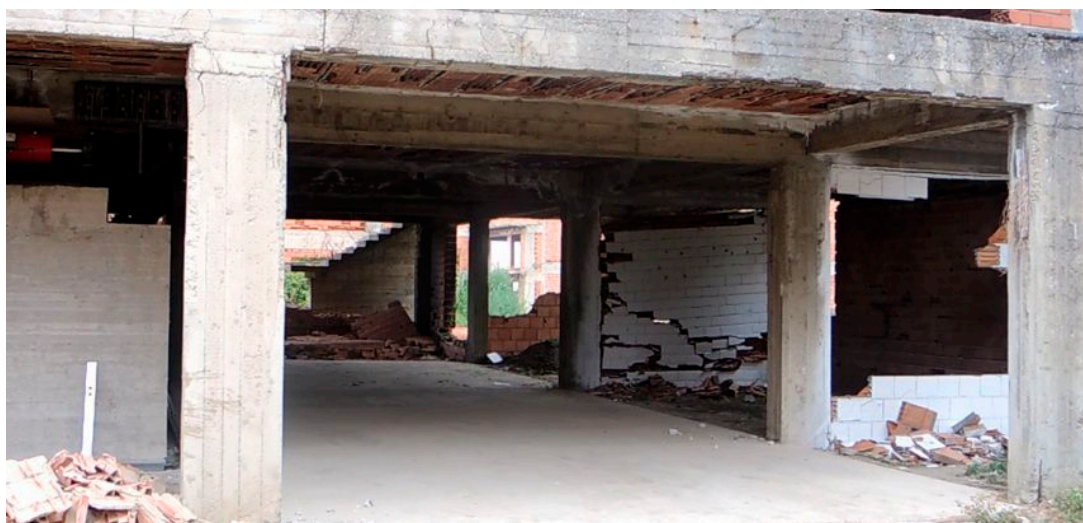
**Figure 15.** Run #9, 62.4 mm—1.69%: Infills parallel to the test direction fully collapsed.

Figures 15–21 show the major damages that occurred at the end of the last test, run #9 (62.4 mm, 1.69%). As expected, beams did not show significant damage, while all the infills along the push direction, heavily damaged by the previous tests, collapsed completely (Figure 15). The most damaged columns were those with the larger size parallel to the push direction, since they attracted larger forces. Most of these elements featured mixed shear and flexural failures at the base and at the top, with concrete spalling and longitudinal rebars buckling (e.g., Figures 16 and 17). The same applies to the central column c11 (Figure 18). A particularly severe shear failure occurred at column c9 (Figure 20, right). Failure modes connected to bending behavior occurred mainly at the base of the columns c4 and c18 (Figure 19): The lower axial load probably shifted the strength hierarchy in favor of the flexural collapse mode. Less damage, in general, was found on the perimeter columns (#3, 4, 18, 19), whose bays were not directly pushed by actuators, and by the columns aligned perpendicularly to the test direction, with an exception done for columns c20 and c3 which showed some shear and flexural cracks, respectively. Some of the not fully confined joints, i.e., those on the perimeter, showed shear failure (Figure 21).

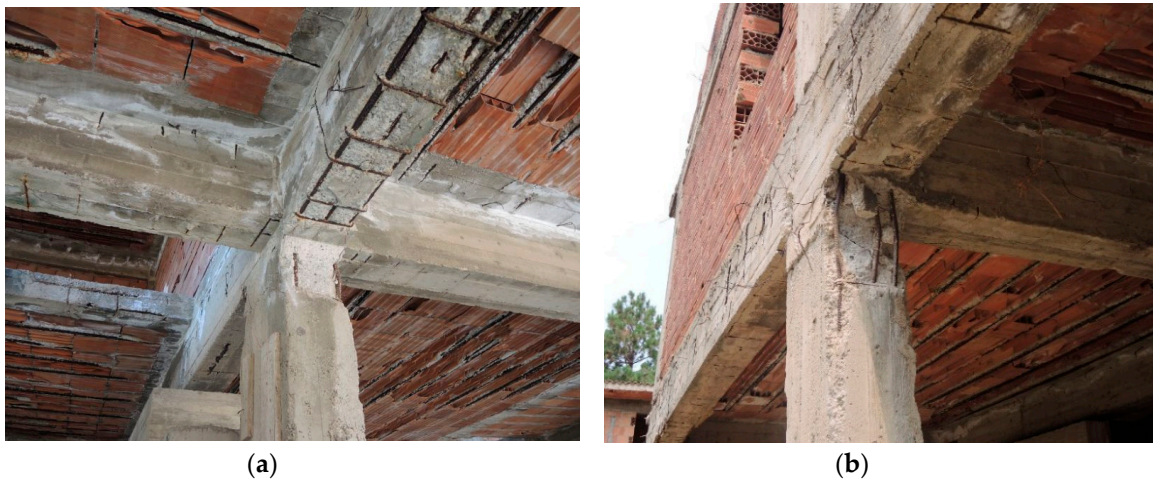
**Figure 16.** Run #9, 62.4 mm—1.69%: Concrete spalling, core crushing, and reinforcement buckling at the top of column c6 (a) and c13 (b).

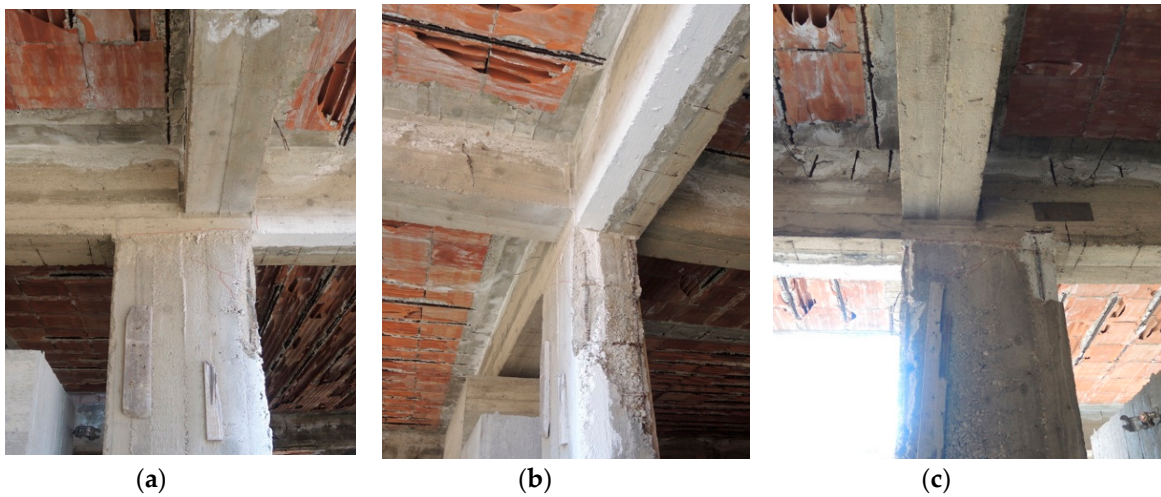
**Figure 17.** Run #9, 62.4 mm—1.69%: Damage at the top of column c5. Front (a), side (b) and back (c) view.

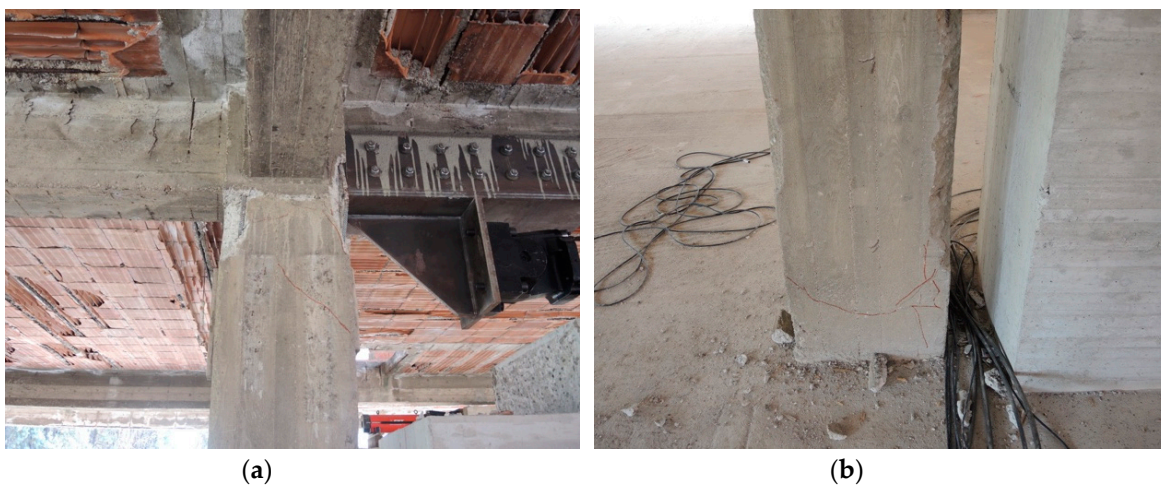
**Figure 18.** Run #9, 62.4 mm—1.69%: Damage at the top (a) and at the base (b) of column c11.

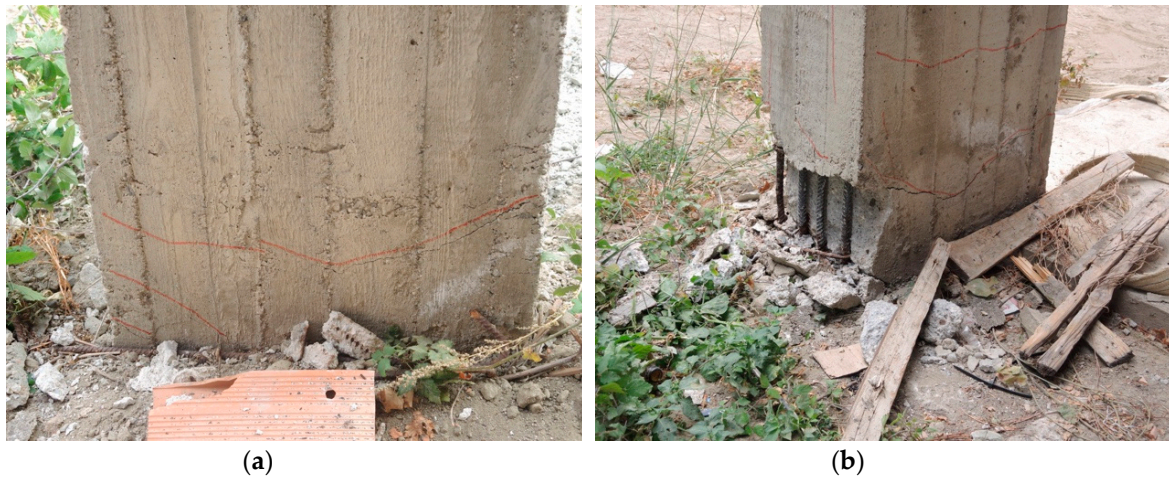
**Figure 19.** Run #9, 62.4 mm—1.69%: Flexural cracking pattern and failures at the base of columns c4 (a) and c18 (b).

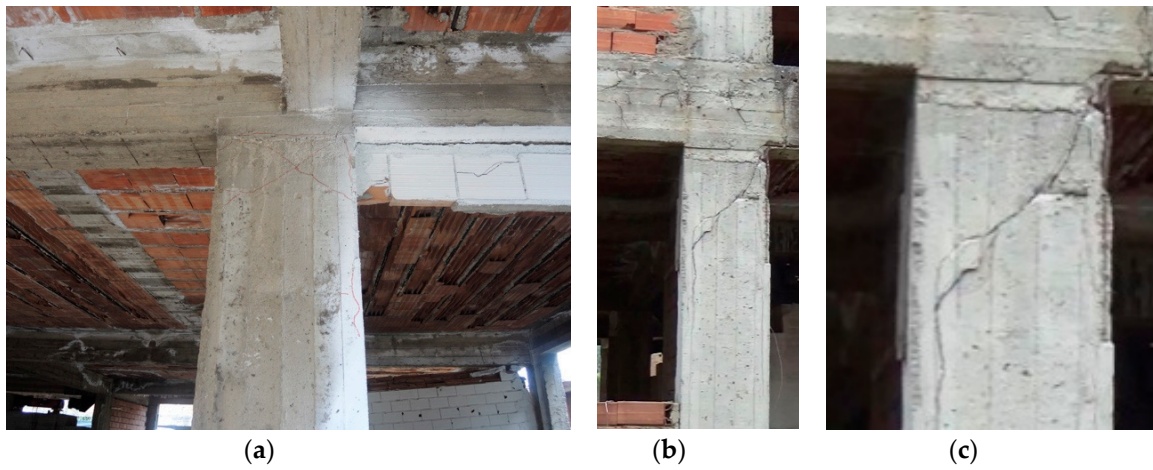
**Figure 20.** Run #9, 62.4 mm—1.69%: Shear failures, columns c17 (a) and c9, overall view (b) and detail (c).

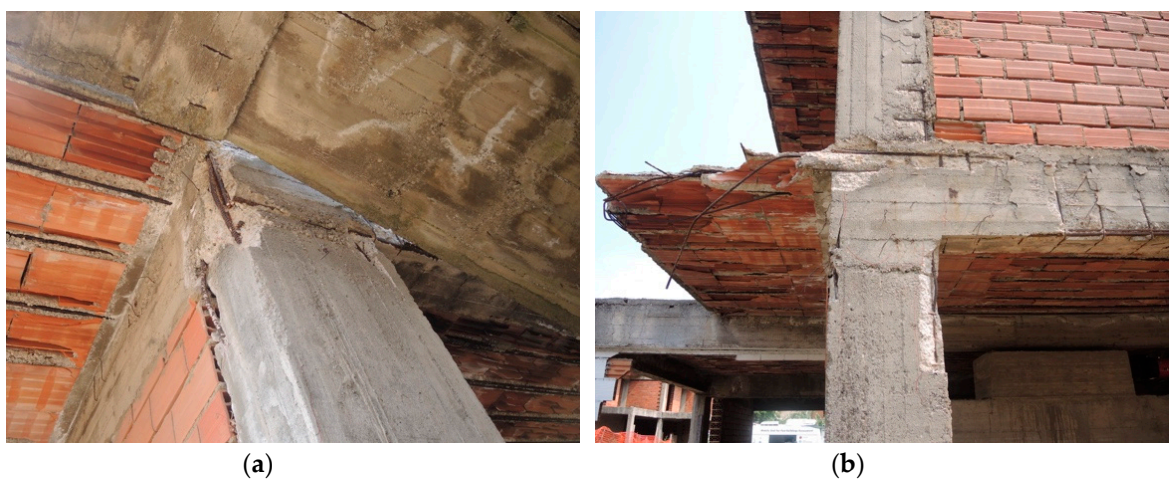
**Figure 21.** Run #9, 62.4 mm—1.69%: Joint damage at the top of column c14 (a) and c8 (b).

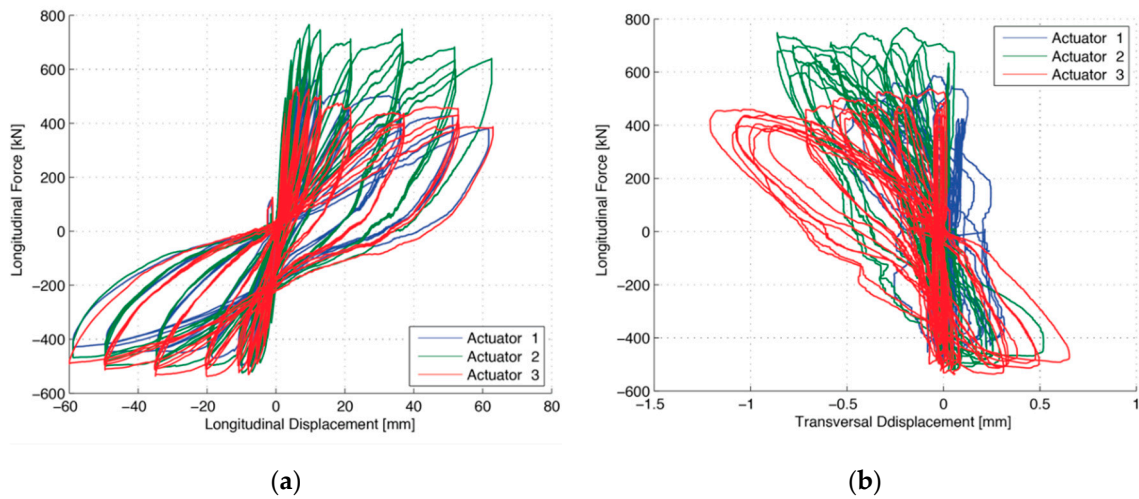
**Figure 22.** Force-displacement loop of individual actuators. Force is in the test direction, displacement is parallel (a) and orthogonal to the test direction (b).

Figure 22 shows the force record of the individual actuators, plotted versus displacement along the test direction (a) and orthogonal to the test direction (b). In Figure 23, the total force-average displacement loops are shown together with the skeleton curve, on which the energy balanced bilinear approximation is plotted. Finally, Figure 24 shows the relation between displacement and equivalent viscous damping: One point for each cycle at every displacement amplitude. These values were evaluated using the well-known Jacobsen's approach on the basis of the hysteretic energy of each cycle. Considering that, due to damages, the equivalent viscous damping was mainly due to the hysteretic contribution, the calculated values appeared to be reasonable.

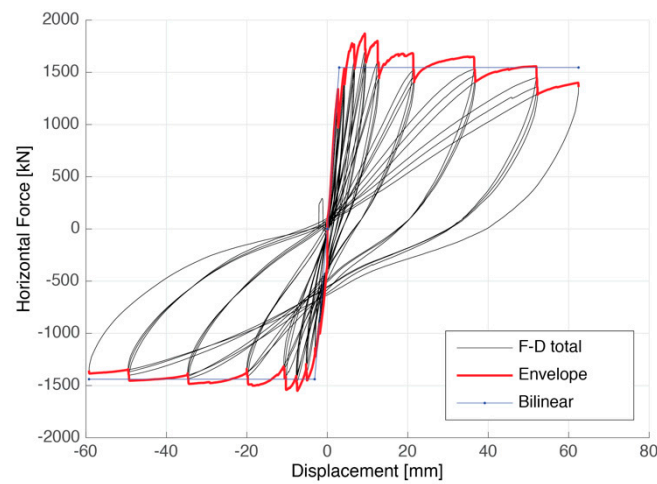
**Figure 23.** Force-displacement loop of the structure, envelope curve, and bilinear approximation.

The analysis of the recorded data substantially confirms what was previously observed on structural damage. The maximum force is achieved at a displacement equal to 9.6 mm. Beyond this threshold, infills began to show significant damages, the maximum force decreased, and the damping increased. When infills were completely damaged, beyond 22 mm displacement, the damping increased considerably because of the increasing hysteretic contribution of the RC frame. Consistently with the progress of the damage, even within the same run, the damping was higher at the first cycle and decreased in the following two cycles of the same amplitude. At the last single-cycle run, the damping did not increase any longer, likely due to the brittle failure of the RC elements, implying the possibility of an incipient global collapse.

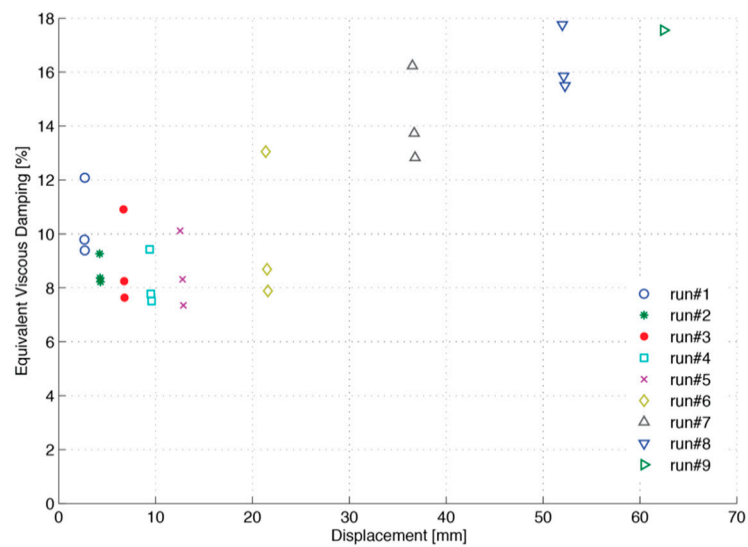
**Figure 24.** Equivalent viscous damping for the three cycles of each run.

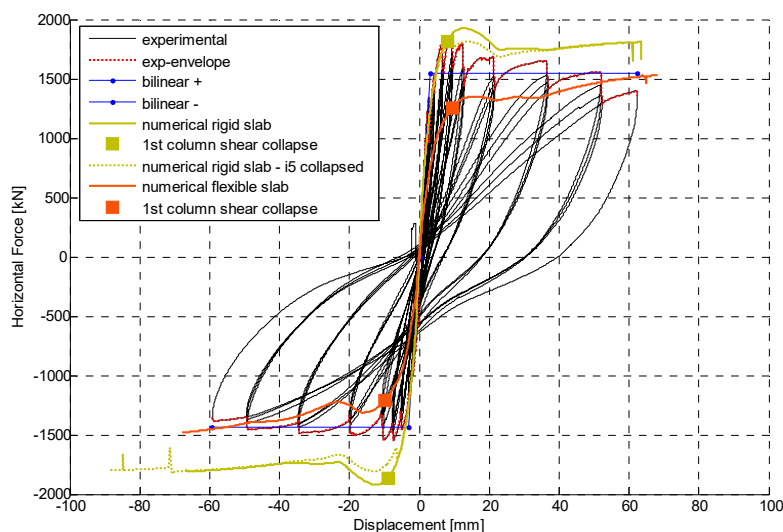
Figure 25. Capacity curves numerical and experimental.

Figure 25 shows the comparison between the experimental skeleton curve the numerical capacity curves modeling infills, with and without the rigid slab assumption. The results of the numerical simulations are in fair agreement with the experimental response. The analytical curve closest to the actual behavior was the one modeling rigid slabs: The maximum base shear value was achieved at the infill break-down limit, and afterwards the base shear decreased until the full exhaustion of the infills' resistance. Henceforth, the resistance was completely entrusted to the structural elements. It was noted that in the experimental curve there was a more pronounced decay in structural capacity, probably due to the shear failures and joints damage, which were not modeled within the software. Markers on the numerical capacity curves indicated when the first column reached its shear resistance, i.e., the displacement level after which modeling was less accurate.

For the sake of completeness, the same figure shows, as a dashed green line, the simulation considering the out of the plane collapse of infill i5 which happened when applying a few millimeters of displacement. Such a failure mode, sudden and very different from the other failed infills, was likely due to the bad connection of the infill itself, and could not be foreseen by modeling; thus, it was introduced after the experimental evidence.
