Article

# A Multilevel Approach for the Cultural Heritage Vulnerability and Strengthening: Application to the Melfi Castle

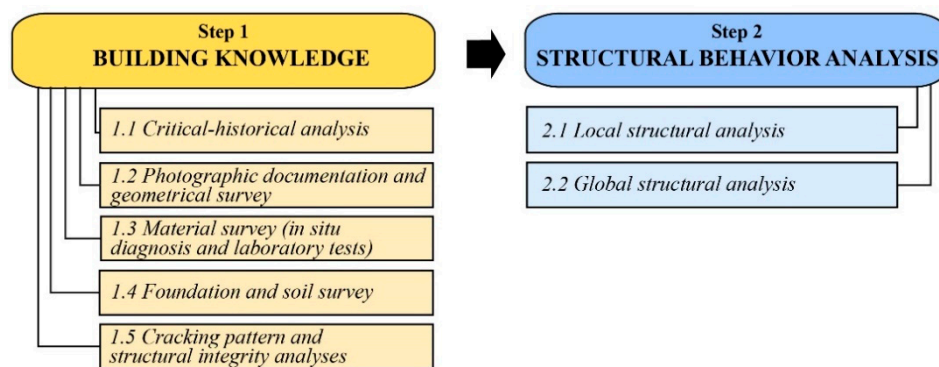
**Figure 1.** General scheme of the procedure necessary for a complete structural behavior analysis of a historical structure.

Figure 1 shows the general scheme of the procedure necessary to perform a complete structural behavior analysis of a historical structure. It shows that, as indicated by [13–17], the structural analysis of these structures should follow a multidisciplinary approach involving a wide variety of activities and the collaboration of different professionals such as architects, civil engineers, restorers, historians, archaeologists and building managers, among others. The structural behavior analysis (Step 2) can be performed only when all the phases required to attain good building knowledge (Step 1) are completed. For historical buildings, the time required to complete the different steps and sub-steps may vary significantly based not only on the skills of the professionals involved in this complex process (architects, engineers, restorers, test labs, etc.), but also on the time needed to find the historical documentation related to the building. Finding this historical documentation can be very time-consuming. In the case of the museum “*Massimo Pallottino*”, some historical documents were provided directly by MiBACT, while others were found at the competent local offices.

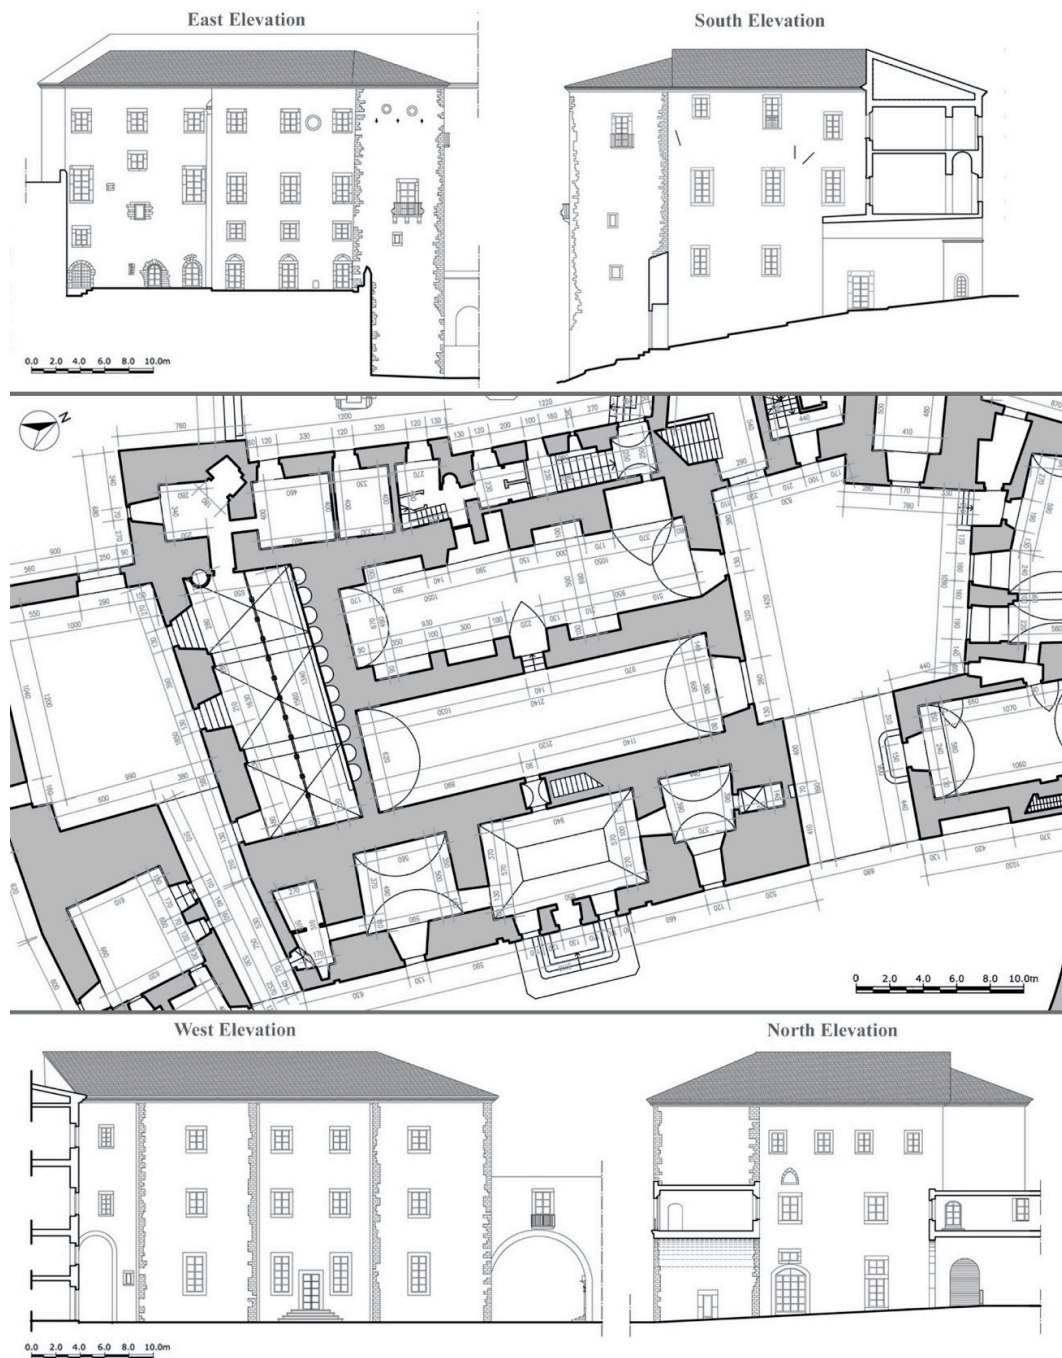
**Figure 6.** Geometric survey of the ground floor and the elevations of the central part of the Castle of Melfi (PZ), Italy.

The comparison between the numerous surveys drafted during past consolidation interventions and the on-site surveys performed during this work enabled the authors to trace a complete geometric survey of the entire Castle of Melfi (Figure 6).

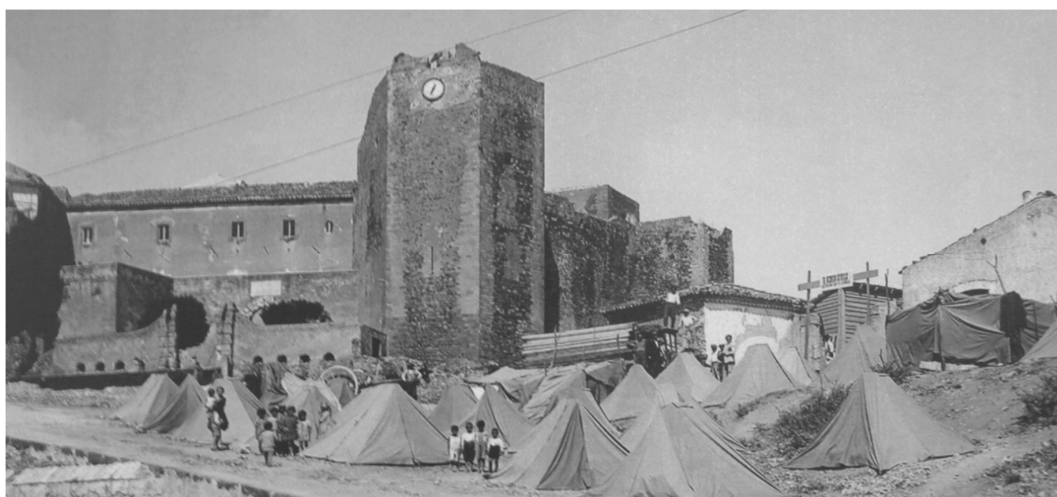
**Figure 7.** The Castle of Melfi after the earthquake of 23 July 1930.

Ref. [20] reported that the castle was damaged by the 1456 earthquake, too. More detailed information on damage caused by earthquakes is available starting from the 1694 Irpinia earthquake. Ref [9,21] reported that the castle was severely damaged by this earthquake. The Doria family called Genoese Francesco Canevaro to repair the castle and reinforce the building. F. Canevaro introduced pillars and walls and added tie-bars, mainly in the central core of the castle. The tie rods are intended to equilibrate the thrust forces (for example, the vaults' unequilibrated forces) that could otherwise destabilize, out of plane, the external walls or columns. The double earthquake of 1851 induced the collapse of the Seven Winds Tower and caused severe damages to the Marcangione Tower and the Throne Hall [20,22]. These collapses were followed by demolitions and reconstructions, including some of the walls of the Throne Hall. The 1930 earthquake caused significant damage to the Castle (Figure 7), more specifically in the vaults, in the Seven Winds, Cypresses, Clock and Church Towers, in the façade on the cistern courtyard and on the east end of the main façade [18]. Following the quake, the Doria family commissioned Architect L. Lenzi to restore the castle to its original architectural splendor.

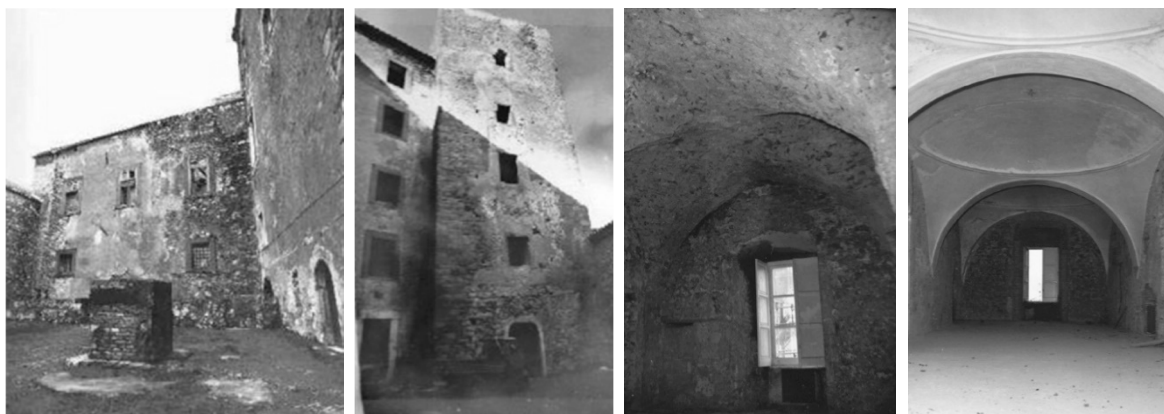
**Figure 12.** Historical photos of the Castle of Melfi (PZ) in the second half of the 1970s (from MiBACT Archives).

The visual inspection of the Castle of Melfi showed that the central part of the castle is in a good conservation state, thanks mainly to the restoration campaigns of the last few decades. However, the detailed investigation of the ancient and recent castle history and its historical photos (Figure 12) show that in the second half of the 1970s, the castle was in a very poor state of maintenance. When historical buildings do not undergo regular maintenance, environmental actions may deteriorate all structural components, including the roof and the walls, as indicated in [26]. It is imperative to identify the actual sources of decay and vulnerability (such as lack of maintenance, prolonged roof leakage, poor initial design, excessive loading, foundation settlement . . . ) in order to plan appropriate interventions, that may be structural, such as wall reinforcement, or non-structural, such as roof fixing.

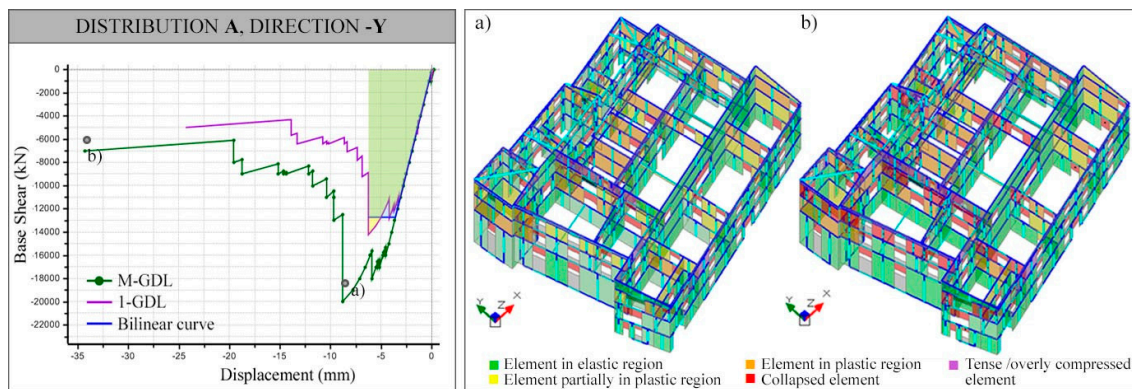
**Figure 18.** (Left): capacity curves from the pushover analysis with a triangular force distribution A in the negative Y direction; (Right): shear status of the masonry walls at the step corresponding to (a) the ultimate limit state (ULS) and (b) the last step of the analysis.

Considering all the combinations and all the seismic directions requested by the Italian and European building codes [23–25], the most severe loading condition is in the y-direction (−Y seismic action) for a triangular force distribution. Figure 18 shows the pushover curve for this load direction, the force distribution and the shear status of the masonry walls at the step corresponding to the (a) ULS and (b) the last step of the analysis. This result is determined by the presence of few bearing walls in the transversal direction (y-direction), and by the dead loads on floors that are mainly distributed

to the walls parallel to the longitudinal direction (x-direction). The central part of the castle served as the Doria family's residence from 1531 to 1954. During this period, the walls' distribution of the first floor was significantly changed, introducing a significant irregularity due to the construction of walls in the Y direction that are not extend vertically from the ground level to the first floor but transfer the vertical load on a barrel vault. Though this condition was partially corrected by the consolidation works at the end of the 1980s, which involved the insertion of a double reinforced concrete beam at the base of the wall rigidly connected at the vault, the walls' irregular distribution is the main cause of the structure vulnerability.
