# Seismic Resistance of Timber Frames with Mud and Stone Infill Walls in a Chinese Traditional Village Dwelling

**Keywords:** timber frame; mud and stone infill; traditional village dwelling; mortise and tenon; seismic behavior

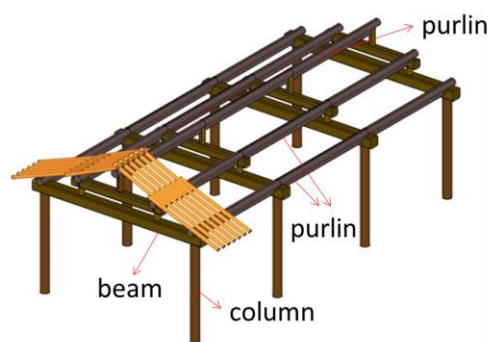
**Figure 1.** Timber frames consisting of four beams and eight columns.

However, traditional village residences in China are substantially different from structures in other parts of the world. In northern China, a common construction type of traditional residences consists of four beams and eight columns, as shown in Figure 1. This timber frame building has the following characteristics: (1) eight wood columns are supported by plinths or the ground without any fasteners. (2) Different mortise-tenon joints are used to connect the wood beams and columns without using nails, dowels, or other steel parts [38]. (3) The top of the structure is heavy, and the weight of the gable roof is transferred to the columns. (4) Stone, masonry, or earth infill is used inside the walls to stabilize the timber frame. As for the stone infill, the timber frame is generally embedded in thick mud and stone infill wall and ties the walls together. Unlike modern construction methods that use uniform rectangular bricks and cement mortar in village houses, the stones have various sizes. They were obtained locally and were joined together and embedded in the clay mud by experienced craftsmen. The traditional wood residences in villages have experienced different levels of damage, and many have been lost. Unfortunately, very few people still have the knowledge and experience to construct traditional village residences.

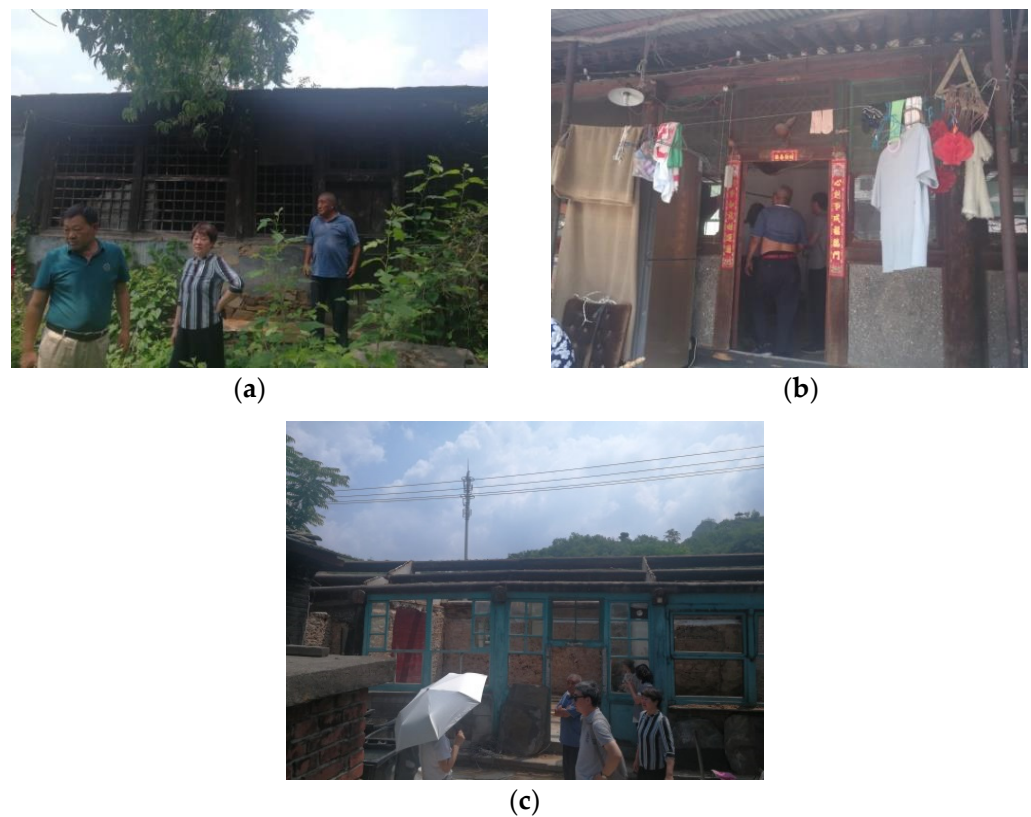
**Figure 2.** Present situations of traditional residences. (a) Abandoned traditional residence. (b) Traditional residence in use. (c) Repairing a traditional residence.

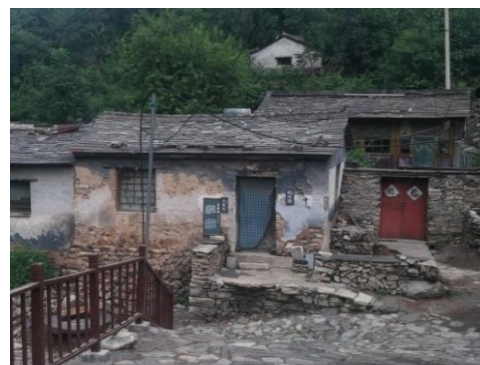
**Figure 3.** Stone foundation of a building in Shuiyu village, Fangshan district of Beijing City.

The old traditional village residences typically have stone foundations consisting of unprocessed rocks and rubble, such as river boulders and round, rectangular, and triangular rocks. The stones were generally layered without mortar or with little mud, forming a platform, as shown in Figure 3. The stone platform itself is a medium of seismic energy dissipation, either by gravitation or by the addition of clay mud, to achieve better adherence. It is probable to require some time to gravitationally distribute settle on the site, after completing laying up the foundation.

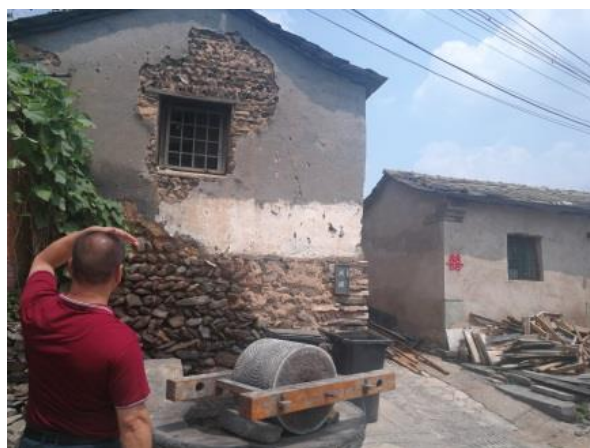
**Figure 4.** External transverse wall consisting of mud and stone with a window.

The old traditional residences generally have three or four rooms with lengths of 3 m and 3.2 m; some residences of poor households may have two rooms. The width of the residences is between 3.9 m and 4.2 m. Figure 4 shows an external transverse wall made of mud and stone with a window. Some of the plaster on the wall has fallen off due to poor maintenance.

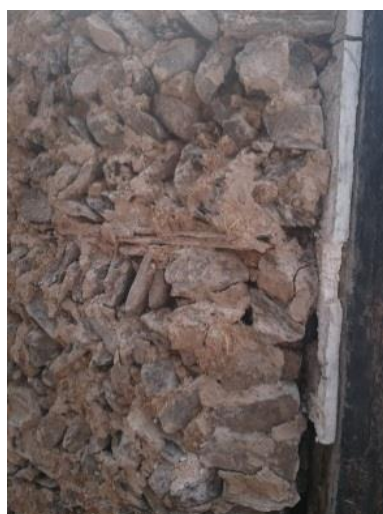
**Figure 6.** Interface between the timber frame and stone infill.

The infill consists of layered stones mixed with mud, and the walls have a minimum thickness of 400 mm. However, no connectors are used to attach the infill wall to the timber frame, as shown in Figure 6. Water, soil, and straw are mixed and used to fill the space between the rocks, as illustrated in Figure 7. The quality of the mud mortar depends on the soil type. Soils containing a high amount of clay are preferred for construction due to their high cohesiveness and hardness. However, clay soils crack when they dry.

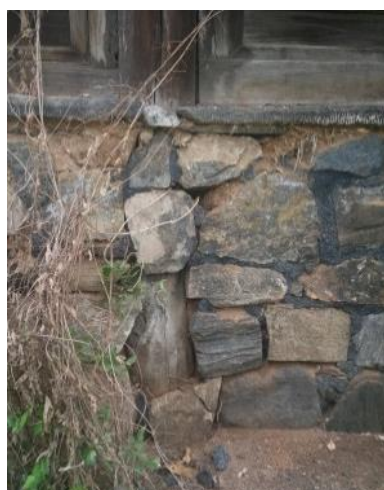
**Figure 7.** A mixture of mud and straw between the stones.

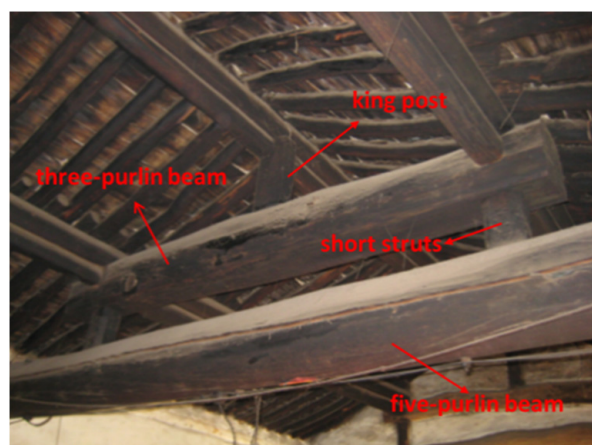
**Figure 8.** Five-purlin flush-gable roof.

A five-purlin flush-gable roof is typically used. The roof consists of a five-purlin beam, short struts, a three-purlin beam, and a king post from bottom to top to support the roof purlins (Figure 8). The traditional roof covering consists of rafters, reed matting, mud, and slate tiles from bottom to top. The rafters have diameters of 70 mm to 90 mm. A layer of reed matting on the rafters was covered by a mud layer with a thickness of about 10 mm. Since the local area is rich in stones, slate tiles are commonly used as roof coverings. They commonly have a thickness of 12 mm to 15 mm (Figure 9).

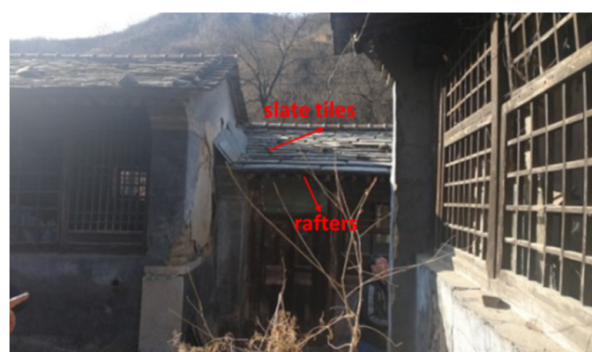
**Figure 9.** Slate tiles used for roof covering.

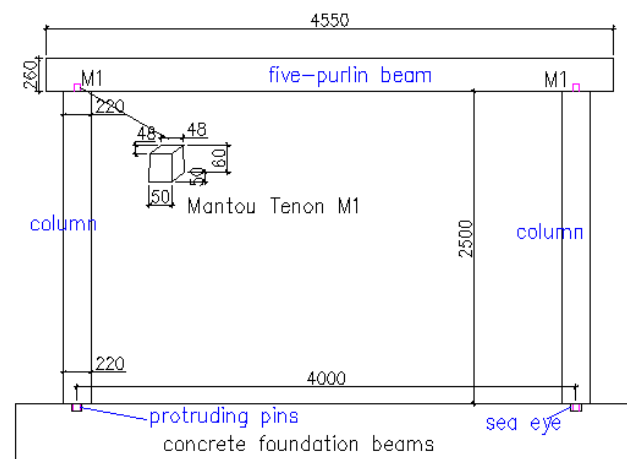
Figure 10. Wood frame Specimen.

In order to understand the seismic performance of the hybrid structure of timber frames with mud and stone infill, two full-scale hybrid wall specimens were reproduced and built for static cyclic in-plane loading tests, according to the field investigations. Two full-scale specimens with different vertical load applications representing the hybrid walls at different positions (external transverse wall and internal transverse wall) to bear the different vertical load from the roof's weight and the snow load were created. Two vertical loads of 20 kN and 38 kN calculated according to roof construction practice were applied to investigate the real lateral performance of the hybrid walls and to assess the influence of this variable on the lateral response. For the same typology of traditional village dwellings, however, there were still small variations in the details for constructions. Thus, it was decided to design a representative building. The main timber skeleton consists of vertical elements (columns) and a horizontal element (a five-purlin beam). The Mantou mortise-tenon joints were used to connect the columns and the beam. The five-purlin beam had a diameter of 260 mm, and the columns had a diameter of 220 mm. The wood frame specimen had a height of 2.5 m (from the foundation to the bottom of the beam), and the columns were spaced 4 m apart, as shown in Figure 10. The Mantou tenon processed similar to a big end up square prism had an end cross-section of 50 mm × 50 mm, a top cross-section of 48 mm × 48 mm, and a height of 60 mm. The protruding pin was a cuboid shape with a cross-section of 50 mm × 50 mm and a height of 60 mm. The mortises had corresponding dimensions (large on the outside and small on the inside) to ensure a tight fit. In the traditional building, the columns were sitting on the cornerstone, and pins protruding from the bottom of the columns were inserted into an eyelet in the stone with a gap to allow for the movement of the columns. Two long concrete foundation beams used to simulate the cornerstones and the foundation were prefabricated. They had a length of 5 m, a height of 0.5 m, and a width of 0.42 m. Two slots with dimensions of 80 mm × 80 mm and a height of 60 mm were cut in the foundation beams at a distance of 4 m to simulate the eyelets.

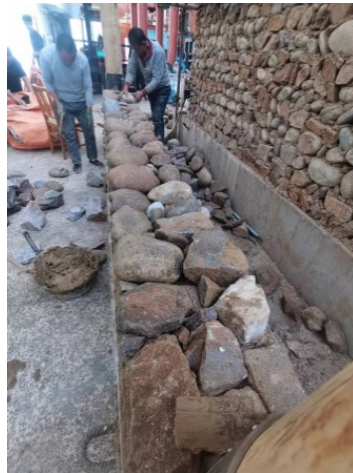
**Figure 11.** Mud and stone infill construction.

The full-size timber frames were erected and attached to the concrete foundation. A double layer of stones and clay mud was used as an infill. The wall construction was performed by experienced local folk craftsmen in the laboratory, following traditional methods, according to the field investigation (Figure 11). The thickness of the mud and stone infill was roughly 400 mm. Stones with various dimensions ranging from 20 mm to 30 mm were used for the infill. The clay mud was mixed with 10–15 mm long straw to connect the stones. Most of the construction material used in the test was obtained from the local village area (clay and stone).

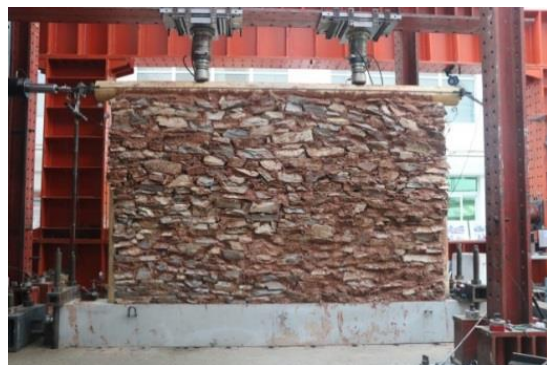
**Figure 12.** Test setup.

Tests were performed using a static cyclic protocol with one horizontal hydraulic jack with a maximum capacity of 100 kN of the force transducer and two vertical hydraulic jacks with a maximum capacity of 1000 kN. The movement range of the horizontal jack was  $\pm 250$  mm, and that of the vertical hydraulic jack was  $\pm 150$  mm. Two different pre-compression load levels were applied at the top of the five-purlin beam, (20 kN and 38 kN). The planes were produced at one-third span at the upper surface of the five-purlin beam. Small steel plates were attached to the plane surface of the five-purlin beam to distribute the vertical load applied by the vertical hydraulic jack and simulate the roof's weight. A horizontal actuator was attached to the horizontal hydraulic jack on the reaction wall and connected to the ends of the five-purlin beam through pull rods and a pin roll. The test setup is illustrated in Figure 12. The vertical hydraulic jack provided translational motion with horizontal movement of the top timber beam through rollers on the rigid beam slide rail. The concrete foundation beam was attached to the floor with steel box beams and large steel anchor bolts. Both end surfaces of the foundation beam were supported by a hydraulic jack to avoid slipping. The vertical loads were controlled manually to ensure constant pressure. A horizontal lateral force was applied manually. The lateral resistance capacity of the walls was appropriate for the force transducer of the testing system, ensuring reliable experimental data.

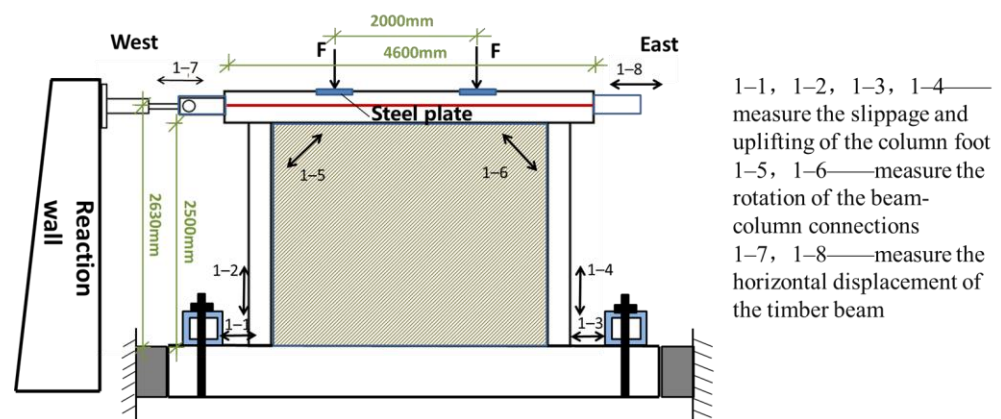
**Figure 13.** The measurement system. The clay materials were subjected to a liquid plastic limit test. The plasticity index was 18.7, and the average compressive strength of a cube of mixed clay and straw (70.7 mm × 70.7 mm × 70.7 mm) was 1.73 MPa (Figure 14). The timber frame wood was *Pinus sylvestris*, grown in northern China. The material parameters of the wood property were analyzed, a bending strength test as an example is illustrated in Figure 15. The average elastic modulus of the wood was 9420 MPa parallel to the grain (EL), 1039 MPa in the radial direction (ER), and 520 MPa in the chord direction (ET). The compression strength was 28.6 MPa parallel to the grain (EL), 6.1 MPa in the radial direction (ER) and chord direction (ET), and the bending strength was 64.4 MPa.

The measurement system consisted of wire displacement transducers at the beam end to measure the lateral drift of the wall at the top, wire displacement transducers at the corner of the wall to measure the rotation angle of the beam-column connections, and dial gauges at the end of the columns to record the slippage and uplifting of the column ends, as illustrated in Figure 13.

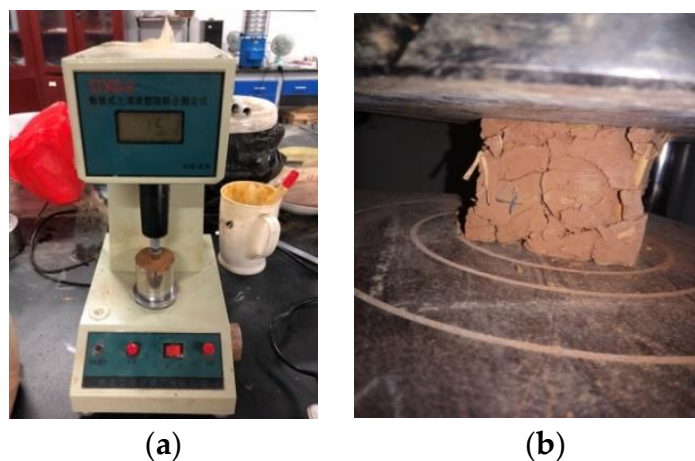
**Figure 14.** Clay material tests. (a) Liquid plastic limit test. (b) Compressive strength test.

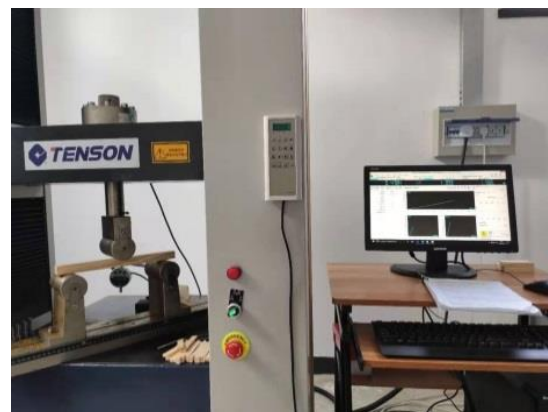
**Figure 15.** Bending strength test of *Pinus sylvestris*.

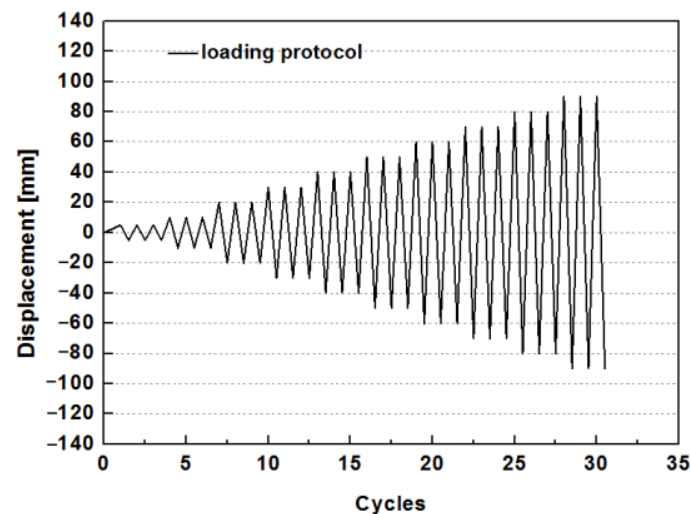
Figure 16. Loading protocols.

Displacement control was adopted in the static cyclic loading test according to the Specification for the seismic testing of buildings [39]; the details are shown in Figure 16. In the beginning, the preloading with two fully reversed cycles at 2 mm displacement was carried out to check the loading system prior to the formal test. Then, the formal test started with the horizontal displacement increased by 5 mm with three fully reversed cycles before the drift ratio of 0.2%. Subsequently, the horizontal displacement increased by 10 mm after the drift ratio of 0.2% in each phase with three fully reversed cycles of equal amplitude at displacements of 10 mm, 20 mm, 30 mm, and larger values with an increment of 10 mm. The loading process stopped when the lateral resistance of the hybrid walls dropped below 80% of the maximum lateral capacity.

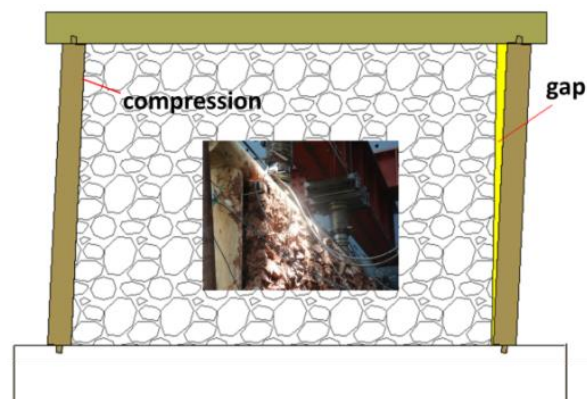
**Figure 17.** Interaction between wood columns and stone infill.

Specimen S1, representing the external wall of the dwelling, was subjected to a vertical load of 20 kN. Specimen S2, representing the internal wall, was loaded vertically with a force of 38 kN. The tests revealed good compatibility between the timber frame and the mud-stone infill, with a horizontal displacement of 10 mm (0.38% drift). In the initial phase, the confinement of the frame kept the mud and stone infill in place, and the infill strengthened the lateral stiffness of the frame. With an increase in horizontal displacement loading, the level of cooperation between the timber frame and the infill decreased due to the larger lateral drift of the timber frame and the smaller drift of the stone wall. The interface between the infill and timber frame was very weak, resulting in the early detachment of the infill wall from the timber frame. The detachment resulted in larger gaps at the upper end of the column and smaller gaps between the wood frame and the infill wall at the bottom of the columns, as illustrated in Figure 17. The timber columns compressed one side of the stone wall and separated from the other side, resulting in mortar and stone dislocation, wall bulging, and falling stones. The details of the results for the two full-size specimens are as follows:

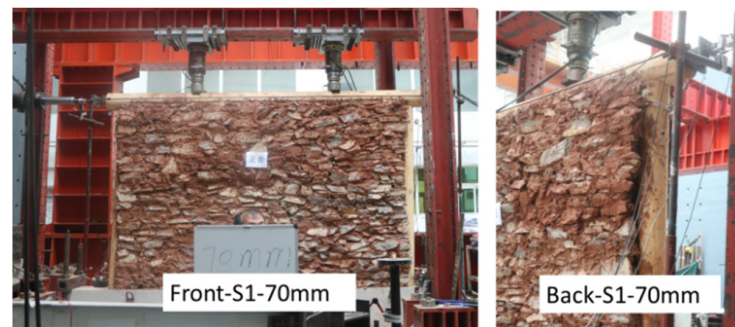
**Figure 18.** Displacement loading of 70mm (drift 2.66%) for S1.

For specimen S1, the mud and stone infill wall separated from the timber frame and bulged at the corner after the loading displacement of 70 mm (Figure 18). At 80 mm horizontal loading displacement, several stone blocks failed at the corner of the infill wall, and the sound of energy dissipation of the mortise and tenon joints due to friction “Pa Pa” was heard (Figure 19). Meanwhile, the wire displacement transducers near the corner of the infill wall and the dial gauges at the end of the columns were damaged by falling stones. Significant damage to the wall occurred after 100 mm horizontal displacement loading (3.8% drift), such as stones falling from the single layer of the wall, representing 1/6 of the wall area (Figure 20). More significant damage to the stone infill wall was observed after 120 mm horizontal displacement loading (4.56% drift), such as a cavity due to falling stones (1/6 of the wall area) (Figure 21). After the last displacement loading of 130 mm (4.94% drift), the stones failed in about 1/3 of the wall area, and the lateral capacity of the hybrid wall dropped to 30% of the maximum capacity (Figure 22). However, the timber frame rocked with a slight uplift and slowly fell to the ground during cyclic loading. The timber frame did not show any significant damage during and after cyclic loading.

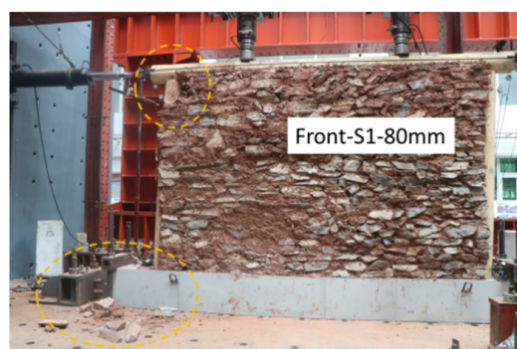
**Figure 19.** Displacement loading of 80 mm (drift 3.04%) for S1.

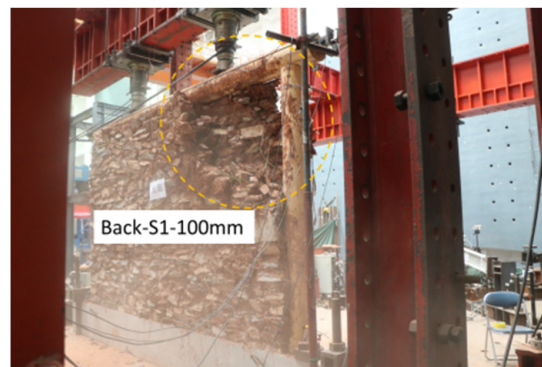
**Figure 20.** Displacement loading of 100 mm (drift 3.80%) for S1.

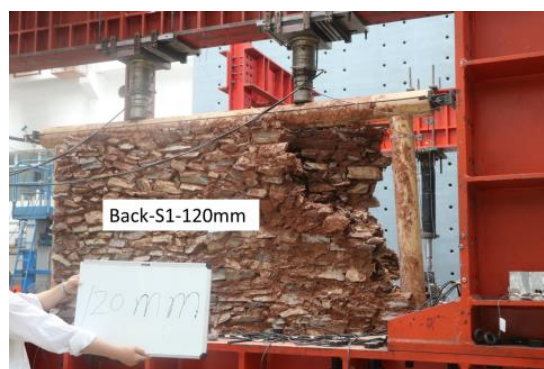
**Figure 21.** Displacement loading of 120 mm (drift 4.56%) for S1.

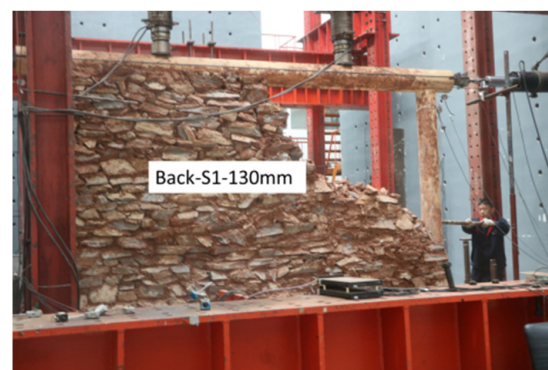
**Figure 22.** Displacement loading of 130 mm (drift 4.94%) for S1.

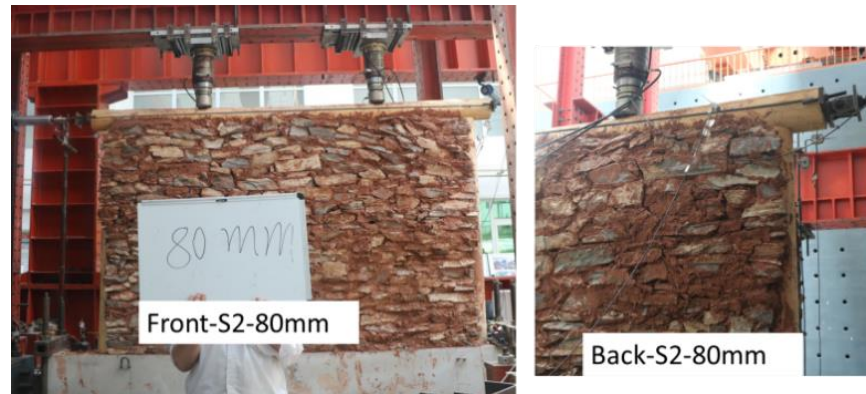
Figure 23. Displacement loading of 80 mm (drift 3.04%) for S2.

For Specimen S2, the surface of the stone wall remained flat except for some bulging and cracks at the corner after 80 mm displacement loading (3.04% drift) (Figure 23). Similar to the S1 specimen, stones fell from the single layer of the wall in about 1/6 of the wall area after 90 mm horizontal displacement loading (Figure 24). The same location on the other layer of the wall became loose and cracked (Figure 25); however, the wall did not fail until 140 mm loading displacement (5.32% drift), and a cavity occurred, representing about 1/6 of the wall area (Figure 26). In the last displacement loading cycle of 150 mm (5.74% drift), the lateral capacity dropped to roughly 6 kN with more stones failing, and the test was stopped. However, the timber frame remained undamaged during the loading process.

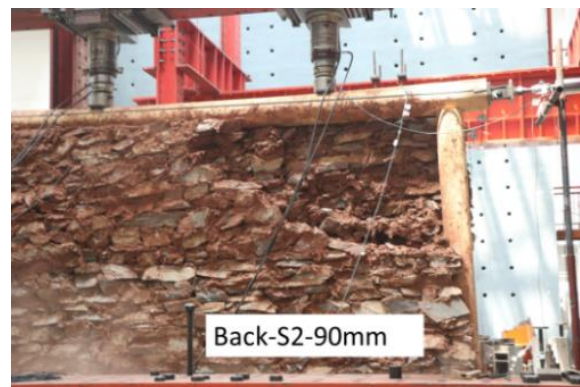
Figure 24. Displacement loading of 90 mm (drift 3.42%) for S2.

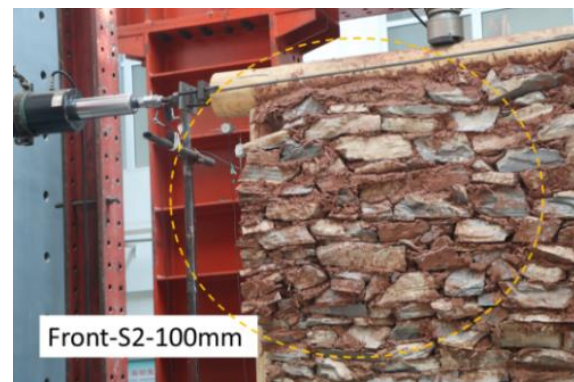
Figure 25. Displacement loading of 100 mm (drift 3.80%) for S2.

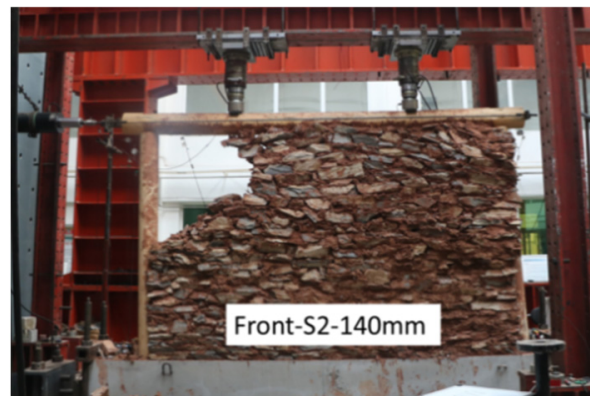
Figure 26. Displacement loading of 140 mm (drift 5.32%) for S2.

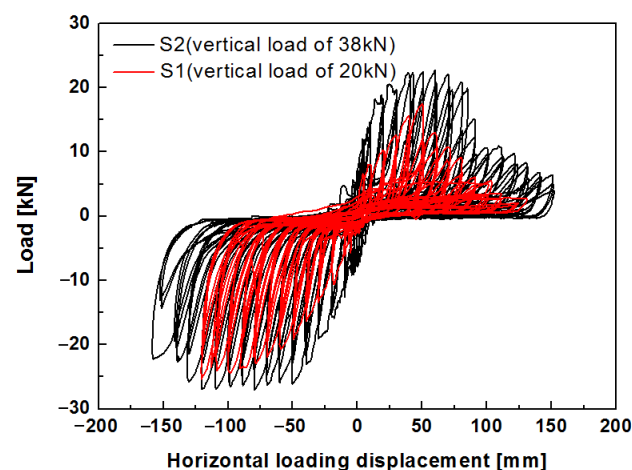
Figure 27. Hysteresis loops for specimens S1 and S2.

The monitored lateral load and recorded horizontal loading displacement at the beam were obtained to plot the hysteresis curves. The two specimens subjected to different vertical precompression levels during cyclic loading exhibited similar behavior. The load-horizontal displacement hysteresis loops exhibit strong pinching with plump ends and slender waists, indicating slipping of the hybrid component. The load-displacement hysteresis curves of S1 and S2 are plotted in Figure 27. The gradient of the unloading curve was close to zero, and the load dropped rapidly, indicating a gap and deformation incompatibility between the wood frame and the infill. In addition, the hysteresis loops of both specimens are asymmetric. During loading, a local collapse occurred at one corner of the infill wall; however, the stones and mud at the other locations were not loosened or did not slip. As a result, the lateral resistance during reverse cyclic loading remained constant for a long time.

Specimen S1 reached a strength of 17.58 kN at the positive loading displacement of 50 mm (1.9% drift), and subsequently, a significant decline in the lateral resistance capacity was observed. Meanwhile, at a negative maximum lateral resistance (25.34 kN), specimen S1 did not fail until about 125 mm (4.7% drift) for negative loading displacement. Specimen S2 had a strength of 22.74 kN at positive loading of 60 mm (2.3% drift) and a

strength of 26.99 kN at negative loading of 80 mm (3% drift). The hysteresis curves of the specimens indicate that S2 with the higher vertical precompression load showed higher lateral resistance capacity than S1, which had larger hysteresis loops. The uplift of the column foot recorded by the undamaged dial gauges on one side is plotted in Figure 28. The maximum uplift (13 mm) indicated the slight rocking of the timber frame; however, the increase in the vertical precompression had a minimal effect on the rocking behavior of the timber frame in the hybrid structure.

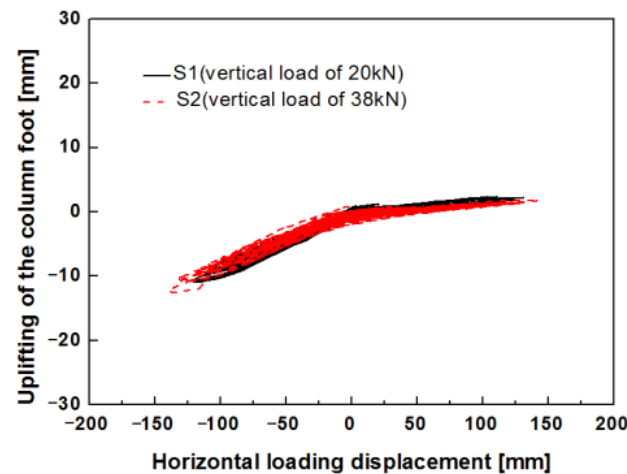
Figure 28. Uplifting of the timber column foot.

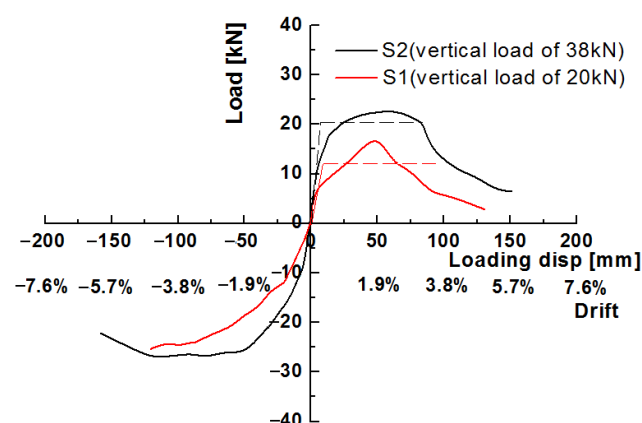
Figure 29. Skeleton curves for specimens S1 and S2.

The skeleton curves of the two specimens subjected to different vertical precompression loads are shown in Figure 29. The equivalent bilinear diagrams based on the hysteresis envelope were obtained using the ASTM 2126-09 standard [41]. The yield point was defined according to the bilinear curves using the equivalent energy elastic-plastic (EEEP) method.

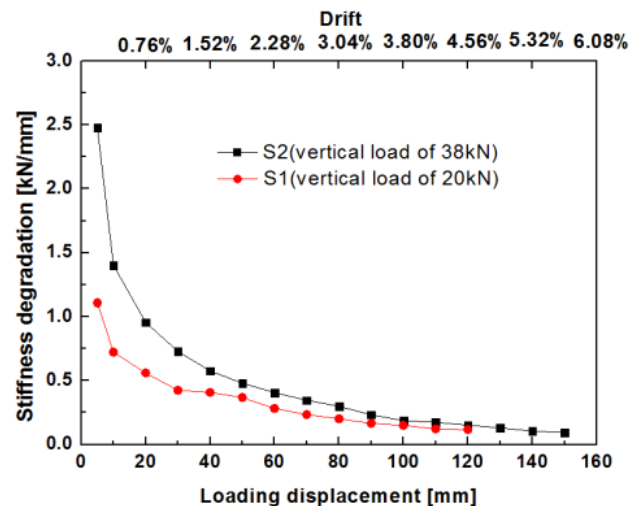
Figure 30. Stiffness degradation of specimens S1 and S2.

where  $+F_j$  and  $-F_j$  are the generalized positive and reverse loads at the  $j$ th loading level (in kN), respectively;  $+\Delta_j$  and  $-\Delta_j$  are, respectively, the positive and reverse displacements at the  $j$ th loading level (in mm). The stiffness degradation curves of the two specimens are illustrated in Figure 30. The effects of the vertical load on the lateral resistance of the hybrid wall are evident. The stiffness curves show a degradation trend with a significant decrease at the beginning (0–20 mm displacement), followed by a gradual decrease (20 mm–80 mm displacement) and stabilization (greater than 80 mm displacement). It is observed that the stiffness of S2 is larger than that of S1 when the drift is less than 3.04% (80 mm displacement). When the drift is less than 20 mm (0.76% drift), the secant stiffness of S2 is twice that of S1. In the horizontal displacement range of 20 mm to 30 mm, the secant stiffness of S2 is 1.5 times that of S1. For a displacement greater than 80 mm, the stiffness degradation curves of the two specimens are similar, with values less than 0.2 kN/mm. The results indicate that an increase in the vertical load results in an increase in the stiffness of the hybrid wall.

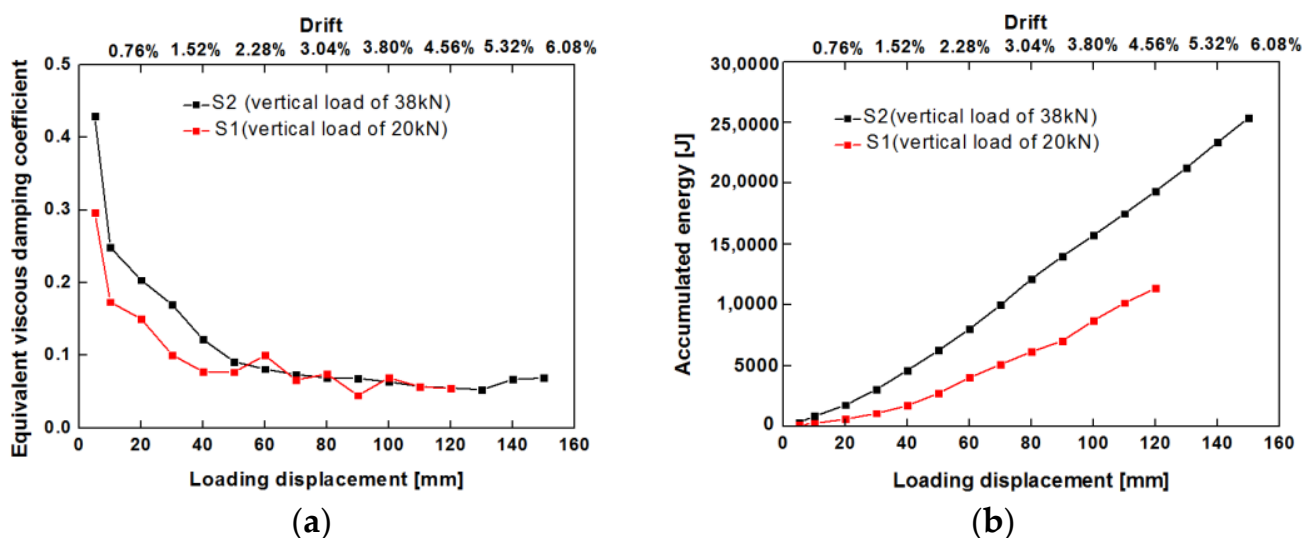
Figure 31. Energy dissipation of specimens S1 and S2. (a) Equivalent viscous damping coefficients of specimens S1 and S2. (b) Accumulated dissipated energy of specimens S1 and S2.

where  $E_d$  is the total dissipated energy of the specimen in the first cycle at different displacement levels;  $E_e^+ + E_e^-$  are the potential energies at maximum deformation in the first cycle in the positive and negative directions at the displacement control level. The equivalent viscous damping coefficients of the two specimens show a decreasing trend

with a large rate of change before 50 mm loading displacement (2% drift, corresponding to the strength limit point of S1) with a range of 0.8 to 0.2, followed by a slow rate of decrease and stabilization at about 0.08, as illustrated in Figure 31a. The viscous damping ratio is higher for S2 than S1 before 50 mm loading displacement (0.09–0.43 for S2 and 0.08–0.3 for S1). An increase in the equivalent viscous damping coefficient occurs as the vertical precompression increases. These results indicate that the internal walls of traditional village dwellings have higher energy dissipation capacity than the external transverse walls.

The accumulated energy was calculated using the cumulative accumulation of the integral area of hysteresis loops. The cumulative dissipated energy of the two specimens increases with an increase in lateral drift and is higher for S2 with the larger vertical precompression level, as shown in Figure 31b. The lateral drift of S2 is less than that of S1 for dissipating the same amount of energy. Increasing the vertical load on the beam enhances the seismic dissipation capacity. Furthermore, the seismic capacity is higher for the internal wall than the external wall.

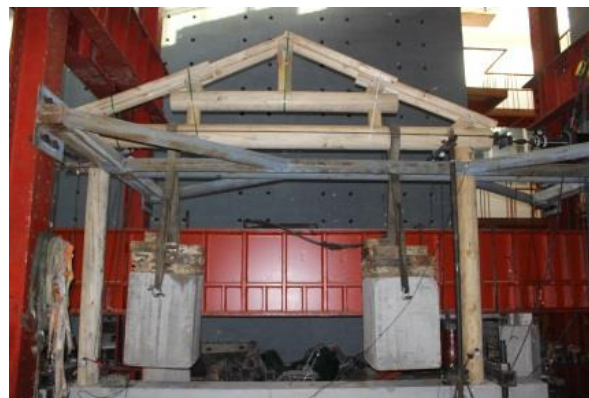
Figure 32. Loading test of the wood frame.

We compared the results with those of a timber frame with the same dimensions and no infill to assess the seismic performance of traditional Chinese houses with mud and stone infill. A full-scale post-and-lintel timber frame of a traditional residence was fabricated and subjected to pseudo-static cyclic lateral loading (Figure 32). The experimental results of this type of timber frame were reported in [7]. The timber frame M1 (M2) in this study subjected to a vertical load of 19 kN (34 kN) corresponds to specimen MGJ-2 (MGJ-3) in [7], representing an external transverse wall (internal transverse wall) in a traditional village residence. The vertical loads applied to the timber frame without infill were slightly lower than those applied to the hybrid wood-stone wall. The reason is that some of the weight of the mud and stone infill in the triangular area of the five-purlin flush-gable roof is transferred to the wooden frame, and some are transferred to the thick stone wall below.

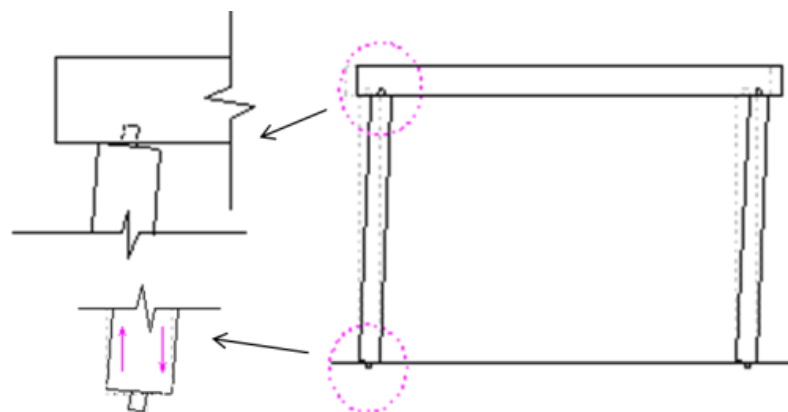
Figure 33. Movement mechanics of the timber frame.

The timber frames without infill exhibited different hysteretic behavior than those with mud and stone infill. The bare wood frame is a rocking system characterized by uplifting and lowering of the column foot. When the timber frame is displaced to the right (left), the left (right) side of the column foot is lifted up from the foundation, and the right (left) side of the column foot is compressed, as shown in Figure 33. The greater the displacement drift of the timber frame, the greater the uplifting of the column foot is, and the smaller the compression area of the column foot is. The hysteresis loops of the bare wood frame are slender and Z-shaped, indicating the continuous slipping and friction between the mortises and tenons. In contrast, the hysteresis loops of the hybrid wood-stone walls are 8-shaped with plump ends and pinching in the middle, as illustrated in Figure 34.

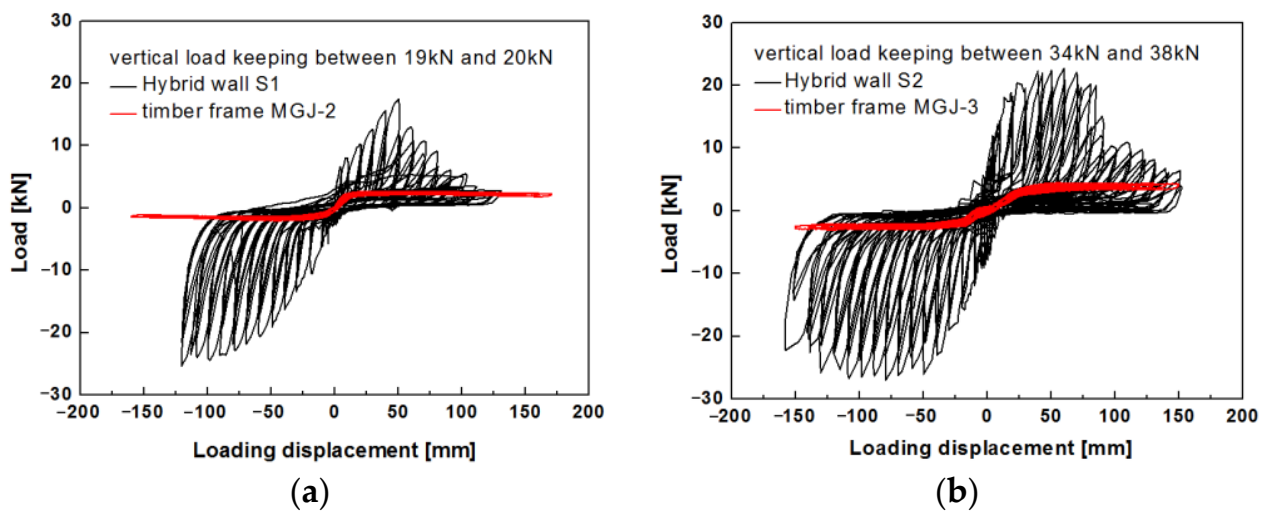
**Figure 34.** Hysteresis curves of the timber frames and hybrid wood-stone walls. (a) Vertical load of 19 kN–20 kN. (b) Vertical load of 34 kN–38 kN.

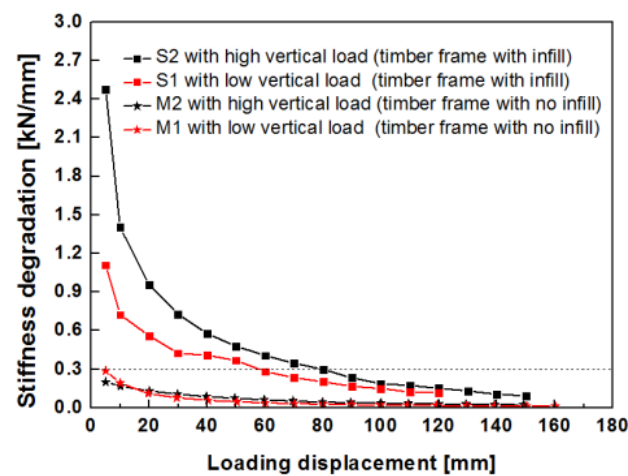
Figure 35. Stiffness degradation of timber frames and hybrid wood-stone walls.

The comparison of the stiffness degradation between the timber frames and hybrid wood-stone walls is provided in Figure 35. The timber frame without infill has substantially lower stiffness values (less than 0.3 kN/mm) than the timber frame with infill, whose maximum value is 2.5 kN/mm before 50 mm loading displacement (2% drift). Afterward, the stiffness degradation of timber frame with infill is close to that of the bare timber frame. The results indicate that the lateral resistance stiffness of the timber frame with infill decreased rapidly after 50 mm of loading displacement.

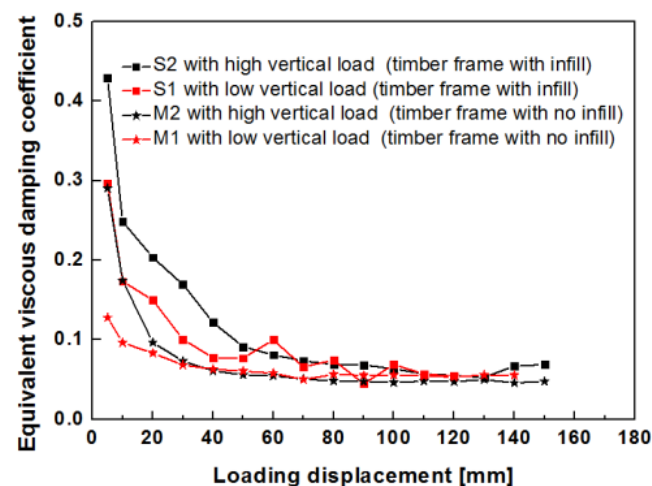
Figure 36. Equivalent viscous damping coefficient of timber frames and hybrid wood-stone walls.

The comparison of the equivalent viscous damping coefficient between the timber frames and hybrid wood-stone walls is presented in Figure 36. The equivalent viscous damping coefficients are higher for low drift values and subsequently decrease before stabilizing. It is observed that the equivalent viscous damping coefficient is affected by the infill and the vertical load. At a high vertical load, the viscous damping coefficient is higher for the timber frame with infill than without infill at low drift values (50 mm displacement, 2%), and the ranges are 0.8–0.42 for the former and 0.8–0.3 for the latter. The values then decrease and stabilize between 0.06 and 0.08. Similar trends are observed for both types of timber frames at low vertical loads. These results differ from those of a study of traditional Portuguese buildings. The coefficients were 0.17–0.20 for timber frames with infill and

0.19–0.20 for timber frames without infill at low drift values [43]. However, a high vertical load increases the viscous damping of timber frames with infill and without infill.
