# Full-Scale Testing on Seismic Performance of Surge Arrester with Retrofitted Composite Insulators

**Abstract:** In electrical substations, glass-fibre reinforced polymer (GFRP) insulators provide an alternative to porcelain insulators for better seismic performance. The bonded connection between the composite tube and the metal end fitting is a weak link under earthquake actions, and the failure risk of ultra-high voltage (UHV) substation equipment with GFRP composite insulators can be considerable in places with high seismicity. This study solved the problem by retrofitting and experimentally qualifying the seismic performance of surge arresters made of composite insulators. To ensure safety under a bending moment corresponding to the seismic demand, the bonded sleeve joint between the tube and end fitting was retrofitted by shear stiffeners and higher strength end fitting. A full-scale shaking table test was carried out to verify the performance of the retrofitted surge arrester, and the seismic responses to increasing earthquake actions were analyzed. The specimens in this study were full-scale, had the largest dimensions among substation equipment of the same type, and were

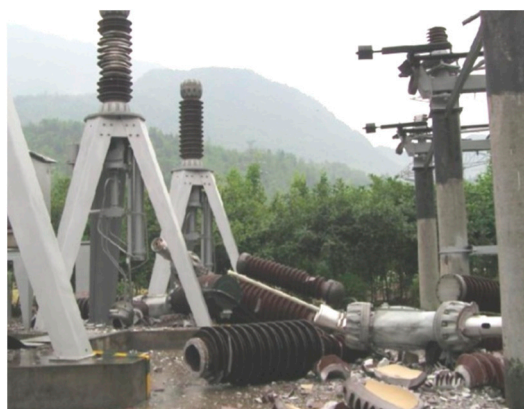
**Figure 1.** Seismic failure of porcelain insulators in the M7.9 Wenchuan earthquake in 2008.

The seismic safety of electrical equipment in substations is essential to the reliability of a power system [1–3]. Substations install a range of cylindrical electrical equipment, such as surge arresters, capacitor voltage transformers, and post insulators. These items are traditionally manufactured using porcelain insulators composed of ceramic material that is brittle and fragile, resulting in a significant risk of failure in earthquakes. Figure 1 shows porcelain insulators that were damaged in the 2008 Wenchuan earthquake in China [4]; similar failures occurred in the 1977 Vrancea earthquake in Romania [5], the 1989 Loma Prieta earthquake in the United States [6], the 2011 Tohoku earthquake in Japan [7], the 2011 Christchurch earthquake in New Zealand [8], and the 2013 Lushan earthquake in China [9]. Due to insulation clearance requirements, electrical equipment in ultra-high voltage (UHV) substations, which are the substations with the highest voltage, becomes substantially taller [10,11]. The normal height of cylindrical electrical equipment in the primary circuit of a substation, such as the 1000 kV surge arrester examined in this study, is approximately 10–15 m, and the diameter of an insulator is approximately 0.3–0.7 m. In seismic hazardous areas, the usage of porcelain insulators for UHV electrical equipment may pose a significant seismic risk [12].

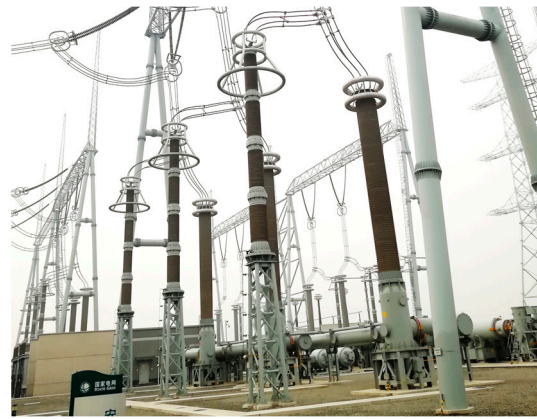
**Figure 3.** The 1000 kV surge arrester with supporting structure installed in an UHV electrical substation.

In substations, the 1000 kV surge arrester would be mounted on the top of a 5~8 m steel supporting frame, as shown in Figure 3. Note that the height of the supporting structure is determined by the requirement of ground insulation distance and the position of nearby equipment interconnected with the surge arrester. The supporting structure can be different even in the same substation. The seismic design and qualification of the surge arrester usually consider a conservative dynamic amplification factor of 1.4, in order to take the influence of the supporting structure into consideration [46]. Conversely, the supporting structures are designed to have a dynamic amplification factor less than 1.4 [38]. During the testing, a linear amplification factor of 1.4 was directly applied to the input excitation, resulting in an input PGA of  $1.4 \times 0.5$  g. The acceleration spectrum is plotted on the left side of Figure 2, with a notation of RS  $1.4 \times 0.5$  g.

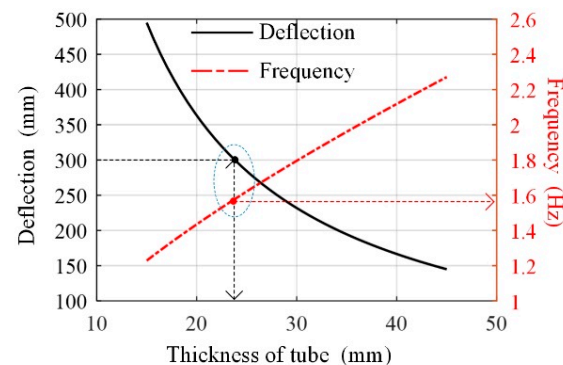
**Figure 6.** Relationship among tube thickness, deflection at the top, and primary frequency.

The seismic demand on the displacement of the cantilever structure is generally related to the rigidity of composite tubes. The criteria limit for the deflection of the cylindrical electrical equipment was  $1/18$  of its length, or  $600 \text{ mm}$  [49]. The safety margin requirement of  $1.67$  limited it to  $360 \text{ mm}$ . Considering uncertainties in modelling, our target of deflection was set to  $300 \text{ mm}$  in the design of the composite tube. A finite element (FE) model of the specimen with the beam element was built, as shown on the left side of Figure 5, and the thickness of the composite tube was taken as a variable, changing from  $10 \text{ mm}$  to  $50 \text{ mm}$ . The response spectrum method was adopted in this parametric analysis. Figure 6 shows that the targeted  $300 \text{ mm}$  deflection corresponded to a  $24 \text{ mm}$  thickness of the tube and  $1.58 \text{ Hz}$  of fundamental frequency. Thus, the thickness of the tube for the insulator at the top was chosen as  $25 \text{ mm}$ , and a slightly larger thickness,  $30 \text{ mm}$ , was selected for the insulator at the bottom. The inner/outer diameters of the four insulators became  $535/585$ ,  $600/654$ ,  $600/654$ , and  $690/750$  (in millimetres). These values were adopted in the production and experiments in this study.

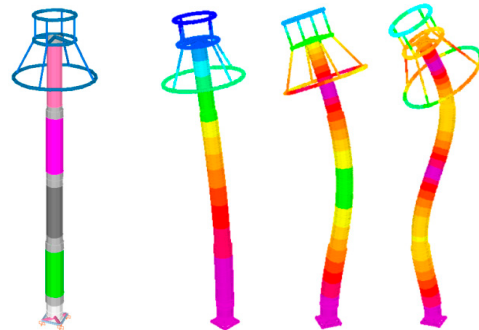
**Figure 7.** FE model of the 1000 kV surge arrester (left) and the first three mode shapes (right).

The vibration modes of the equipment are shown on the right of Figure 7, and the frequencies of the first three modes were  $1.73 \text{ Hz}$ ,  $8.8 \text{ Hz}$ , and  $22.5 \text{ Hz}$ . By inputting the  $1.4 \times 0.5 \text{ g}$  PGA seismic motion, a time history analysis was carried out to estimate the

The relationship between the input motion and the seismic response of the specimen was used to identify the vibration modes of the specimen. The transfer function,  $T(f)$ , between acceleration at the top of each insulator and acceleration at the table surface was calculated using  $T(f) = P_{yx}(f)/P_{xx}(f)$  [50], in which  $P_{yx}(f)$  was the cross power spectral density between the output and the input, and  $P_{xx}(f)$  was the power spectral density of input. The imaginary part curves of the transfer function are shown on the left side of Figure 20. The peaks of the curves represent the coordinates of a mode shape, as shown on the right side of Figure 20. The fundamental frequency was  $1.69 \text{ Hz}$  in the test and  $1.73 \text{ Hz}$  in the analysis, which had a different rate of  $2.2\%$ . The second mode frequency was  $8.7 \text{ Hz}$  in the test and  $9.3 \text{ Hz}$  in the analysis, which had a different rate of  $7\%$ . The mode shapes in the test (as shown on the right side of Figure 20) could also match the mode shapes in numerical analysis (Figure 7).

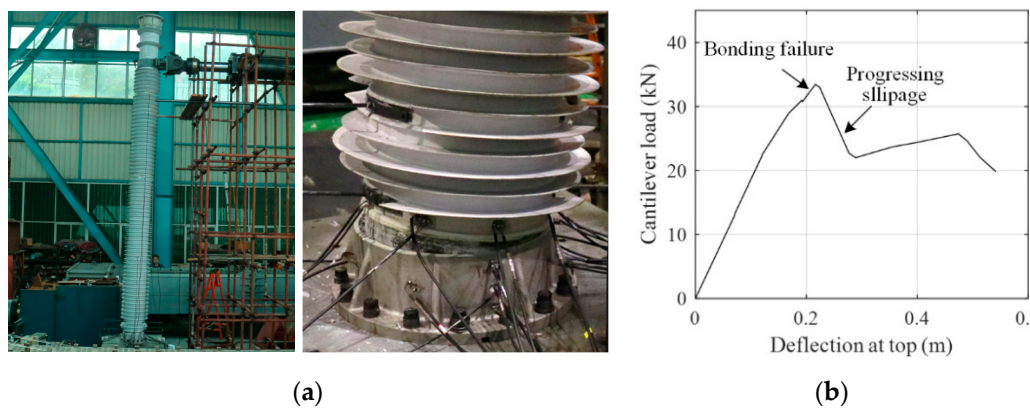
**Figure 10.** Bonding failure of an 800 kV composite insulator under a cantilever bending test (a) and loading–deflection curve (b) [33].

When the combined stress reaches a threshold, bonding failure may happen. Previous testing on an 800 kV composite post insulator by the authors [33], as seen on Figure 10a, revealed that the bonded joint at connection was a significant weak point. When the load reached 33 kN, slippage or pull-out occurred at the bonding interface, resulting in a significant loss of stiffness and loading capacity, as indicated by a sharp turn in the loading–deflection curve shown in Figure 10b. The maximum stress on the composite tube was approximately 80 MPa, considerably lower than the bending strength of the tube.

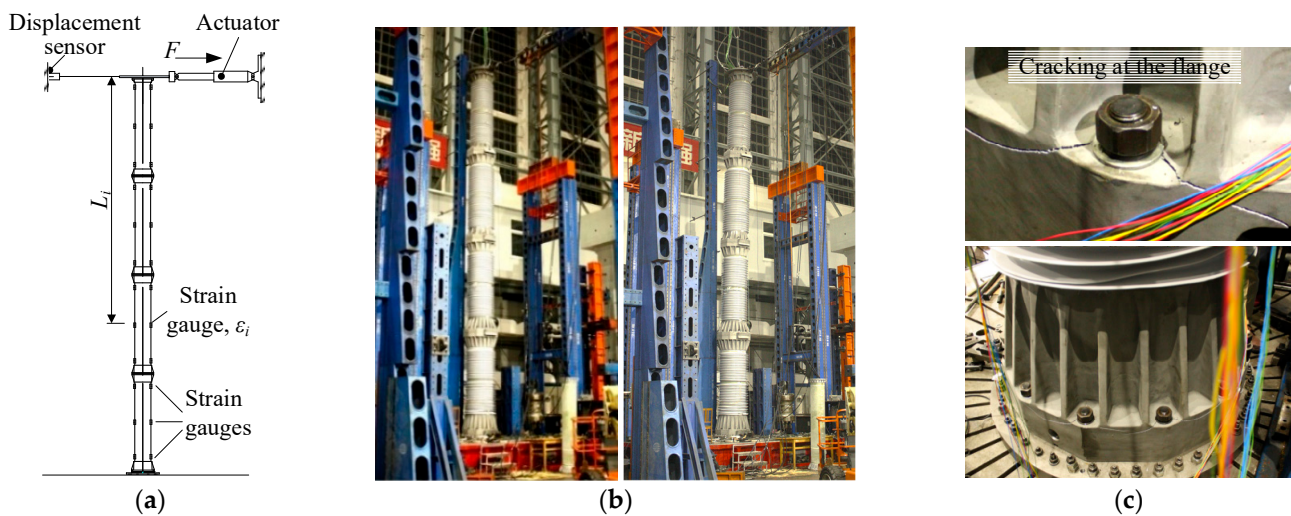
**Figure 12.** Cantilever bending test of composite insulators retrofitted by shear stiffeners. (a) Test setup. (b) Specimen and loading facility. (c) Cracking of the flange.

A full-scale bending test was conducted to evaluate the performance of the aforementioned retrofitting on the composite insulators of the 1000 kV surge arrester. Figure 12 shows the specimen, which was made up of 4 insulators and was 11.2 m long. The joints at the insulators had ring-shaped shear stiffeners applied for retrofitting, and the flange was made of cast aluminium. Figure 12a depicts the setup for the bending test. Figure 12b illustrates the application of a cantilever force at the top, where the displacement was

measured. The pull force at the top gradually increased until the bending failure of the specimen. The testing setup and loading protocol followed the procedure in [49].

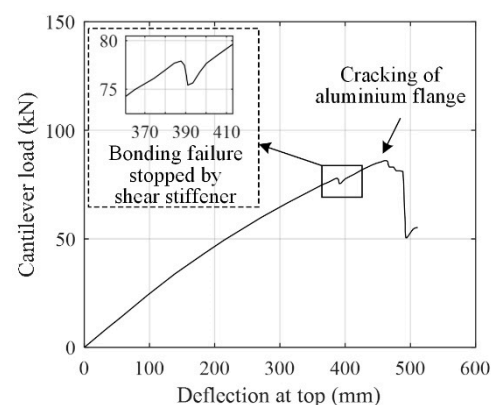
**Figure 13.** Cantilever loading–deflection curve recorded in bending test I.

Figure 13 shows the loading–deflection curve of the bending test. When the loading reached 78 kN (corresponding to an 867 kN·m bending moment), audible sound emission and a minor drop in force occurred, indicating the debonding at the interface. However, as shown in the zoomed window of Figure 13, the specimen continued to undertake lateral loads, proving that the shear stiffeners were successful in preventing the development of bonding failure at the interface. Following that, an abrupt failure occurred at the base when loading reached 85.8 kN or 954 kN·m, as shown in Figure 12c. Interestingly, the break appeared at the cast aluminium sleeve, contrasted sharply with the debonding at the interface in the previous test (shown in Figure 10). By referring to the crack’s location and orientation, it can be concluded the crack was brought on by tension stress, implying the cast aluminium flange’s lack of tensile strength. The ultimate bending moment at the bottom was 963 kN·m, lower than the targeted 1112 kN·m predicted in Section 2.

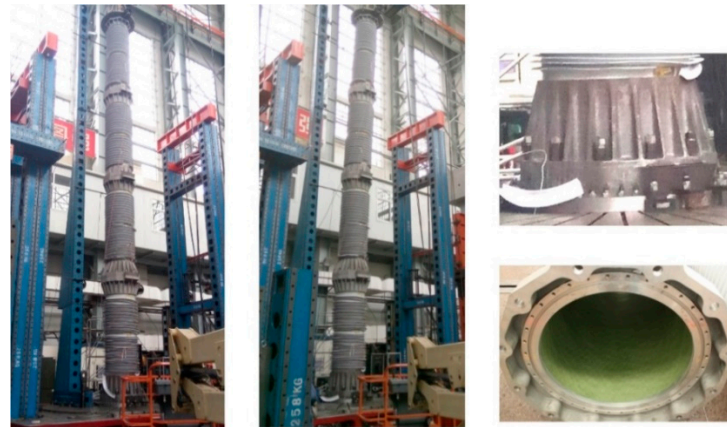
**Figure 14.** Cantilever bending test of composite insulators retrofitted by shear stiffeners and cast iron flange.

Figure 14 shows a repeat of the bending test, and Figure 15 depicts the loading–deflection curve. An acoustic event was initially heard when the load was 74.7 kN. The force was close to the 78 kN in Section 3.2, which corresponded to the initial debonding at the joint that was stopped by the shear stiffeners. After that, a major acoustic emission event occurred when the load was 96 kN with 780 mm deflection. The resistance force slightly decreased, and the stiffness deterioration became more pronounced. This incident could be caused by the partial breakdown of some shear stiffeners. Notably, the specimen continued to withstand bending loads after 1067 kN·m, which indicated the structure’s earthquake resilience.

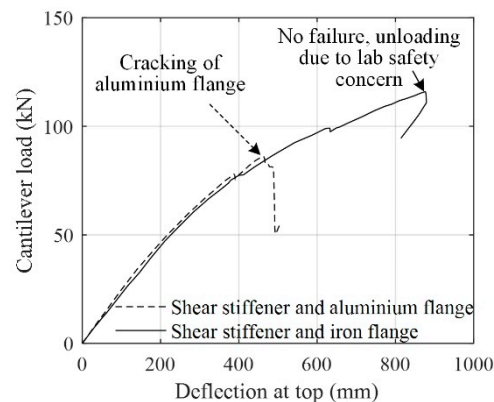
**Figure 15.** Cantilever loading–deflection curve recorded in bending test II.

When the load reached 117 kN or 1301 kN·m with 1080 mm deflection at the top and 115 MPa stress at the tube, the testing was ended. The testing was terminated because of safety concerns in the laboratory. This load was considerably larger than that of the estimated seismic demand in Section 2. As shown on the right side of Figure 12, the specimen was inspected after the test. The effectiveness of the retrofitting at the bonded sleeve joint was demonstrated by the absence of slippage in the bonded interface or crack on the metal flange.

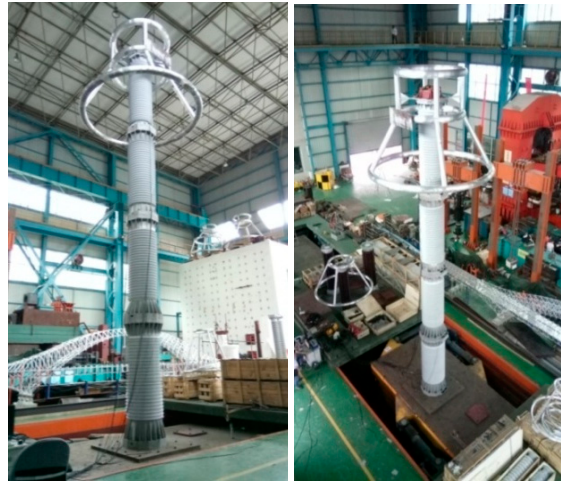
Figure 16. Shaking table test of the 1000 kV surge arrester with GFRP insulators.

In this section, a full-scale shaking table test was conducted as a direct method of seismic performance validation of the surge arrester with the retrofitted composite insulators. All of the electrical parts had been assembled inside the surge arrester, and the insulators utilized were the same as those in the flexural test. The specimen was fixed on a 4 m by

6 m shaking table, as shown in Figure 16. Sensors were arranged as shown in Figure 17. It included strain gauges at the bottom of each insulator and accelerometers at the top. Displacements of the specimen can be acquired by integrating the acceleration curve, and deflections of the specimen can be obtained by subtracting the displacement at the top of the specimen from the displacement at the shaking table.

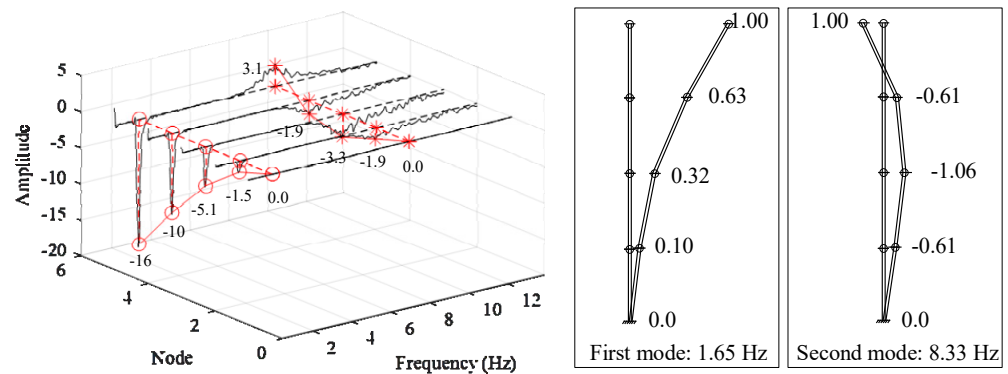
Figure 20. Transfer functions and vibration modes were obtained from the shaking table test.
