Article

An Experimental Study of the Hysteresis Model of the Kanchuang Frame Used in Chinese Traditional Timber Buildings of the Qing Dynasty

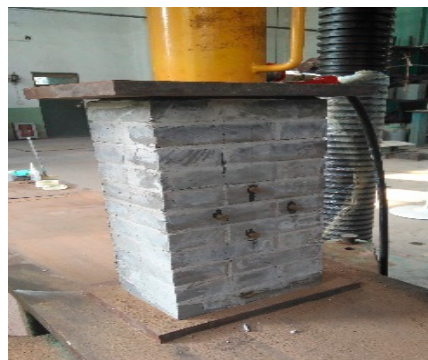
Figure 5. Compressive strength test of the masonry.

Compressive strength tests were also carried out on the brick and masonry samples according to the test method for wall bricks (GB/T 2542-2012) [40] and the standard test method for the basic mechanical properties of masonry (GB/T 50129-2011) [41]. Ten brick samples were made. The dimensions of the bricks were 75 mm × 75 mm × 60 mm (length × width × height). A universal testing machine was used to test the compressive strength of the bricks. The average compressive strength of the brick samples was 9.3 Mpa. The dimensions of the prism in the compression tests including 12 layers of brick and 11 layers of mortar were 130 mm × 200 mm × 415 mm (length × width × height) (see Figure 5). The average compressive strength of the masonry samples was 3.4 Mpa. The average Young's modulus of the masonry samples was 1259 Mpa. Shear stress tests were performed on nine test samples. The test sample was composed of three layers of brick and two layers of mortar. The dimensions of the test sample were 130 mm × 200 mm × 230 mm. The whole operation process was strictly controlled according to the Chinese National Standard (GB/T 50129-2011) [41] (see Figure 6). All of the samples were cured indoors at a temperature of 15–20 °C for 28 days. The test samples were then positioned on the center of the test machine. Steel plates and sands were used to level up the bottom and top of the test sample. Vertical loads were applied by the testing machine, and the strength was calculated according to $f = F/A$ (F is failure load and A is contact area). The average shear stress of nine test samples was 0.041 Mpa (see Table 2).

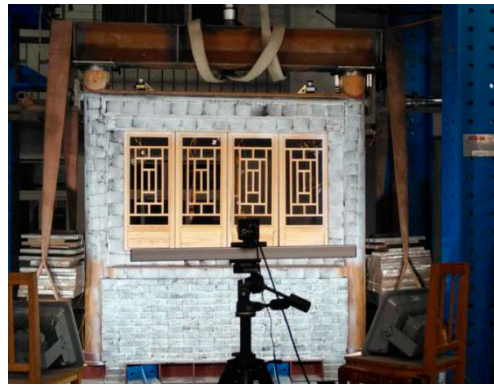
Figure 10. Test setup.

Cyclic loadings were applied using a hydraulic actuator with a displacement range of ± 250 mm. The actuator was positioned at a height of 1.6 m, with a transverse cyclic load with a programmed load cycle. A displacement meter (Displacement meter 3) and a force sensor were used on the actuator. The force versus displacement curves were measured directly. The horizontal cyclic loads were applied under displacement control according to the ISO/FDIS 21581:2010(E) standards [48]. The frame was loaded with three initiation cycles with an amplitude of 3 mm. The amplitude of the second three cycles was 5 mm. The amplitude of the cycles gradually increased by a step of 5 mm until the amplitude was 70 mm. It then increased by a step of 10 mm until the amplitude reached 150 mm. Figure 9 presents the shape of the loading history. An overview of the test setup is shown in Figure 10.

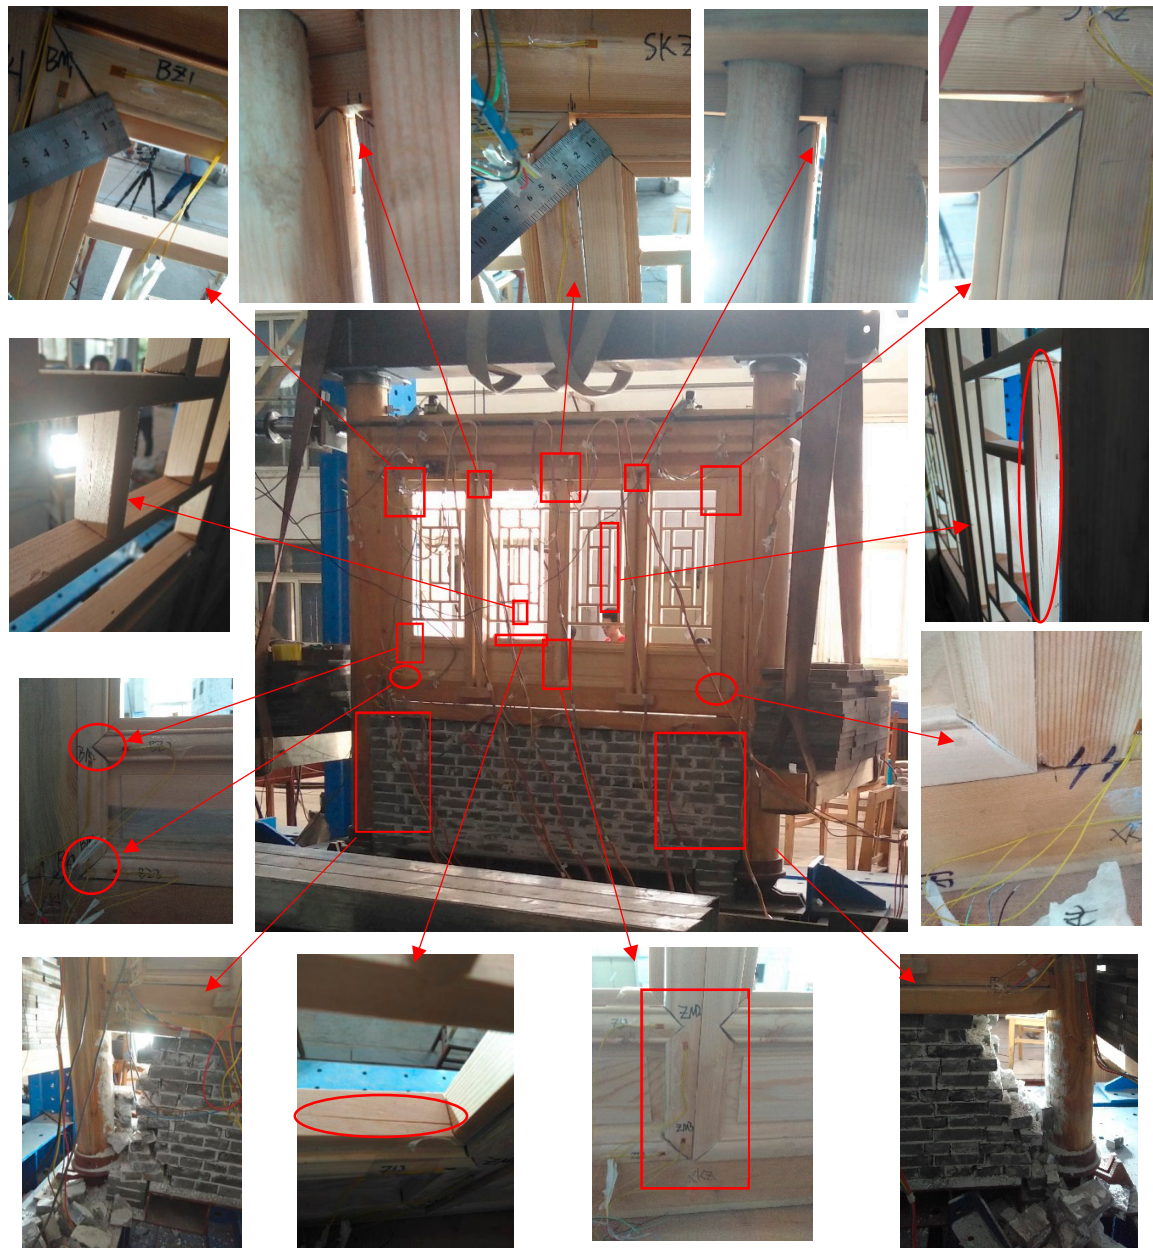
Figure 11. Failure modes of the specimens: (a) crack on the left side of masonry wall at a displacement of 10 mm (the drift angle was $1/160$); (b) penetrating cracks on the right side of the masonry wall at a displacement of 35 mm (the drift angle was $7/320$); (c) the tenons pull out of mortise at a displacement of 15 mm (the drift angle was $3/320$); (d) the tenons pull out of the mortise at a displacement of 30 mm (the drift angle was $7/320$); (e) cracks on the masonry wall at a displacement of 50 mm (the drift angle was $1/32$); (f) failure modes of the specimens at a displacement of 150 mm (the drift angle was $3/32$).

The Kanchuang frame was loaded until the displacement reached 150 mm (the drift angle was $3/32$). Before the 10 mm (the drift angle was $1/160$) cycles, no obvious damage was observed. Cracks primarily appeared in the side area of the masonry wall when the displacement reached 10 mm (see Figure 11). Then, the cracks developed further at an angle of 45° as the displacement increased. X-shaped cracks were formed when the displacement reached 50 mm (the drift angle was $1/32$). Finally, cracks covered the whole wall and collapsed until the displacement reached 150 mm (the drift angle was $3/32$). The tenons of the wood windows started to pull out of the mortise when the displacement reached 15 mm (drift angle is $3/320$). Then, the gap gradually increased as the displacement increased. Finally, the gap reached 3 mm. Cracks appeared on the Lingtiao and Zaibian when the displacement reached 150 mm (the drift angle was $3/32$). Figure 11 shows the final failure pattern.

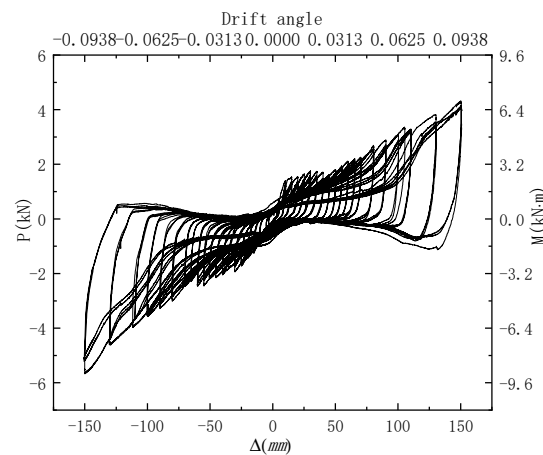
Figure 12. Load–displacement hysteresis curves.

Figure 12 shows the load–displacement hysteretic curves of the Kanchuang frame. The curves were Z-shaped, particularly at the ultimate state. The pinch phenomenon was also shown in the curve. The pinch effect was clear as the displacement and loading cycle increased; it was caused by the plastic deformation of the wood, the pull-out of the mortise–tenon joints, and the crack development of the masonry wall. The peak values of the hysteretic loops increased as the loading displacements increased. The bending capacities of each loading displacement in the first cycle were higher than those in the second cycle. Moreover, the bending capacity of the second cycle was higher than that of the third cycle. This was caused by the accumulation of the damage and strength degradation of the mortise–tenon joints and the masonry wall.

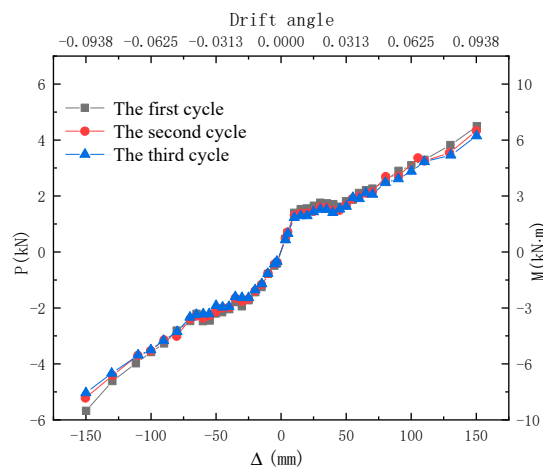
Figure 13. Load–displacement envelope curves.

Figure 13 shows the load–displacement envelope curve of the Kanchuang frame:

- (1) In different displacement cycles, the strength of first cycle was found to be stronger than the second and third cycles. The strength degradation was caused by the crack development and the plastic cumulative deformation of the wood components.

- (2) Both the positive and negative curves followed the same trend up to 25 mm (the drift angle was 1/64) displacement. Before the 25 mm (the drift angle was 1/64) cycles, no obvious damage occurred in the timber components and no penetrating cracks formed on the masonry wall. The whole frame was still in the elastic stage.

- (3) During the 30–65 mm (drift angle during 3/160 and 13/320) cycles, strength degradation began in both the left (negative) and right (positive) loading directions while the load was increasing. This happened because of the failure of the masonry wall, and the tenons were pulled out of the mortises. The penetrating cracks began to appear in the masonry wall, and the crannies became larger as the loading displacement increased. The gaps between mortise and tenon joints of the frame and wood windows increased as loading displacement increased. In the 65 mm (the drift angle was 13/320) cycles, the left and right side of the masonry wall began to collapse. During the loading process, the cracks on the right side (the positive direction) of the masonry wall grew faster than those on the left side (the negative direction) (see Figure 11e). Therefore, the strength degradation of the frame in the positive loading was weaker than that in the negative direction. The whole frame entered the elastoplastic deformation stage.

- (4) After the 65 mm (the drift angle was 13/320) cycles, the stiffness increased in both the right (positive) and left (negative) directions. The stiffness was stronger than that of the 30–65 mm (the drift angle during 3/160 and 13/320) cycles but weaker than that before the 30 mm (the drift angle was 3/160) cycles. This is because the masonry wall failed after the 65 mm (the drift angle was 13/320) cycles, and the components of the timber frames were compressed with each other. The structure reached a new elastic–plastic stage characterized by the increase of the stiffness and the residual deformation of the timber components.

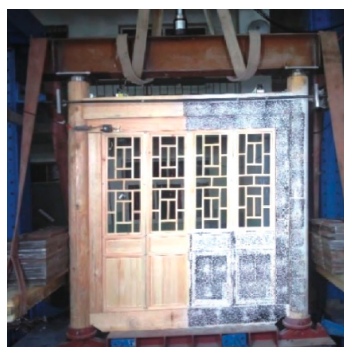
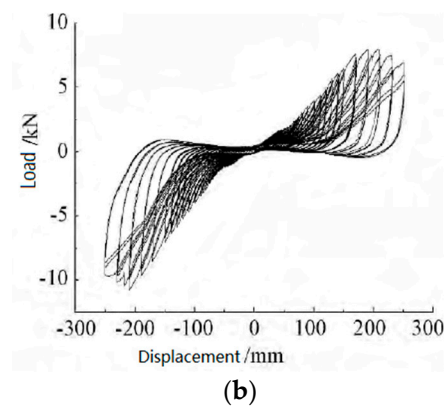
Figure 14. Figures from reference [29]: (a) Test model; (b) hysteretic curves.

Research [29] has been conducted on traditional timber frames with wood plane infill. This frame has been used in ancient timber buildings. The test model was made of *Pinus sylvestris* var. *mongolica*. Figure 14 presents the test model and hysteretic curves of the test model. The peak values of two hysteretic curves at different displacement (drift angle) cycles are different between Figures 12 and 14. This is because the dimensions, structures, wood species and loading positions are different. The peak values (in Figure 14b) decreased while the loading displacement exceeded 200 mm (the drift angle was 1/8). However, the peak values of the Kanchuang frame’s hysteretic curves did not decrease. Both hysteretic curves turned into Z shapes a despite the different dimensions, structures, wood species and loading processes. Both curves showed a degrading trend while the loading cycles increased.

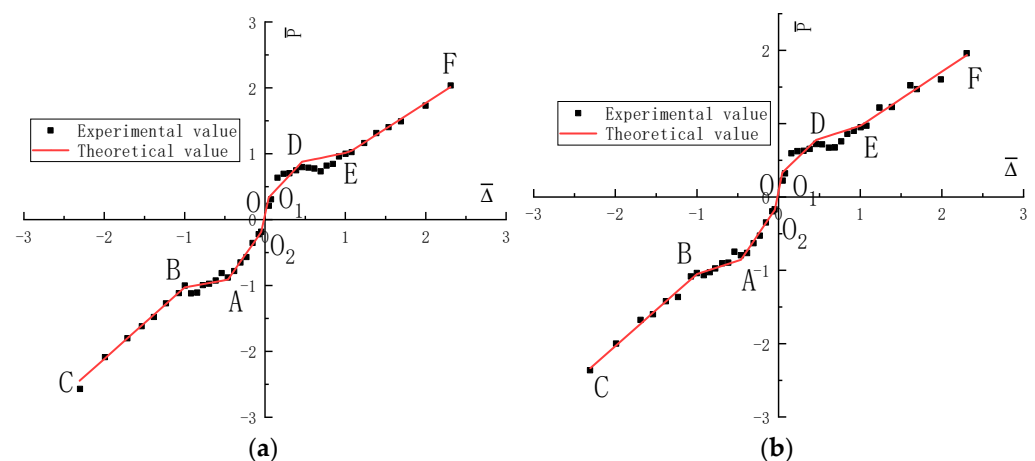
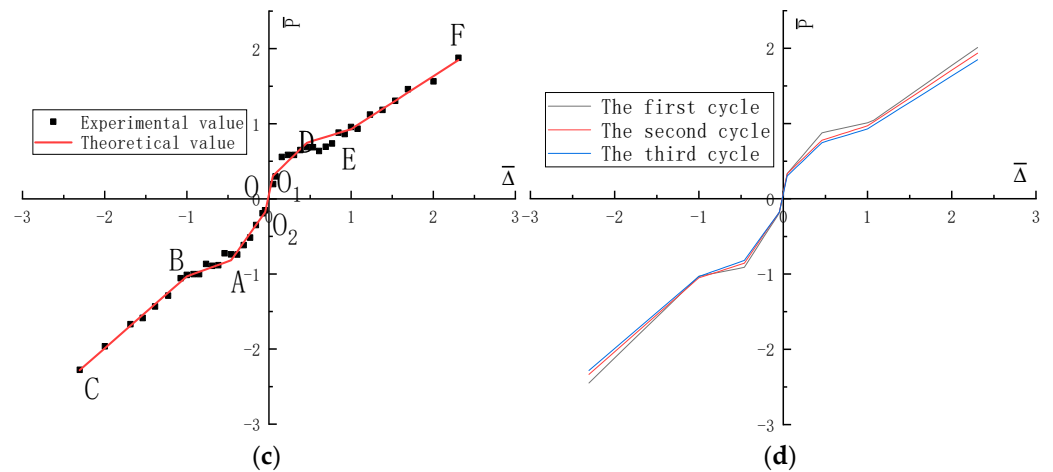
Figure 15. Fitting curves of the skeleton curves of the Kanchuang frame: (a) the first cycle; (b) the second cycle; (c) the third cycle; (d) fitting envelope curves of three cycles.

Δ and P are the loading displacement and the corresponding force. Δ_m^\pm and P_m^\pm are displacements in both the right (positive) direction and the left (negative) direction of the 65 mm cycles and the corresponding forces. Points O1, O2, A, B, D and E are vital points, and points C and F are ultimate loading points (see Figure 15). It was found that the shapes of the dimensionless envelope curves are close to the experimental data points. Table 4 presents the coordinates of the critical points and ultimate loading points; Table 5 shows the regression equations of the fitting envelope curves. The fitted envelope curves (see Figure 15d) indicated a strength degradation trend in the different cycle processes, as is consistent with the test results.
