Analysis of the Recorded Response of a School Building Heavily Damaged by the 2016 Central Italy Earthquake

Abstract: The OSS (acronym of the Italian “Osservatorio Sismico delle Strutture”) is a network of permanent seismic monitoring systems installed on about 150 buildings in Italy. Each system consists of a number of sensors sufficient to completely describe the dynamic response of the structure. Structural typologies have been selected according to their representativeness of the public building stock and to their importance for emergency management. Data available for each building include: structural survey and in situ tests on materials, experimental modal analysis, finite element models and model updating. In the above framework, a school building located in Amatrice, a small town in the meizoseismal area heavily impacted by the 2016 Central Italy earthquake, is one of the buildings instrumented by the OSS; thus, its monitored dynamic response, including that under the main shock, is available. The building showed diffused huge damage with partial collapses. Firstly, a linear finite element model is used in the interpretation of small amplitude vibrations in order to give

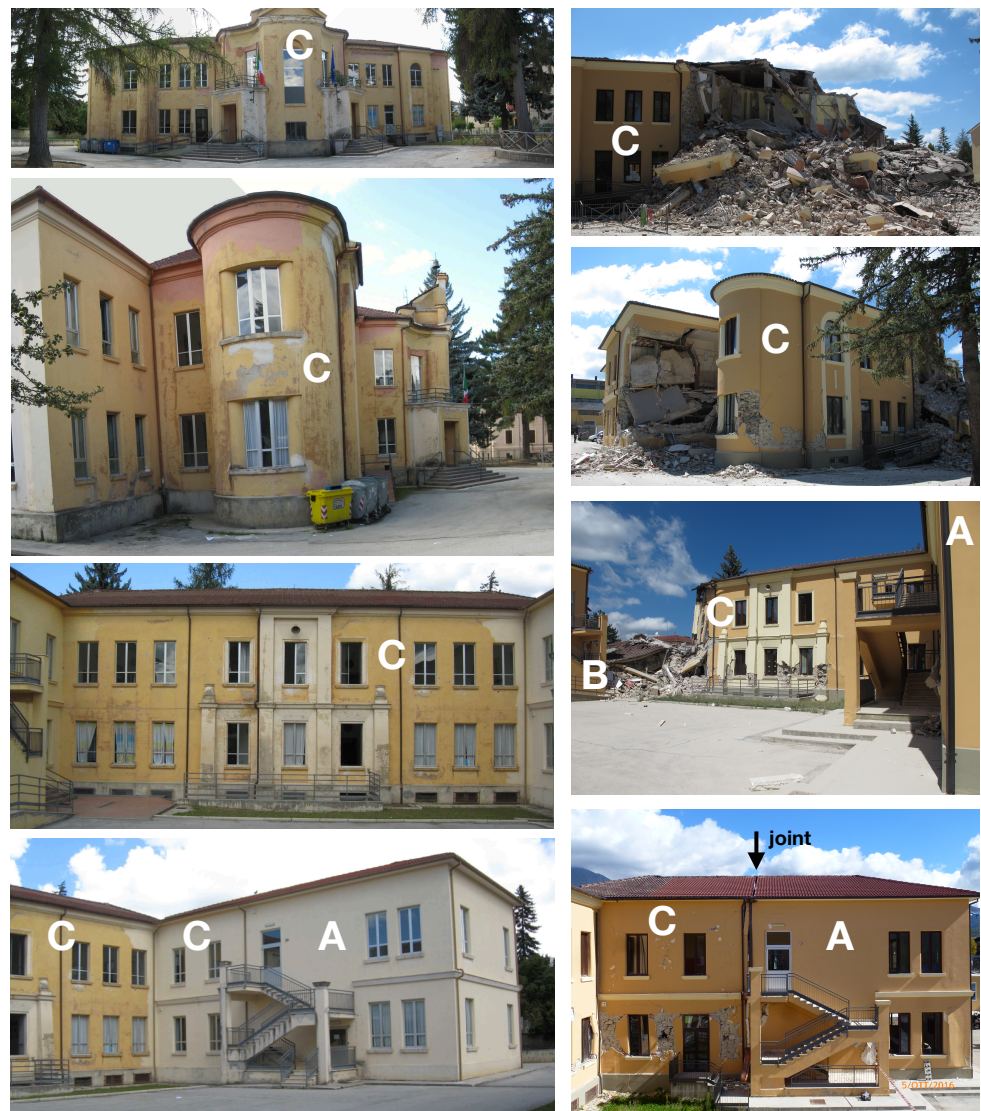
After the main shock of the 24 August 2016 earthquake, in the following simply denoted as the 2016 earthquake, the conditions of the buildings were as depicted in Figure 2. Building C underwent a partial collapse, involving the portion of the building having an underground level (Figures 2 and 4). The remaining portion of the building showed very heavy damage, with several diagonal cracks in the walls and an overturning of a facade owing to out-of-plane actions. Buildings A and B showed relevant damage to infills and partitions without collapse and moderate damage to structural elements. Damage was also evident to the joints between buildings C and A, where the tiles collapsed and a 15 cm opening appeared (see bottom picture of Figure 2).

Figure 2. Views of the buildings before (left) and after (right) the 24 August 2016 earthquake; the letters refer to the nomenclature of the buildings reported in Figure 1b. The photographs on the left were taken prior to the 2012 interventions.

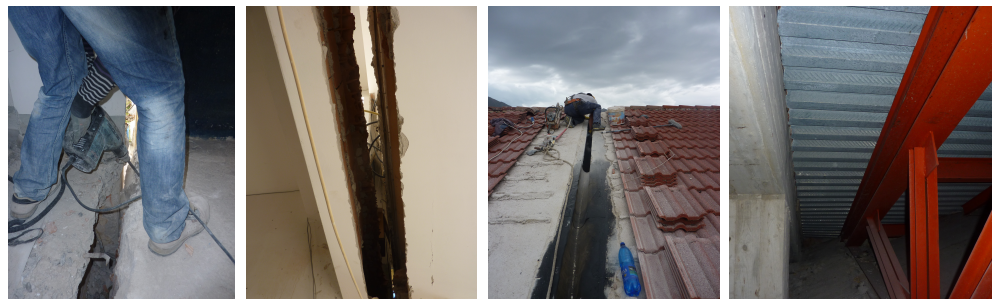
Figure 3. Details of the structural joints upgraded during the 2012 interventions (from left to right): increment of the distance between floor slabs; effective distance between floor slabs visible after the interventions; waterproof layer on the joint between two roof slabs; corrugated steel sheet between adjacent buildings A and C under the joint (photo courtesy of R. Amici).

Special attention must be paid to the dimensions of the structural joints between buildings A, B and C. At the time of the construction of both buildings A and B, a minimum joint dimension of 1% of the height with respect to the foundations was enforced. This corresponds to nearly 10 cm for building A and 12 cm for building B. According to the code [26] applicable for the 2012 interventions, the 1% minimum joint dimension must be multiplied by a factor depending on the site seismicity, corresponding to a 30% increment of the previously reported values. In 2011, some tests on all buildings concerning material properties, structural details, and, in particular, the joints between buildings C, A and B were performed by DPC. As documented in Figure 3 during the 2012 seismic upgrading of buildings A and B, the structural configurations of the joints were checked at all levels. At the roof level, in order to avoid damage to the tile layer in ordinary conditions, a weak connection was built to sustain the nonstructural elements. The performance of the structural joints will be discussed in the following on the basis of the recorded quantities.

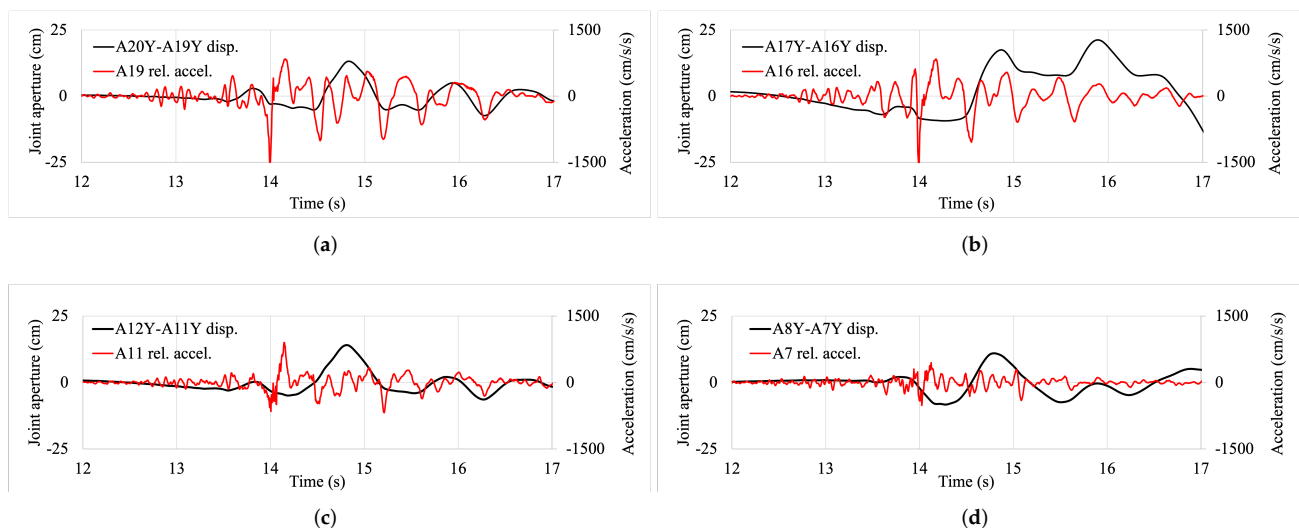
A special attention, for this aggregate, must be paid to the behaviour of the structural joints. The recorded opening of the joints at each level is reported in Figure 10. At first glance, the relative displacement curves are not symmetric: the closure is always smaller than the opening. Very high values of opening before the collapse of about 15–20 cm were registered. During the first relevant cycle, all joints tend to close and, especially at the roof level, acceleration impulses can be observed, reasonably due to the rupture of the light structures supporting the tiles. The results suggest that the minimum joint dimension, as enforced by the current Italian code, should be improved if pounding between adjacent buildings is judged to be avoided even under very severe earthquakes.

Figure 10. Time histories of the structural joint openings (in cm) between masonry and RC buildings (black curves) and of the relative (with respect to the ground) accelerations (red curves, in cm/s^2): (a) level 3, joint near sensor A19; (b) level 3, joint near sensor A16; (c) level 2, joint near sensor A11; (d) level 2, joint near sensor A7. Sensor locations are reported in Figure 4.

A special attention has been paid to the behaviour of the structural joints. It can be observed that the relative displacement curves are not symmetric: the closure is always smaller than the opening, which reached high values of about 15–20 cm, greater than the gap required by the current seismic code. This result suggests that this minimum joint dimension should be improved if pounding between adjacent buildings is deemed to also be avoided under severe earthquakes.
