Article

Load versus Strain Relationships of Single and Continuous Span Full-Scale Pre-cast Prestressed Concrete Girders for Monorail Systems

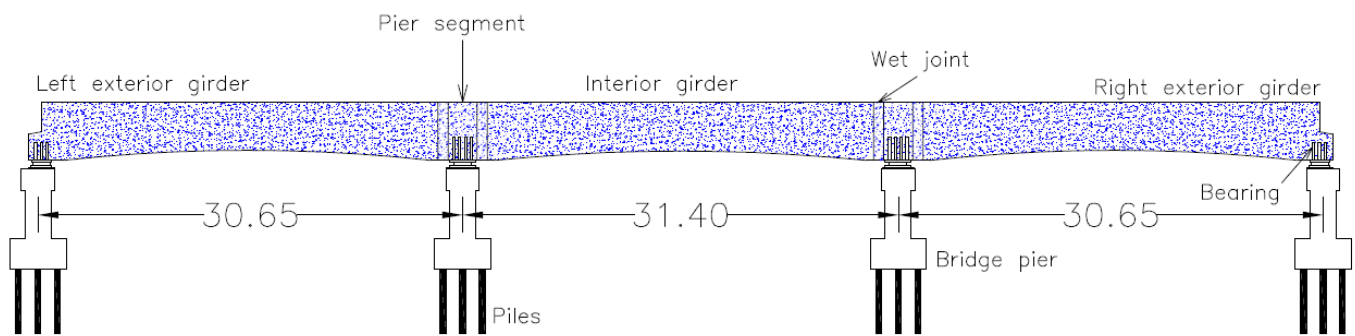
Figure 1. Typical details of test specimen (SP-1).

Three different full-scale precast post-tensioned (FPP) girder specimens were tested. Considered girders simulated the actual design, size, and construction details of the girders for the newly proposed straddle monorail system. One of the specimens (SP-1) contained three reinforced concrete (RC) hollow haunched girders, two pier segments, four piers, four wet joints, and four bearings at each support, as shown in Figure 1. Two of the exterior spans simulated the response of exterior girders, while the middle span mimicked an interior span. Right and left exterior spans were 30.65 and 31.4 m, respectively. Both the exterior spans were constructed with similar construction details. Cross-sectional dimensions of the girders at the ends were 690×2000 mm, which were gradually haunched to achieve a cross-section of 690×1600 mm at its mid span. The size of the hollow opening in the middle of the girders was 270×1100 mm. The Interior girder had a total length of 30 m, with sectional details similar to those of the exterior girders. Internal supports were achieved through a combination of wet joints and pier segments, while girders were directly supported on external piers/supports. Each pier segment was $1000 \times 690 \times 2000$ mm (length \times width \times height). The increased bond strength between wet joints and pier segments was achieved by means of special shear keys. The empty space between girders and pier segments was grouted with a high-strength non-shrink cement grout to attain a wet joint of 20 cm in length. However, its width and depth were kept identical to those of the adjacent girders. Bearings were provided between each pier segment and its underneath pier. The second specimen SP-2 replicated the cross-sectional and reinforcement details of the interior girder of specimen SP-1. There were no wet joints provided and SP-2 rested directly onto pier segments. Similar to girders, pier segments, bearings, and piers were also identical to those provided in specimen SP-1. The third specimen SP-3 was intended to simulate the response of the exterior girders of specimen SP-1, with similar construction and reinforcement details, as well as identical support details. Further details of cross-sections, reinforcement, and post-tension tendons (PT) can be found in previous studies [14,15].

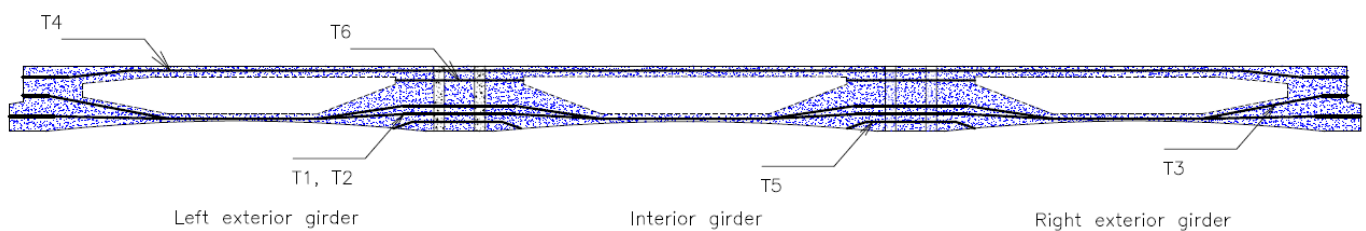
Figure 2. Details of post-tension tendons.

The continuity of the specimen SP-1 was accomplished by means of four post-tensioned tendons (T1, T2, T3, and T4), as shown in Figure 2. In addition to this, short tendons T5 and T6 were also provided with a bifold purpose: to achieve a connection between exterior and interior girders and to resist negative moments at the interior supports. Proper placement and alignment of post-tensioned tendons were accomplished using special-purpose steel plates and grips, as depicted in Figures 3 and 4.

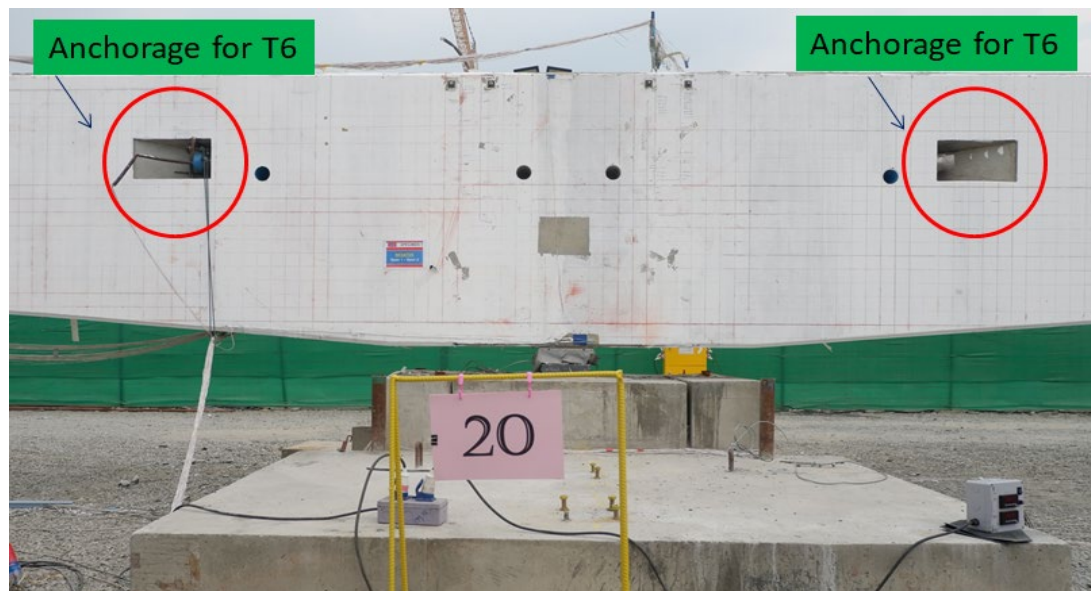
Figure 3. Anchorage for T6.

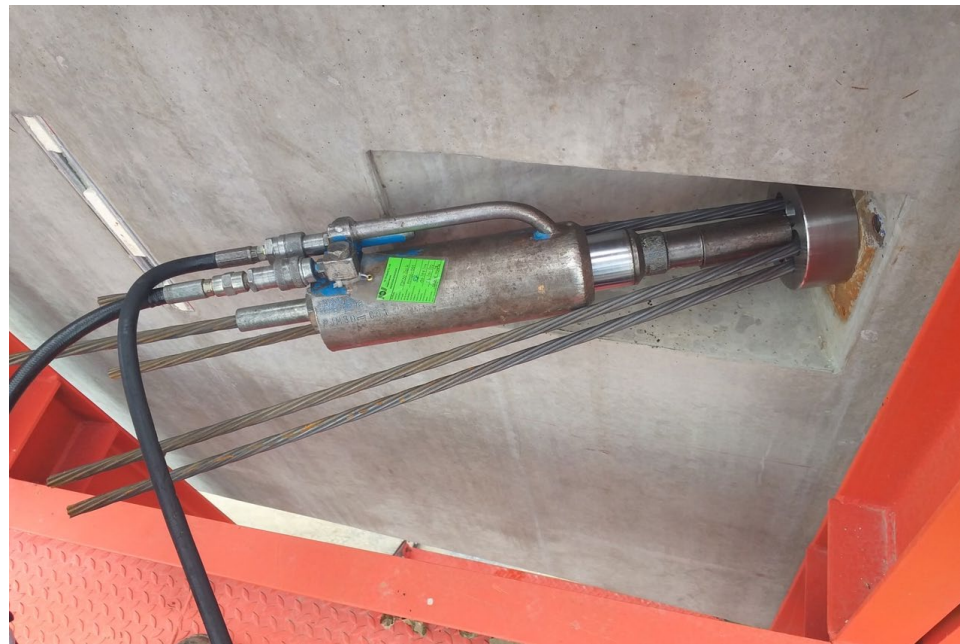
Figure 4. Application of tension to the PT tendons.

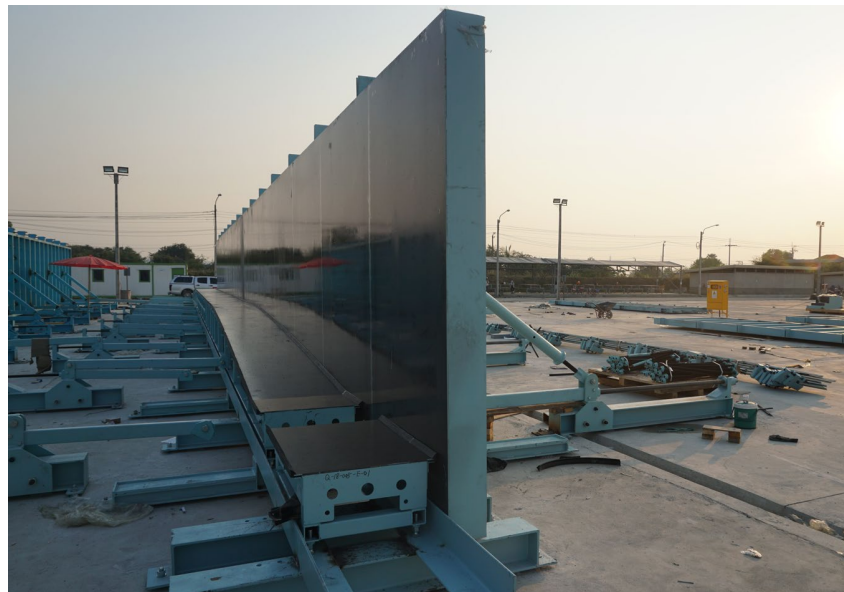
Figure 5. Typical view of formwork.

Construction of all three specimens was carried out in a similar manner. Therefore, this section summarizes the construction method for specimen SP-1 only. Both the construction and testing were carried out at the site of Sino-Thai Engineering and Construction Public Company Limited (STECOM), located in Saraburi Province, Thailand. A special steel formwork was prepared to achieve the haunching of the girders. The bottom arch of the girders was achieved by providing a bottom haunch at the middle of the formwork, as shown in Figure 5. A steel cage for reinforcement was prepared separately and placed in the formwork by means of a crane after its completion. Inside, the hollow section of the girders was accomplished by adding a special foam into the steel reinforcement. High-strength concrete was then poured into the formwork. Steel formwork was removed 12 h after concrete placement while curing was continued for 28 days in ambient conditions. It is to be mentioned that the construction of pier segments and piers was conducted parallel to the construction of girders. A total number of 4 and 12 foundations was constructed to support three girders of specimen SP-1 and reaction frame, respectively. For the specimens SP-2 and SP-3, two and four foundations were constructed for the single girder and reaction frame, respectively. All foundations consisted of precast piles driven into the ground using a pile hammer, as shown in Figure 6a. Pile caps were introduced at the top of piles to facilitate the load transfer from top to bottom (Figure 6b). In the case of foundations of reaction frames, steel bolts were embedded in pile caps to fix the reaction frame, as shown in Figure 6c. For the case of piers, a column, with height of 1000 mm, was constructed at the top of the pile cap to support pier segments. In this study, special-purpose bearings were used to connect girders of all test specimens, i.e., SP-1, SP-2 and SP-3. Two types of bearings, fixed and free bearings, were used, as shown in Figure 7. The function of both bearings is identical, except that movement in the transverse direction was restrained in fixed bearings. For specimen SP-1, fixed bearing was used only at one end for support and free bearings were provided at the remaining supports, whereas in the case of specimens SP-2 and SP-3, one fixed and one free bearing was used at end supports. Once foundation work was finished, piers and girders were installed and aligned accurately. Then, post-tensioning was performed after placing continuous stands through all girders. This step was not carried out for specimens SP-2 and SP-3. Finally, wet joints were constructed and post-tensioning ducts were filled with high-strength non-shrink cement grout.

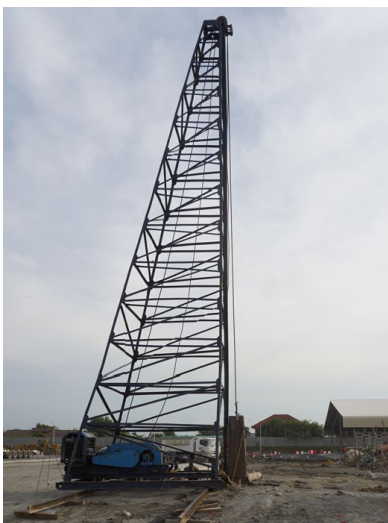
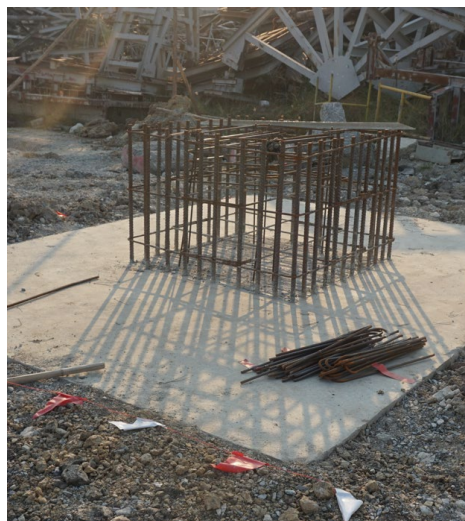
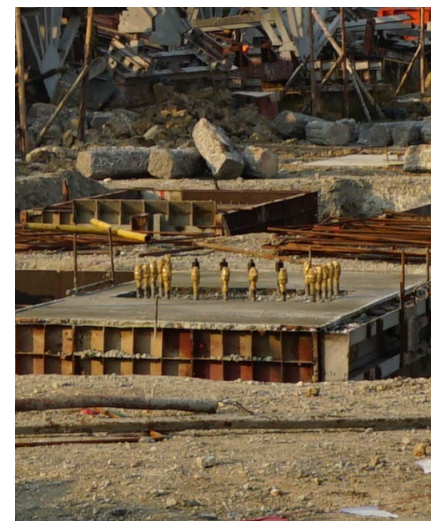
Figure 6. Construction details of foundations: (a) driving piles, (b) pile cap, and (c) steel bolts.

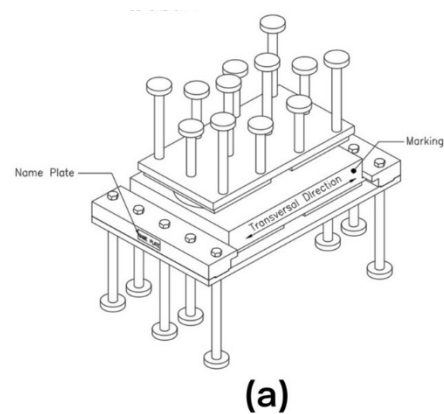
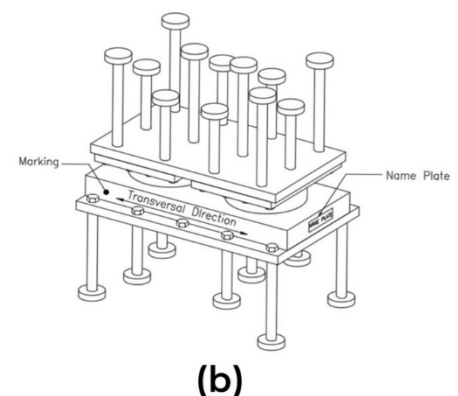
Figure 7. Details of bearing: (a) fixed bearing and (b) free bearing.

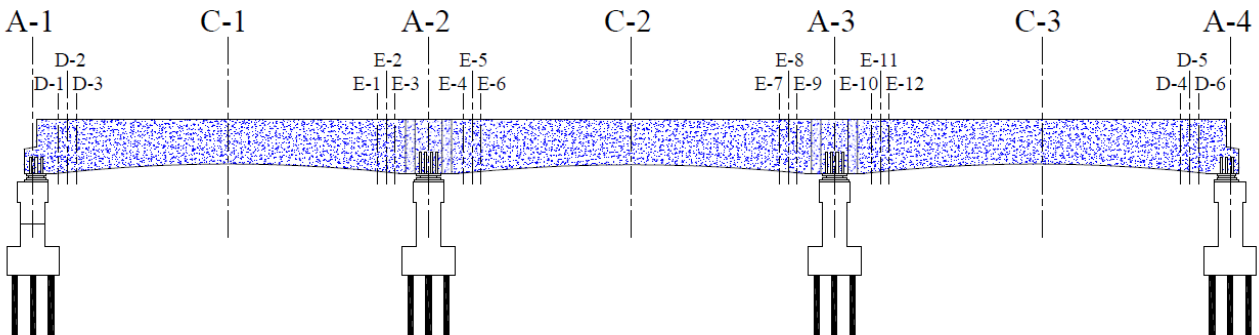
Figure 8. Details of locations for strain gauges (SP-1).

In this study, strain gauges were installed on longitudinal steel bars, vertical stirrups (shear reinforcement), and post-tension (PT) tendons for each specimen at different locations. For specimen SP-1, the locations are graphically shown in Figure 8. The locations for both specimens, i.e., SP-2 and SP-3 are shown in Figure 9. In specimen SP-1, strain gauges for longitudinal steel bars (LG1) were installed at locations C1–C3 and E1–E12 (Figure 10), whereas in the case of specimens SP-2 and SP-3, strain gauges for longitudinal steel bars (LG1) were installed only at the middle of the span, i.e., C1. Further, at each location, four strain gauges (two strain gauges at top longitudinal and two strain gauges at bottom longitudinal steel bars) were installed, as shown in Figure 11a. The strain gauges at the top and bottom were recognized by the letters “T” and “B”, respectively. At the top and bottom, two strain gauges were used: one at the front side and one at the back. Therefore, the letters “F” and “K” were used to recognize strain gauges at the front and back, respectively. For instance, “TF” refers to the strain gauge on the front side of the top of the girder. The strain gauges (SG1) for vertical stirrups were installed at end locations of each girder in each specimen, i.e., D1–D6 and E1–12. Further, the strain gauge at the front side was referred to with letter F and strain gauge at the back side was referred to with K (Figure 11b). Further, to measure the strain of PT tendons, the strain gauges (TG1) were installed at PT tendons at different locations. In specimen SP-01, the strain gauges at PT tendons were installed at locations C1–C3, A2, and A3, whereas in specimens SP-2 and SP-3, strain gauges at PT tendons were installed only at the middle location C1. Although in this study, PT tendons comprised a 7-wire strand, only four strain gauges were installed due to their high cost, as shown in Figure 11c. It is pertinent to mention that in Figure 11a,b, XX shows the location of strain gauges, while in Figure 11c, XX also shows the location of the strain gauges. However, TX shows the number of PT tendons. These notations are represented for the convenience of the readers so that multiple repetitions can be avoided throughout the manuscript henceforth.

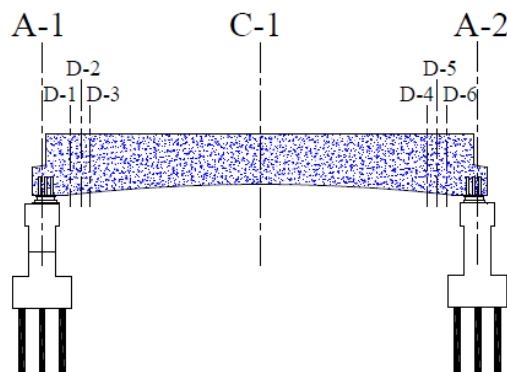
Figure 9. Details of locations for strain gauges (SP-2 and SP-3).

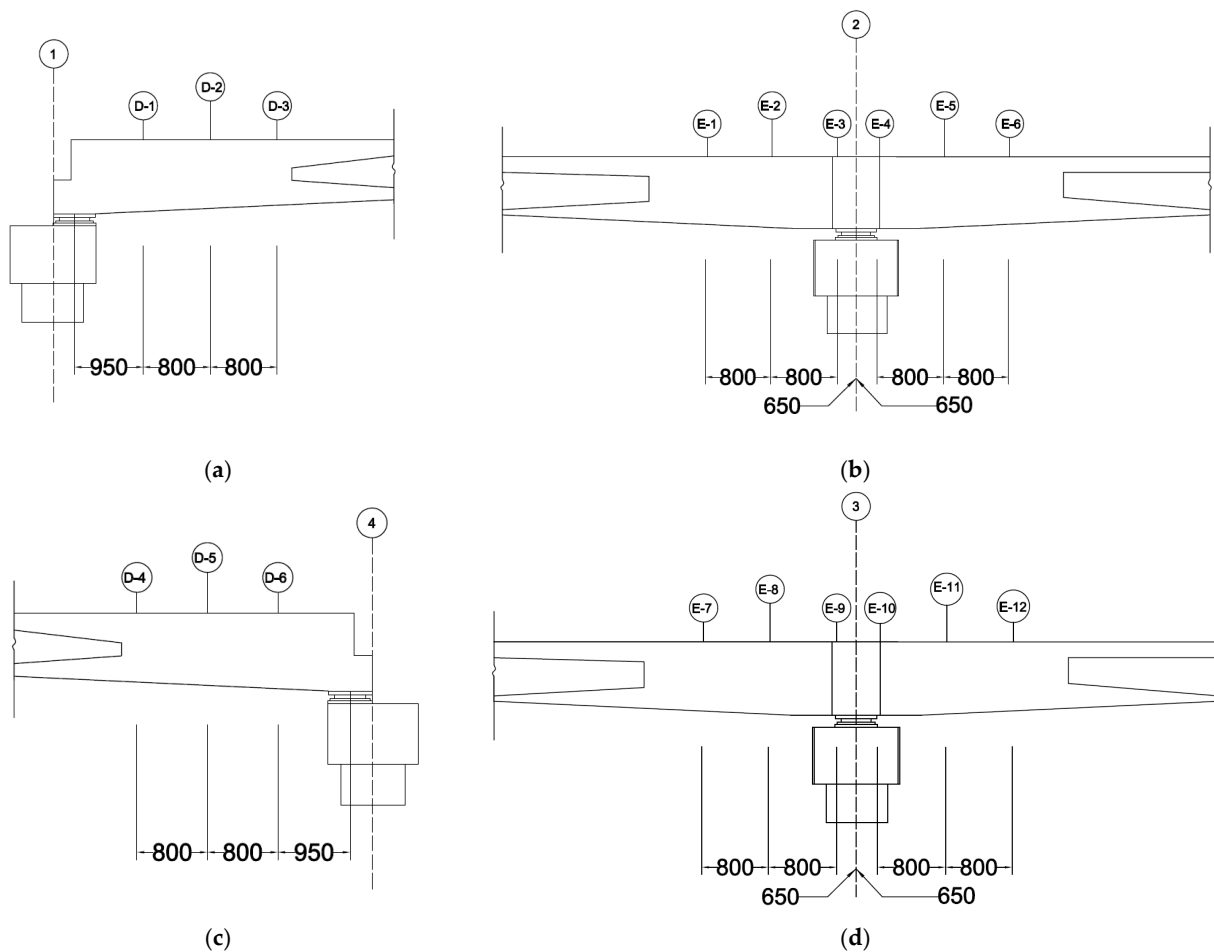
Figure 10. Details of end sections at locations (a) A-1, (b) A-2, (c) A-3 and (d) A-4 (units: mm).

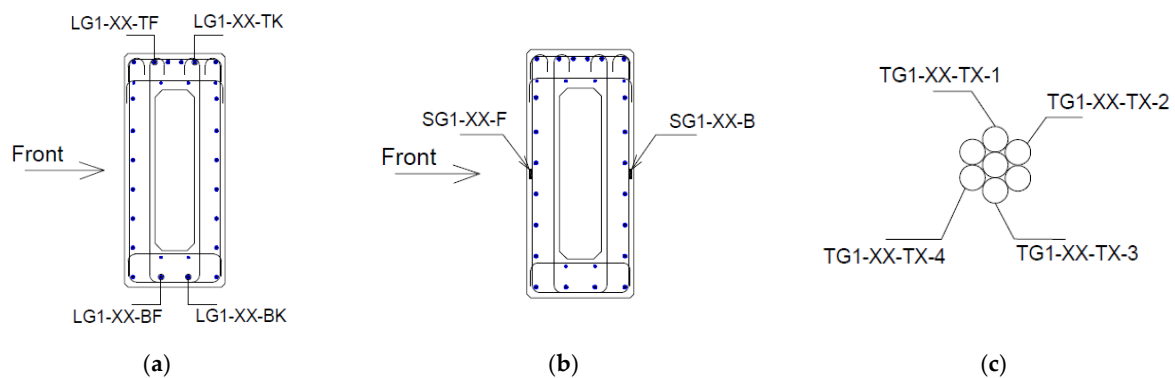
Figure 11. Details of strain gauges (a) LG1, (b) SG1, and (c) TG1.

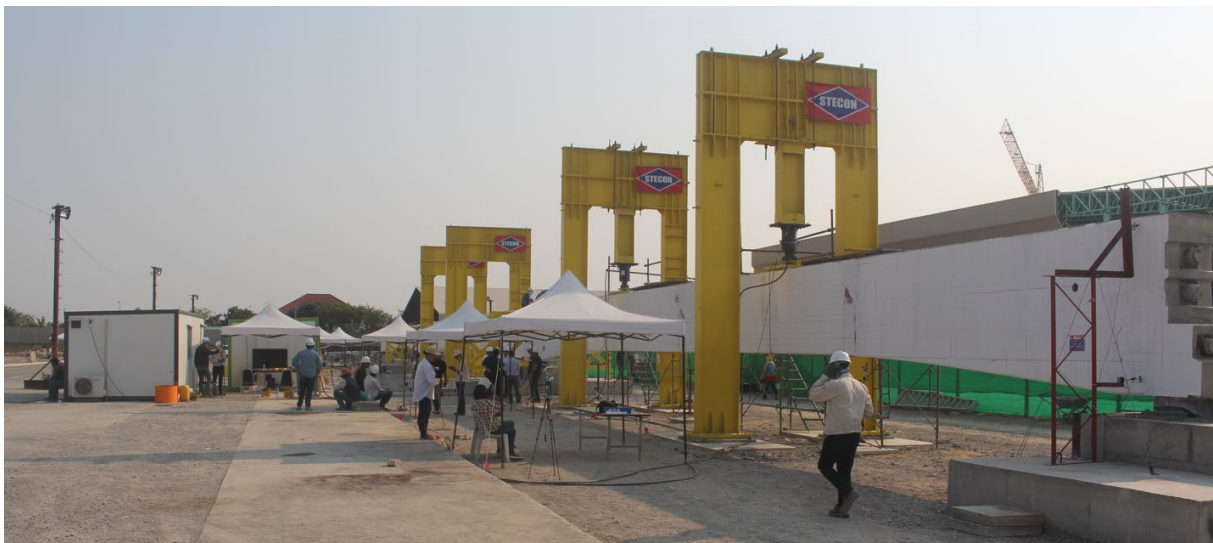
Figure 12. Typical load setup SP-1-L03 and SP-1-L04.

Specimen SP-1 was subjected to four types of loadings to analyze its structural performance, both within serviceability and ultimate states. The first type of loading included a two-point load applied at the right exterior girder with a magnitude limited to the service limit. The second type of loading was also a two-point service load, but its point of application was the interior span. The third type of load was a four-point loading with magnitude limited to service load. However, the points of application were two points each on the left exterior and interior spans, as depicted in Figure 12. The last loading was similar to the third loading type. The only difference between the third- and fourth-point loading

was the magnitude of loading, which was increased to the ultimate state in the fourth type. Four types of loading setup will be referred to with SP-1-L01, SP-1-L02, SP-1-L03, and SP-1-L04 for the first, second, third, and fourth loading types. Loadings on specimens SP-2 and SP-3 were of two types. In the first type, a two-point load was applied up till the service limit, while it was increased to the ultimate state in the second type. It is worth mentioning that the service limit of the load was set corresponding to the onset of longitudinal steel bar strains, equivalent to 50% of their yield values. A two-point loading setup on specimen SP-2 is shown in Figure 13. Loading setups for specimen SP-2 are referred to with SP-2-L01 and SP-2-L02 for first and second loading types, respectively. Similarly, designations SP-3-L01 and SP-3-L03 are used for first and second loadings on specimen SP-3, respectively. A typical loading setup of specimen SP-3 is shown in Figure 14. Additional details on loading setups can be found in previous studies [14,15].

This load corresponds to the application of a four-point service load at the interior and left exterior spans, as shown in Figure 12. In this loading setup, a linear relationship between load and strain was observed at all locations, as shown in Figure 17. At locations E1–E3 (exterior face of the left interior support), maximum positive and negative strains were approximately 120 microns, as shown in Figure 17a. At locations E4–E6, maximum positive and negative strains recorded at this position under four-point service load were limited to 105 and 110 microns, respectively, as shown in Figure 17b, whereas, at locations E7–E9, maximum strains recorded at this position were quite low, as compared to strains at other locations under the same load. Both positive and negative strains were limited to 50 microns (see Figure 17c), substantially lower than the yield strain. At location C1, maximum positive and negative strains were limited to 75 and 90 microns, respectively (see Figure 17d), under a four-point service load. At location C2, the maximum positive strain recorded at location C2 and under four-point service load was limited to 90 microns, while its corresponding negative recorded value was 105 microns, as shown in Figure 17e. It is worth mentioning that strain values recorded at this position and under two-point service loads were significantly higher, reaching around 190 microns.

Under this setup, a four-point load was applied until the ultimate state to the interior and exterior spans of specimen SP-1 (Figure 12). At locations, E1–E3, the maximum positive strain recorded was around 1800 microns, which is less than the yield strain of steel bars. On the negative side, the maximum recorded strain was limited to 950 microns (see Figure 18a). At locations E4–E6, maximum positive and negative strains recorded at the interior face of the left interior supports were 1500 and 800 microns, respectively, as shown in Figure 18b. These strains were found to be significantly higher than those recorded under the same loading setup with load limited to service limits, whereas, at Locations E7–E9, maximum positive and negative strains recorded at the interior face of the right interior support were 200 and 350 microns, respectively, as shown in Figure 18c. At location C1, maximum strains obtained in both directions were limited to 750 microns, significantly lower than the yield strain (see Figure 18d). On the other hand, at location C2, the maximum positive recorded strain was lower than that recorded at location C1. However, the negative strain

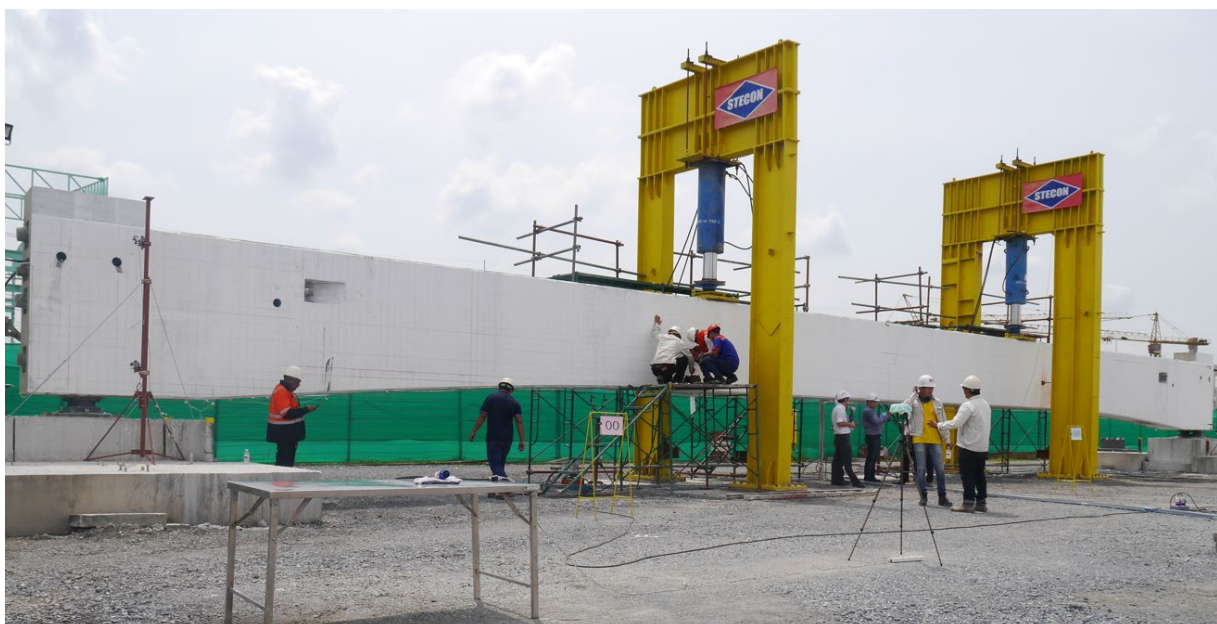
Figure 13. The two-point load applied to specimen SP-02.

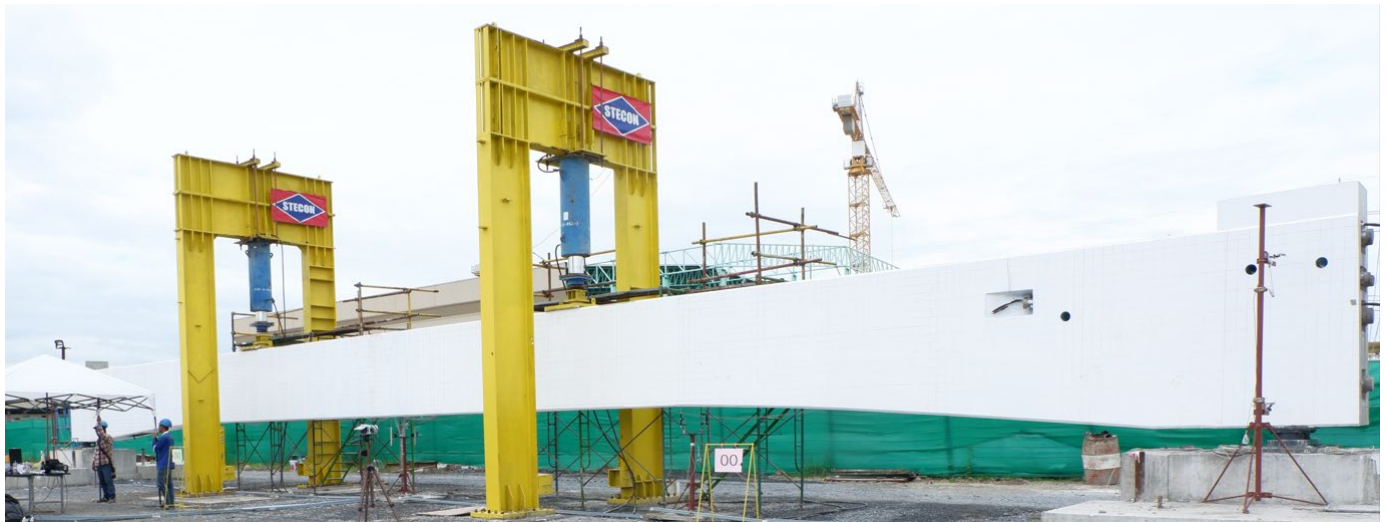
Figure 14. The two-point load applied to specimen SP-02.

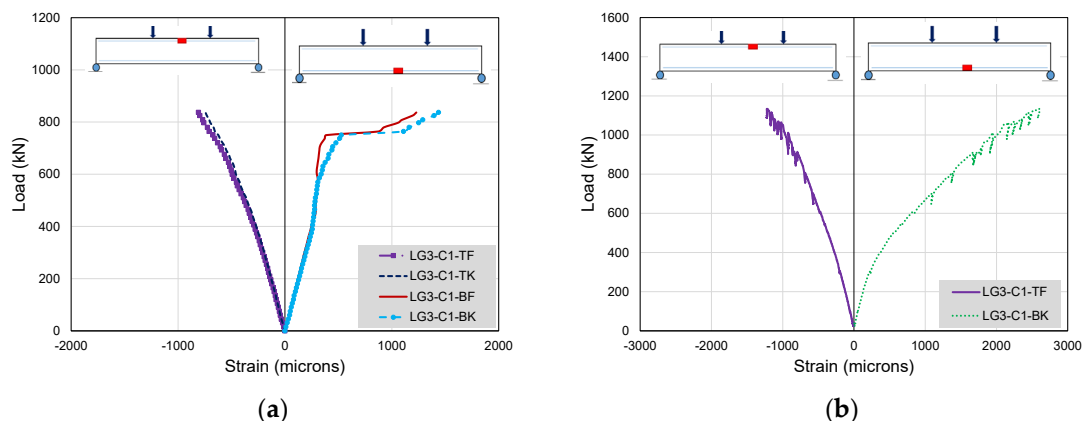
The loading setup for specimen SP-3 was similar to that of specimen SP-2. Two types of loading were applied. Firstly, the maximum load was limited to service load, while the load was increased to the ultimate state in the second type. In load setup SP-3-L01, the maximum load was limited to the service load. Maximum positive and negative strains recorded were lower than the yield strain with corresponding values of 1470 and 800 microns, respectively, as shown in Figure 20a, whereas for the load setup SP-3-L02, the load was increased to the ultimate load. As seen in Figure 20b, the maximum positive strain was around 2500 microns, which is higher than the yield strain of steel bars. However, a similar value of negative strain was not observed as the maximum value was limited to only 1200 microns.

Figure 20. Strain versus load responses (a) load setup SP-3-L01 and (b) load setup SP-3-L02.

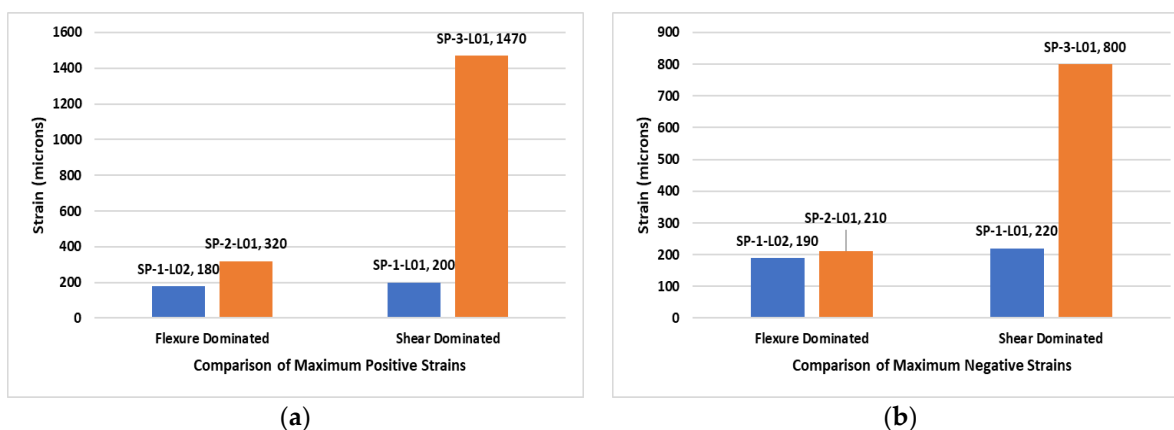
Loading types SP-1-L02 and SP-2-L01 refer to the application of two-point service load to the interior span of specimen SP-1 and specimen SP-2, respectively. The comparison is made possible since both the interior span of specimen SP-1 and specimen SP-2 were supposed to dominate in flexure. Maximum positive and negative strains recorded for loading setup SP-2-L01 were 320 and 210 microns, respectively (see Figure 21a). It is evident that under service loads, maximum positive strains recorded in the interior span of continuous girder were lower than those recorded on longitudinal steel bars of a single-span girder (see strains for SP-1, for instance). A similar trend was observed for negative strains as well, as presented in Figure 21b.

Figure 21. Comparison of strain under two-point service load (a) positive and (b) negative strain.

Specimen SP-3 was designed to dominate in shear. Therefore, its comparison was made with the response of exterior girders of specimen SP-1. Under two-point service load conditions, corresponding loading setups for specimen SP-1 and SP-3 were SP-1-L01 and SP-3-L01, respectively. Analogous to the flexure-dominated specimen, maximum positive and negative strains recorded in shear-dominated specimen SP-3 were significantly higher than their counterpart strain values recorded in specimen SP-1. The results are presented in Figure 21a,b for positive and negative strains, respectively.

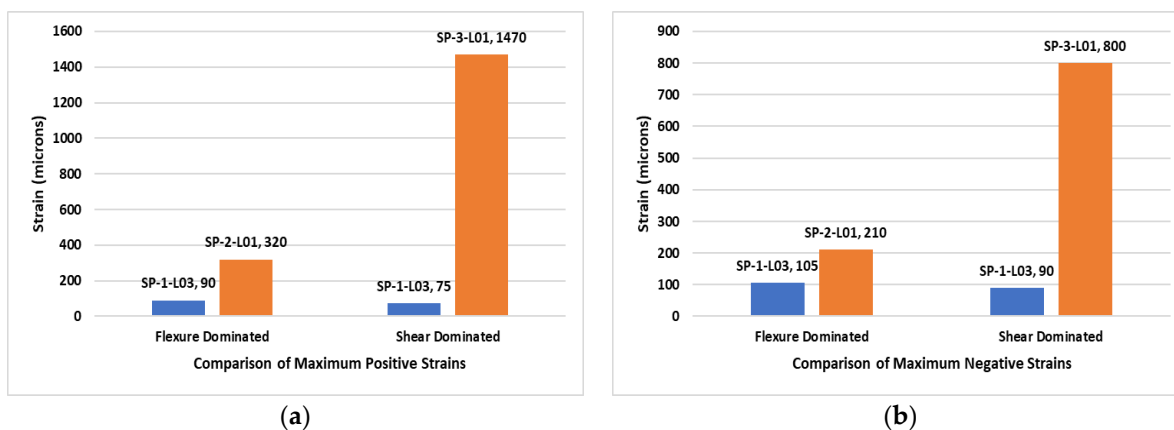
The transition from two-point to four-point loading did not significantly change the trend, as was observed for the loading SP-1-L01 and SP-1-L02. Strains monitored at

the interior span of specimen SP-1 were noticeably lower than their counterpart values measured in specimen SP-2 under service loads. This trend was held for both positive and negative strains, as shown in Figure 22a,b.

Figure 22. Comparison of strain under four-point service load (a) positive and (b) negative strain.

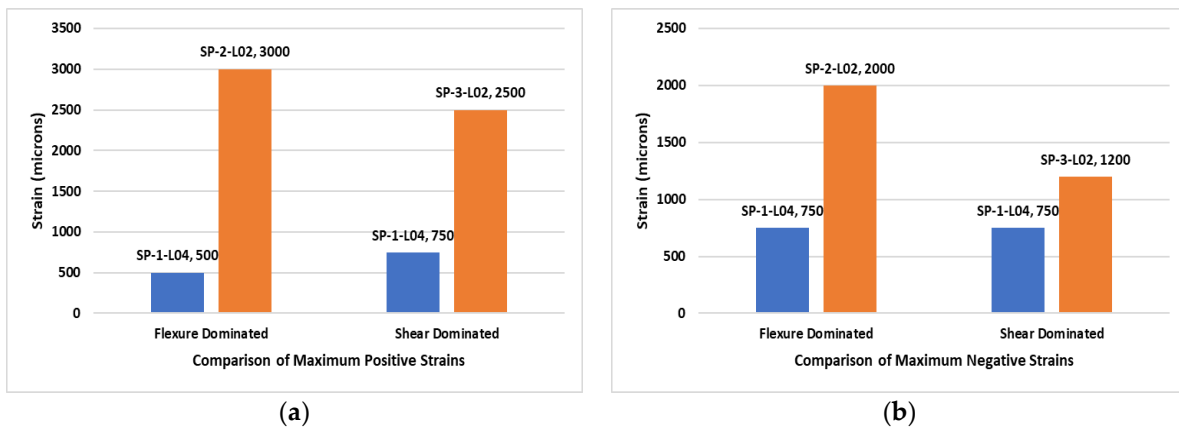
Load setup SP-1-L04 corresponds to a four-point ultimate load applied to the interior and left exterior spans of specimen SP-1, while load setup SP-2-L02 represents a two-point ultimate load applied to specimen SP-2. As shown in Figure 23a,b, maximum positive and negative strains for SP-1-L04 were 500 and 750 microns, respectively. On the other hand, maximum positive and negative strains for SP-2-L02 were 3000 and 2000 microns, respectively. This agrees with previous load cases, as longitudinal steel strains recorded in continuous girder SP-1 were found to be significantly lower than those recorded in specimen SP-2 under similar load conditions.

A similar trend to that of flexure-dominated specimens was also observed in the shear-dominated specimen. Load setup SP-3-L02 corresponds to a two-point ultimate load subjected to specimen SP-2, which was designed to dominate in shear. However, results from Figure 23a,b confirm that longitudinal steel strains are significantly overestimated in single-span girders, which incorporated similar structural details to those of the exterior girders of specimen SP-1. Despite having similar structural details and loading conditions, strains recorded in the single-span shear-dominated specimen (i.e., specimen SP-3) reached almost double the values of those recorded in specimen SP-1.

Figure 23. Comparison of strain under four-point service load (a) positive and (b) negative strain.

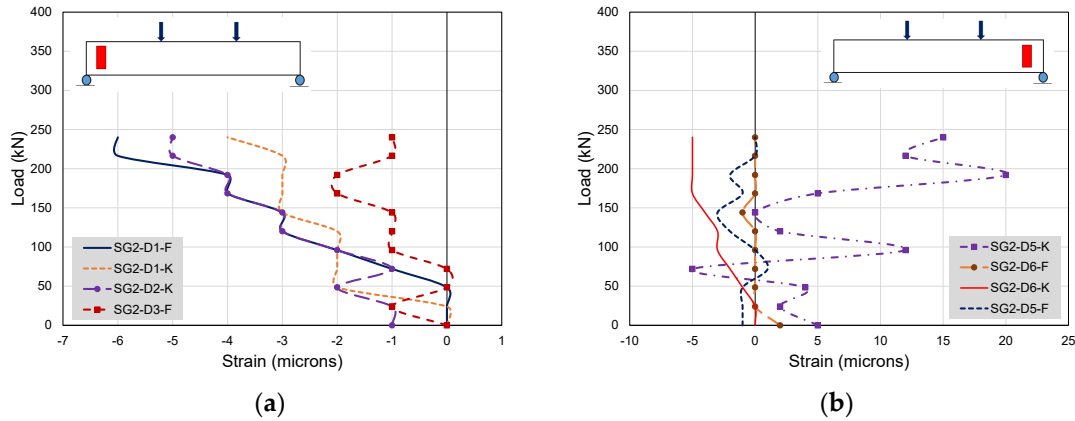
70 microns, respectively. Some strain gauges, such as SG2-D1-F and SG2-D5-K, showed negative values. However, the small values of strain suggest that specimen SP-2 did not experience significant shear demand even under ultimate loads.

Figure 28. Load versus strain responses in load setup SP-2-L01 (a) D1–D3, and (b) D5–D6.

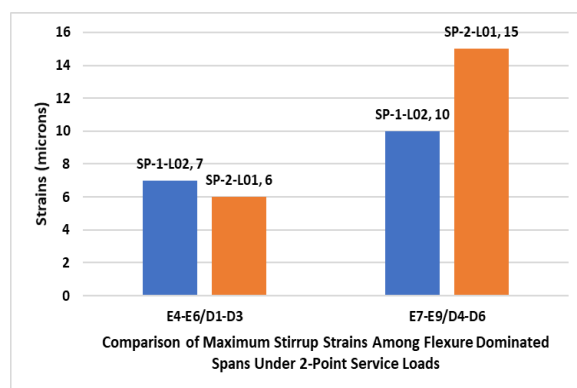
This section presents a comparison of maximum stirrup strains monitored among three specimens. The comparison is made on the basis of the resemblance between the loading type and span's attributes. For instance, loading SP-2-L01 refers to a two-point service load applied to specimen SP-2, which was designed to dominate in flexure. Corresponding strain components in a three-span specimen are found under the loading type SP-1-L02, i.e., two-point service load applied to the interior span of specimen SP-1.

Figure 32. Comparison of maximum stirrup strains recorded for loading setup SP-1-L02 and SP-2-L01 under two-point service loads.

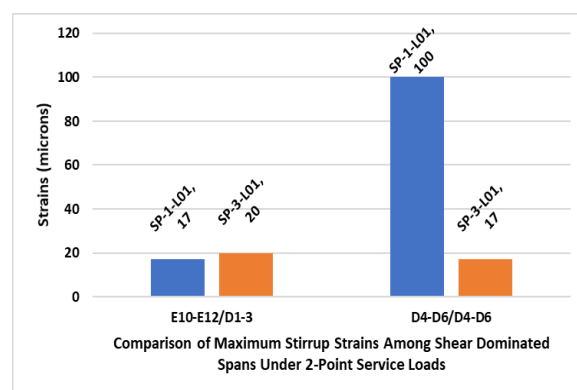
shear strain at position D4–D6 in specimen SP-1 was approximately six-times higher than that recorded at the corresponding position in specimen SP-3, as shown in Figure 33.

Figure 33. Comparison of maximum stirrup strains recorded for loading setup SP-1-L01 and SP-3-L01 under two-point service loads.

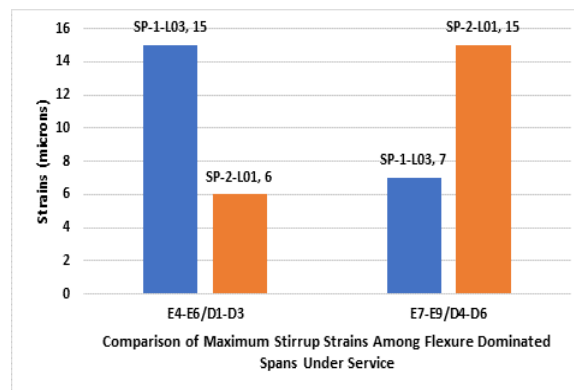
Figure 34. Comparison of maximum stirrup strains recorded for loading setup SP-1-L03 and SP-2-L01 under four-point service loads.

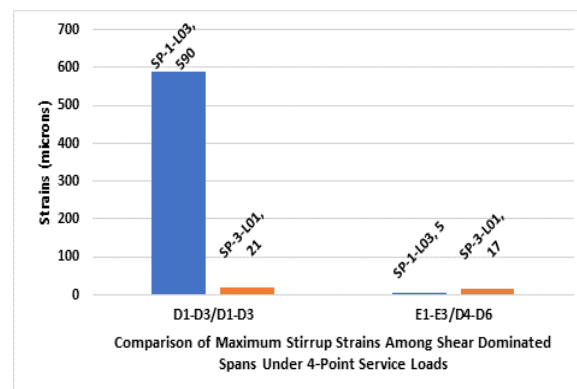
This section is similar to the previous section, except that the load case SP-1-L03 is compared with SP-3-L01. Since SP-3-L01 corresponds to the shear-dominated single-span girder subjected to service loads, its maximum stirrup strains are compared with those measured at the left-exterior span of specimen SP-1. A comparison of maximum stirrup strains in this category is presented in Figure 35. At the left exterior span of specimen SP-1, stirrup strains reached approximately 590 microns. On the contrary, specimen SP-3 did not mobilize strains of the same magnitude at its corresponding location.

Figure 35. Comparison of maximum stirrup strains recorded for loading setup SP-1-L03 and SP-3-L01 under four-point service loads.

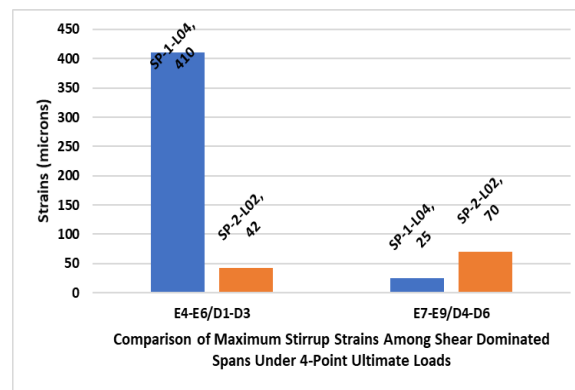
Figure 36. Comparison of maximum stirrup strains recorded for loading setup SP-1-L04 and SP-2-L02 under four-point ultimate loads.

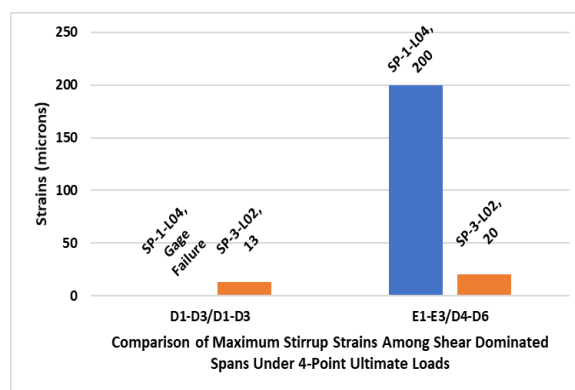
In this category, stirrup strains recorded at the left exterior span of specimen SP-1 are compared with those recorded in the stirrups of specimen SP-3 subjected to ultimate loads. The comparison is presented in Figure 37. This comparison is, again, consistent with previous results. Specimen SP-1, which was a three-span girder, was able to mobilize higher strains in stirrups at the exterior face of left interior support than the corresponding strains recorded in specimen SP3. It is worth mentioning that both load cases were designed to dominate in shear. However, single-span specimen SP3 exhibited lower demand on stirrups than that imposed by specimen SP-1. Due to the malfunction of strain gages at the left exterior support of specimen SP-1, no reliable data could be obtained.

Figure 37. Comparison of maximum stirrup strains recorded for loading setup SP-1-L04 and SP-3-L02 under four-point ultimate loads.

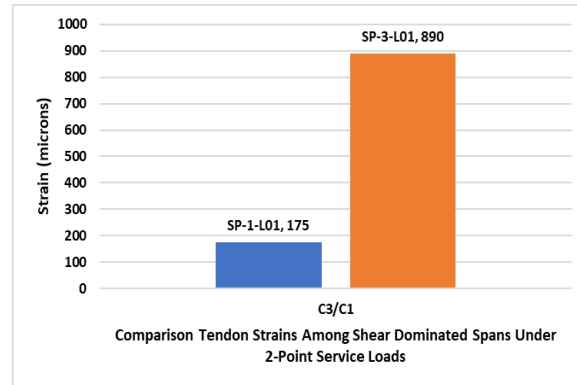
was approximately four-times higher than the corresponding tendon strain in specimen SP-1 under service loads. Nonetheless, maximum strains in both cases remained well below the yield strains of tendons.

Figure 44. Comparison of maximum tendon strains recorded under two-point service loads between specimen SP-1 and SP-3.

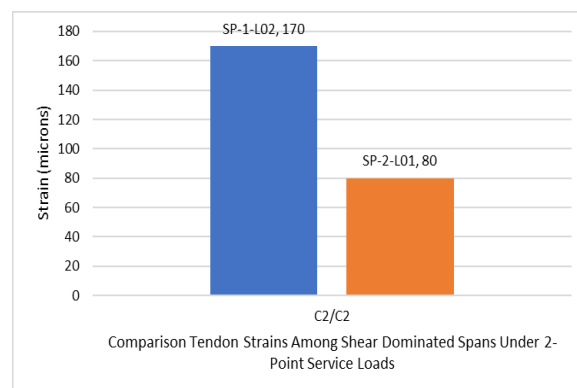
This section compares maximum tendon strains recorded in specimens SP-1 and SP-2 under two-point service loads. As shown in Figure 45, both strain values were comparable and maximum strains were limited well below the yield strain limits of tendons.

Figure 45. Comparison of maximum tendon strains recorded under two-point service loads between specimen SP-1 and SP-2.

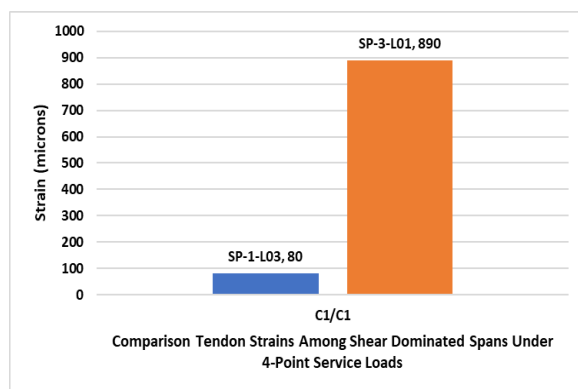
Loading setup SP-1-L03 corresponds to the application of a four-point service load on specimen SP-1. Maximum tendon strain recorded at the exterior span is compared with that recorded in specimen SP-3 under service loads, as shown in Figure 46. The trend is similar to that obtained under two-point service loads, with tendon strain in specimen SP-3 reaching as high as 890 microns, whereas the corresponding tendon strain in SP-1 only reached 80 microns.

Figure 46. Comparison of maximum tendon strains recorded under four-point service loads between specimen SP-1 and SP-3.

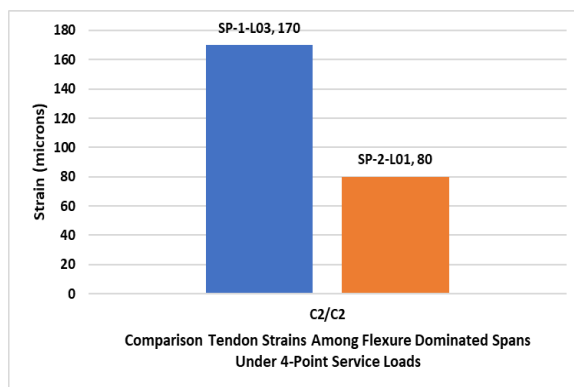
Figure 47. Comparison of maximum tendon strains recorded under four-point service loads between specimen SP-1 and SP-2.

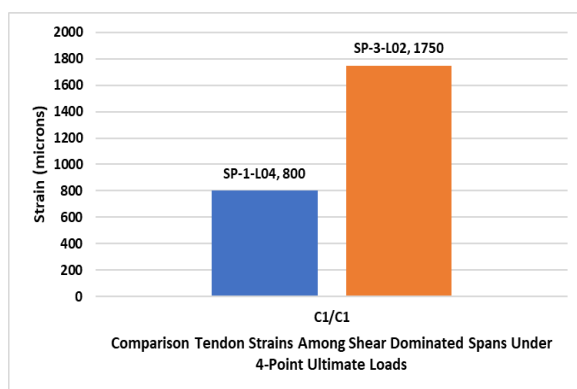
Figure 48. Comparison of maximum tendon strains recorded under four-point ultimate loads between specimen SP-1 and SP-3.

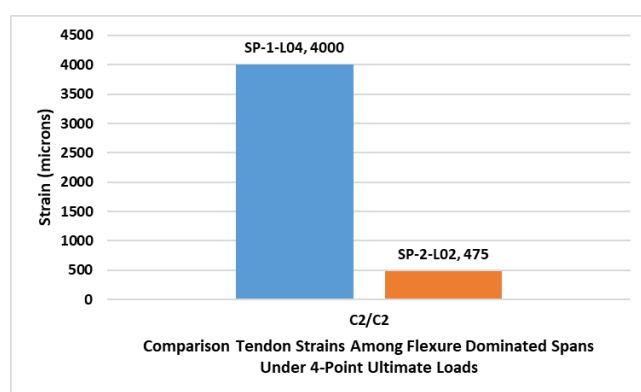
The maximum tendon strains are compared between specimen SP-1 and SP-2 in this section, with the exception that the load magnitude was increased to the ultimate limit. Figure 49 presents the maximum recorded tendon strains in this category. Specimen SP-1 was able to record tendon strains in excess of the yield limit. However, single-span specimen SP-2 was able to record 10-times lesser strains than those mobilized by specimen SP-1 under ultimate loads, which is basically due to the damage to the strain gauge.

Figure 49. Comparison of maximum tendon strains recorded under four-point ultimate loads between specimen SP-1 and SP-2.

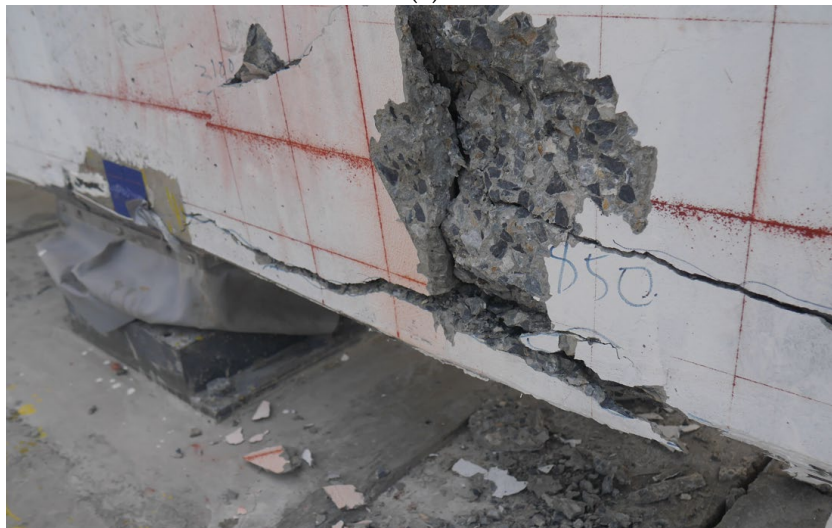
Further, under the service loads, no cracks were observed in specimen SP-1 at any location. The first cracks were observed in the midspan of the interior girder at a load of 550 kN. Cracks started to appear in negative moment regions near wet joints at a load of 800 kN. The first flexural crack in the midspan of the left exterior girder was observed at a load of approximately 1200 kN. No flexural cracks were observed in the right exterior girder till a load of 2000 kN. At this stage, the first crack appeared in the negative moment region of the right exterior girder. At the ultimate load, wide flexural cracks were observed, whereas severe cracking was observed near the wet joints. In addition, severe crushing of concrete was observed near the supports (Figure 50).

Figure 50. Ultimate failure of specimen SP-1, (a) line diagram, (b) concrete crushing.

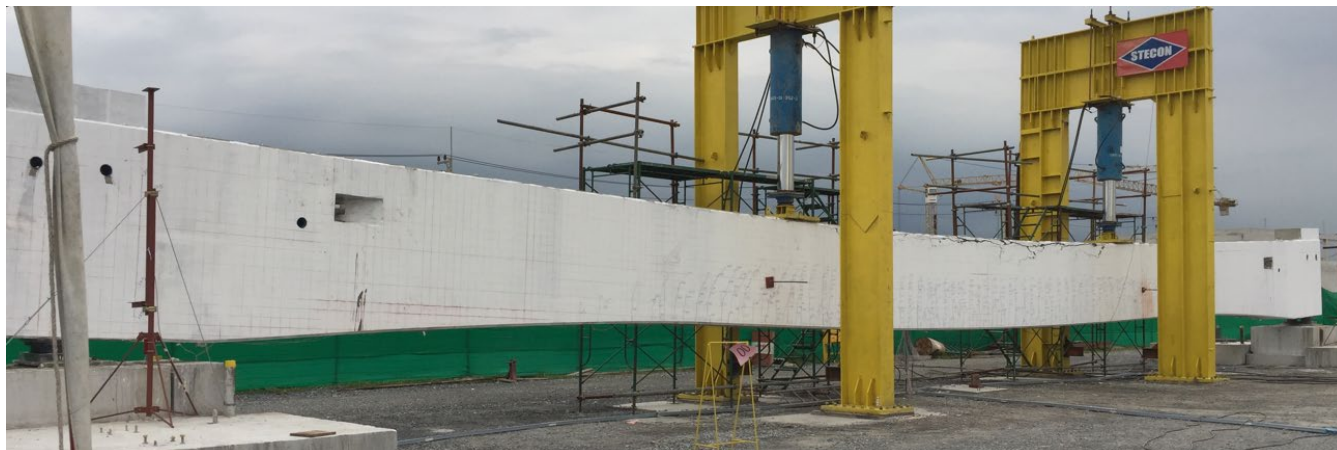
Specimen SP-2 did not exhibit any cracking under the service loads. Cracks in the positive and negative moment region of the left support started to appear at the load of 475 kN. Cracks near the right support appeared at the load of approximately 575 kN. A further increase in the load witnessed widening and propagation of cracks along the height of the girder. The final failure of specimen SP-2 accompanied severe concrete crushing and bearing support failure (Figure 51). Similar to specimens SP-1 and SP-2, no cracks were observed in specimen SP-3 within the service load limits. The first flexural cracks were observed at the load of 510 kN, whereas the first cracks at the right and left supports were observed at loads of 600 and 700 kN, respectively. The final failure of

Figure 51. Ultimate failure of specimen SP-2.

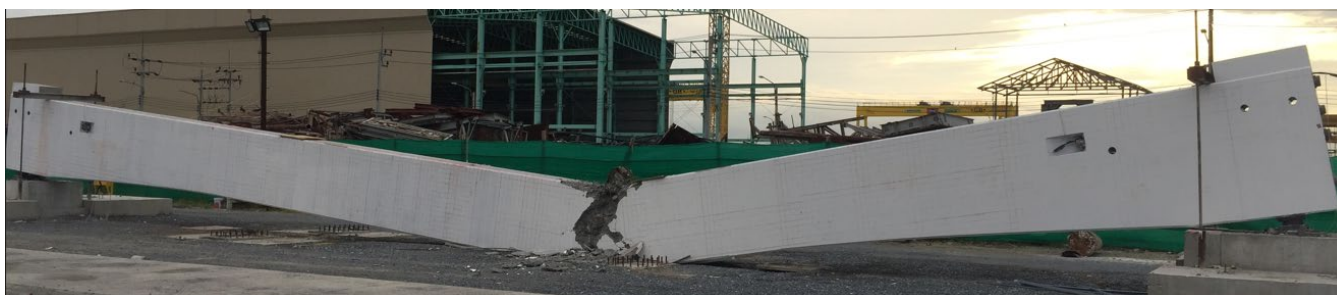
specimen SP-3 also experienced concrete crushing in the compression zone of midspan, buckling of longitudinal steel bars and tendons, and failure of bearing supports following sudden collapse, as shown in Figure 52.

Figure 52. Ultimate failure of specimen SP-3.
